RESIDENTIAL BUILDING SURVEY

OF
Luton, Beds LU2

1950's
Semi-detached Property

INDEPENDENT CHARTERED SURVEYORS

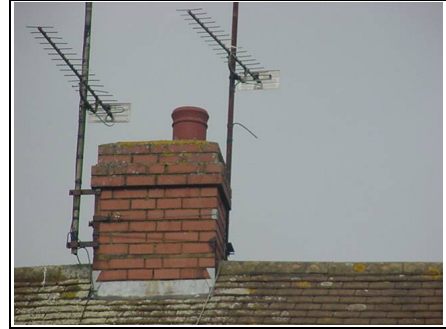
Main chimney in the middle of the property

ACTION REQUIRED: Carry out a general high level check to the chimneys, the ridge tiles and the roof before the summer of 2012 to stop any future deterioration and dampness.

ANTICIPATED COST: In the region of £1000-£2000.
You are likely to need some scaffolding as well; quotations should be obtained.

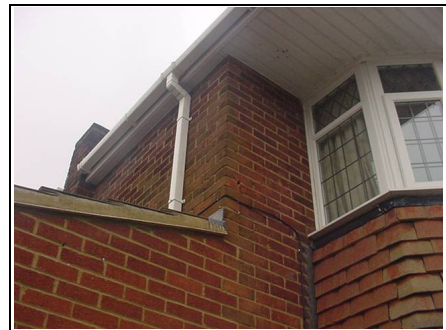
There is a very awkward gutter that has been formed for the garage that sits over your left hand wall. This means that if it leaks it gets damp. However, what is probably far worse is that the water from the garage roof discharges against your neighbour's wall in No 24 Kingsdown Road. We knocked on the door to have a chat with them about any problems they have but unfortunately no-one was in at the time of the inspection.

Awkward guttering

ACTION REQUIRED: You need to speak to your neighbour before you purchase the property and view the inside of the garage to see what problems are being caused. You could minimise the problem by adding a lead flashing to your neighbour's wall but for this you would need their permission.

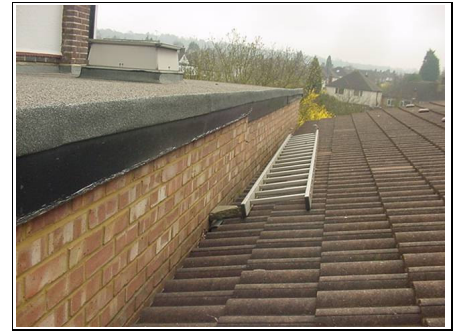
Awkward guttering

ANTICIPATED COST: In the region of £1000-£2000 as this is very awkward work. We would also add that should the gutter leak it will leak onto an "I" beam beneath it so you need to check that this is not rusting from time to time.

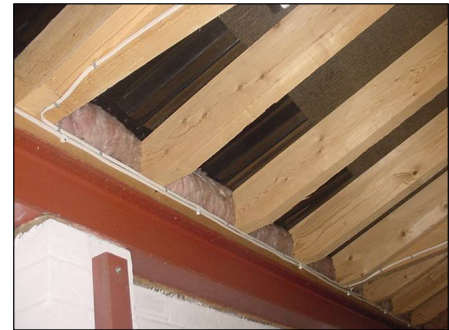
"I" beam sitting under the awkward gutter detail

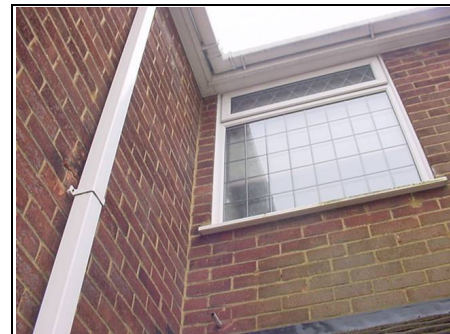
We note that the windows had no trickle vents and that some of your radiators were internal. This means there is a lack of general air movement and airflow within the property which increases the likelihood of condensation. You need to ensure that any moisture/humidity created in the bathroom and kitchen needs to be extracted from the area as quickly as possible.

Plastic double glazed window without trickle vents

ACTION REQUIRED: The best way to do this is to have extract fans that are thermostatically controlled, recommend these are added.

ANTICIPATED COST: In the region of £150 - £300 and always recommend that extract fans are added; quotations required.

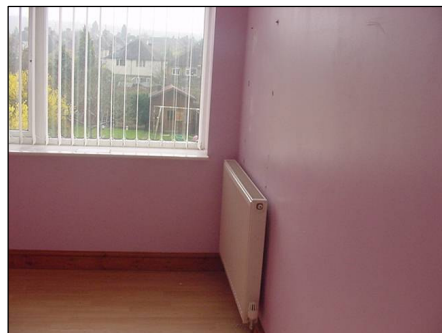
The property has internal radiators. Where internal radiators are used you have a higher than average chance of having condensation as you do not get the same amount of air flow around the property as you do when radiators are positioned underneath the windows. Where the warm air rises it meets the colder air of the window and circulates around the room.

Internal radiators

ACTION REQUIRED: Relocate the radiators underneath the windows

ANTICIPATED COST: A few hundred pounds per radiator; quotations required.

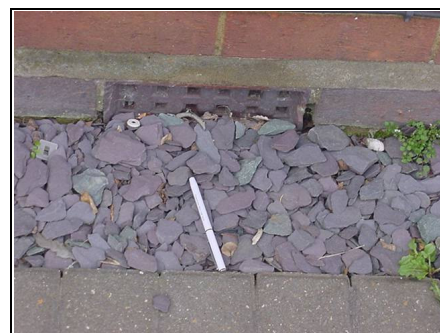
Air bricks acting as gutters

ACTION REQUIRED: You need to protect the air brick and ideally open up the floor to check its condition before you purchase the property. To elaborate further, you have a suspended timber floor which can be affected by dampness getting into it.

ANTICIPATED COST: A few hundred pounds to open up the floor and protect the air bricks. Protection of the air bricks is normally done by putting bricks on edge around them. In a worst case scenario there may already be damage to the timber under the floor; quotations required.

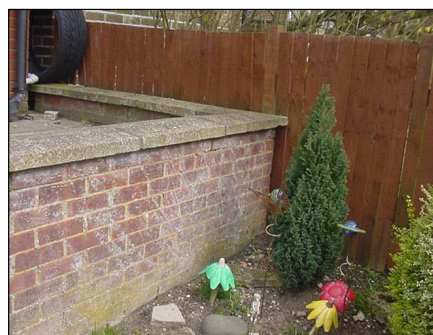
Rear retaining wall

ACTION REQUIRED: Add weep holes.

ANTICIPATED COST: Protecting the air bricks and opening the floor we would expect costs in the region of £500-£1000. Remember it is very important that the floors are opened up as currently the condition of the floor is completely hidden by the vinyl floor covering. To the rear the adding of the weep holes a few hundred pounds for a diamond core drill; quotations required.

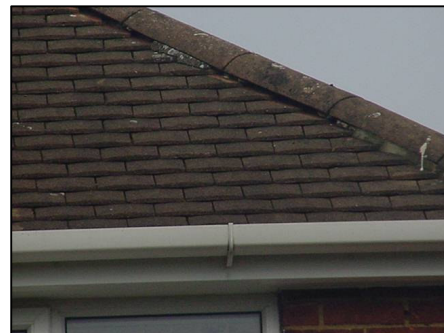
We did notice minor movement in the property and some mortar missing to the ridge of the hipped roof. This often applies to movement in the roof but we can also see some hairline cracking internally. We are slightly concerned that the new decoration internally could be hiding latent defects in the structure.

Mortar missing to ridge of hipped roof

ACTION REQUIRED: We would recommend your solicitor specifically asks the existing owners if there has been any structural movement in the property and if a structural claim has been made with regards to the property.

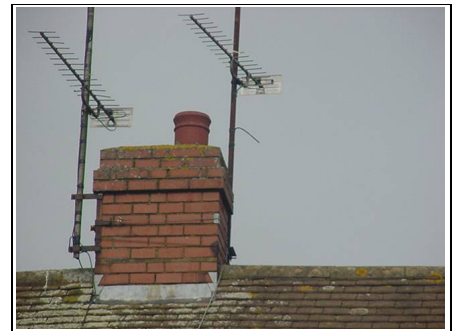
Chimney one

This chimney is built in brick with a lead flashing and one chimney pot. From what we could see the chimney looks weathered and we can also see some moss to the top of it. We were unable to see the very top of the chimney known as the flaunching, we therefore cannot comment upon it. We suspect from the moss we can see that there will be some deterioration.

ACTION REQUIRED: Carry out repointing as soon as possible, check flashing immediately and replace with lead in the long term.

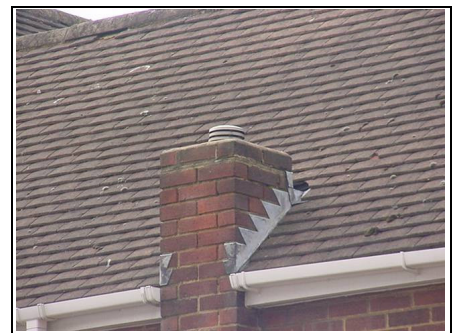
Chimney Two

This chimney is brick finished with a lead flashing and a flue. Brickwork pointing looks slightly weathered.

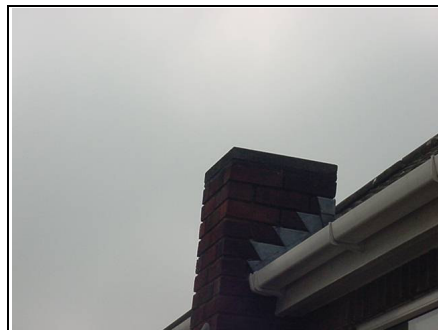
Chimney Three

Again this brick built chimney is slightly weathered and we would recommend it is viewed when the main chimney is viewed. In this case the chimney looks to be capped and we notice there is a vent there for the Worcester boiler in the rear left hand bedroom.

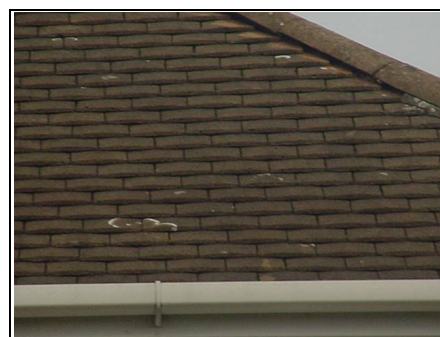
Main roof

The roof is pitched and clad in a small nibbed concrete tile. From what we could see the concrete tiles are lying level and true and look in average condition. We did note that the pointing to the ridge needs renewing and you will need to periodically check these.

It is noted that there were some areas of moss on the roof. This can build up and ultimately block gutters. Ensure the gutters are cleared periodically. Sometimes we find that deterioration occurs to the ridge as in this case and exposed areas such as the perimeter and so you should periodically check these areas.

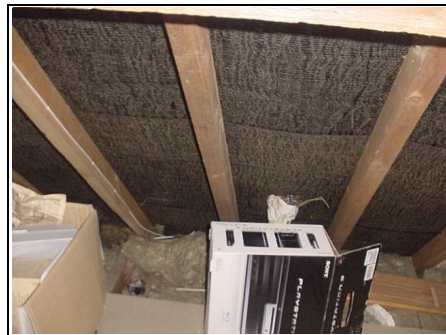
When we inspected the loft space we found a Hessian base Bitumen membrane. This type of membrane has been used since the 1960s. We generally found it to be in average condition, it is damaged in a few more places than we normally find.

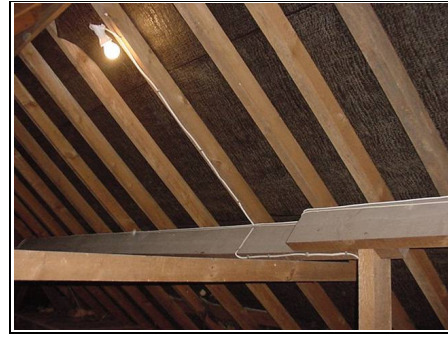
Roof timbers

We found the roof timbers generally in average condition considering their age. There was an unusual stepped purlin detail. We have inspected the roof structure for:

Our examination was limited by the general configuration of the roof, the insulation and stored items. As mentioned what we could see was generally found to be in average condition with exception of the stepped purlin detail. It is feasible that there are problems in the roof that are hidden.

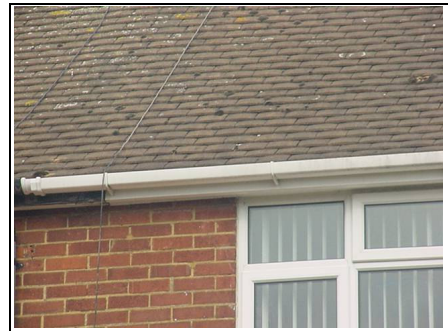
Guttering

The property has profile gutters from ground level and look to be in reasonable condition and be formed of plastic. We would comment that there is moss on the roof which can block the gutters. We also note that you have a different profile gutter to your neighbour. They have a half round gutter and you have a shaped square gutter. This can cause problems but you do need to look to have the correct connector fitted. Although we would add, from our experience, half round pipes work is better than profile pipes or drain pipes such as these.

ACTION REQUIRED: We would always recommend that the gutters and downpipes are cleaned out, the joints are checked and the alignment checked to ensure that the gutters fall towards the downpipes.

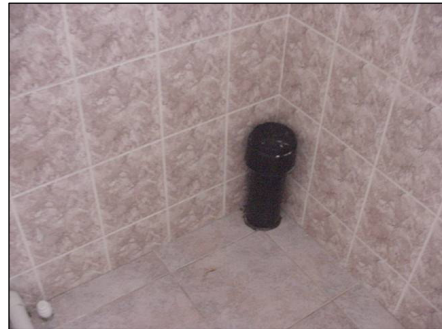
There is an internal soil and vent pipe located in the bathroom. These are known as air inlet valves and are a fairly modern invention. We are not a great lover of internally vented pipes and much prefer them to be vented externally.

ACTION REQUIRED: Ideally extend the soil and vent pipe so it becomes externally vented.

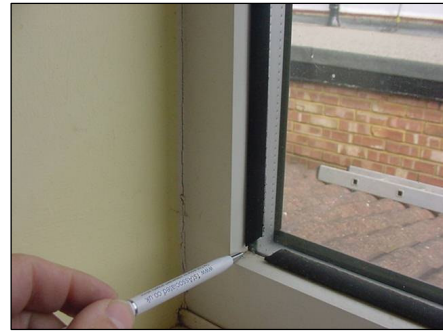
We would draw your attention to the fact that sealed double glazed units can fail, particularly as a result of poor workmanship during installation. Failure of the seal leads to condensation between the two panes of glass and simply replacing the affected units may not provide a satisfactory long-term solution. In this case they are in average condition.

Seal not finishing properly

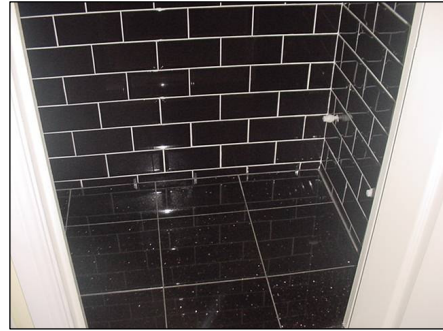
We cannot imagine that the small shower under the stairs is not getting condensation. It does of course depend how you use it and for how long. We can see no obvious signs of condensation, however, it depends upon how you utilise the building.

Small shower

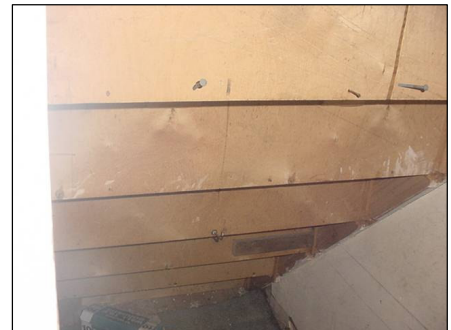
Underside of staircase
(unlined)

Would recommend it is lined.

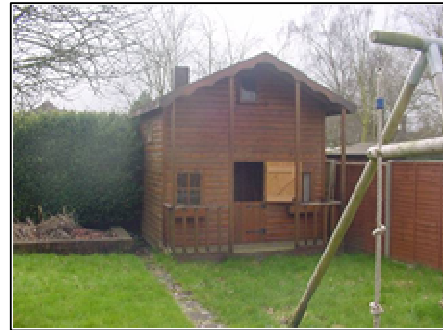
Wendy House – it is likely to require Planning Permission or it needs to be taken down.

Huge Wendy House
