RESIDENTIAL BUILDING SURVEY

XXXXXXXXXXXXX,
Luton,
Bedfordshire,
LU3

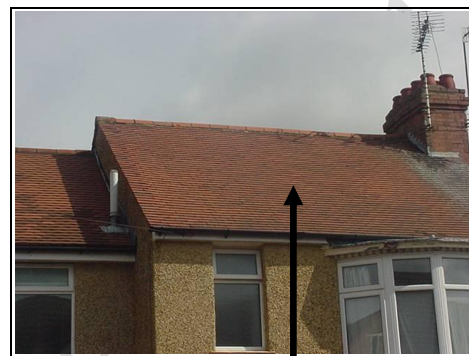
The original roof has nibbed tiles without a protective underlayer. This type of roof has been superseded by a modern roof with a protective underlayer. We would recommend that a protective underlayer is added to the roof.

Original roof

ACTION REQUIRED: Within the next five to ten years we would remove the existing roof and add a protective underlayer, re-batten and add the tiles. You will probably have in the region of thirty per cent waste so you will need to replace some of the tiles.

ANTICIPATED COST: In the region of £5,000 - £7,500 (five thousand to seven thousand, five hundred pounds) assuming that some tiles can be re-used. A substantial part of the cost for this type of work is for the scaffolding. Many insurers/companies now require the properties to have scaffolds not only to the sides but also to be roofed over to protect against weather damage; please obtain quotations.

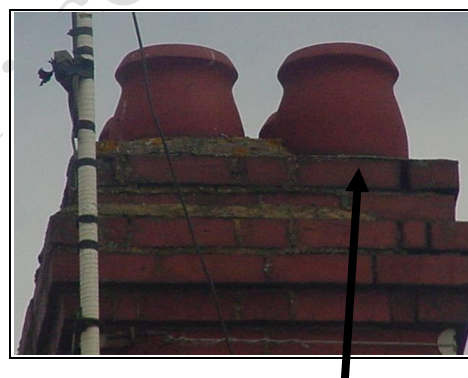
We can see in the top front bedroom sulphate attack from the chimney. This is normally caused where dampness gets into the chimney and is drawn through the soot causing damage and deterioration.

Some of the flaunching is missing. We believe this is where the damp is getting in.

ACTION REQUIRED: Repairs are needed to the chimney. Again this is likely to require scaffolding and this will be the most expensive part of the cost

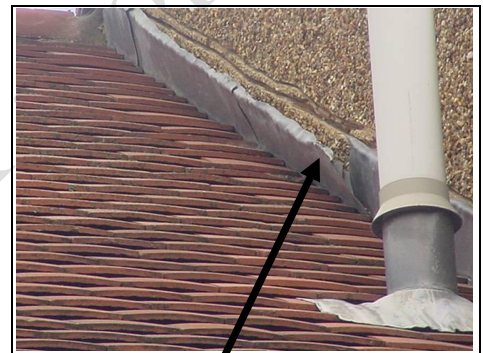
Close up of flashing coming away

ACTION REQUIRED: We would recommend a tradesman that is used to carrying out lead work is used. We prefer to see bonding in Plumbers Mate or equivalent mastic to bed the lead into the wall.

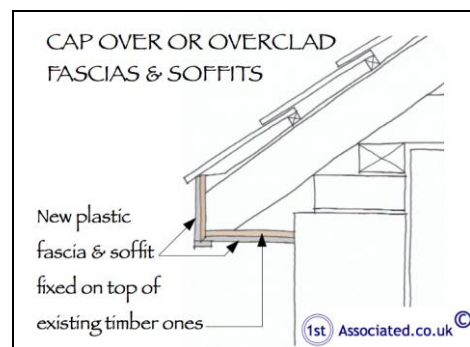
Over cladding

This is a practice that we are not at all keen on as it is usually put over the top of damaged or deteriorating timber fascias and soffits. Although it gives a clean look externally it can promote rot internally and in a worst case scenario can damage the roof joists.

ACTION REQUIRED: Drill and check to see if it is plastic over cladding. If it is then we suggest that it is all removed and replaced with a new fascia and soffit.

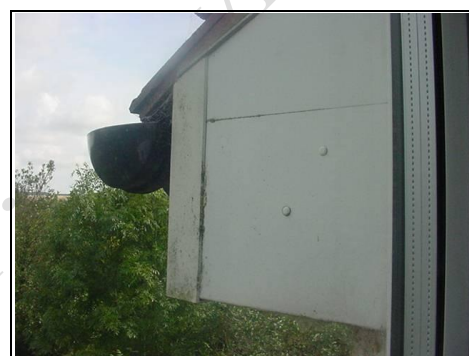
Plastic over cladding

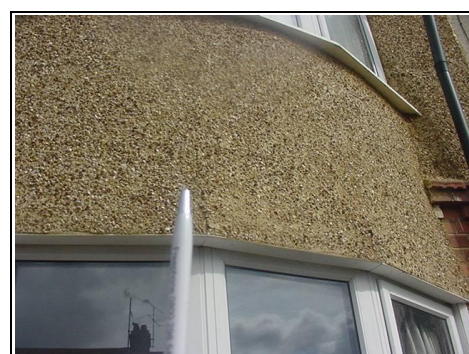
We can see cracking in the pebbledash render. In this age of render there is likely to be on-going maintenance.

Crack in pebbledash render on bay window

ACTION REQUIRED: To the front we would leave and repair the render in due course. To the rear we would open up above the windows and investigate to see what is there. As we discussed you have a business in double glazing. There may be no lintel in this area. The concern is that the windows slightly exceed the soldier course of bricks above them, which is unusual. There may be other problems that are revealed when the double glazing is removed.

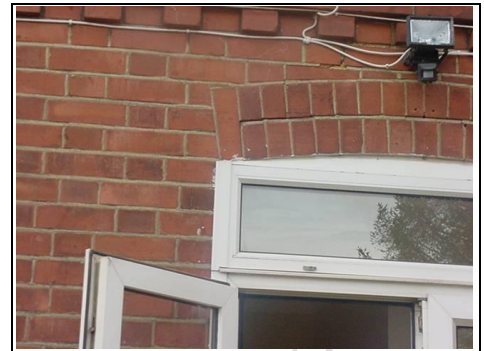
The cracks to the rear appear to relate to the plastic windows that have been put in. We would add that these windows are from the cheaper end of the market and as such may not have metal within the frame (to give additional stability).

Brick movement over the rear windows

ANTICIPATED COST: Likely to be thousands of pounds with further investigation required; please obtain quotations.

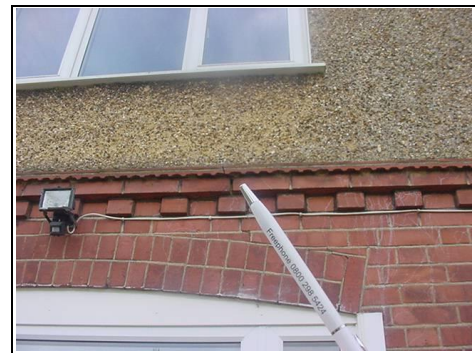
Cracking to rear window

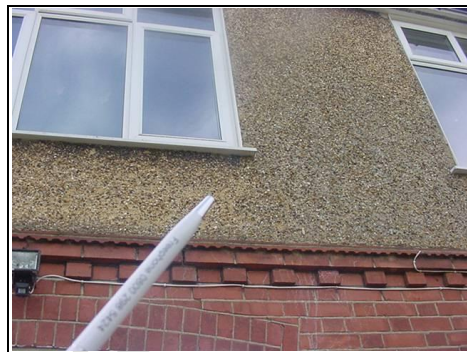
Cracking in render (rear)

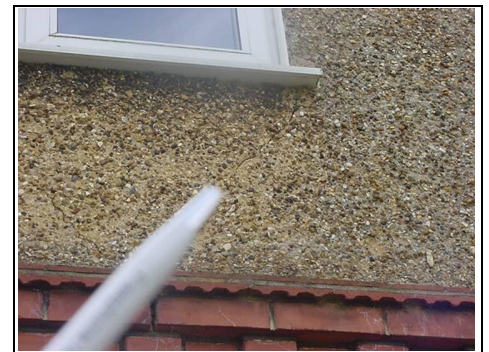
Closer view of cracking

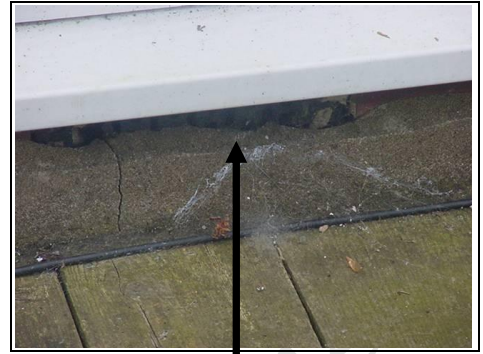
Covered over air brick (rear)
behind decking

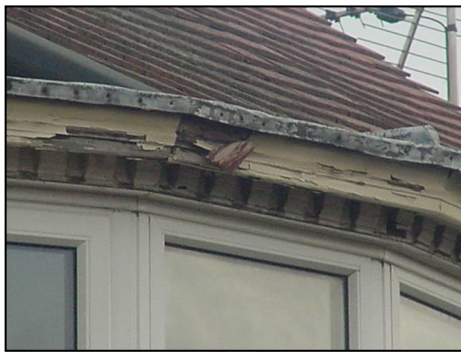
Dampness to the flat roof of the bay window

Bay window –shows how the
roof has failed

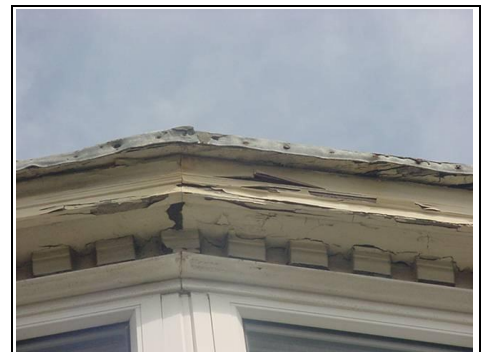
The fascia boards and soffit boards are in poor condition at the front of the property and look as if they are letting in dampness.

Deterioration to fascias and
soffits

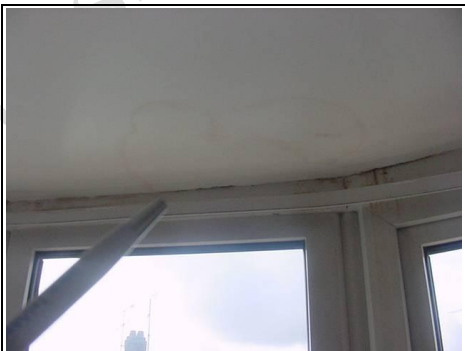
Dampness internally

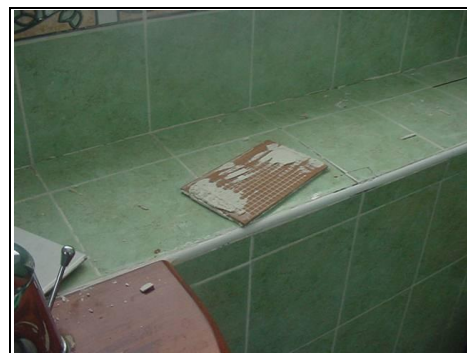
You commented that there had been damage caused in the shower room since you last visited (this is the shower room in the new part of the property). There looked to have been a leak of some sort that has been resolved by switching off the W.C. This does leave you with some damaged tiles that may be difficult to repair/replace.

Damaged tiles in shower room

ACTION REQUIRED: Replace the tiles if possible or if not you need to allow for re-tiling.

ANTICIPATED COST: In the region of £250 - £750 (two hundred and fifty pounds to seven hundred and fifty pounds); please obtain quotations.

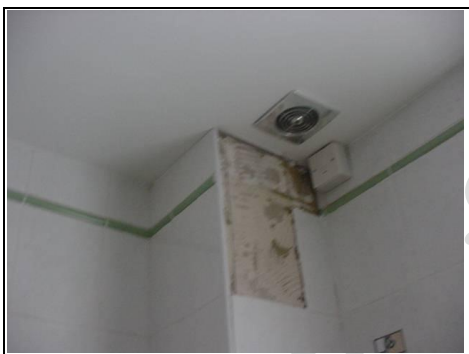
Tiles that have come away

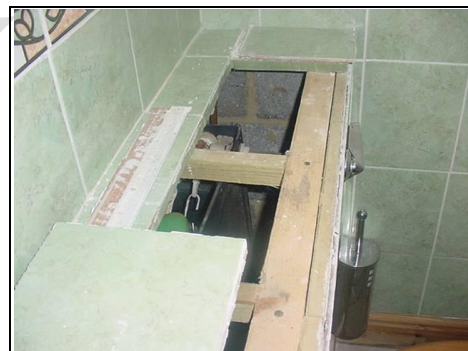
W.C needs repair

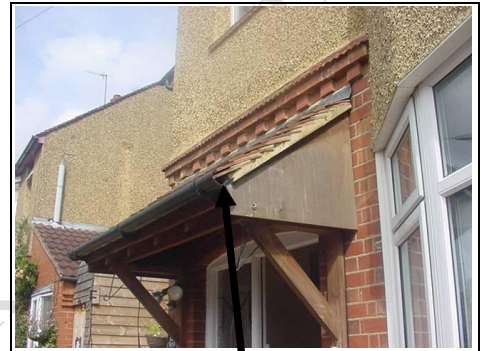
There is a small porch to the front of the property with a single pitch roof in a similar tile to the main roof. We would comment that there is no downpipe from the gutter. The end cap is missing and will allow water to travel down the front of the door. We would also refer you to our comments on lead flashing within the Executive Summary.

Porch roof with end cap missing

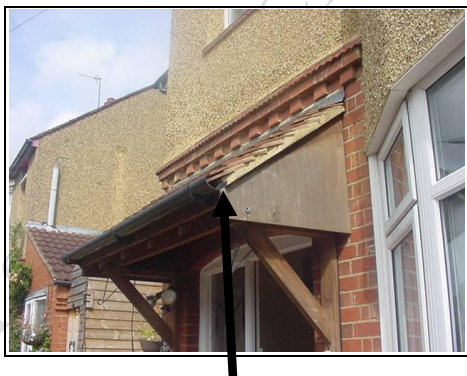
Missing end cap to gutter front entrance or is it a missing down pipe?

We would also recommend that the gutters and downpipes are cleaned out, the joints are checked and the alignment checked to ensure that the gutters fall towards the downpipes.

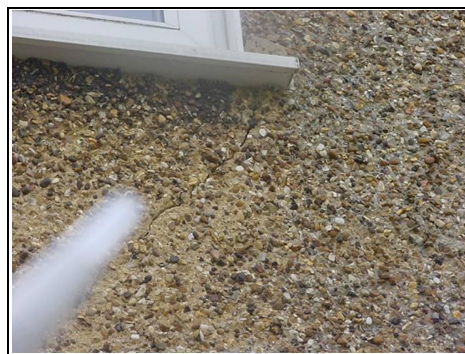
The cracking in the render mainly relates to the plastic windows that have been added in. It is also in part to do with the old age of the render.

Cracking in render

ACTION REQUIRED: Carry out render repairs.

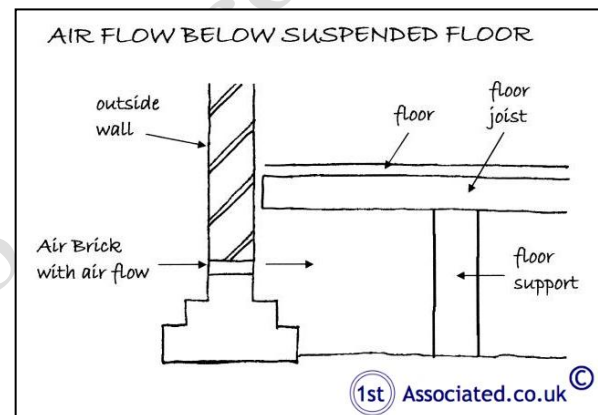
Air brick at rear, possibly blocked

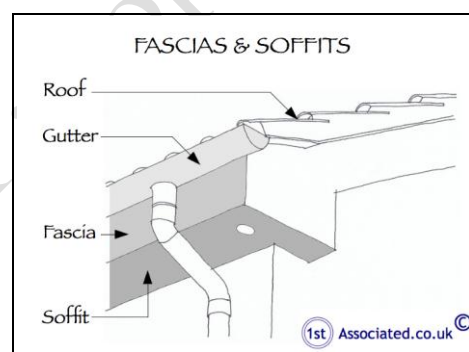
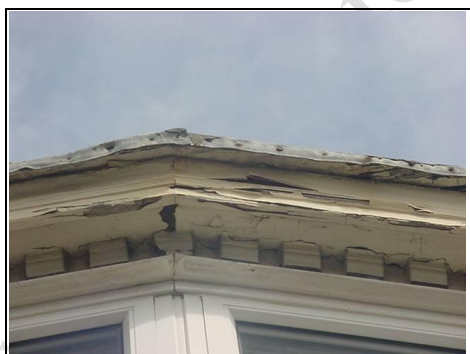
Timber fascias and soffits over bay window are in poor condition.

ACTION REQUIRED: Please see our comments and photo within the Executive Summary regarding over cladding.

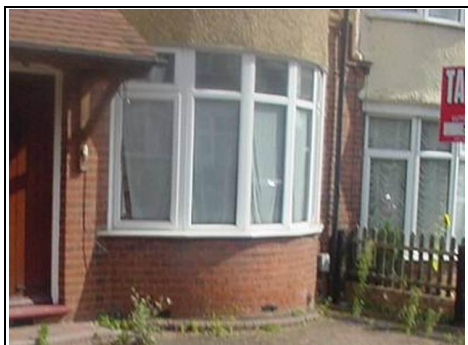
The property has plastic double glazed windows. The windows in the original property do not have trickle vents and we would term them as being from the cheaper end of the market. We are concerned that they do not have additional structural elements in the windows to the bay and to the rear which has caused the movement in the walls.

Old bay window without trickle vent

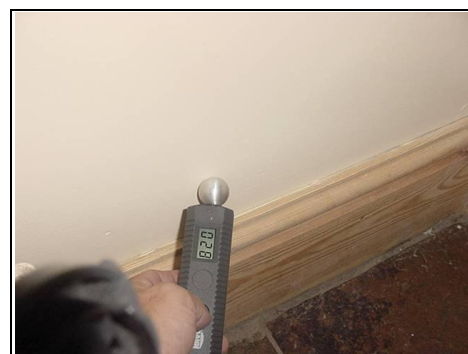
A visual inspection and tests with a moisture meter have been taken to the perimeter walls. In this particular case we have found some rising damp to the front bay although this was relatively minor.

Testing for rising damp

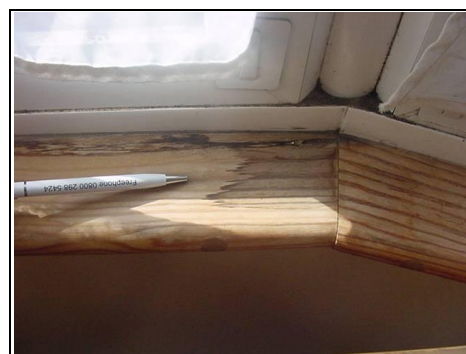
At the time of the inspection the property was empty and as such signs of condensation are hard to spot. However we did note staining to the front bay window which may well relate to condensation in this area.

Possible sign of condensation

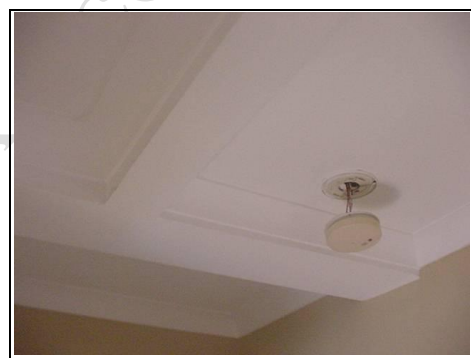
Some smoke detectors were noted, although one was literally hanging from the ceiling. The current Building Regulations require that they be wired into the main power supply. Obviously in a property of this age this is difficult, as it would mean having surface mounted wires or cutting wiring into the plaster.

Smoke detector has fallen out of ceiling

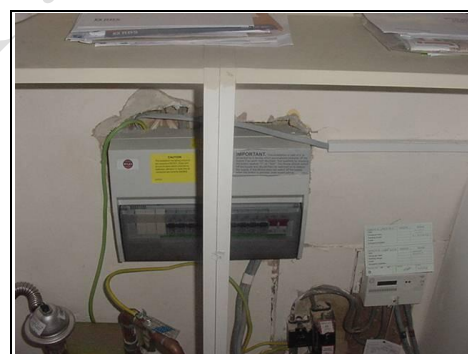
The electric fuses and consumer units were located in the cupboard under the stairs. The fuse board looked slightly dated and better are now available. There should be test certificates available as the property has been rented out. We would also comment that we noted what we class as DIY electrics.

Fuse Board

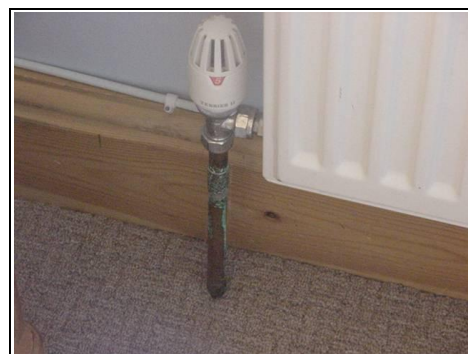
Radiator is leaking slightly

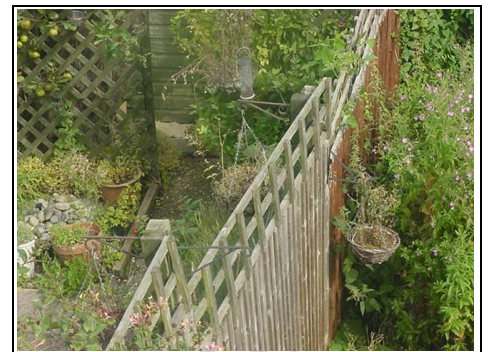
Fence needs repairing (rear left)
