RESIDENTIAL BUILDING SURVEY

Buckinghamshire

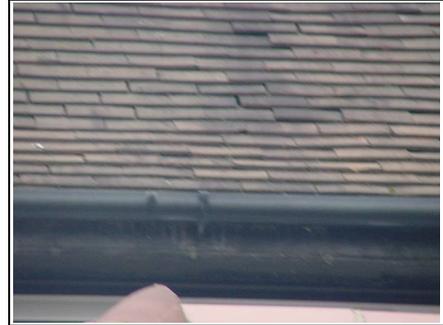
The property has an original clay tiled roof which is nibbed, sitting onto a tapered close boarded roof. In our experience whilst these roofs are very strong, which is important with a hipped roof as this is, we have come across problems with spalling to the nibs and spalling in general. We could see in this instance that adjoining roofs have been replaced and we feel that this roof is a risk. Unfortunately we cannot see the underside of it properly due to it being insulated and lined although we did open up a small section of approximately 1% of the roof and of course we have experience of these types of roof problems.

Roof – be aware of problems

ANTICIPATED COST: We feel that you should be looking for a £10,000 - £15,000 reduction in the price of the house to reflect the future risk of the roof repairs or the present owners can open up the roof or re-roof the property (note next door have a new roof). Please obtain quotations.

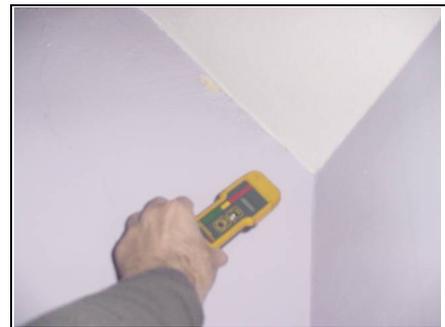
We can see staining to the valley gutters, particularly in the roof conversion. Although we didn't obtain excessive damp meter readings we did find some in the rear right hand bedroom (all directions given as you face the front of the property).

Dampness in rear right hand bedroom

ACTION REQUIRED: We wouldn't advise buying this property unless you are happy to carry out future repairs, possibly re-roofing in the not too distant future. The number of years is very difficult to estimate without opening up the roof, the close boarding beneath it does hide any problems (as well as making it a very strong roof) but it is the water-tightness that is in question in this instance.

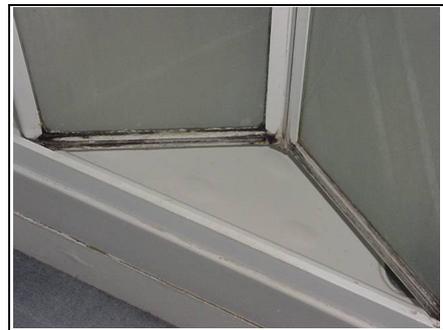
There have been condensation problems in this property and there still are. We believe this to relate to the humidity generating areas such as the bathroom (in particular the bathroom) and the kitchen. This together with a combination of factors of the age of property and the style of construction results in condensation.

Mould in shower

ACTION REQUIRED: Add humidity controlled large extract fans into the bathroom and the kitchen and make sure that the property is adequately aired and vented. We do believe it will be difficult to get rid of the condensation; depending upon your lifestyle and number and age of people in the property, it may prove almost impossible to get rid of.

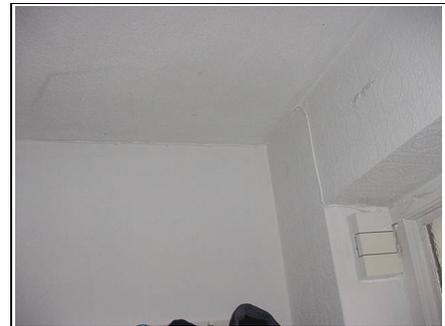
You have an older style textured paint, commonly known as artex, to the ceiling which is said to have an element of asbestos in it. We are aware that we cannot be 100% certain of this from a visual check and we are also aware that we are not asbestos surveyors.

Artex ceiling although it doesn't show up very well in the photo

ACTION REQUIRED: We would recommend that the ceilings are either sealed by painting them or that a

smooth plaster is put over them. We wouldn't of course, recommend sanding the area. If you want to be absolutely sure that it is asbestos or not, then you will need to have an asbestos test.

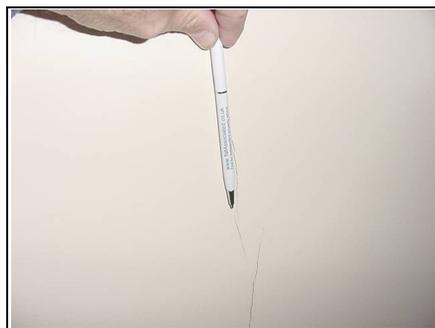
There is hairline cracking visible in many of the rooms. We believe this is due to a modern gypsum plaster being used on an old property where we believe the original lime plaster has been skimmed over or it could be a cement based hard render that has been plastered over; either way, it has resulted in hairline cracking occurring. This is combined with general moisture and condensation that is occurring in the property which creates hairline cracks.

Hairline cracking

ACTION REQUIRED: As previously, we would recommend that you reduce the moisture in the property and better vent it, fill the hairline cracks and redecorate with lining paper.

ANTICIPATED COST: For general redecoration and filling of hairline cracks, a few hundred pounds; please obtain quotations.

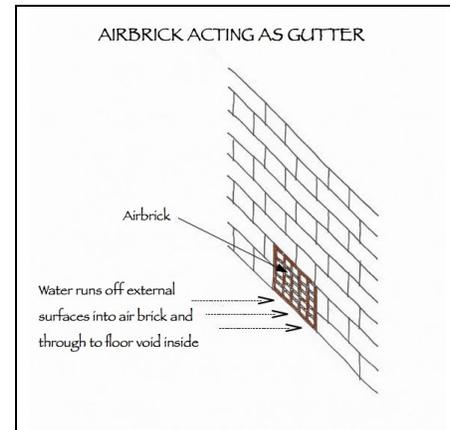
Airbrick acting as a gutter

ACTION REQUIRED: Present owners to provide sets of drawings for the extensions to check if air vents were put underneath the floor. Either way, we would recommend you open up the floors to check there is an air ventilation underneath the floors and we would recommend adding additional airbricks.

ANTICIPATED COST: Assuming the floor is not damaged or deteriorated then we would expect costs to be in the region of a few hundred pounds for adding additional airbricks, possibly more if you have to replace some timber; please obtain quotations.

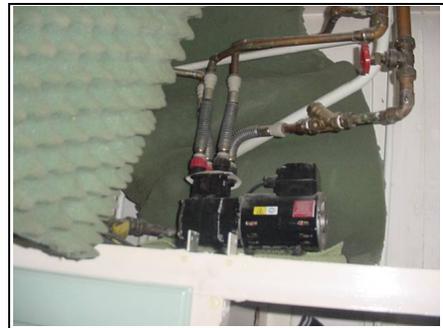
We found what looks like a pump in the office adjacent to the rear left hand bedroom surrounded by foam which indicates that it is noisy. It wasn't switched on at the time of our inspection.

Pump hidden behind insulation in study

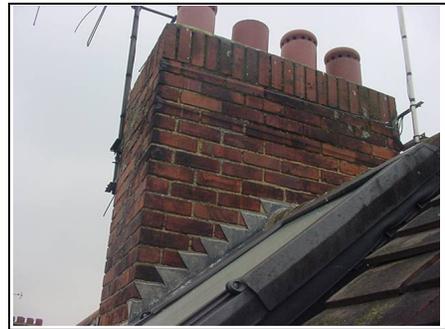
Front chimney

We noted that there are aerials on this chimney which can cause damage and cut into it like a cheese wire into cheese.

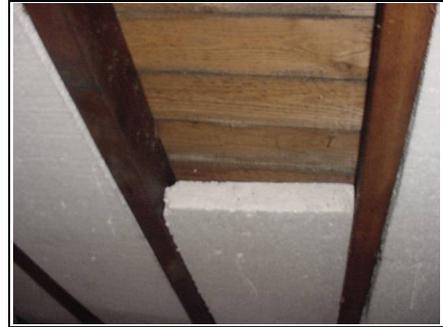
Close boarding with insulation beneath it

The tiles are nibbed tiles with no protective under layer. This means that wind driven rain can get underneath the tiles and indeed we can see that this is happening from the staining within the roof. We are always in a Catch- 22 with regard to this type of roof as although it is letting in some rain water it is not letting in that much. We have taken guidance from the adjoining roofs which show that the majority haven't been replaced; some have such as the next door roof. We would comment that looking specifically at this property that we could see some undulations in the tiles which is why we have made the comments we have in the Executive Summary.

ACTION REQUIRED: A roofer for half a day to reposition the displaced tiles. You also need to have a supply of tiles for when the roof next causes a problem. The way to see how much rainwater is coming through is to board out the roof space with an insulated roof board (insulated to give you insulation and no other reason). This would then show any new water staining onto the boarding. We would be more than happy to return and comment further once you have been in the property for a while assuming this is a risk that you are happy to take and a cost that you are happy to pay.

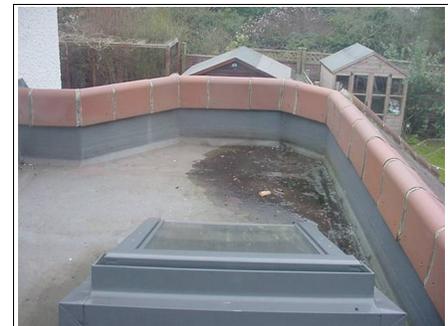
Unfortunately with this roof we can see ponding on it (this is where water is sitting on it), which does tend to deteriorate roofs quicker. Having said all of that, it is still a relatively new fibreglass roof, therefore should have some life left in it. You may live perfectly well underneath it for many years to come.

Ponding to flat roof

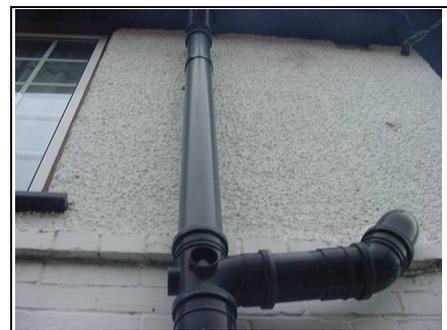
The property has plastic soil and vent pipes with a swan neck which can cause problems. We couldn't see any excessive leaks in this instance.

Bend in soil and vent pipe

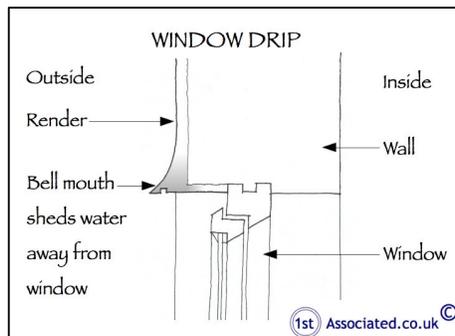
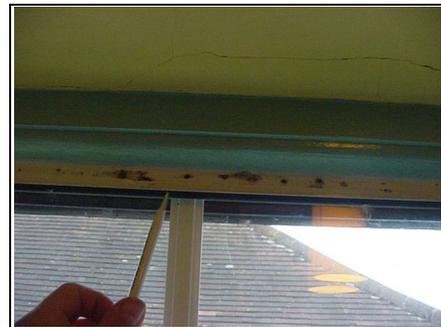
In this case we found no drip detail to the windows.

No Drip detail to windows

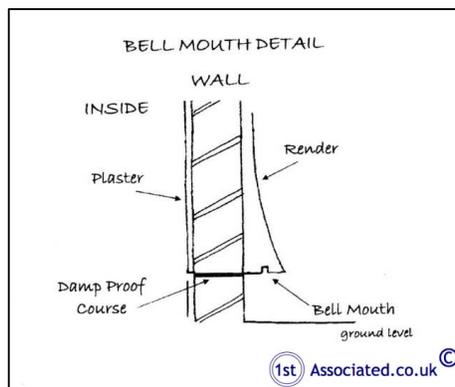
To the base of the render there was no bell mouth detail.

No bell mouth to the base of the property

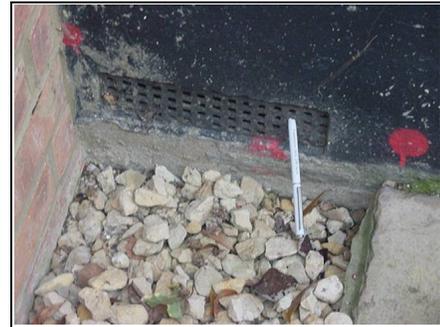
Air brick acting as a gutter

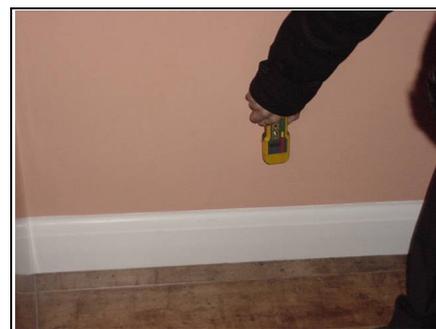
In this particular case we have found some minor areas of rising damp to the front of the property which we believe relate to dampness getting in via the hairline cracking in the render and a slightly higher ground level.

Testing for rising damp

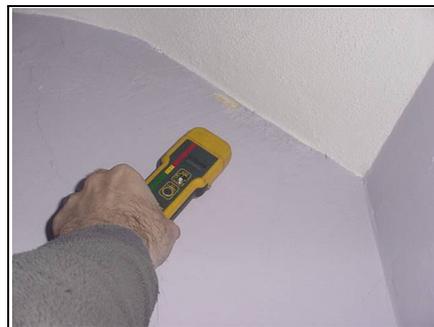
We used a damp meter on the external walls. We have found lateral dampness in the rear bedroom which we believe relates to roof problems.

Lateral dampness found in rear right hand bedroom

ACTION REQUIRED: Please see our comments in the Executive Summary.

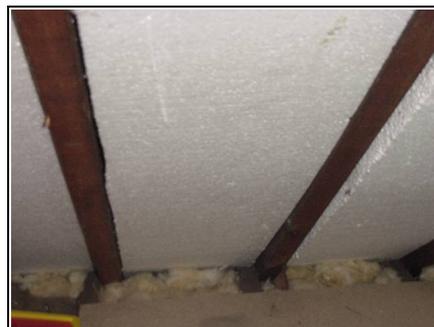
We could see some insulation between the common rafters (the ones that form the pitch of the roof) which is not an ideal location for it. We would much prefer it to be between the ceiling joists as this doesn't cause condensation in the same way. The other problem with insulation between the common rafters is that it hides any dampness that is coming through from the roof above.

Insulation board in roof space

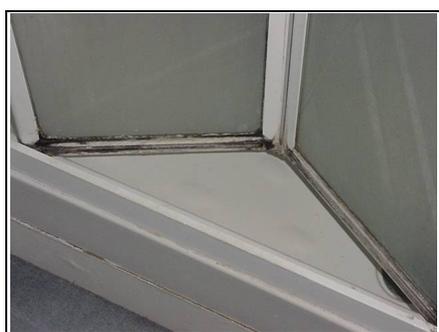
Mould to bathroom
