RESIDENTIAL BUILDING SURVEY

Merton, London. SW19

Firstly, may we thank you for your instructions of XXXX we have now undertaken a Building Survey (formerly known as a Structural Survey) of the aforementioned property. This Survey was carried out on XXXX

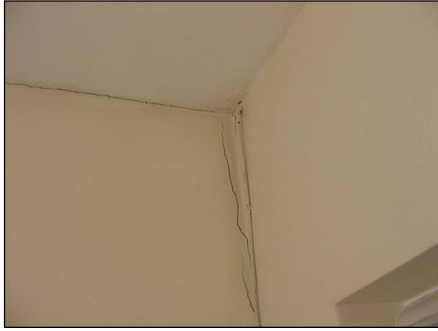
- 1.1 There has been movement to the rear of the property and to the right hand side. We believe that the movement has been caused by a combination of issues these are:-
- 1.2. DIY quality construction of the rear single storey extension not being tied into the main structure correctly.

Close up of the cracking to the wall between extension and original building

ACTION REQUIRED: An insurance claim needs to be made by the existing owners particularly concerning the rear extension identifying this movement. We also recommend that you have a closed-circuit TV camera report carried out in the drains as soon as possible, this is in your best interest to identify if there are any leaks to them. This is likely something that the insurance company will do as well as monitoring the property but we feel it would be prudent to have it carried out as quickly as possible.

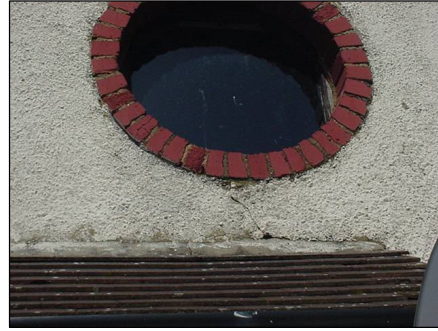
Cracking to the rear render really concerns us.

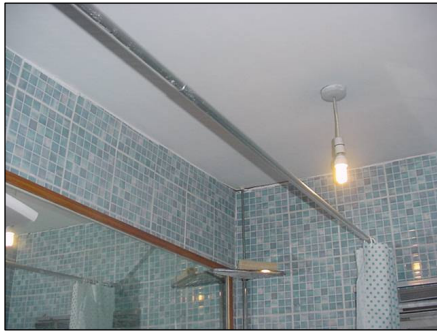
Movement between wall and ceiling in the first floor bathroom

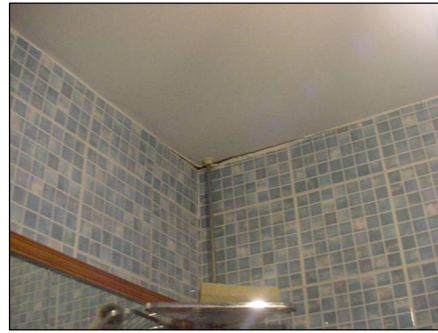
Close up of movement

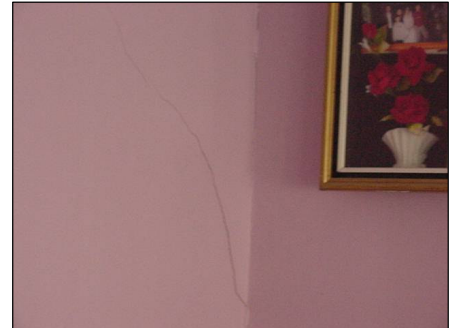
2.1 There is also movement to the right hand side of the property which we feel is a combination of issues including the movement mentioned above to the rear extension and also and mainly we feel it is due to removal of the original structural studwork partitions and replacement with a modern structural partition. This combined with the removal of the wall on the ground floor which has then had a lintel put on it, as you are aware and as we showed you, we could see the deflection present in the floor. Another possible issue could be leaking drains as they run along the right hand side of the property.

Cracking to the right hand side walls and ceiling

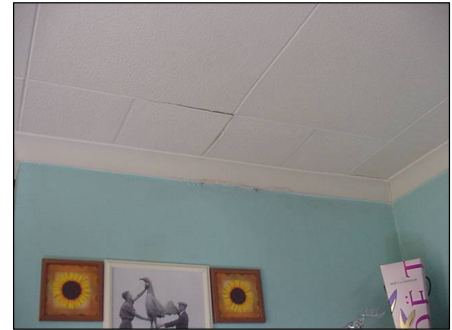
Dampness coming into the rear right hand chimney

ACTION REQUIRED: The chimneys need re-pointing and the flashings checking. This is high level work and we recommend that professionals carry this out.

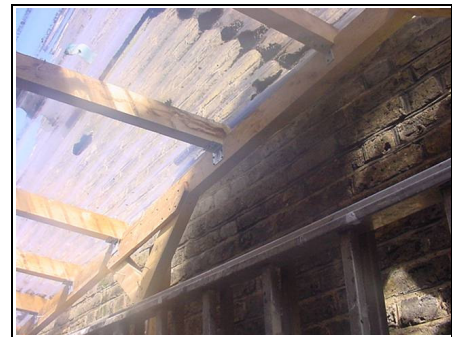
Amazing construction of left hand garage

ACTION REQUIRED: You need to speak to your left hand neighbour and check to see if there is any dampness coming through and we would suggest that the structure is completely separated from your neighbours' property.

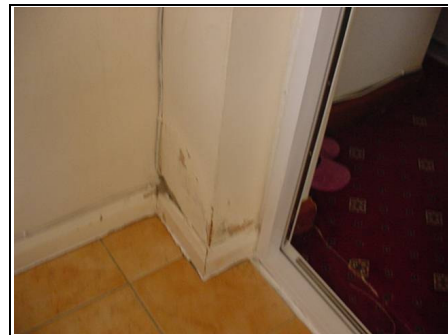
The property to the rear extension has rising damp, which again calls into question the quality of the build or it could relate to a combination of factors such as:-

Rising damp

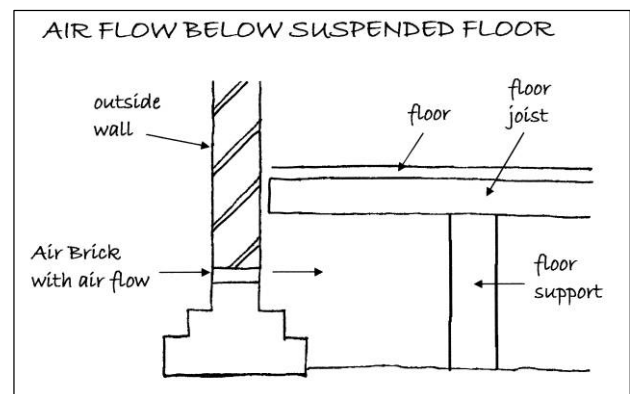
The suspended timber floor, you are meant to have a through flow of air which is being blocked although we did note airbricks to the front and the right hand side of the property but the airbricks to the rear looked to be blocked.

Rear airbrick partially covered

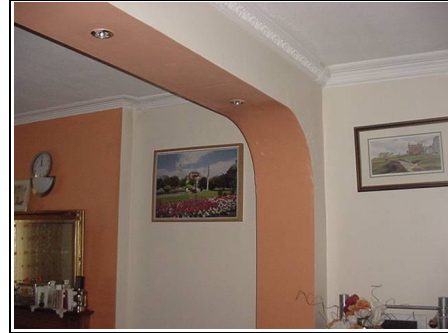
The first floor right hand side (all directions given as you face the property) bedrooms floor deflects more than we would expect. There are stress marks in the walls, this we think is in relation to the floor not having appropriate support and the central wall having been replaced and where it takes the strain from the supporting struts from the roof above.

Wall removed

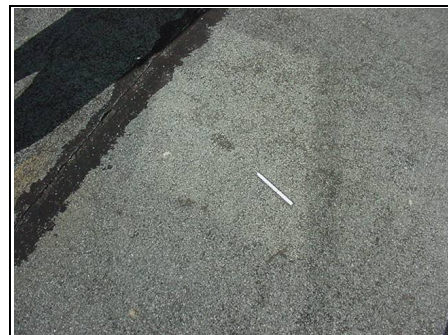
There is a felt flat roof and our main concern is that the roof is flat and does not fall towards the outlet. In addition to this the felt covering is also blistering and needs repairs to these areas. We would also add that the lead flashings have been incorrectly embedded into the wall using cement mortar and this should have the appropriate mastic.

Blistering to roof

ACTION REQUIRED: The cement mortar to be removed from site and re-pointed in appropriate mastic.

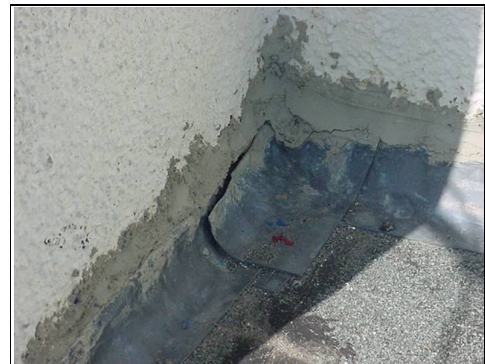
Poor quality lead flashings

ACTION REQUIRED: We would recommend replacement at the same time repair work is carried out to the main rear flat roof.

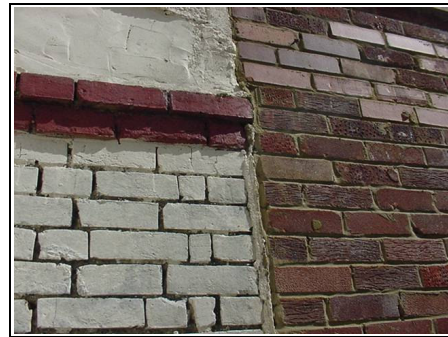
There are areas of brickwork which we would generally recommend are re-pointed in appropriate lime mortar

Brickwork needing re-pointing in appropriate mortar

ACTION REQUIRED: Re-point in appropriate lime mortar.

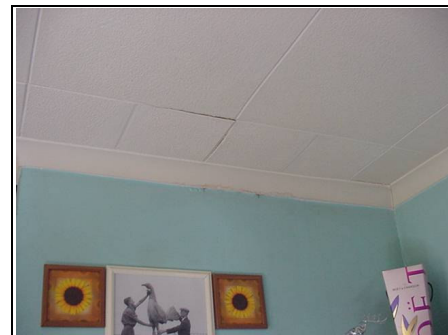
There are polystyrene ceiling tiles in the rear right hand room which are no longer recommended due to problems if there is a fire as they drip molten plastic down.

Polystyrene ceiling tiles

ACTION REQUIRED: Replace polystyrene ceiling tiles

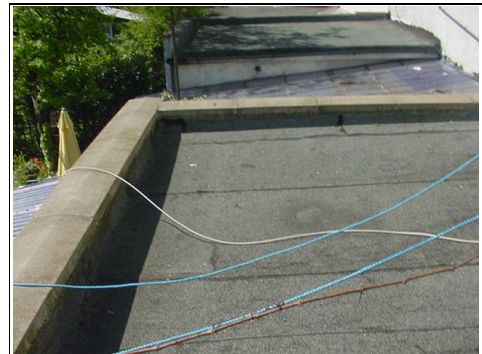
DIY extensions to the electrics? – electric cabling travelling across the flat roof, we would expect an electrician to run this more professionally.

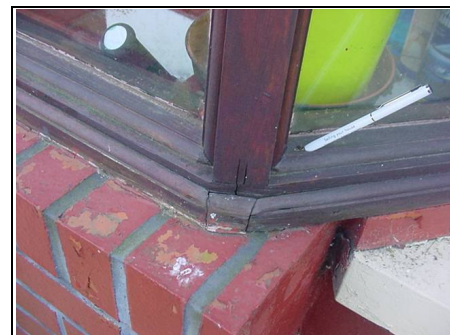
Wet rot was found to some of the wooden windows to the front of the property.

Testing for wet rot at front window

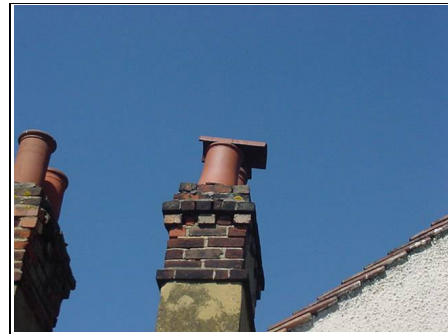
This chimney is brick built with a render finish with two chimney pots with cement flashings. From what we could see the chimney looks in below average condition and needs re-pointing in an appropriate mortar. The top of the chimney known as the flaunchings we could not see but we could see internally that there is dampness.

ACTION REQUIRED: Re-pointed needed.

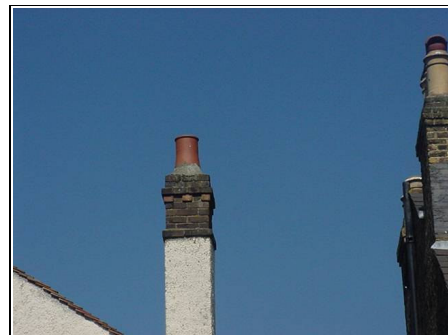
This chimney is brick built finished predominately in render and needs a close inspection, as our view is limited, but we suspect it is also allowing dampness into the property as with chimney one.

ACTION REQUIRED: Carry out minor repairs, ideally when the chimney work and flat roof work is being carried out.

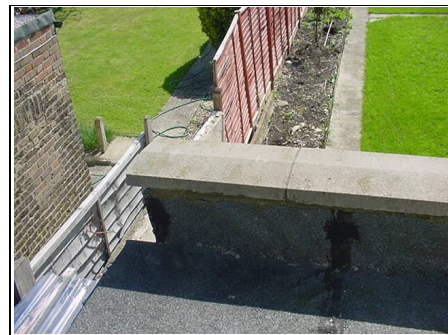
Parapet wall to flat roof

ACTION REQUIRED: Parapet walls all need checking to see if they are watertight.

ACTION REQUIRED: Replace the felt flashing with a lead flashing and check the parapet wall coping stones and the brickwork.

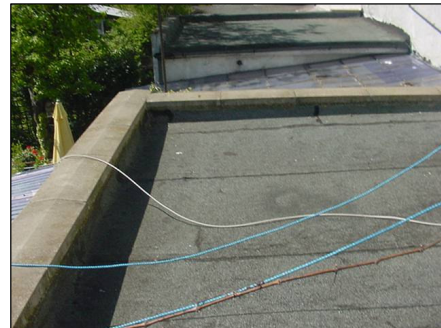
The flat roof is located at the front of the property and is covered with felt. We found blistering on the roof and poor quality repairs.

Rear flat roof

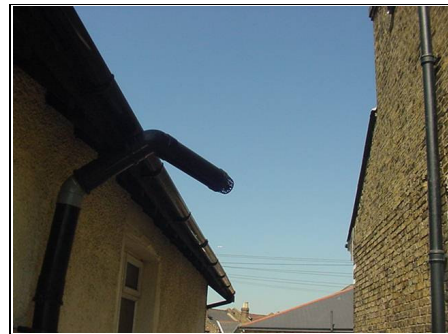
There is a plastic soil and vent pipe on the left hand side of the property (all directions as you face the property) which should discharge and metre above the verge of the property as you can see it does not. This would normally be taken through the roof rather than being swan necked around it, again this looks like DIY work.

Soil and vent pipe should be pointing upwards

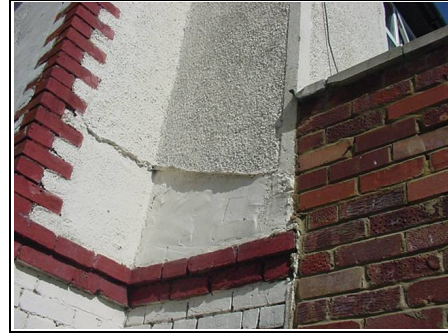
The walls to this property are finished in a painted render. With this age of render some deterioration is to be expected. We have carried out a tap test to the render at low level (literally hitting the render with the back of a screwdriver) to try to establish if there are any hollow areas and found it to be in average condition for its age. It is, however, very important to keep the render in good decorative order as without this the render will deteriorate.

Cracking to the render

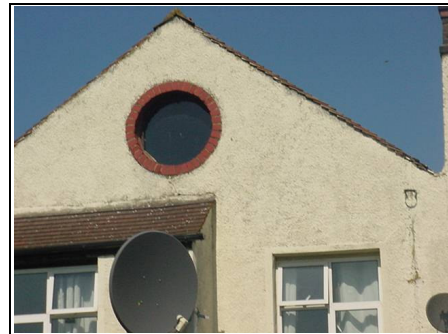
We did note that there are hair line cracks to the property, some of which have been filled/repaired. All cracks need sealing as soon as possible to stop dampness getting in the property.

Render at the rear

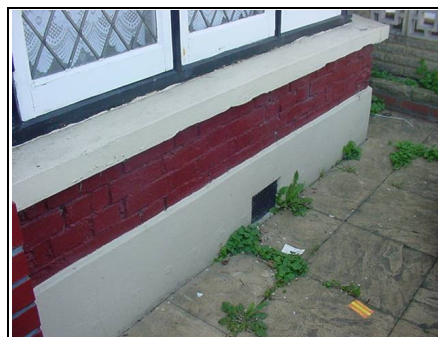
Render obscuring view of damp proof course

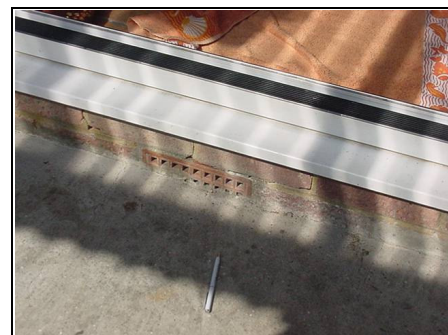
Airbrick at rear partially covered

ACTION REQUIRED: You need to ensure the air vents are kept clear to vent the floor. Please see our comments in the Executive Summary.

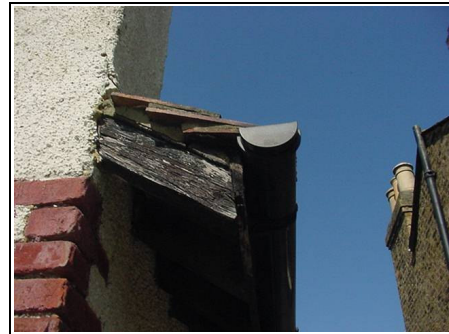
Fascia boards in need of redecoration although most hidden behind guttering

ACTION REQUIRED: We recommend redecoration by the summer of 2012.

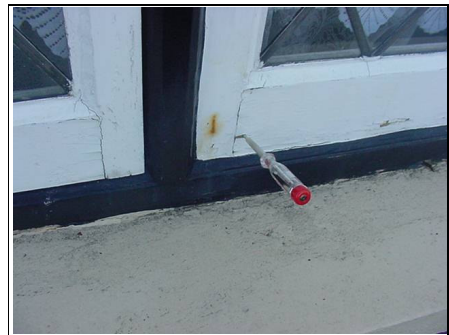
The property timber double glazed windows without draft seals and trickle vents. Some of these are in a poor condition please see the example in the Executive Summary where we could literally push our pen into the window. With the quality of the construction of the property as a whole we would give the following warning with regard to double glazing.

Timber degrading

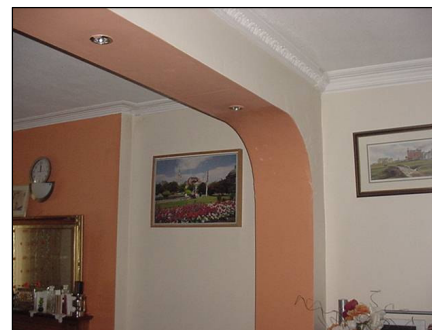
This wall has been removed and has resulted

Removal of wall

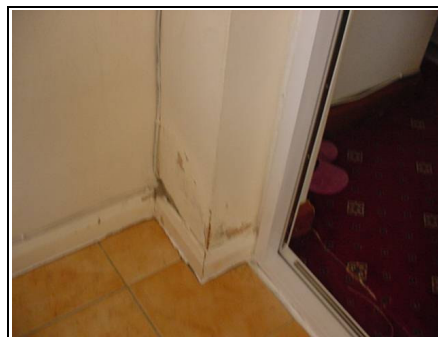
A random visual inspection and tests with a moisture meter have been taken to the perimeter walls and some internal walls. The readings we obtained indicated that there is dampness particularly to the rear of the property.

Rising damp

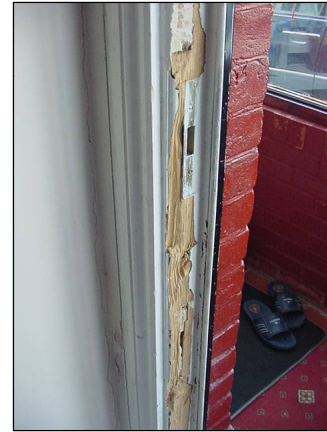
There is a mixture of doors in the property from reasonably good timber doors to the door out to the utility room which is very much a DIY installation which does not fit properly. There is also damage to the front door.

Damaged front door

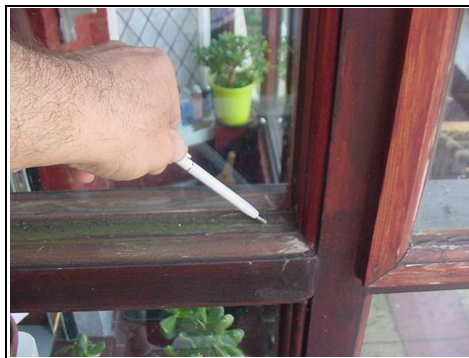
Wet rot in timber

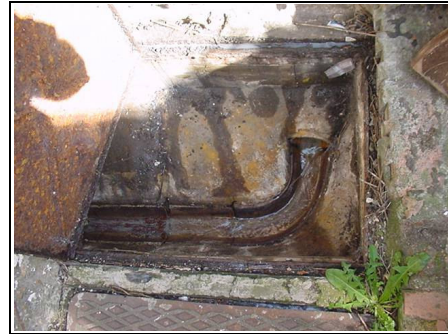
Rear left hand side drain with signs that it has been overflowing

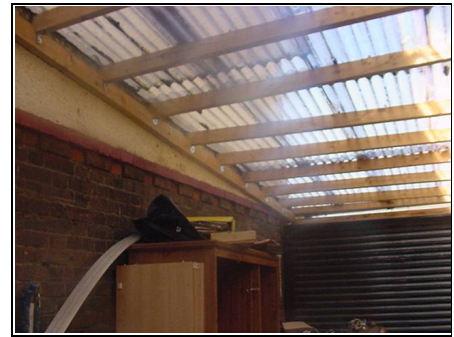
Lean to style garage, not certain it has full Planning permission

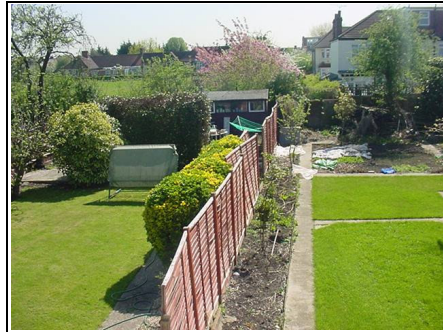
Rear garden fence to left hand side in need of securing
