PROPERTY REPORT

Mitcham CR3

We have been asked to inspect and prepare a Report and Schedule of Condition for property in Mitcham, CR3.

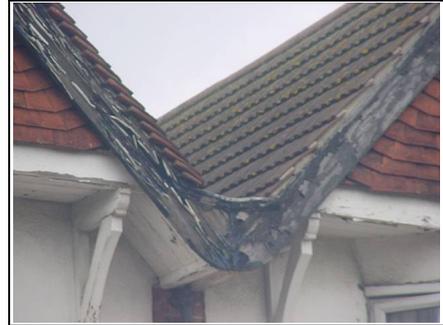
1) Leaking Valley Gutter

The main roof to the front of the property has a leaking valley gutter to the right hand side. We spoke to the owner about this who advised it was a problem with the outlet. Unfortunately, we were unable to see this area, however it is a fairly typical problem and we would recommend the following.

Leaking valley gutter on right hand side

ACTION REQUIRED: Supply and fit a roof light to the pitch of the roof to ensure that you can access the area without scaffolding, or a cherry picker. Next, we would recommend making a larger opening and also regularly checking the valley gutter for build up or back up of vegetation and debris.

ANTICIPATED COST: With the roof light giving a view of the valley gutter it would be best to then estimate costs. However, we would suggest, as this requires scaffolding or a cherry picker lifting device, and in addition we would recommend a sky light to be added, we would estimate the sum of £2,500 to £5,000, plus redecoration internally once the plaster has dried out; some re-plastering may be needed. Please obtain quotations.

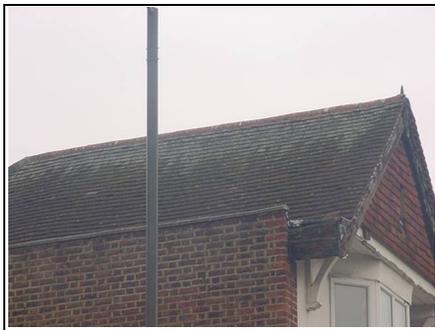
2) Box Gutter Detail

To the left hand side there is a box gutter. This appears to be blocked. It was difficult to see what the problems are in the box gutter, but we can see there looks to have been re-pointing of the brickwork, indicating that problems have occurred.

Box gutter on left hand side

ACTION REQUIRED: The box gutter needs checking. Again, if possible we would add a sky light so you can view the box gutter and check its condition, and fit a lead detailing if one is not present. You need to be clearing any debris and ensuring there is a good fall on it. Typically, the box gutter and valley gutter would have been lead lined; in our opinion this is the best way forward.

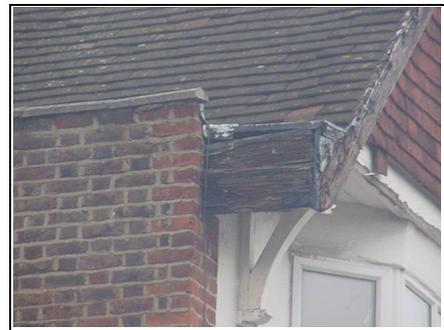
Close up of box gutter

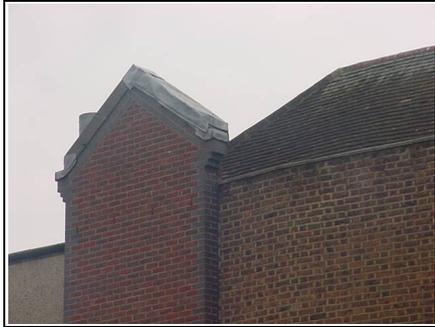
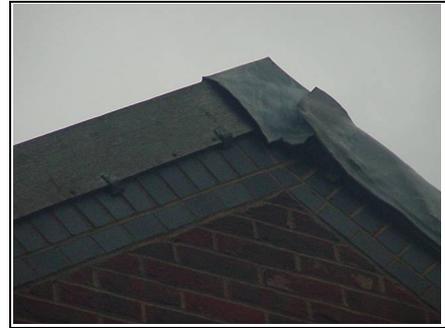
3) High Level Parapet Wall

The lead capping to the high level parapet wall has come away. This needs to be re-secured and the whole parapet wall needs to be checked.

Parapet walls

ACTION REQUIRED: It is likely that you will need to put a replacement lead capping to the parapet wall, plus repair any damage.

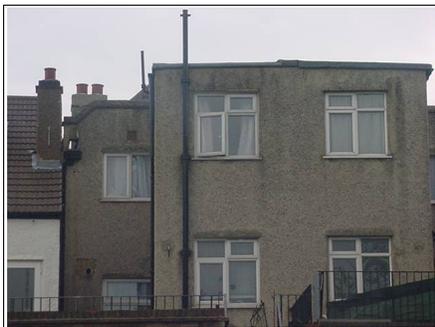
4) Flat Roofs Leaking

There is a flat roof above the top part of this property. From the edge detailing it looks as if the flat roof has a mineral felt. A stain is visible to the rear of the upper floor and the flat roof area is leaking. Again, unfortunately, we were unable to see this area so we have made the following assumptions. In our experience it is likely to be a defective flat roof and judging by the staining it has been taking place for some time. It is likely that the decking beneath also needs to be repaired.

Flat roof

ACTION REQUIRED: Re-felting or re-asphalting, depending upon the system of roofing that has been used.

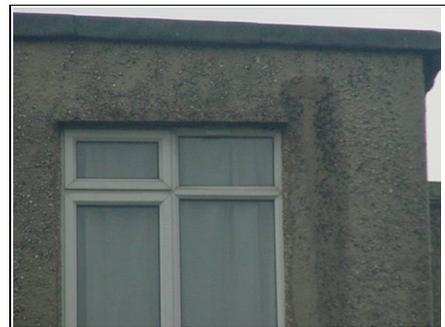
Close up of flat roof

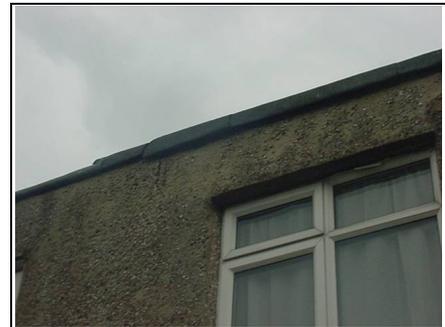
5) **Pebbledash Render**

The pebbledash render is old and this age of render starts to deteriorate quite rapidly. We can see that some repairs have been carried out.

Pebbledash starting to deteriorate

ACTION REQUIRED: We would anticipate there will be a future need for repair, particularly over the next five or ten years.

ANTICIPATED COST: Put aside the sum of £1,000 to £2,000 for ad hoc repairs. In addition to this, you will need scaffolding access. This work may not be an immediate requirement but it does need budgeting for.

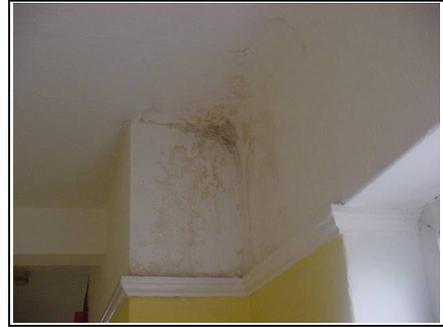
6) Internal Work

Painting is needed where dampness is coming through from the valley gutter, the box gutter and the flat roofs to the upper floors, once this has been resolved. Also, some general cleaning is needed, particularly to the kitchen and bathroom and trading areas. Finally, we think the carpet will need cleaning and/or replacing in many areas.

Dampness coming through

ACTION REQUIRED: You need to allow for cleaning these areas. We would also recommend that the sink needs a deep clean; if this does not work then replacement and clean/replace carpets. Finally, in the trading area a general deep clean will be required to the wall tiling, quarry tiles to the floor and redecoration to the ceilings.

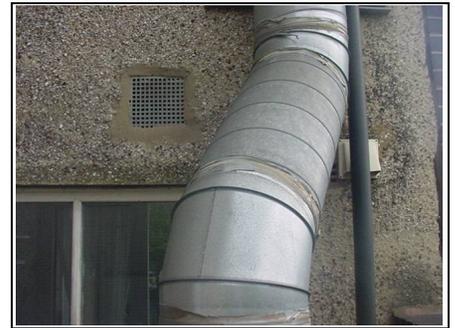
There is an extract flue to the rear left hand side of the property. We can see that the joints have been taped, indicating leakage in these areas. We would also comment that we could not see any access holes in it to allow cleaning.

Taping of the joints to the flue

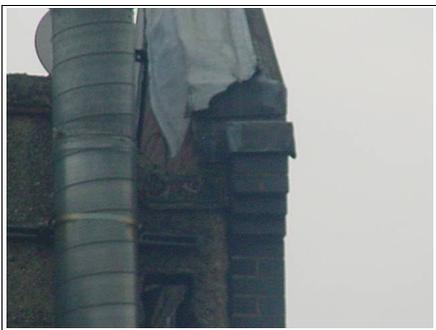
Flashing hanging off parapet wall

ACTION REQUIRED: The lead needs to be re-secured and/or replaced.

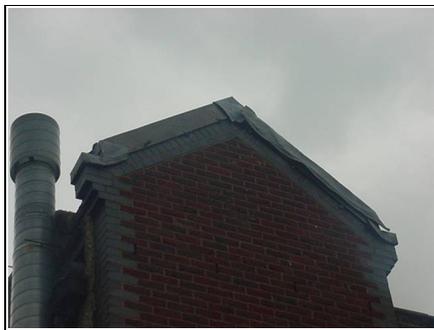
Missing lead coping
On left hand side

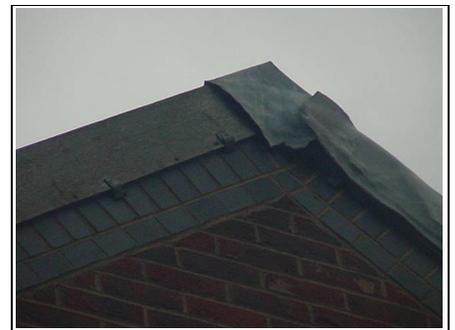
Close up

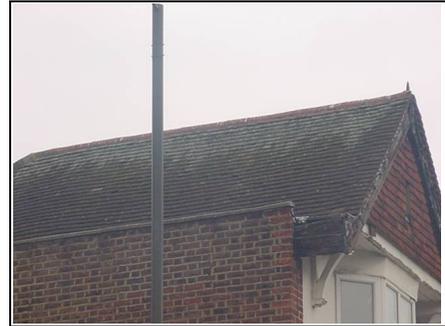
Main roof

The roof is pitched and clad in a small nibbed concrete tile. From what we could see the concrete tiles are lying level and true and look in reasonable condition. Please note that we could not see the right hand side of the roof properly.

There are problems with valley gutters causing leaks within a property.

ACTION REQUIRED: Make watertight. We suggest placing a roof light on this section to allow easier visibility.

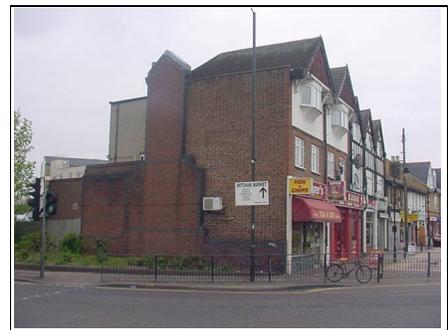
Low level first floor flat roof

To the left hand side of the photo below you can see the staining of the brickwork, which we believe is caused by the low level parapet wall and the detailing to it, which allows water to sit on it.

ACTION REQUIRED: We would suggest a coping stone on the lower wall to throw the water away.

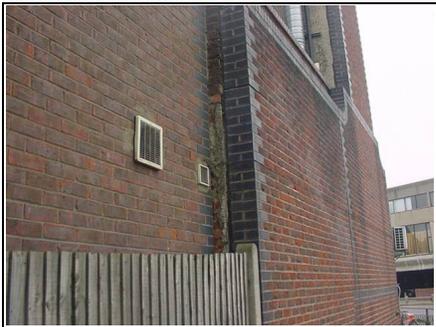
If you look at the photos overleaf you can see the parapet wall with the brick coping and the tile on edge. The original parapet wall is in reasonable condition, although there is some efflorescence on it, but the lower parapet wall, which is really a secondary wall because of the properties that were taken down (if you recall we believe this was once a mid-terraced property) are allowing water to sit on it and are getting through the walls and into the render as well.

Staining to brickwork indicating dampness

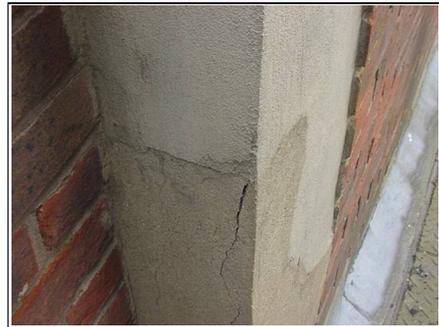
Dampness getting into render

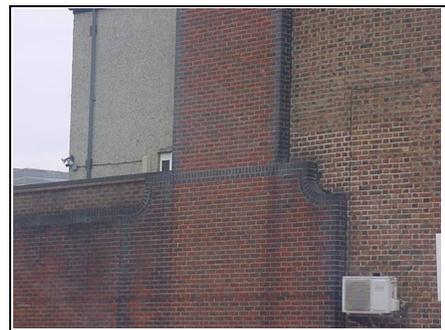
There is dampness in the side wall caused by the poor detailing. We suggest that a coping stone, or something similar, be positioned in this area to resolve the problem. We feel this area has to be given some thought, particularly as this could cause major problems in years to come.

Pattern staining/
dampness getting into walls

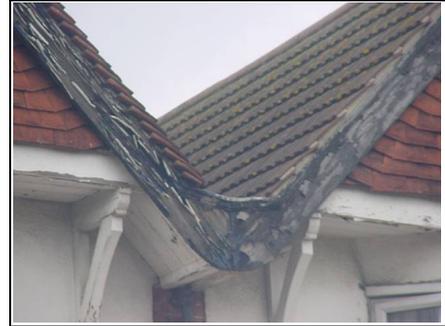
Bargeboards

The bargeboards are peeling badly and there looks to be wet rot to the front left hand side as well as the front right hand side gutter area (all directions given as you face the property).

ACTION REQUIRED: We believe that the bargeboards have simply not been painted over many years. However, you do need to have a close inspection just to check the areas near the box gutter and the valley gutter will may also have been affected by the blockages in the gutter system.

ANTICIPATED COST: In the region of £2,000 to £3,000 but work will have to be carried out using a cherry picker or similar lifting device and scaffolding, which may increase the costs further. Please obtain quotations.
