JOB REFERENCE: XXXXXXXXXXXXXXXX

RESIDENTIAL BUILDING SURVEY

XXXXXXXXXXXX,
XXXXXXXXXXXX,
XXXXXXXXXX,
Norfolk NR2 XXX

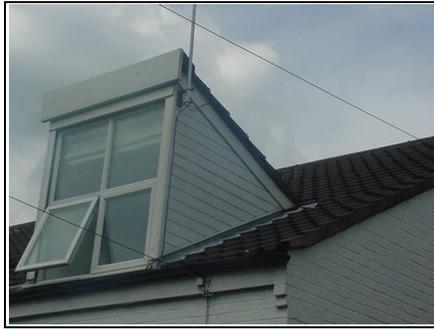
There is an awkward/awful roof detail where the dormer to the front meets the main roof. We have tested internally and not found any damp but we do think it is a potentially weak area.

Awkward roof detail

ACTION REQUIRED: Having said that, as mentioned we have not found any dampness and you just need to be aware that it is a potential weak area, particularly when it snows, as this is when roofs are really tested.

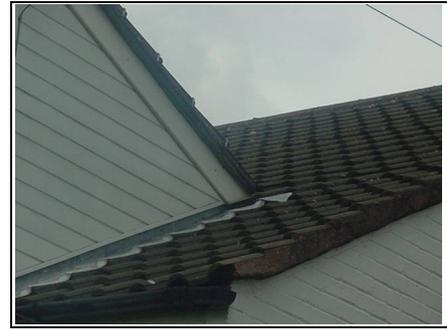
Close up view

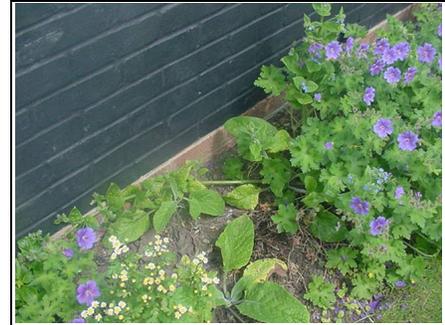
High ground level right hand side

ACTION REQUIRED: We recommend you reduce the ground level around the front of the property slightly. In a worst case scenario it would mean the adding of a French Drain (see Appendices), although we think this is unlikely and should be tested by reducing the ground level.

ANTICIPATED COST: DIY type job or a few £100; please obtain quotations.

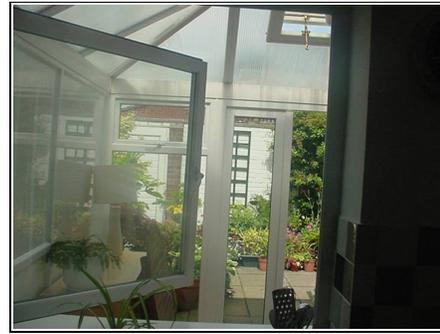
Window sticking in kitchen

ACTION REQUIRED: You may wish to budget in the future to replace the plastic windows.

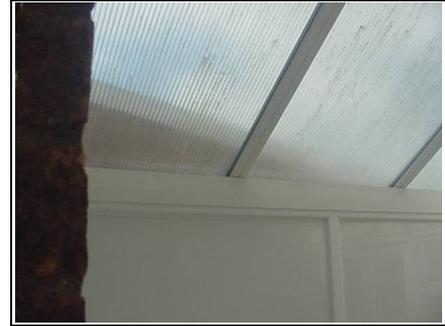
Moss on conservatory roof

ACTION REQUIRED: We recommend you clean the plastic.

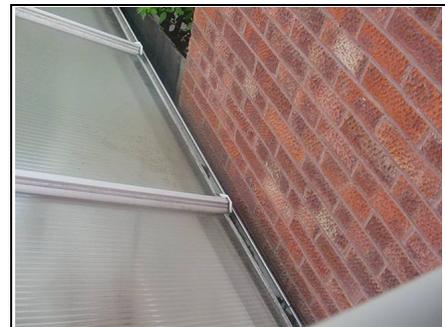
Small guttering on conservatory

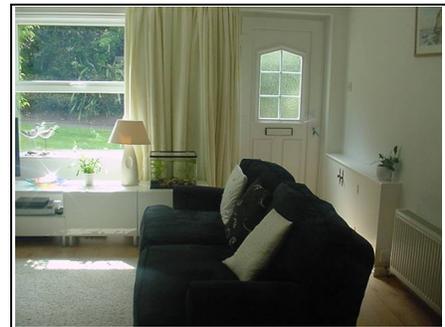
Front door straight into front room, may cause heat loss during cold winter months

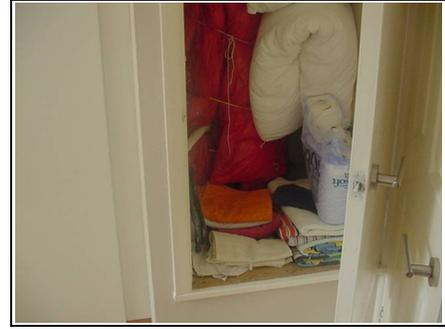
There is a hot water cylinder upstairs in the cupboard of the front bedroom. This has had insulation added around it in the form of an insulated jacket. These are the older style cylinders and may leak at any time without warning.

Hot water cylinder

ACTION REQUIRED: We recommend you look at replacing this.

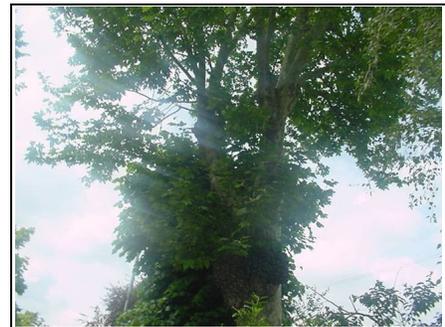
We noted that you had a large tree which looks to be in need of maintenance; the owner advised it has a Tree Preservation Order on it. This is the type of thing that should be covered with your annual service charge, although often they do not have sufficient funds.

Tree preservation order on this large tree

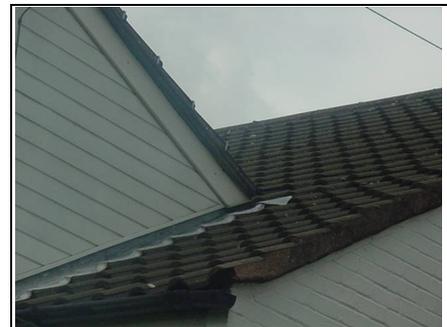
Close up of awkward roof detail

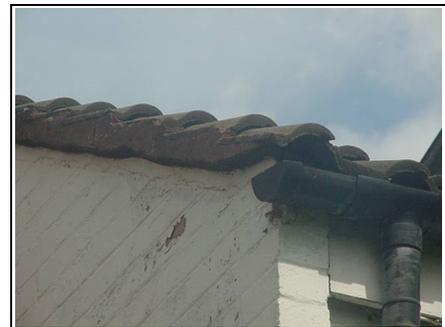
However, it is the verge detail that we are concerned about as this seems to be letting in water. It is allowing water to drip down the side of the building causing deterioration to the paintwork, brickwork and hairline cracking.

Verge not large enough and is letting in water

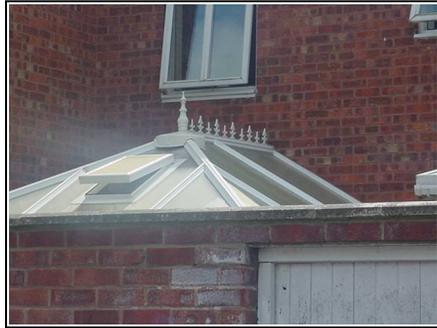
The rear conservatory roof is a polycarbonate (plastic) roof. It has a good fall but we would comment that it is in slightly below average condition due to the moss on the right hand side and it would benefit from a good clean.

Polycarbonate conservatory roof

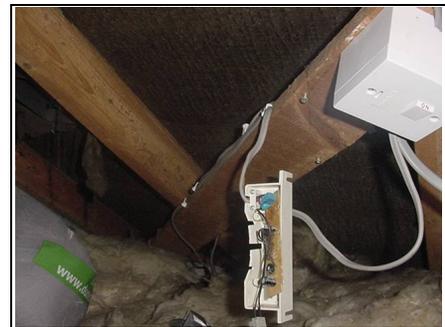
We noted an unusual bit of wiring, which needs further investigation.

Please see our further comments in the Services Section of this Report.

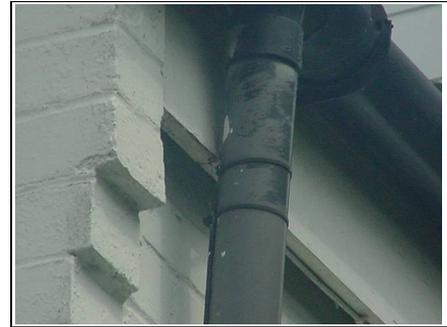
We can see that repairs have been carried out to the downpipe to the left side of the property, which we believe to be a known problem area.

Repairs carried out to gutter front left side

There may be some minor leaks but most people would be happy to live with these providing repairs are carried out within the next six to twelve months.

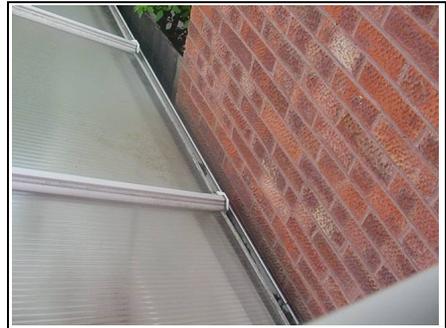
Miniscule gutters

We also recommend that the gutters and downpipes are cleaned out, the joints are checked and the alignment checked to ensure that the gutters fall towards the downpipes.

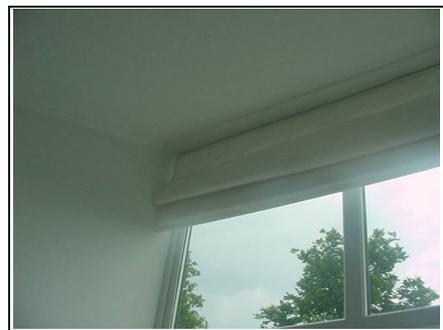
The property has plastic double glazed windows without trickle vents, which generally look to be of a average quality. We would draw your attention to the fact that sealed double glazed units can fail, particularly as a result of poor workmanship during installation. Failure of the seal leads to condensation between the two panes of glass and simply replacing the affected units may not provide a satisfactory long-term solution.

Plastic windows – no trickle vents

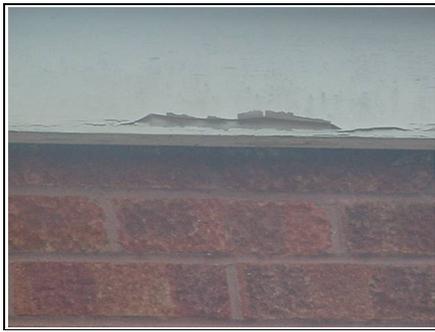
The fascias and soffits require work, as does the white painted wall. You should not under estimate the cost of this and you may end up completely re-painting white areas.

Fascia board to rear in need of redecoration

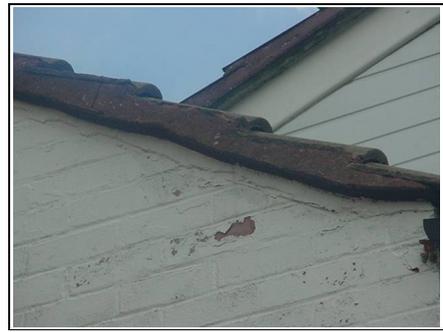
Areas to redecorate

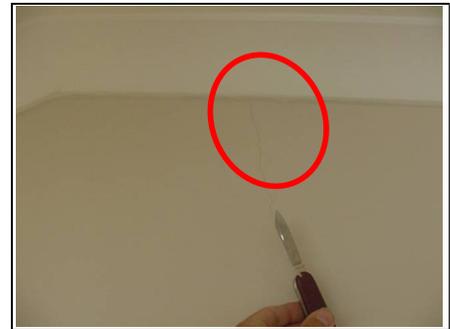
Hairline crack to left wall in front bedroom

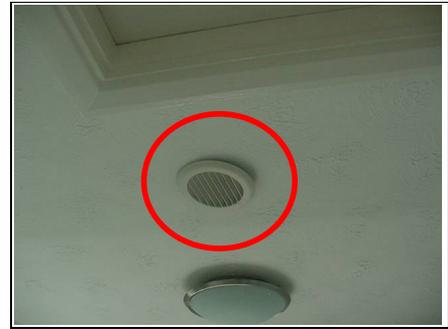
Small extract fan in bathroom

ACTION REQUIRED: We would recommend large humidity controlled extract fans be added to kitchens, bathrooms and drying areas.

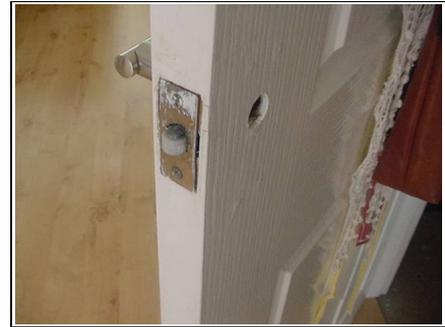
Door handle missing

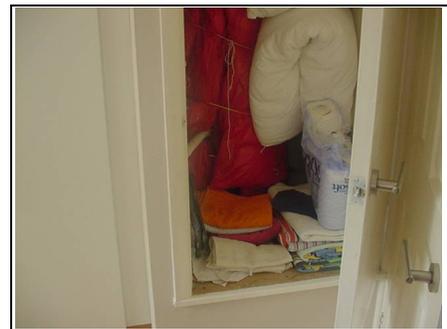
Hot water cylinder

ACTION REQUIRED: Budget for a replacement in the next few years.

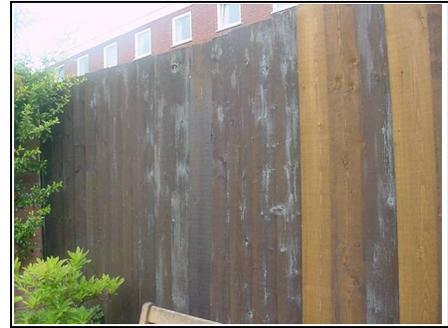
Fence needs re-staining
