JOB REFERENCE: XXXX

# RESIDENTIAL BUILDING SURVEY

**XXXX**  
**Berkhamsted,**  
**Hertfordshire.**  
**HP4 XXX**

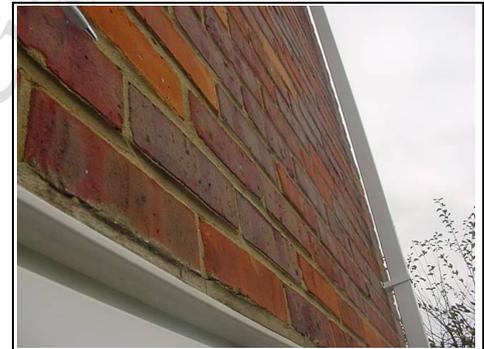
To the rear of the property where the French doors are and the adjacent window; we can see there has been some movement around the window areas. This can often occur where double glazing from the cheaper end of the market has been used where the plastic windows have not been reinforced or measured particularly well therefore not fitting in properly the wall above settles onto the new window/door level.

Movement to brickwork to rear French doors

This is normally amended by packing (which is formed by fitting around the window small pieces of plastic or timber wedges), in this instance we assume this has not happened and the wall has moved leaving the cracks.

**ACTION REQUIRED:** There is very little that needs to be done with this type of cracking from a structural point of view however aesthetically some people do try to re-point the brickwork. We would advise unless

the re-pointing is carried out very well and the new mortar colour is matched against the mortar original poor re-pointing can stand out more than the cracking itself. Unfortunately we often find that making good makes the movement cracking look worse therefore we would recommend leaving this in its current condition.

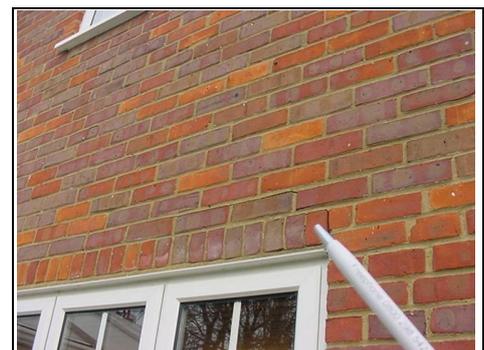
Cracking above window

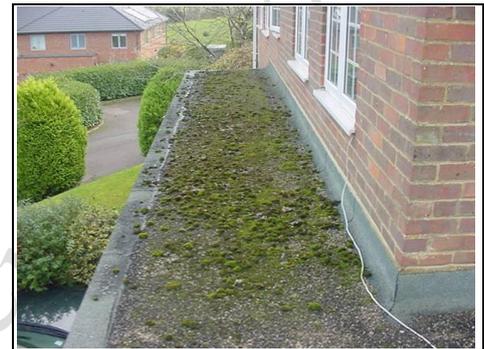
The flat roof over the garage and over the front covered area and rear is very flat with moss sitting on it; it should typically have a fall of fifteen degrees, moss sitting on it indicates that the fall is not sufficient to take the rainwater away. When we spoke to the owners about this during our question and answer session they advised that they had not had any problems over the years. When we inspected the underside of the garage roof the damp staining that we did note we were advised had been there since they moved into the property.

Moss on flat front roof

**ACTION REQUIRED:** We recommend you clear the moss off the roof and set aside a budget to carry out repair work. We also would note

that the flashing has been formed in felt and prefer to see this in lead.

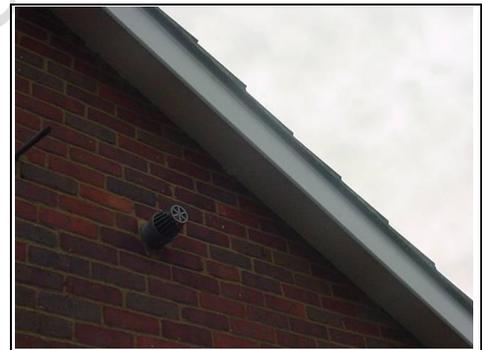
We were only able to obtain a close inspection of the fascias and soffits and bargeboards from the roof level and here we could see that they were plastic but it is not clear if they are solid plastic or over-cladding. Where plastic has been added over the top of the original timber fascias, soffits or bargeboards often it is due to them being in poor condition. Ironically the plastic then causes the timber to degrade more so it is not an ideal way of carrying out this work. The correct way is to replace them in the entirety.

Over-clad bargeboard

**ACTION REQUIRED:** We recommend that test holes are drilled into the fascias, soffits and bargeboards to see if it is a solid plastic or if it is over-cladding the timber as we suspect; if this is the case the over-cladding needs to be removed and new fascias, soffits and bargeboards added.

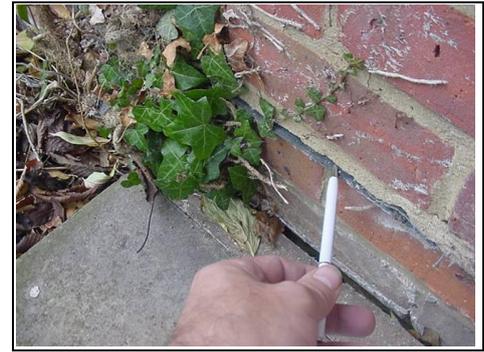
We noticed there had been some slippage on the brickwork on the damp proof course which normally indicates minor movement has occurred. With this type of modern timber frame structure there is very little internally to hold any movement in the walls in position. Whilst we have personally not seen any major problems in relation to this we are not aware of a history of any and should be monitored from time to time.

Slippage on damp proof course to the front of the property

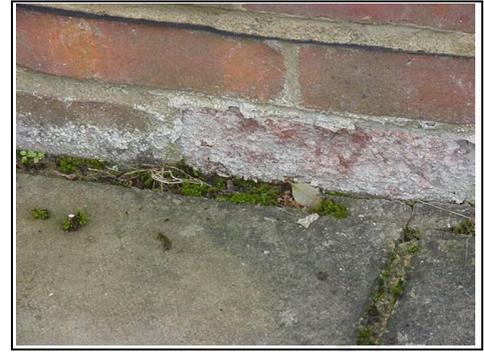
In addition to this the property sits on a sloping site and the rainwater wishes to travel from the top of the site to the bottom. We could see water marks and spalling to the base of the brickwork which we believe is caused by this movement of water around the property.

Damage to bricks due to being on a sloping site

**ACTION REQUIRED:** You can see from the photograph that deterioration is starting to occur to the brickwork. Whilst in theory it should not be a problem as it is below the damp proof course we would much prefer to see a channel around the property which would allow the rainwater to pass from the high areas to the low areas without damaging the brickwork.

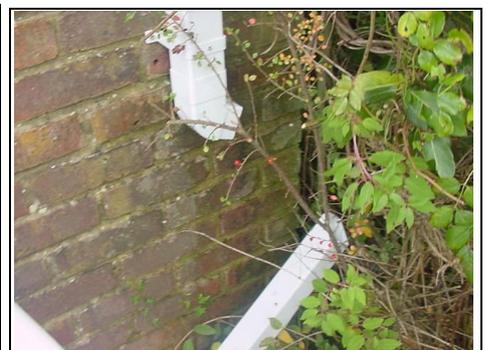
Rear left hand downpipe

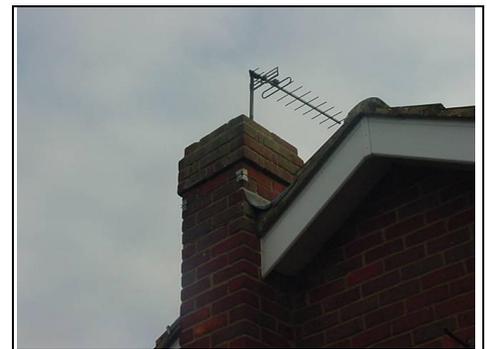
Chimney Two

This chimney was built in a similar manner to the first chimney, with one flue on it and an aerial. The tv aerial is fixed by a wire which can cut into the brickwork like cheese wire into cheese and should be removed.

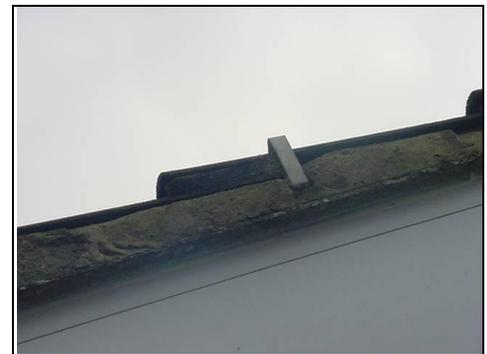
Clip to tile at edge of roof

**ACTION REQUIRED:** We noted some minor deterioration to the edge of the tiles where the clips are which need to be looked at again during the summer of 2012 and carry out periodic inspections and maintenance of the roof, as required.

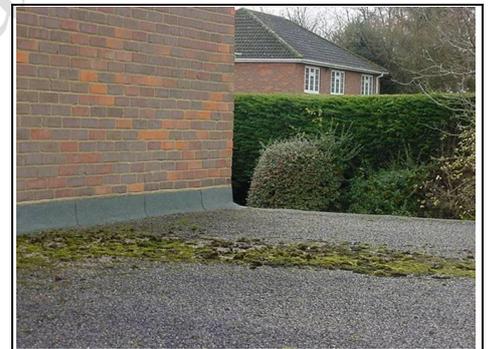
Flat roof to right hand side

The latest Building Regulations require flat roofs to be ventilated. Building Regulations are not retrospective but the reason for the requirement is to make sure that any moisture that enters the roof construction is dispelled by way of ventilation. We would suggest that if the opportunity arises ventilation should be provided. This will stop the possibility of fungal growth above the ceiling in the flat roof area.

Also it could not be established if there is insulation within the roof. Where we could see the underside of the roof in the garage area we could see that no insulation had been put in place or vapour barrier which is now a requirement and we suspect this will be the same in the other areas such as the utility room which will increase the risk of wet or dry rot.

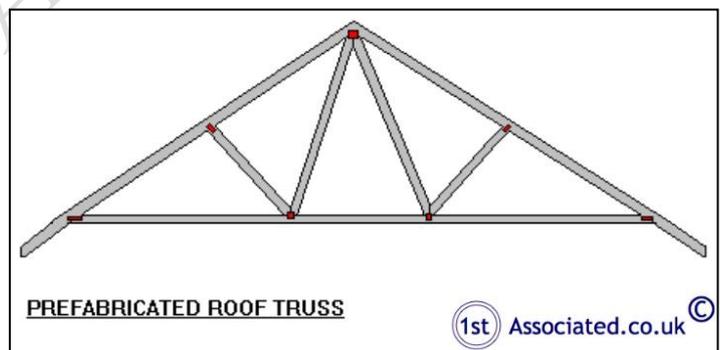
Wind brace within roof – diagonal timber

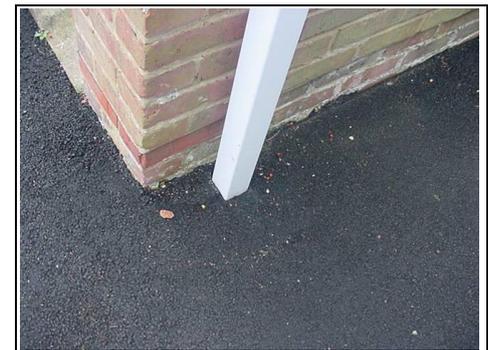
Downpipe directly into ground

**ACTION REQUIRED:** We would always recommend that the gutters and downpipes are cleaned out, the joints are checked and the alignment checked to ensure that the gutters fall towards the downpipes.

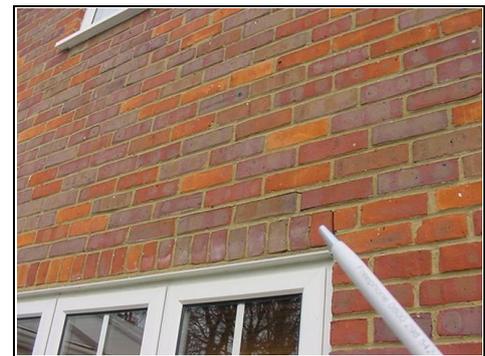
Cracking to brickwork around windows

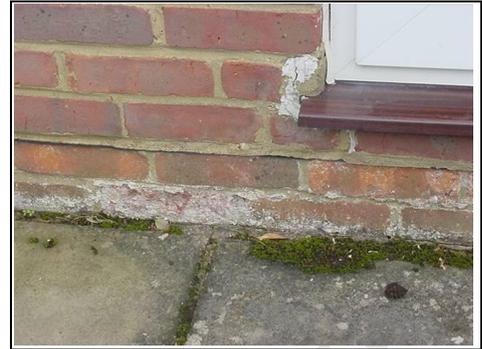
Damage to brickwork due to being on a sloping site

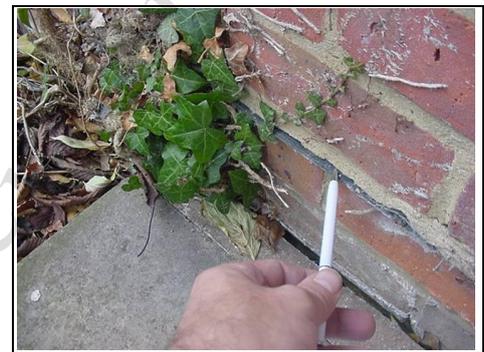
Damp proof course slippage to front of property left hand side

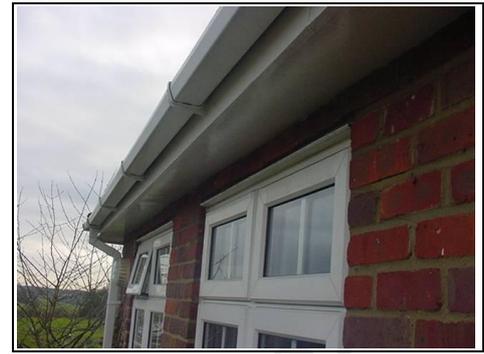
The property has plastic double glazed windows, which generally look to be from the cheaper end of the market; we make this comment due to the lack of trickle vents and the thickness of the profiles of the window frames.

Window with no trickle vent

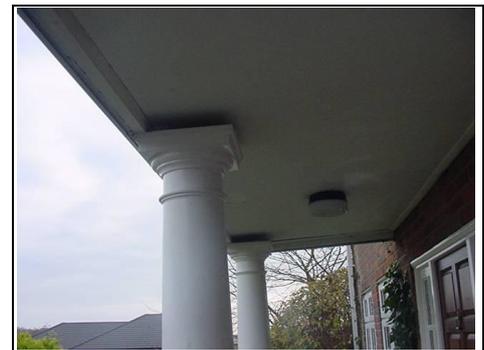
We are uncertain what to say about these other than it looks like the flat roof above them is cantilevered rather than being supported by them although they would have to be opened up to check this.

Imitation columns

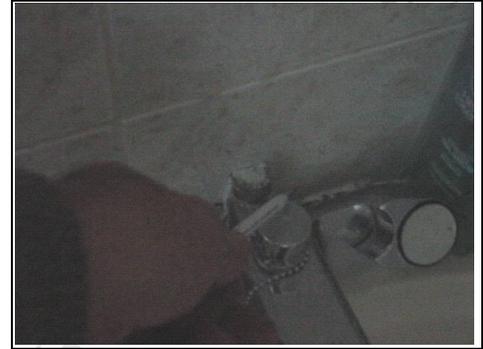
Mould in bathroom

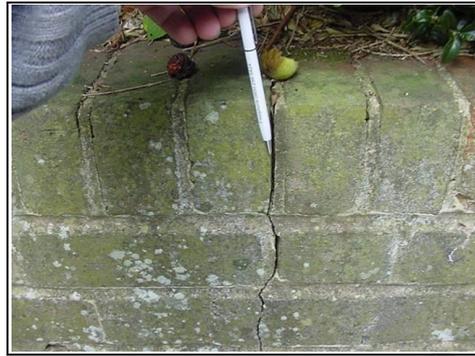
Retaining wall needs weep holes

Retaining wall cracking
