JOB REFERENCE: XXXX

RESIDENTIAL BUILDING SURVEY

XXXX Cambridge. CB4.

**1970s/80s
semi detached
extended
property**

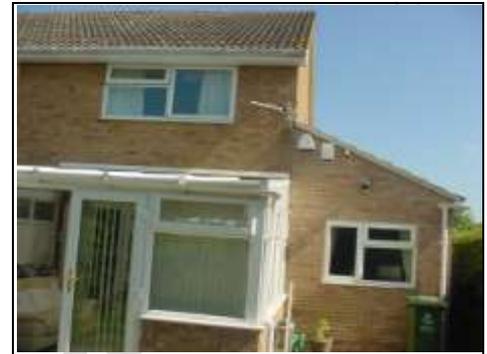
1) Conservatory roof meets main building likely to leak soon if not leaking already

Where the conservatory roof meets the main building there is a Flashband flashing which we consider a temporary product and note areas where it is starting to perish. We also noted plastic cover plates have come away to the rear left hand side (all directions given as you face the property from the front) which will be allowing dampness into the area.

Conservatory with shallow roof

ACTION REQUIRED: Replace the Flashband and also check all the mastic seals but most importantly you need to check to see if there is a cavity wall tray.

ANTICIPATED COST: In the region of £1000-£2000, possibly more if there is no cavity wall tray; quotations required.

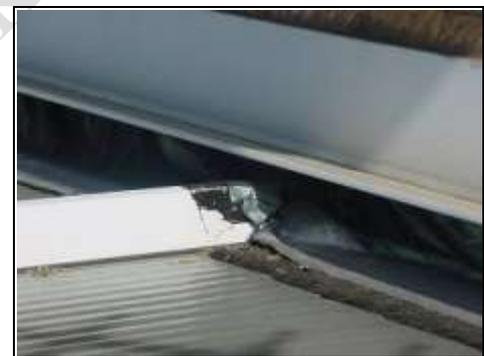
We believe that a cavity wall tray has not been added.

Conservatory roof problem flashing

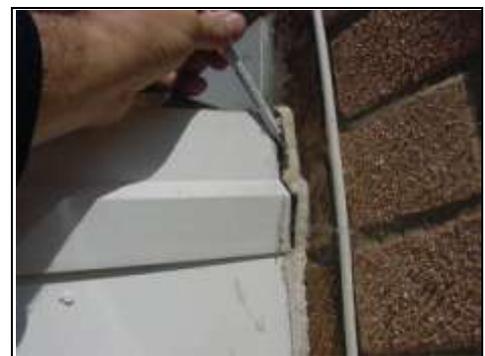
Conservatory roof cover plates coming adrift to the side

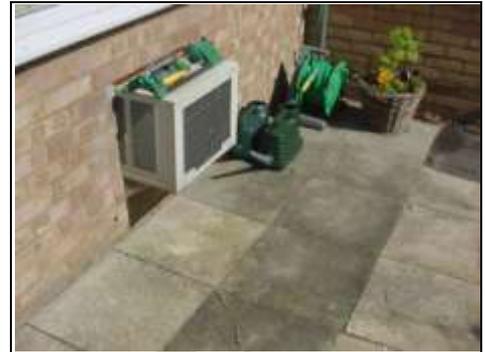
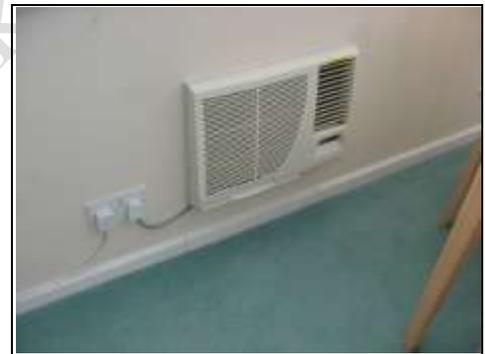
Air cooling/warming unit

ACTION REQUIRED: We recommend that a roof light is added to allow this to be opened up and heat to be discharged through the roof. We did leave the air cooling system on to test for quite awhile but in our opinion it did not have a satisfactory result. We often find that there is a problem with heat gain and heat loss in modern conservatories where they have not been thought through with regard to their location and the amount of sun they will get etc.

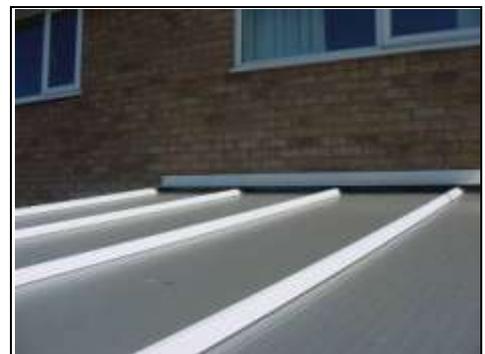
Large conservatory roof facing the sun

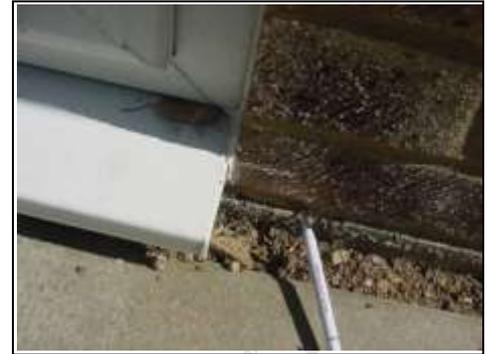
3) Conservatory Damp Proof Course too low to the rear

We noted the 150mm Building Regulations requirement for a damp proof course was too low therefore you may get some dampness in the conservatory area where the rain splashes back over the top of the DPC. There was none visible at the time of our inspection and we suggest that you live in the property and see if this is a problem before you carry out any work. We certainly would not recommend adding a damp proof course but would recommend lowering the outside ground level if any work is required.

Damp Proof Course too low to conservatory

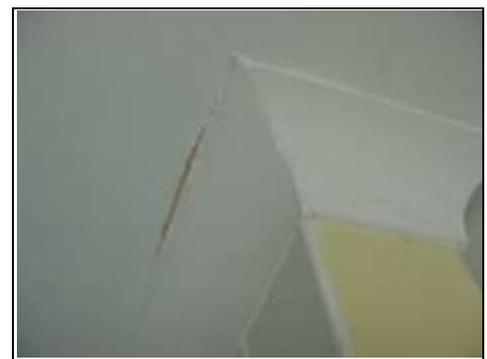
Close up within the shower unit showing deteriorating paint and hairline cracks.

ACTION REQUIRED: The shower room would benefit from an extract fan, we recommend humidity controlled extract fans with a 150mm diameter.

ANTICIPATED COST: In the region of £100-£150 fitted.

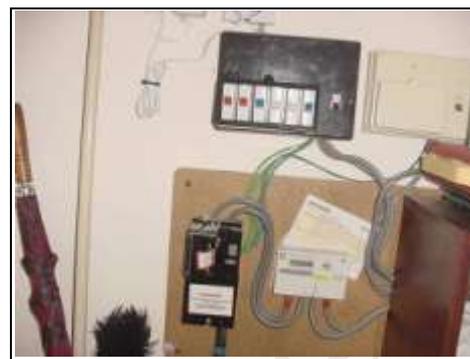
The electrics are at a point where they will need renewing, we recommend a changing of the fuse board. We also recommend that you increase the single socket points to double socket points and carried out associated re-decoration as a many more electrical appliances are used compared to when this property was built.

Dated fuse board

ACTION REQUIRED: Install new fuse board

ANTICIPATED COST: £250-£400; quotations required. You may wish to increase the number of socket points.

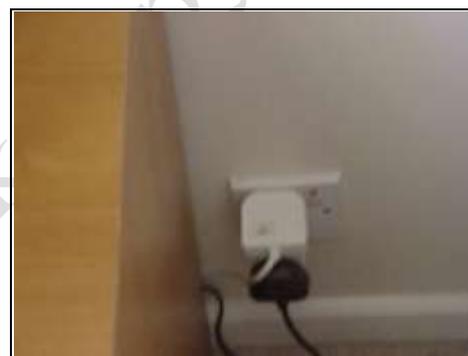
Crowded Single Socket

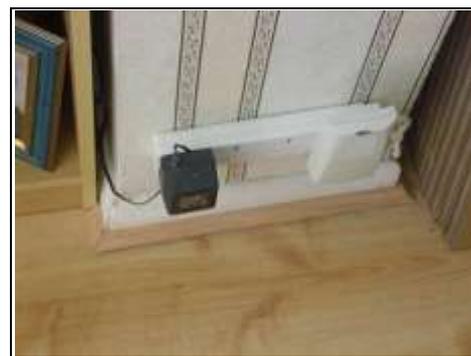
Extension cable unit attached to wall

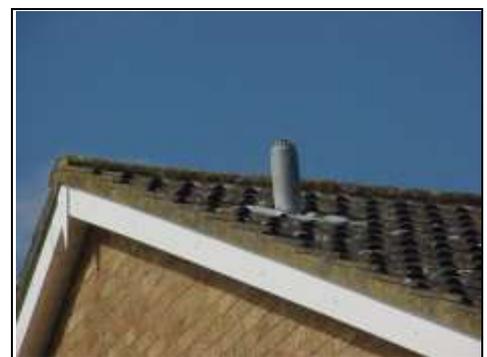
Cement verge looked in reasonable condition

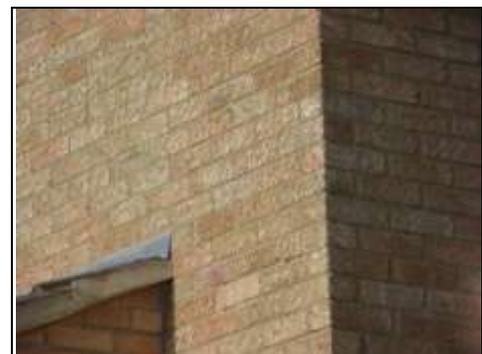
The mastic looked in average condition to the flashing

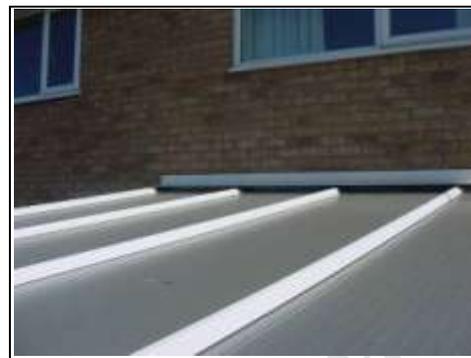
Conservatory roof

There is a very shallow polycarbonate conservatory roof which generally looks in good condition but we do find that they tend to leak sooner or later as they are very much from the cheaper end of the market.

Where the polycarbonate roof meets the main property there is a poor detail.

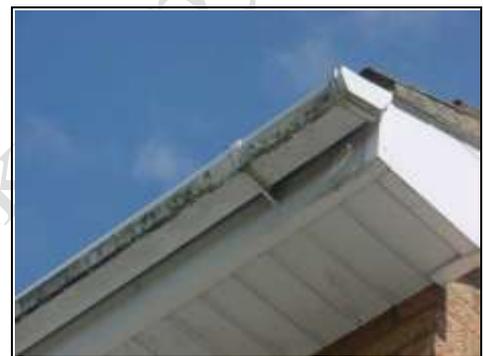
Staining to the rear gutters

ACTION REQUIRED: We would always recommend that the gutters and downpipes are cleaned out, the joints are checked and the alignment checked to ensure that the gutters fall towards the downpipes. General maintenance required such as the rear gutters look like they overflow and therefore will need cleaning.

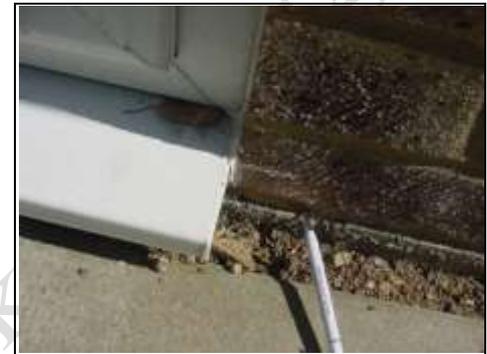
All modern properties should incorporate a damp proof course (DPC) and good building practice dictates that a differential of 150mm (6 inches) should be maintained between the damp proof course and ground levels. In this case, some of the damp proof course is too low to the ground level in areas. Your attention is drawn to the section of the report specifically dealing with dampness.

Damp Proof Course too low to conservatory

ACTION REQUIRED: Please see our comments in the Executive Summary. You need to reduce the ground level, a French drain works quite well in this situation.

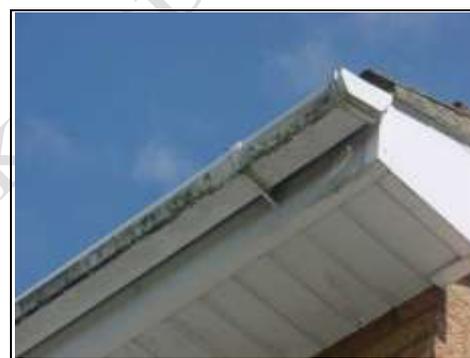
We noted that the property has plastic fascias and soffits, we think that these over clad the original timber fascias and soffits. This is a system used by what we can only term 'cowboy builders' to look as if the fascias and soffits have been carried out in plastic. The plastic is usually stuck on and, as there is no ventilation in this area, rot can occur.

Over clad fascias and soffits

ACTION REQUIRED: Request copy of invoices showing what was done or strip off (or for less damage drill into) the over cladding and check if there is any timber beneath. If there is then you need to replace the fascias and soffits completely. This will now be awkward due to the conservatory at the rear.

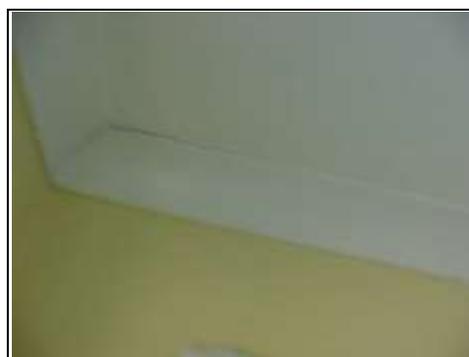
We noted hairline cracking in the en suite shower room/WC on the ground floor, this we believe is due to condensation and needs an extract fan adding in this area as soon as possible.

Hairline cracking to ground floor shower room ceiling

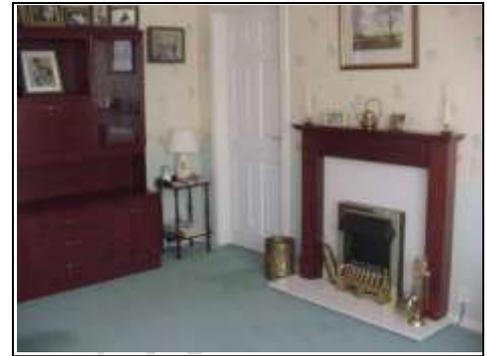
False Fireplace in Living room

ACTION REQUIRED: Your legal advisor needs to check and confirm if this fire is legally vented to allow its use and any invoices relating to its insulation to be provided.

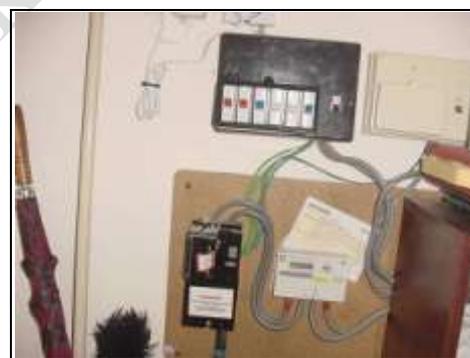
Fuse board

ACTION REQUIRED: Replace the fuse board. Please see our comments in the Executive Summary.
