RESIDENTIAL BUILDING SURVEY

Biggleswade
Bedfordshire
SG18 XXX

**Two storey
mid terraced
modern property**

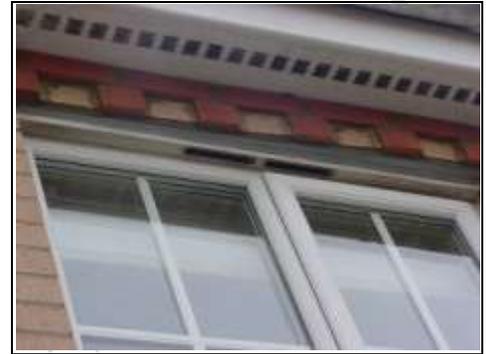
The property has been built at an angle which we mean is that we can see this by looking at the lintels which show the property is not square which is unusual for this to be this pronounced.

Property not square – twist in lintel

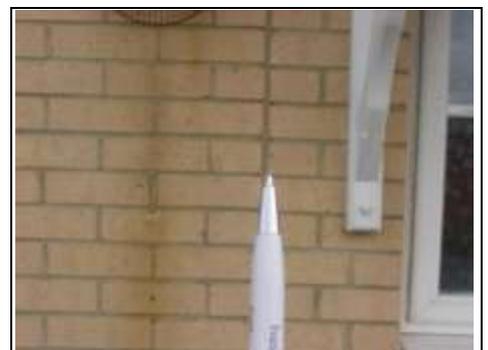
Mastic joint between two buildings

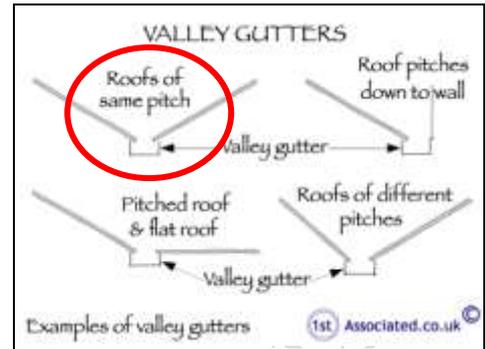
Valley gutter to pitched roof

ACTION REQUIRED: Check all valley gutters and verge details and remove the cement mortar and replace.

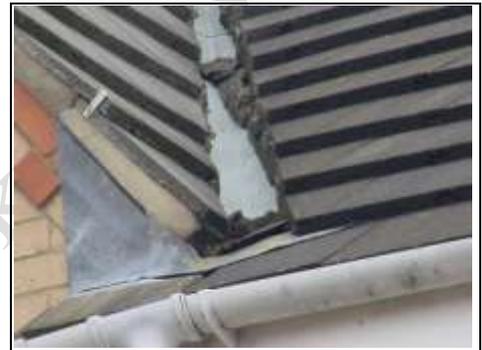
The property has a valley gutter which we noted the cement mortar has come away which in turn means you will get leaks into the roof.

Cement mortar has come away

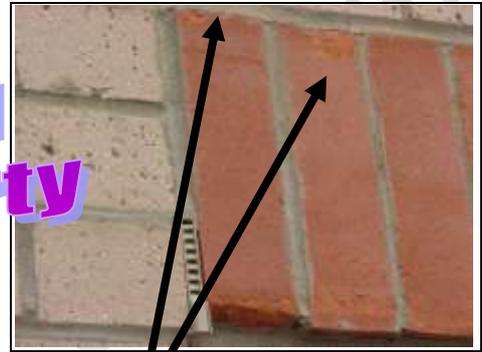
Spalling starting to occur to red brickwork at the front of the property

For example: to the soldier course of bricks over the windows.

Whilst the spalling is minor this really should not be occurring on such a modern property.

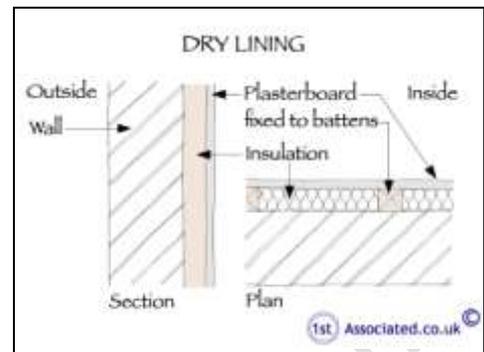
The cracking is relatively straight which tends to mean that it is a plasterboard crack (the property is lined with a gypsum plaster) and is what is known as dry lined or false wall construction please see our sketch. This type of hairline cracking is relatively common in this type of modern property particularly where there are problems with humidity/condensation.

The walls have been dry lined

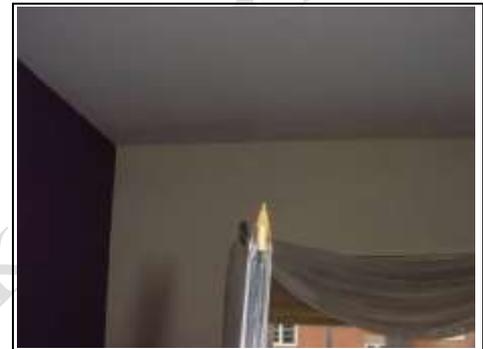
We noted hairline cracking throughout the property

Cracking in master bedroom

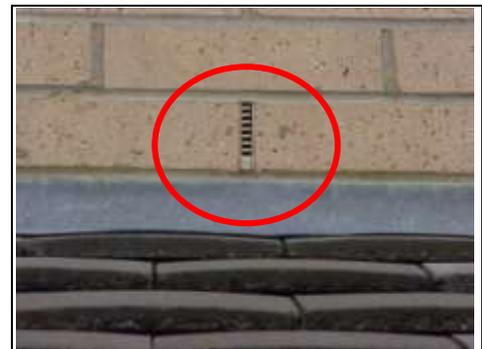
Another feature of this type of dry lined construction is the trickle vents on the outside of the property.

Trickle vent

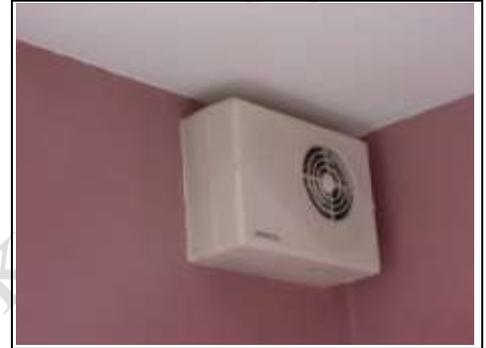
Extract in kitchen never used

Interestingly when we spoke to the present owner they advised that they have never used the extract fan in the kitchen and did not know where the switch was located. We could not get the extract fan to work and recommend you replace this extract fan.

ACTION REQUIRED: Again, we would recommend replacement of the fan with a large humidity controlled extract fan.

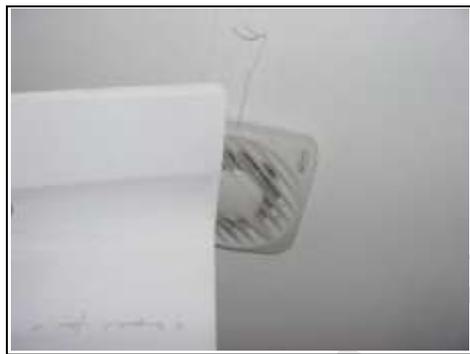
We would just like to reiterate the internal bathroom problems. We noted that the extract fan was not drawing the air from the bathroom which ultimately results in condensation occurring in the property.

Extract system not working
- Testing suction of extract fan by putting some paper against it

ACTION REQUIRED: Please see our previous comments regarding replacing the extract fan with a humidity controlled large extract fan but still internal bathrooms can struggle.

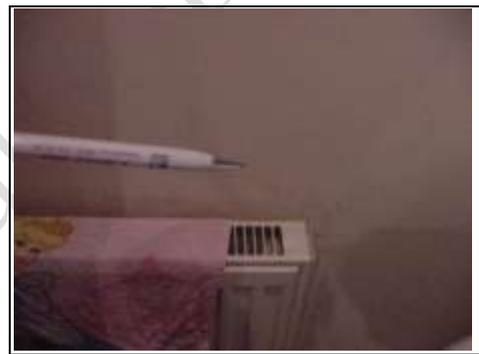
Quite unusually we noticed some staining around the radiators which may relate to drying of clothes internally.

Staining around radiator

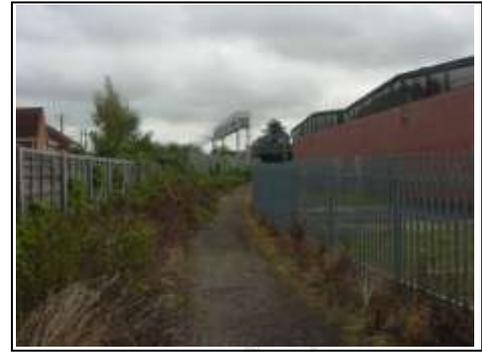
The property is located quite near to industrial buildings and train line. Throughout the time we were carrying out our survey we could hear a beeping noise which sounded like a truck reversing which may relate to an industrial premises. In the end the noise was carrying on for so long we did not believe it was a truck reversing but a noise made by one of the industrial buildings.

Nearby industrial buildings with bridge in the background over train line

ACTION REQUIRED: Is the area noisy? We believe the area is noisier than we would expect. This is a personal choice you need to revisit the property to ensure you are happy with the location prior to committing to purchase the property.

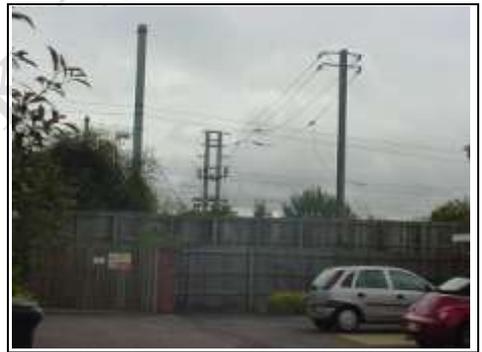
We also noted that the railway line is fairly close by and that you will probably be able to here noise from the railway whilst in the garden although we did not experience this on the day of our survey.

Railway line at the end of the road

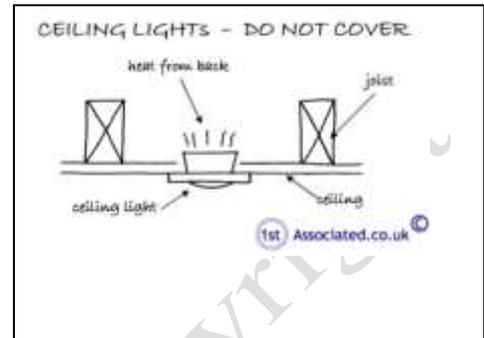
The property has electric lights to the ceiling. In some instances these can cause problems as the heat given off has in some cases lead to outbreaks of fire; these tend to be in the older type of ceiling lights and we recommend that where ceiling lights are used that the rear of the light is not covered; this is particularly the case in rooms with a loft space above it where stored items are placed in it.

Ceiling lights must not be covered

ACTION REQUIRED: Check when putting stored items into the roof that you do not cover the lights.

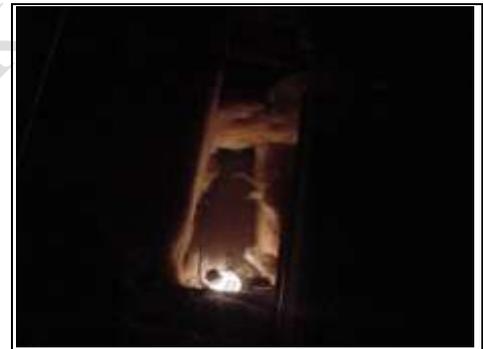
Heat and light being given off by the ceiling lights

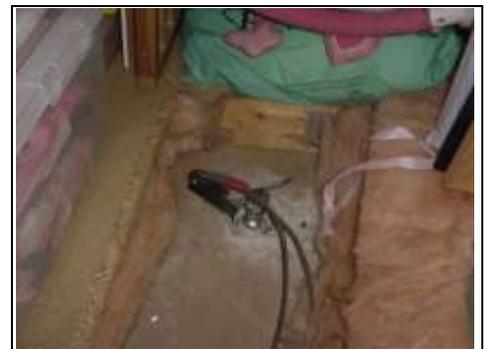
Ceiling lights cannot be covered

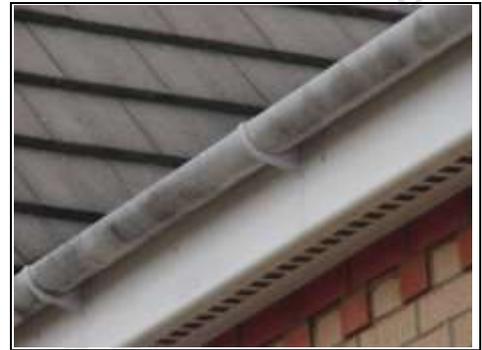
This type of property is relatively modern (i.e., less than one hundred years old) but nevertheless still requires ongoing maintenance and repair. A budget for such work must be allowed to ensure it is maintained in a good condition. This will prevent undue and unnecessary deterioration. For example we noted that your gutters are covered with a moss which does indicate that they may be overflowing and need cleaning.

Moss covered gutters

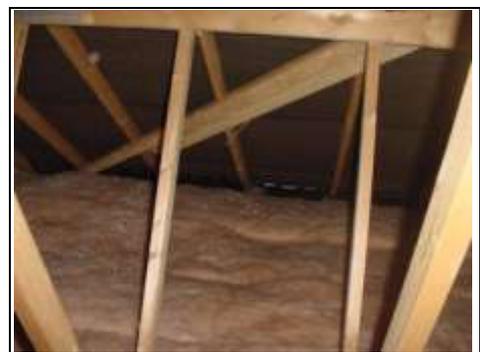
- 1.0) as we did not have full view of the roof space due to the mass of insulation and stored items.

Mass of insulation

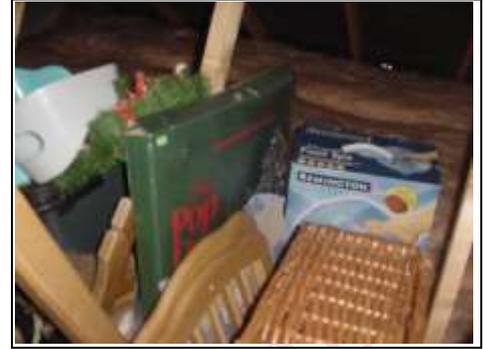
Stored items in the roof space
