RESIDENTIAL BUILDING SURVEY

New Malden, Surrey KT3

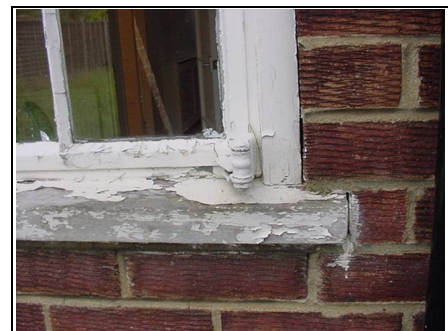
The timber work to the windows and the metal windows and doors need repair, easing and adjusting and redecoration.

ACTION REQUIRED: We believe that it would be more economical in the long term to replace the windows, as metal windows often warp and rust and become almost impossible to shut.

ANTICIPATED COST: This really depends upon the quality of the window system used. We would recommend a double glazed system, which we would expect to be in the thousands of pounds.

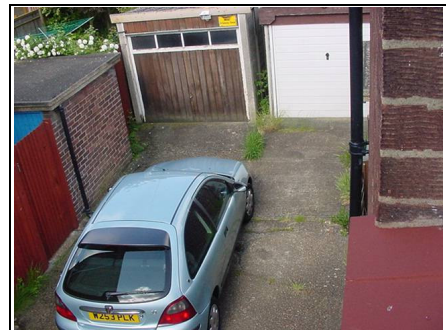
Shared driveway

Whilst it is an advantage having off road parking you would also need to be considerate to your neighbours. When we spoke to your neighbours they mentioned problems they have had in the past with tenants from the house you are buying parking on the shared driveway, which stops access to the garage.

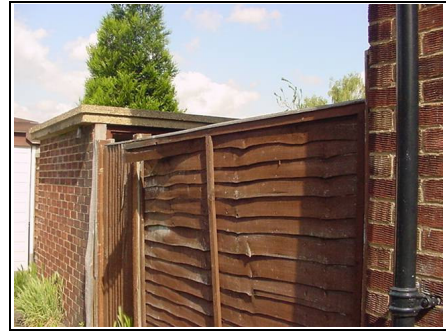
The fences surrounding the property require realigning, straightening, repair and re-staining. The neighbour was very keen for this to be carried out.

Fence falling down

ACTION REQUIRED: Realign, straighten, repair and re-stain the fences.

ANTICIPATED COSTS: In the region of £200 - £1,000.

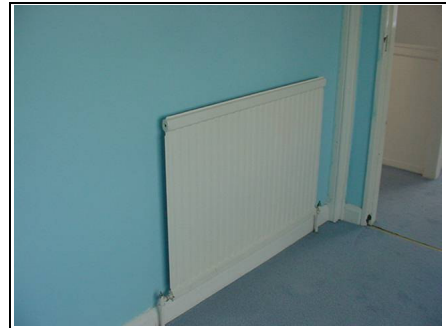
We noticed throughout the property that there are internal radiators, most of which are single panelled. This system is often used as a cheaper heating system, as it means the plumber does not have to cut the joists to run the pipes as far. It can mean that the rooms do not warm up as quickly as they would do under a window where the radiated heat circulates around the room. This can cause condensation.

ACTION REQUIRED: You need to live with the existing heating system to check to see if you are happy with this; if you are not then the radiators will need to be repositioned underneath the windows and increased and improved to double panel convection radiators.

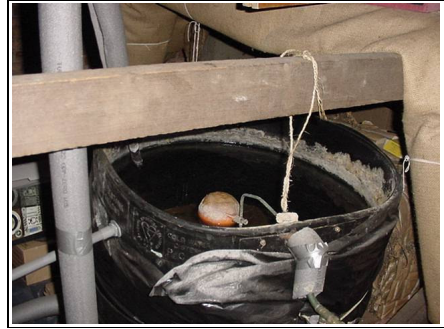
We noted that there was no lid to the water tank in the roof space.

ACTION REQUIRED: Add a lid.

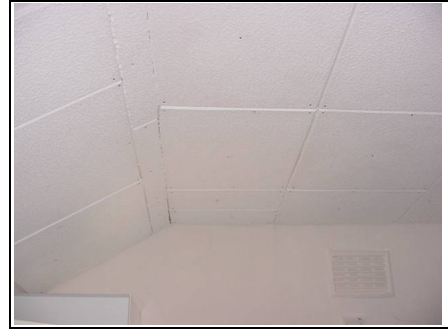
In several of the rooms, for example the kitchen and cloakroom, there are polystyrene tiles to the ceilings. These are considered to be a risk if there is a fire as it can drip down onto you.

ACTION REQUIRED: Remove and repair the ceilings. We would add that often these tiles were added to ceilings because of the ceilings being defective.

ANTICIPATED COST: This depends upon how well the ceiling tiles are fixed and the condition of the ceilings beneath them. We would expect costs in the region of several hundred pounds and an additional amount to repair and make good the ceiling.

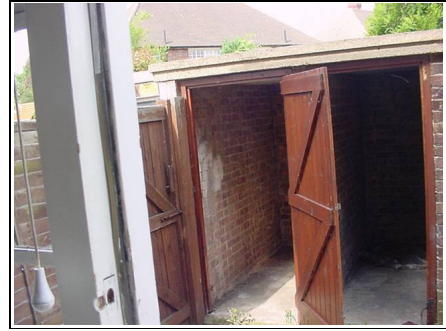
The outside shed doors have come off. Whether someone has broken into these sheds is not clear. We spoke to the neighbour who believes that they have come off due to wind damage.

ACTION REQUIRED: Re-secure doors.

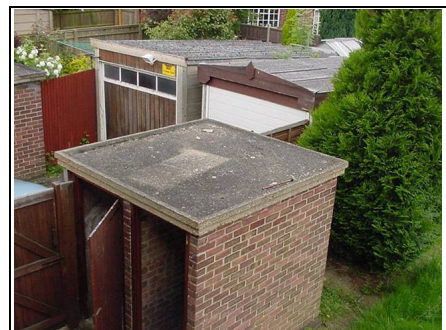
As is common in this age of property the outside shed has a concrete roof. It is not completely watertight but were acceptable in their day because this was often used for a cold store.

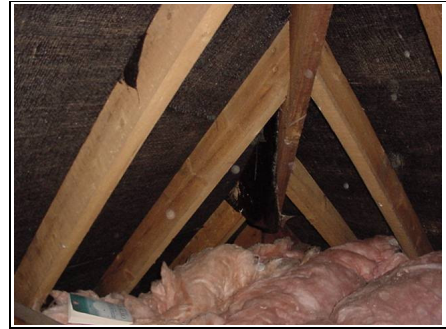
Hipped roofs are known for slippage / movement which can occur in the structure. In this case we feel it is within acceptable limits.

Looking at the hip for movement

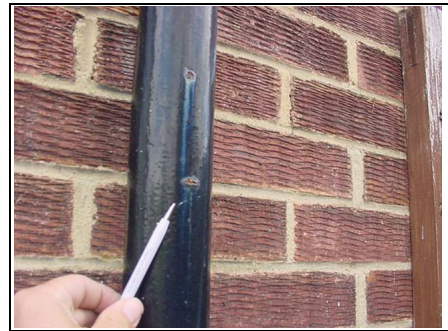
The cast iron is in below average condition, all things considered, and we could see areas where the cast iron gutters and down pipes are rusting and damaged. On the down pipes, for example, the cast iron rusts from the inside out.

Rusting downpipe

ACTION REQUIRED: Next time it rains hard you need to watch the gutters and down pipes for leaks, make a note and repair them. This process will need to be repeated several times until you have repaired all the leaking areas.

We would always recommend that the gutters and downpipes are cleaned out, the joints are checked and the alignment checked to ensure that the gutters fall towards the downpipes.

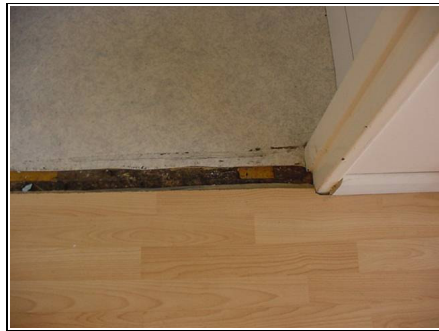
Laminated flooring – fitted badly

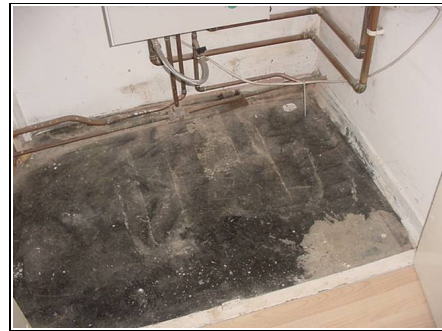
Under the stairs we could see the pitch, which was often applied to the concrete floor finish.

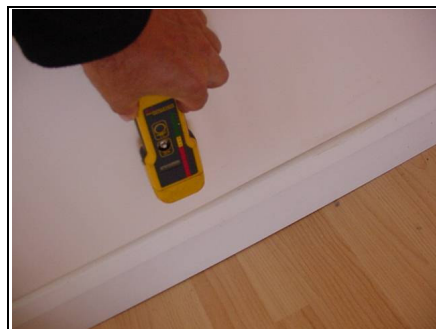
We would add that to the rear of the property we noted a small concrete step, which may cause some dampness to the rear French door areas.

ACTION REQUIRED: This would simply mean that you have to cut back a small amount of the step.
