**RESIDENTIAL BUILDING SURVEY**  
**OF**  
**Newmarket, Cambridgeshire CB8**

**FOR**  
**Mr G**

**INDEPENDENT CHARTERED SURVEYORS**

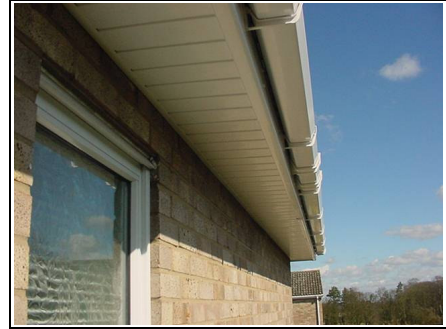
There is plastic cladding to the fascias and soffits at high level and we believe these have possibly over-clad the original timber. This can cause wet rot in these areas, particularly as it is normally carried out when the timbers are not in good condition.

**ACTION REQUIRED:** Carry out a sample by drilling into the fascia to see if wood is below. If wood is present, strip off the over-cladding and check the condition of the timber beneath. Ideally you should add a vent to the soffit and repair and redecorate as necessary.

**ANTICIPATED COST:** To replace the fascias and soffits would mean removing the gutters and as this is high level work you may need scaffolding or special access equipment. We would therefore suggest in the region of £2,000 - £3,000, but you do need to obtain quotations.

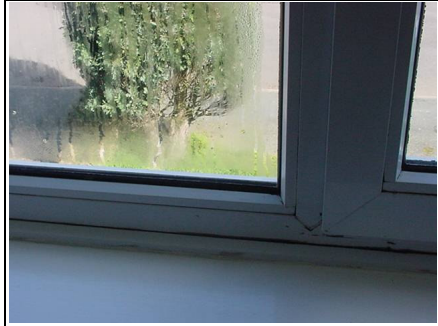
Some of the units have failed to the double glazed windows and have condensation in them. This looks to be an old problem as we could see some DIY repairs.

Condensation

**ACTION REQUIRED** Replace double glazed units as required, price varies depending upon the size of the glass.

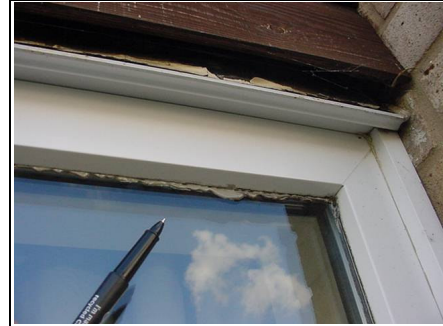
Repair to double glazing on front window

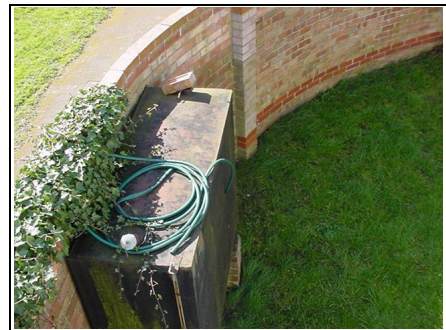
The oil tank is metal and rusting and coming to the end of its useful life. Although, having said that, it may still last a few years. We much prefer to see plastic oil tanks, as these are usually double lined, which means that if they do leak there is a second lining which catches the spillage.

**ACTION REQUIRED:** Have the oil tank checked by an independent OFTEC registered heating engineer prior to committing to purchase the property. You may have to replace with a plastic tank.

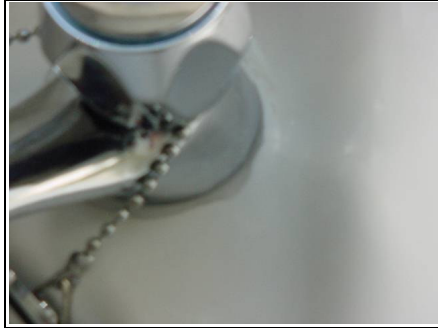
During the course of the survey we turned the taps on for approximately 15 – 30 minutes and noted a minor leak on the cold tap which left a puddle of water on the floor.

Leaking Tap

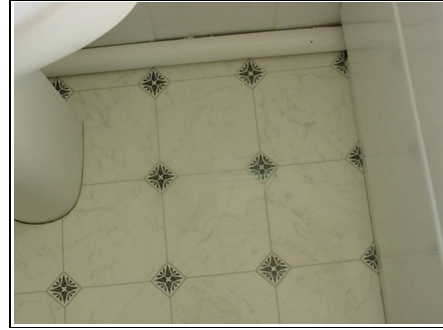
Puddle of water on the floor

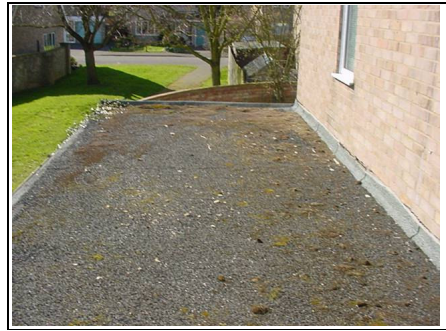
The flat roof over the garage is very flat and has moss present on it indicating that water is sitting on it. In addition to this the felt flashing (we would always recommend lead flashings) has come away and needs repair.

Moss sitting on flat roof

**ACTION REQUIRED:** Ideally completely re-roof in the next five years using an insulation cut to falls to ensure there is a definite fall on the roof. More immediately you need to replace the felt flashing with a lead flashing.

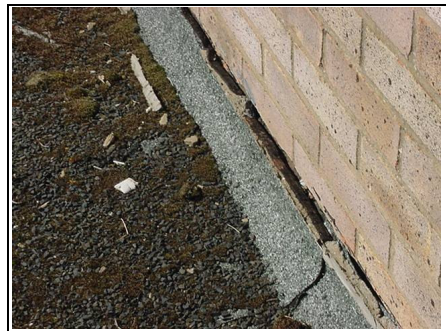
Flashing coming away

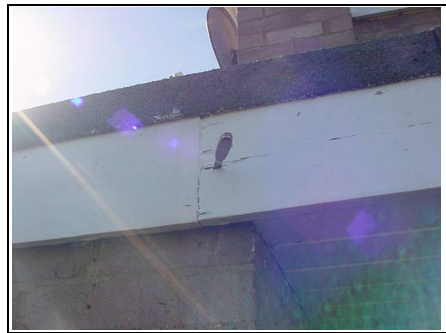
There is some minor rot to the low level timber fascias and soffits.

**ACTION REQUIRED:** We would recommend that these are replaced when the roof is replaced. This is possibly a DIY-type job.

**ANTICIPATED COST:** £5,000 - £10,000 for the roof replacement and the various other repairs.

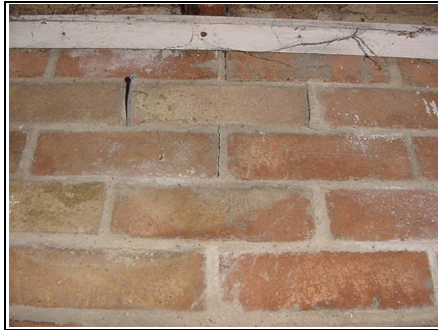
There are vertical cracks visible in the single skin of brick wall on the left hand side. This is hidden externally by a wall that has been built in front of it.

Single skin brick wall opening up - note the vertical cracks.

**ACTION REQUIRED:** Your Legal Advisor needs to confirm who owns the wall and we would suggest repair work / rebuilding work as necessary, depending upon what your future requirements are for the wall, i.e. if you do plan to rebuild in the next few years then we suggest you wait until then.

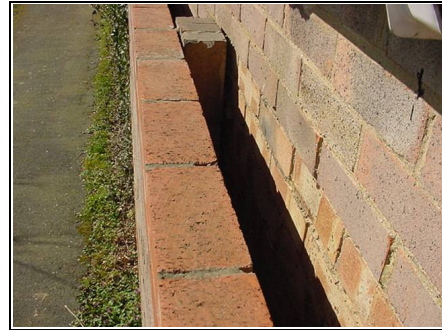
The right hand wall in this photo is the one with the cracking

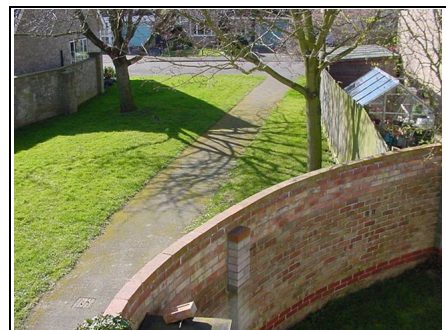
We thought we would add this as you have a fairly high single skin brick wall that normally can be prone to cracking and minor movement. This wall adjoins a Right of Way public footpath that the public use and the wall is near enough, if it fell down, to land on someone.

**ACTION REQUIRED:** You need to keep this wall well maintained on both sides of the wall and make a periodic inspection of the far side of the wall (the one that you cannot see by looking out of the window).

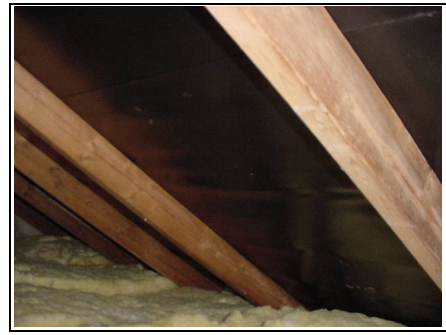
When we inspected the loft space we found a reinforced plastic sarking felt. This type of sarking felt was used in the 1970s/1980s and its use was generally stopped because it was susceptible to causing condensation unless the roofs are adequately vented, which they are usually not.

**ACTION REQUIRED:** In this case we would recommend vents are added.

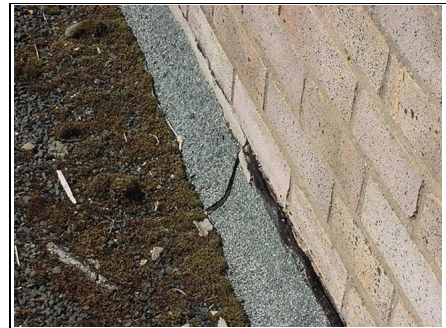
The property has an older style Bitumen flat roof that has a 'protective' chipping covering. This roof has passed its sell by date. We recommend replacement with a modern, high performance felt within the next five years. You also need to ensure the roof has a proper fall (flat roofs are not meant to be flat!) and we would recommend ventilation to reduce the risk of condensation, and insulation.

Flashing coming away.

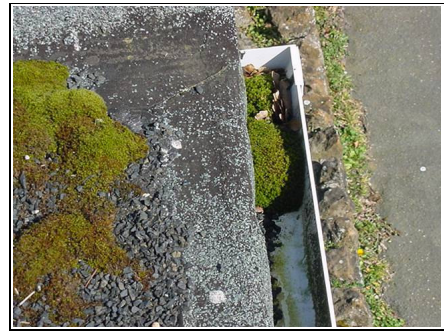
Low level guttering blocked with moss

**ACTION REQUIRED:** We noted that some of the gutters had moss in; no doubt built up on the shallow pitched roof and also the flat roof. We would recommend that the roofs are cleared of moss.

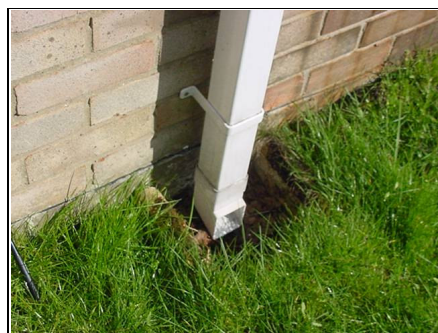
The gully is blocked with leaves and needs clearing.

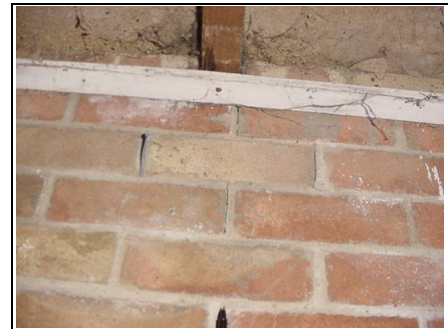
In this instance we noted hairline cracking. Please see our comments in the Executive Summary.

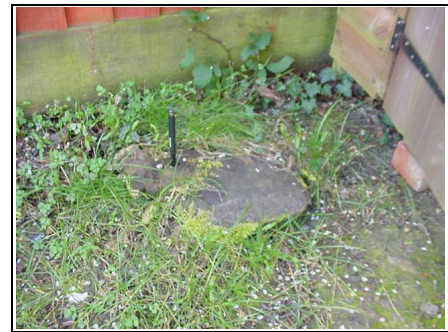
Quite a large tree has been removed to the rear garden.

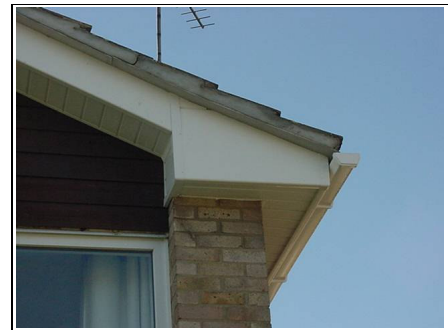
There are painted timber fascias and soffits at low level that has some wet rot and would benefit from repair and redecoration.

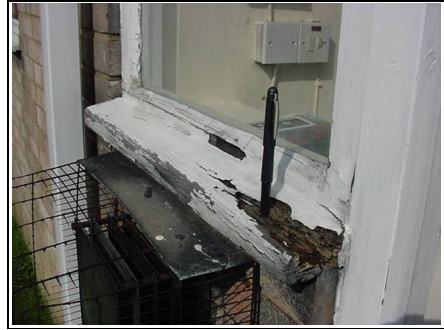
Rotten window to the rear next to the garage.

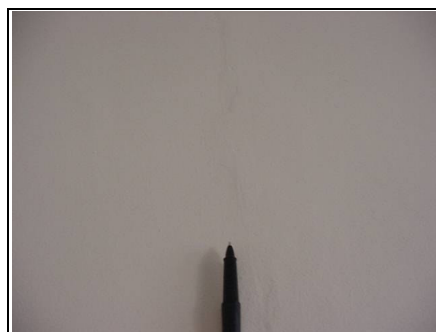
Hairline cracking to the chimney

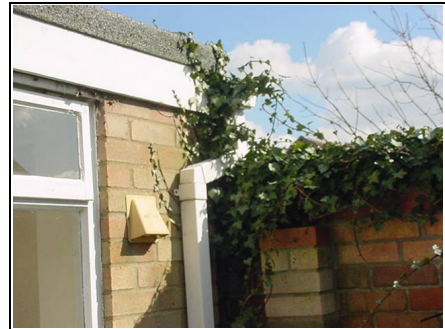
Ivy needs cutting back
