# RESIDENTIAL BUILDING SURVEY

Powys  
LD8

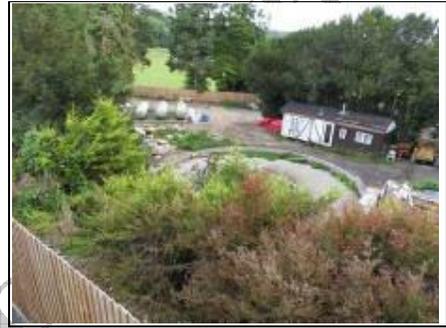
The sewerage treatment works for the site is just beyond the rear fence of the property, hence it was quite badly affected by unpleasant odours. We expect this would be changeable depending on the temperature, time of day/year and wind direction.

Sewerage treatment works

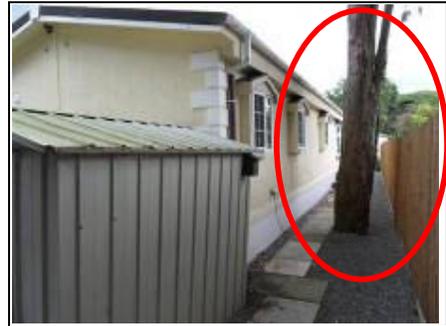
The caravan is situated adjacent to a particularly large tree and whilst the building does not have traditional foundations there is of course a raft foundation underneath which could be disrupted by the tree roots in the future and we can give no guarantees as to the long term stability of the ground.

Large tree

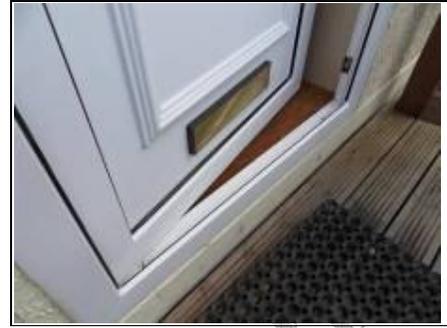
The front door, and the windows generally, do not have external sill details and the door does not have a drip rail. This means that water does not discharge away from the face of the building. This is of particular importance as the building is of timber frame construction which may be prone to decay if dampness penetrates. Although by no means urgent, we recommend the detailing is improved.

No drip rail to door

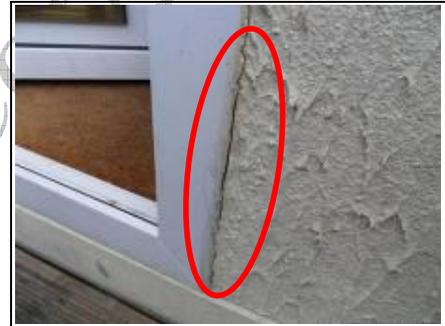
There is minor cracking in the finishes around the door and also some of the window openings may lead towards penetration in the future. Whilst only hairline in width at present ideally this should be raked out and filled with colour match flexible mastic in the future.

Hairline cracking around door

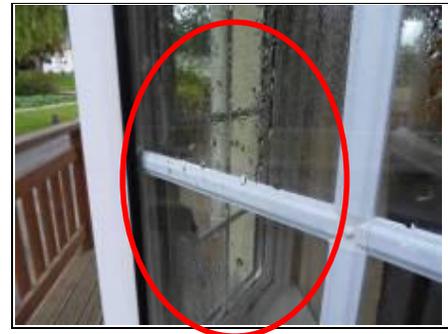
Two of the sealed double glazed units have failed on the outward projecting oriel bay windows.

Failed window

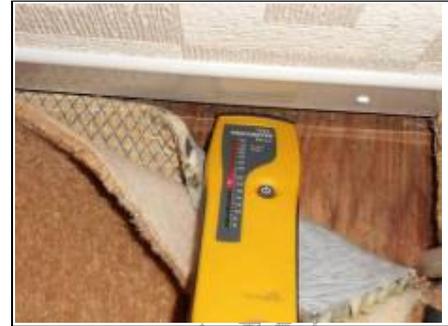
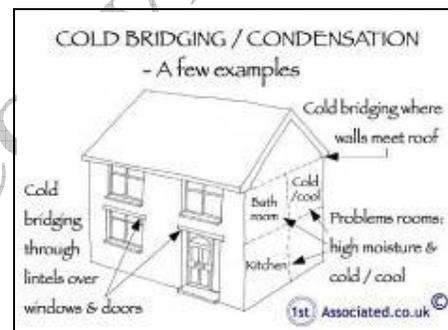
We noticed a general level of background dampness to the majority of the wall and floor panels. The level of dampness would usually indicate that decay is inevitable in natural timber but we do believe this to be marine ply which is much more robust.

We cannot rule out the occurrence of decay, particularly to the concealed timbers where we have been unable to gain access and we cannot confirm the presence or otherwise of a vapour barrier in the wall or floor construction, which modern buildings should be provided with.

Taking damp meter readings

Cold bridging

**ACTION REQUIRED:** We recommend the wall structure is opened up to confirm the presence or otherwise of a vapour control layer and also to ascertain the quality and condition of the concealed timbers.

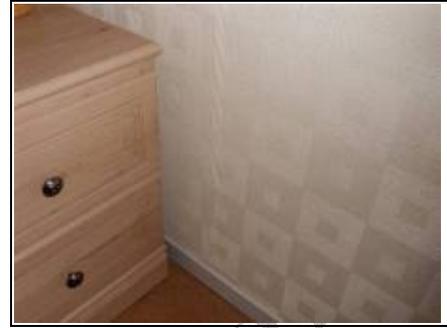
Various areas of rucking to the paper finishes were noted. This will be difficult to eradicate and avoid going forwards and it is simply minor movement between the plywood panels of the walls.

Movement between wall panels

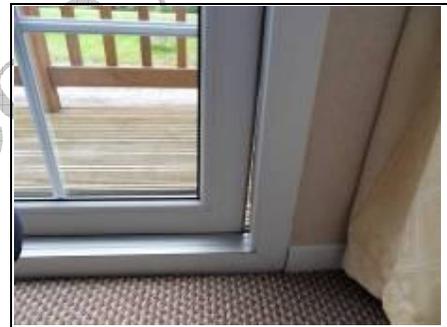
The patio door aperture has distorted since it was installed and when the door is closed there is an uneven gap at the base, whilst the top hits the frame. At present this still locks and operated correctly, however we cannot confirm whether the caravan will move further and it must be considered a risk that some future repairs will be required.

Patio doors out of square

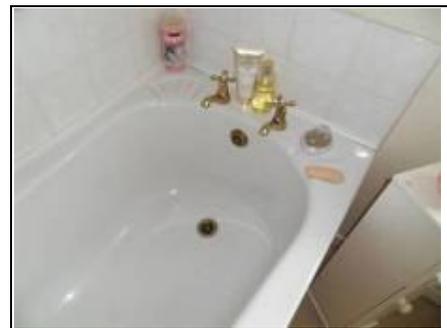
The sealant to the sanitary fittings and the sealant to the perimeter of the bath is a self-adhesive strip and this has become detached and loose. No sealant is provided to the rear of the kitchen worktops and the sealant to the shower also looks as though it could leak.

Sealant to sanitary fittings

**ACTION REQUIRED:** It is imperative that these are kept in a watertight condition with this style of construction, since any water which does penetrate could cause decay to the timber frame and failure of the structure and significant decay could occur before visible signs become apparent on the surface.

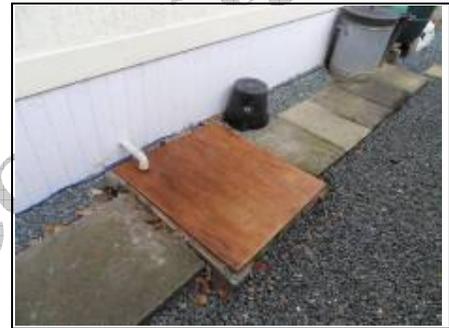
Whilst we do not believe there is a requirement for the building to comply to Building Regulations for permanent structures, the foul drainage to the rear has a chamber which is covered by a loose laid timber panel. Not only could this become detached it is poorly sealed and does not comply with regulations.

Timber cover over drainage chamber to rear

**ACTION REQUIRED:** We must recommend this is upgraded in accordance with Building Regulations.

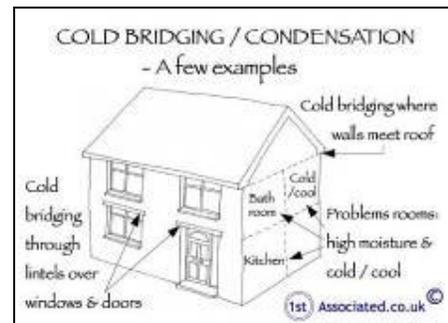
Cold bridging

**ACTION REQUIRED:** There are things you can do to help such as add large humidity controlled extract fans in the bathroom and the kitchen and any rooms that you use for drying.

Upgrading insulation and providing background ventilation and heating generally.

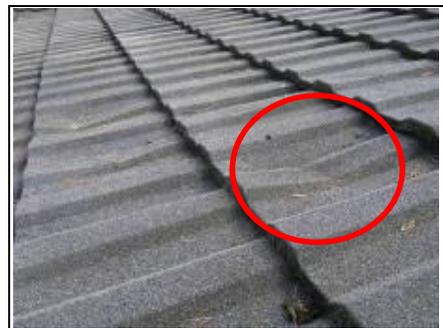
Minor impact damage to the roof finish was noted in some areas, presumably as the result of foot traffic. Decra panels are particularly lightweight and crawl boards should be provided for access of the roof's surface for any reason. The impact damage does not appear to be detrimental to the weatherproofing of the roof at this time but future problems cannot be ruled out.

Minor impact damage to roof

**ACTION REQUIRED:** Carry out periodic visual inspections and maintenance of the roof as necessary and ensure it remains watertight.

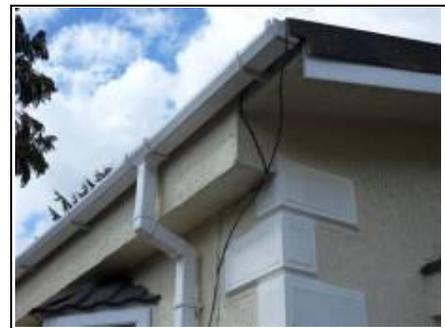
The gutters and downpipes are plastic and are generally in good condition, although to the front elevation they are quite congested and will need to be regularly cleaned out because of the overhanging trees. This is, again, particularly important with a timber framed structure. To the rear one of the downpipes has been replaced in a non matching colour.

Gutters and downpipe

There may be some minor leaks evident but most people would be happy to live with these providing repairs are carried out within the next six to twelve months.

**ACTION REQUIRED:** We would always recommend you stand outside the property next time it rains heavily and see how well the drains cope with the rainwater particularly looking at the guttering and the joints.

We also recommend that the gutters and downpipes are cleaned out, the joints are checked and the alignment checked to ensure that the gutters fall towards the downpipes.

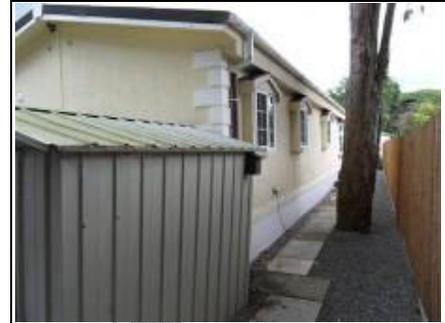
We believe it likely that trees maintenance is the responsibility of the park owners and that any foundations that have been installed should have taken adequate account of the proximity of the trees.

Large tree

**ACTION REQUIRED:** We recommend you instruct your legal adviser to confirm who would be responsible for any damage to the property as a result of the adjacent tree and the design of the foundations. Although not traditionally constructed there is a foundation with tripods supporting the caravan at various intervals and clearly any substantial ground movement could have a negative impact on the construction.

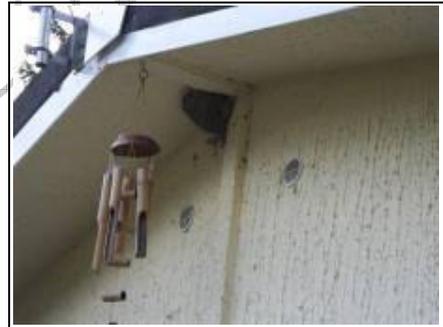
Textured finish fascias and soffits  
(with bird's nest underneath)

**ACTION REQUIRED:** The fascias and soffits are formed in a similar manner to the walls, presumably with plywood sheeting. Some evidence of joint line cracking was noted around the plywood sheet abutments. These should be checked regularly to make sure they do not allow the penetration of water.

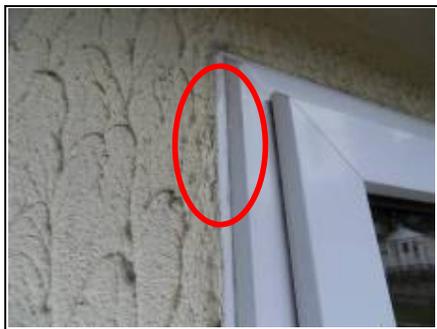
Minor cracking around some of the window reveals

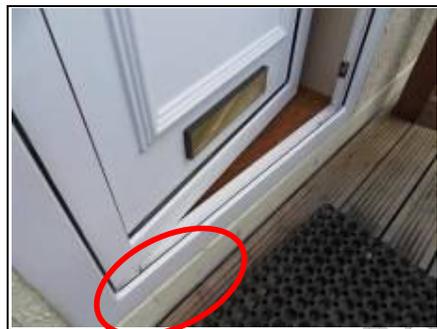
To the front door the lack of a drip detail and threshold is beginning to cause evidence of decay to the timber rail below and we recommend consideration be given to upgrading this.

No threshold or drip rails to door beginning to cause damp problems to the timber rail below

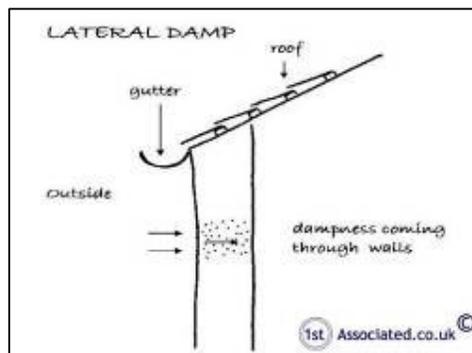
Otherwise we do not believe there to be lateral or penetrating damp issues caused as a result of external building defects. We have found dampness to the internal finishes but these generally are consistent throughout and are more likely to be the result of condensation from poor ventilation, heating, insulating and cold bridging.

Cold bridging

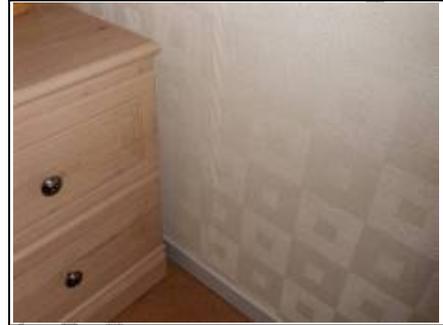
Rucking paper noted in bedroom one near the rear window
