RESIDENTIAL BUILDING SURVEY

**Barking,
IG11**

INDEPENDENT CHARTERED SURVEYORS

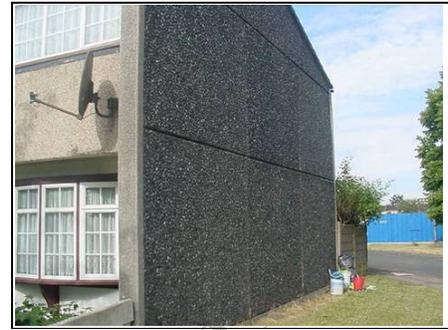
Concrete walls – red lines indicate where the concrete walls start

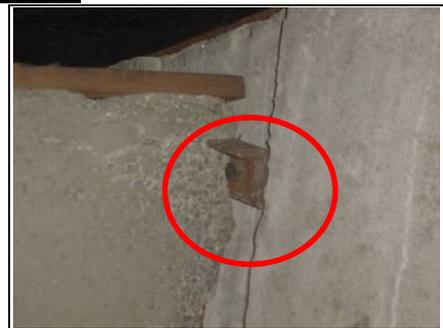
How front and rear are held in place with brackets

We can see at this property that the anchor brackets are rusting and whilst you can use, and we recommend, a rust stop agent and redecoration, this is only part of the story as your neighbours also need to be carrying out the same work.

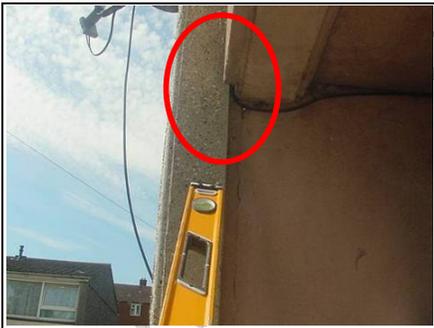
We examined the pre-cast concrete that we can see vertical and horizontal cracks within the concrete panels externally and internally on the right side and on the left side adjacent to the staircase and this looks to be in average condition for its age.

Vertical cracks within concrete panels externally

ACTION REQUIRED: The only way to be 100% certain as to the condition of this reinforcement within this property is to cut back the concrete to check the condition of the reinforcement.

Monitor how its condition continues.

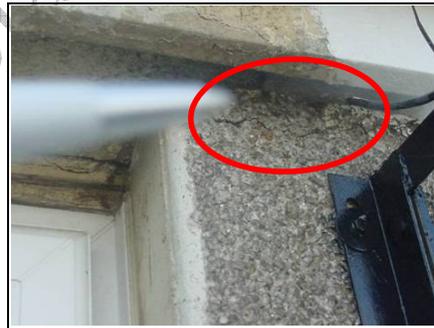
Horizontal external crack

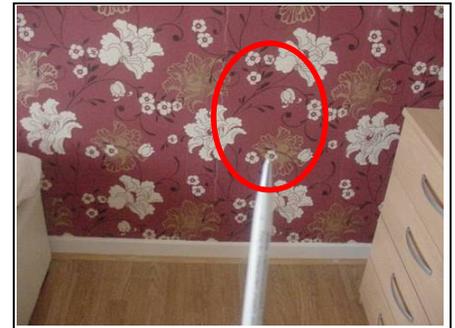
Vertical cracks on right side

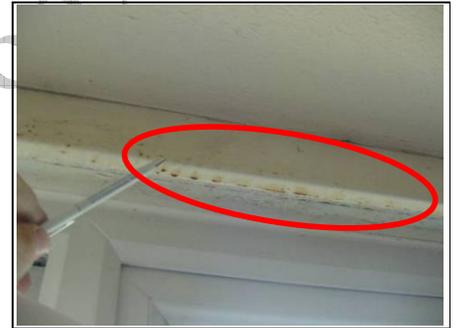
There looks to be a steel frame to the front and rear of the property. This has not been identified as an element with the construction of the Carlton pre-cast concrete house, however from what we can see there looks to be metal beams to the front and rear of the property and there also looks to be some rust, for example, within the bathroom area.

Rust is never a good sign within a building.

Rusting visible on metal beam in bathroom

ACTION REQUIRED: Install large humidity controlled extract fans to the humidity generating areas, the bathroom and kitchen and also areas where you will carry out drying. We spoke about this and you mentioned you are likely to use the front left hand room for this type of activity, we therefore recommend you also have an extract fan there.

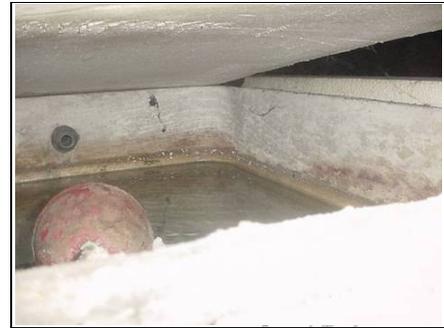
Asbestos water tank

ACTION REQUIRED: We would always recommend all asbestos is removed from a property by an asbestos specialist as not only can it cause health problems, it also, we believe, affects value as there are perceived problems with it.

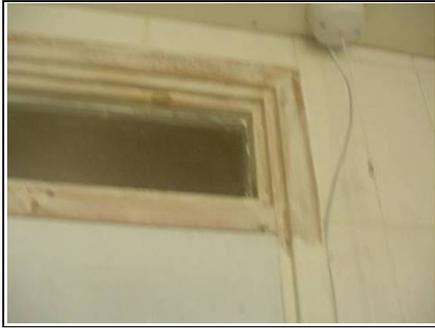
There was a general lack of cleaning and a lack of redecoration throughout the property. The only room that looked to have been redecorated was the rear right hand bedroom, but here there were signs that they were literally papering over cracks.

Door frame around borrowed light in bathroom in need of redecoration

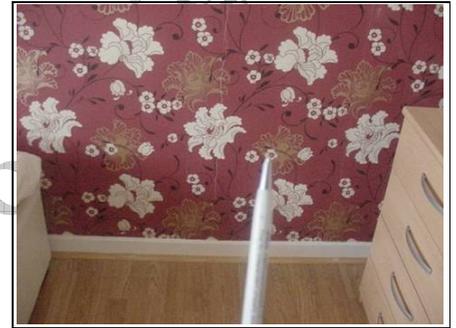
Signs of cracking in rear right hand bedroom which have been papered over

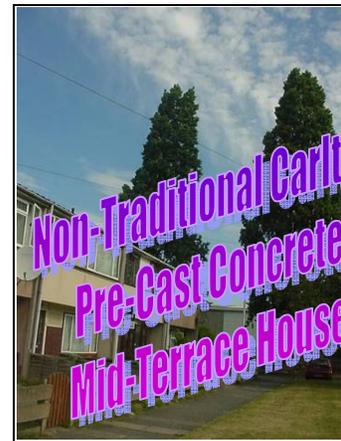
Trees on Local Authority land

ACTION REQUIRED: We recommend that you or your legal adviser speak with the Local Authority to confirm they do maintain these trees.

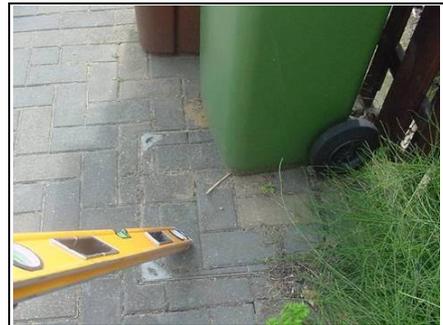
Manhole

ACTION REQUIRED: We would recommend a closed circuit TV camera report of the drains.

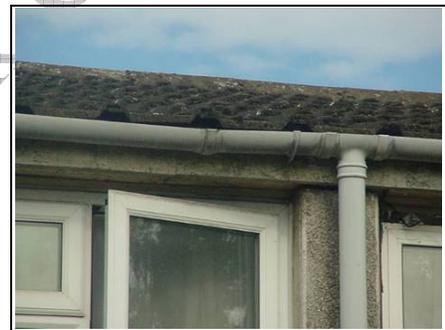
We were unable to view the main roof very well from ground level. We believe it to be a shallow pitched concrete or possibly an asbestos tile, which look to be covered with moss.

Main roof

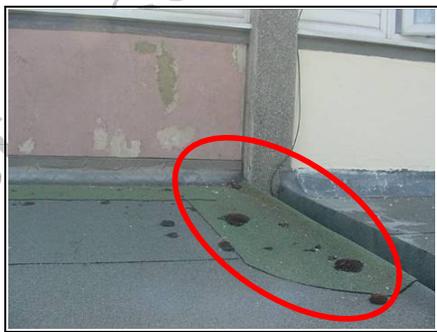
This low level roof, with a fairly modern mineral felt. We can see it has been repaired to the rear and has a Flashband flashing, which we generally consider to be a temporary material and not of good quality.

Repairs to flat roof (with moss that has come down from main roof)

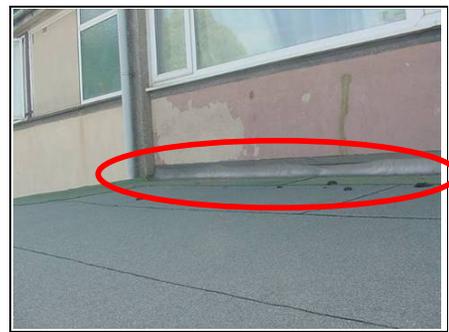
Flashband flashing

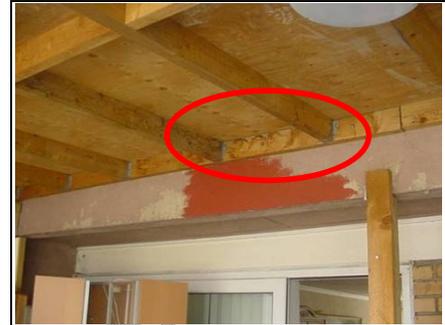
We can see staining to the timbers, indicating a roof leak.

Staining to timbers

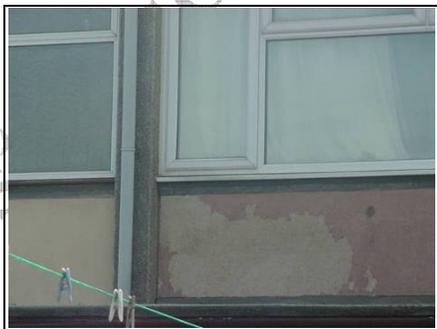
There are areas of render to the rear that need redecoration and repair.

Deterioration to render to rear

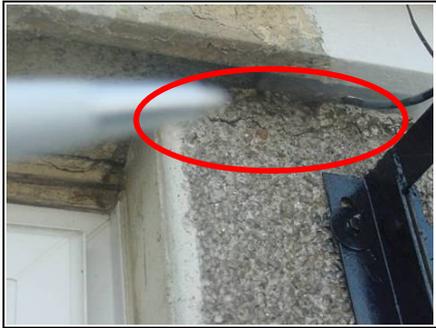
Small amount of cracking
to rear left hand corner

We would remind you that any hairline cracks that appear need to be sealed as soon as possible to stop dampness and water getting in and causing blisters and hollow areas.

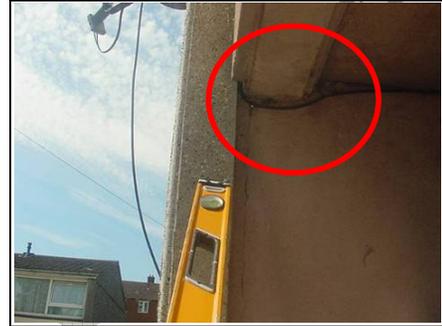
Cracking to front of property

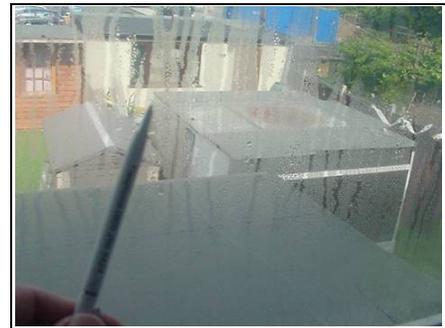
We would draw your attention to the fact that sealed double glazed units can fail, particularly as a result of poor workmanship during installation. Failure of the seal leads to condensation between the two panes of glass and simply replacing the affected units may not provide a satisfactory long-term solution.

Seal has gone to double glazing

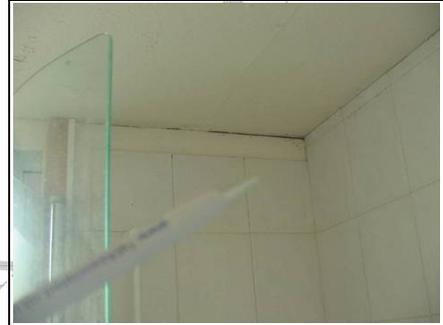
Bathroom – large humidity controlled extract fan needed as close to the shower as possible

ACTION REQUIRED: We would recommend large humidity controlled extract fans be added to kitchens, bathrooms and drying areas.

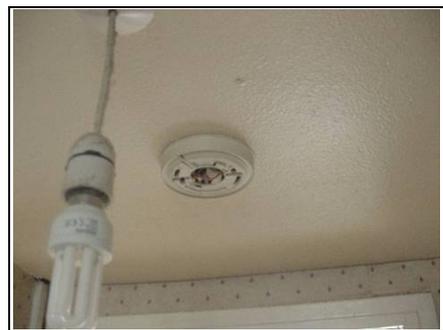
Some smoke detectors were noted; we believe these to be battery operated. The current Building Regulations require that they be wired into the main power supply, which do not appear to be working in some cases.

Smoke alarm not working
