RESIDENTIAL BUILDING SURVEY

Cheshire

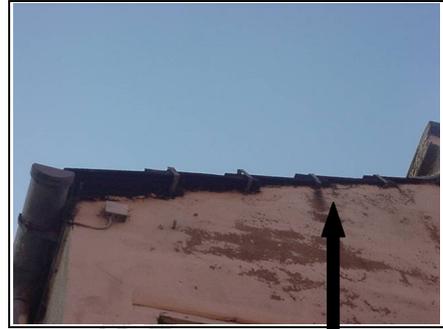
There is dampness coming down the render which we believe is due to the roof tiling that does not overhang properly. We feel also that the render may be defective as the amount of dampness is considerable.

Dampness on end gable probably due to way the roof tile is

ACTION REQUIRED: We recommend a roofer investigates the roof. They are likely to have to do some re-roofing plus put a proper flashing around the chimney and possibly vent the chimney.

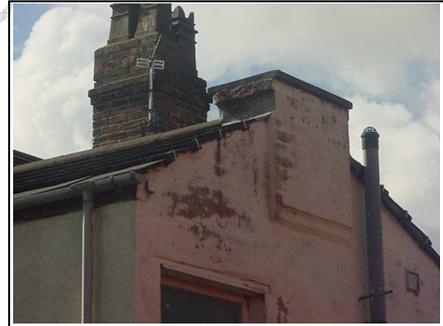
There is sulphate attack on chimney

You will then have to allow the render to dry out which can take some time and check to see if it damaged or deteriorated and then finally redecorate in a masonry based paint. To some extent you will always have a problem where you have used a cement based render or pointing on an older property such as this which is meant to breathe. One final point, often in this age of property there is a timber lintel to the windows and these may have been damaged/deteriorated by the dampness in the wall over the years.

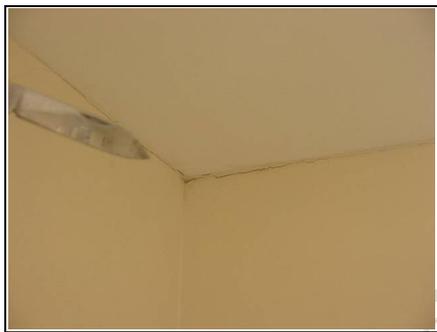
It is likely as most Victorian roofs were slate that the original roof has now been changed for a concrete roof, which is much heavier than slate roofs. As such extra timbers should be added into the roof. We could not see these additional timbers although, as mentioned, our view of the main roof was limited.

Cracking at roof level – no supporting timbers in roof

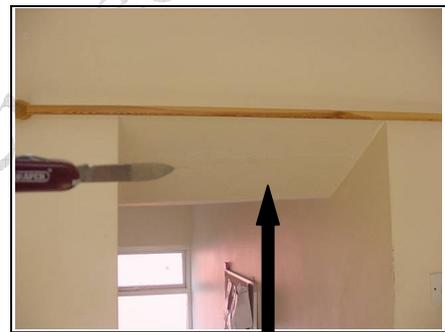
Cracking at roof level – no supporting timbers in roof

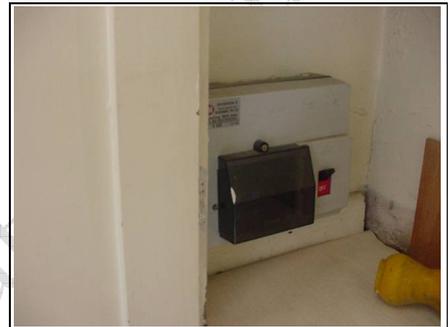
Electric unit in cupboard on first floor – not sure what this is for

ACTION REQUIRED: We recommend that the whole system is replaced and an Institute of Electrical Engineers standards (IEE) test and report carried out by an NICEIC registered and approved electrical contractor or equivalent.

ANTICIPATED COST: Depends upon how much is replaced but we estimate in the region of £2,000 to approximately £4,000; please obtain quotations. The cost will very much depend upon how much re-wiring is required.

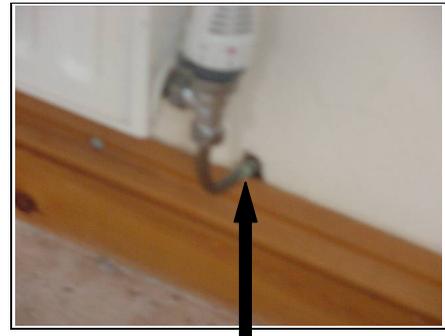
Microbore pipes

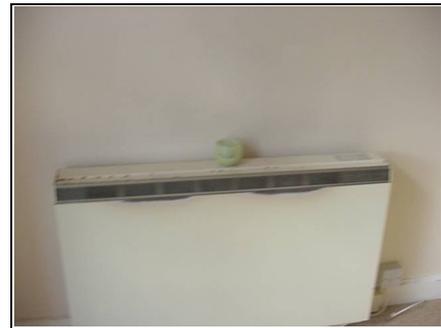
Electric heater on first floor

ACTION REQUIRED: We recommend this is replaced by gas, at the very least the electric heating is modernised.

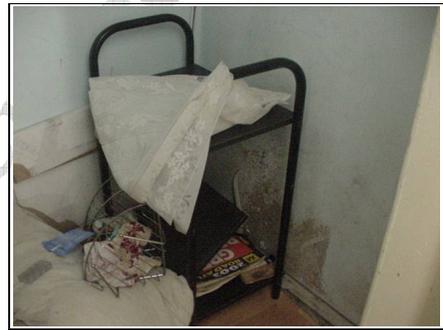
1. Lack of good ventilation in the property.
2. The mixing of dry lined (false walls) construction and traditional Victorian construction
3. Cold bridging will occur in this age of property.

Condensation in first floor

ACTION REQUIRED: Whilst the problem is not 100% possible to stop it can be improved by adding humidity controlled extract fans to the bathrooms/shower rooms and kitchens. At the time of our inspection we noted the form of condensation within the cupboard in the bedroom in the first floor.

ANTICIPATED COST: We would expect costs in the region of £250 to £800 for extract fans; please obtain quotations.

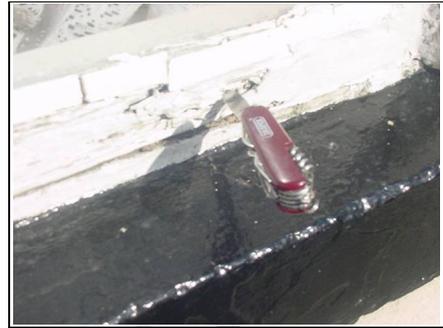
Knife test of condition of timber windows

ACTION REQUIRED: We recommend that for the time being they are filled and painted at cost of approximately £500 to £1,500, but in the long term you need to look at replacing them one way or another.

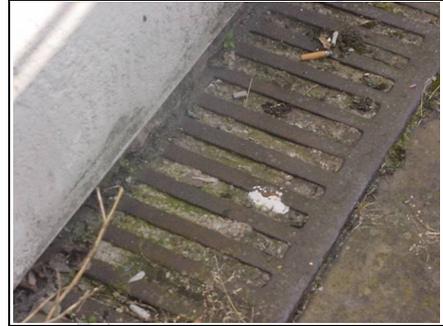
We believe the original suspended timber floor has been partially blocked by concrete in the corner section of the property where the old cellar used to be. This has blocked the ventilation to the timber floor which can cause deterioration. If you recall, we asked you to jump up and down on the front bedroom floor and there was quite a bit of flex/deflection to it.

Where cellar used to be

ACTION REQUIRED: We recommend you open up the suspended floor and check the condition of the joists (timbers). It may well be possible to through vent the area with some timber repairs; alternatively, it may not! The only way to be certain is to open up the floor. Ideally, you need to open up the floor before you purchase the property as this would give you a better indication of the costs.

ANTICIPATED COST: A best case scenario would be costs for air bricks at a few hundred pounds, a worst case scenario would be replacement of the floors in timber which we would recommend. This is likely to be in the region of £2,000 to £5,000; please obtain quotations. As mentioned, we have actually carried out this type of work and propped up the floor which lasted for many years in a similar Victorian property.

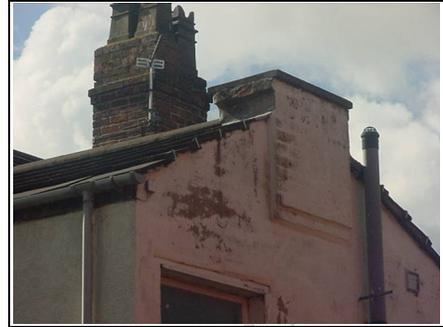
Rear chimney

This chimney has been lowered and rendered and capped. We noted it had sulphate attack. This is where the soot from within is getting damp and seeping through.

ACTION REQUIRED: You can sweep the chimney and then vent it to resolve this problem and also check the flashings. Please see our comments in the Executive Summary.

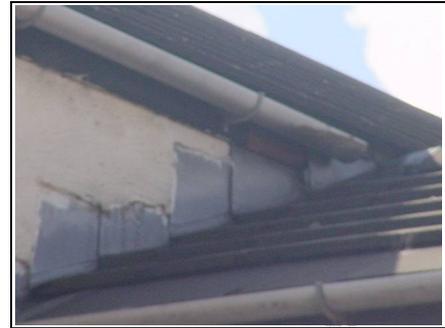
Tile on edge rather than lead flashing

ACTION REQUIRED: We suggest that that when your roofer gets up on to the roof using a long ladder or a tower scaffold they check to see if there is a tilting fillet.

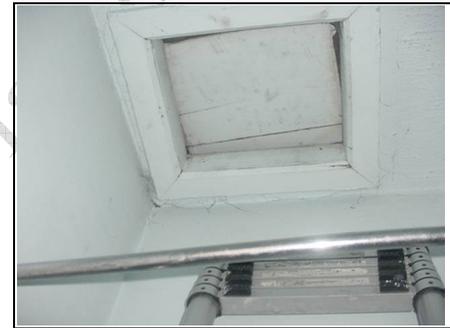
There is no loft ladder, electric light or secured floorboards. We recommend that these be added, as well as a large loft hatch opening to make the roof space safer and easier to use.

Roof access

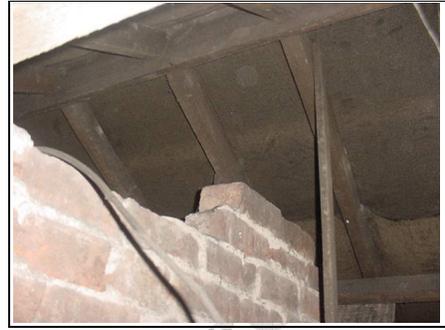
General view of inside of roof - limited view

Our examination was very limited due to us not being able to get into the roof. What we could see was generally found to be in average to slightly below average condition for its age, type and style. We thought we saw some woodworm in the roof but it really is difficult to say with the loft hatch being so small.

ACTION REQUIRED: We recommend you widen both access hatches so you can get a proper view of the woodworm and the fire wall and the dampness. We would also ask a woodworm company to visit. Please be aware they are trying to sell woodworm products.

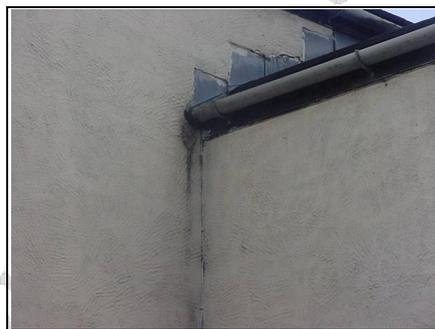
There is likely to be some leaks but it was not raining at the time of our inspection so we cannot confirm this but we could see there was an overflowing gutter to the rear of the property for example, and it may need a realignment of the guttering and general clearing or may need a hopper head and a downpipe.

Overflowing gutter

ACTION REQUIRED: We would always recommend you stand outside the property next time it rains heavily and see how well the drains cope with the rainwater particularly looking at the guttering and the joints. We would also recommend that the gutters and downpipes are cleaned out, the joints are checked and the alignment checked to ensure that the gutters fall towards the downpipes.

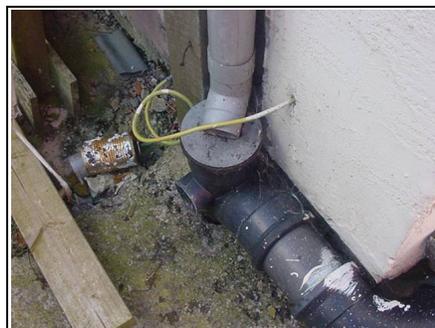
We could also see that one of the downpipes discharged on top of the soil and vent pipe, which we have not come across before.

Rainwater pipe discharging on top of soil and vent pipe

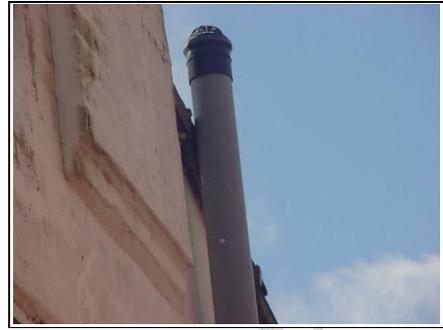
The property has plastic soil and vent pipes. We could see what we would describe as a tangle of pipes feeding into the soil and vent pipe. This is why we believe there may be some blockages to the property. As mentioned, the water was switched off at the time of our inspection so we could not check.

Top of soil and vent pipe

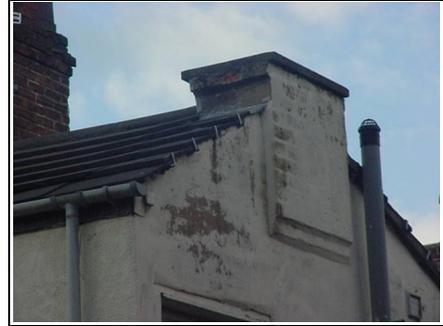
We have mentioned various problems to the rear, for example where we believe there is sulphate attack from the chimney and there certainly is dampness also to the rear. The problem with this type of deterioration is that it can cause blown or hollow section which can be hidden.

Dampness to rear of property

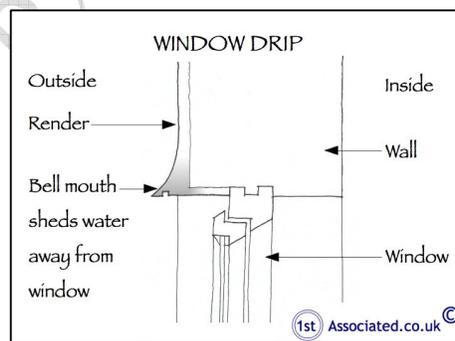
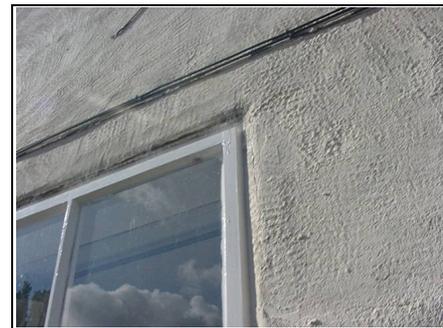
In this case we found no drip detail to the windows and this does give an indication as why the windows are deteriorating.

No drip detail above window

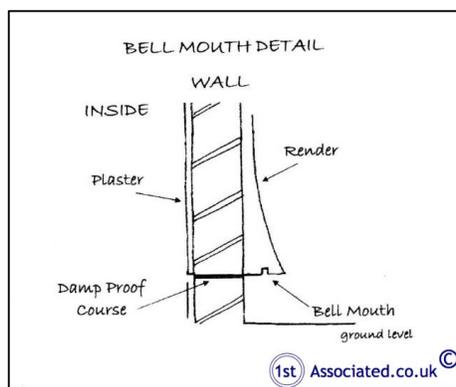
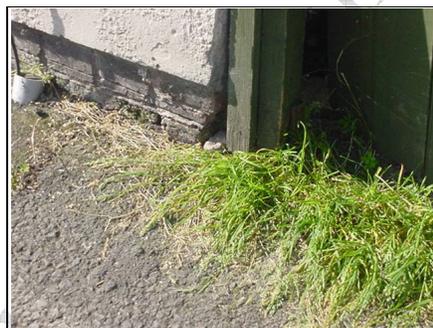
Bell mouth to base of property – with vegetation growing there

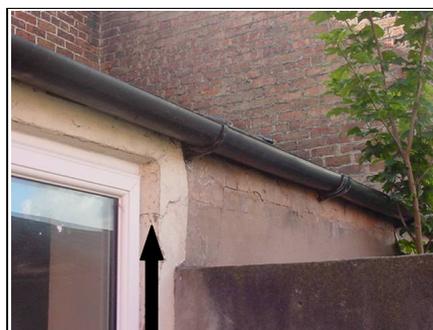
We would remind you that any hairline cracks that appear need to be sealed as soon as possible to stop dampness and water getting in and causing blisters and hollow areas.

Cracking to render

ACTION REQUIRED: Please see our comments in the Executive Summary.

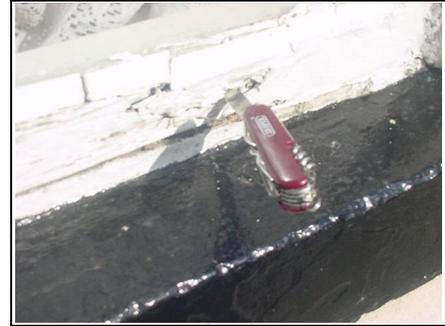
Knife test of condition of timber

ANTICIPATED COST: In the region of £500 to £1,500; obtain quotes.

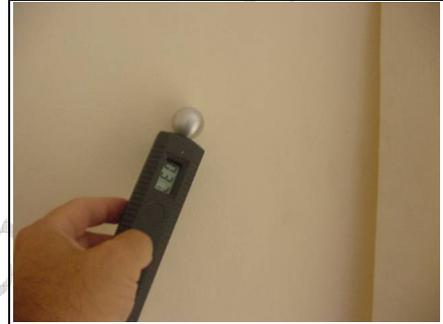
Taking lateral damp readings
– all in the mid 30s

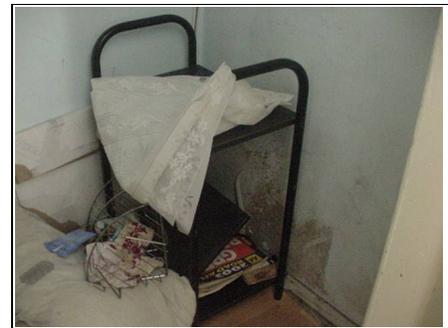
Condensation in cupboard left hand
side room

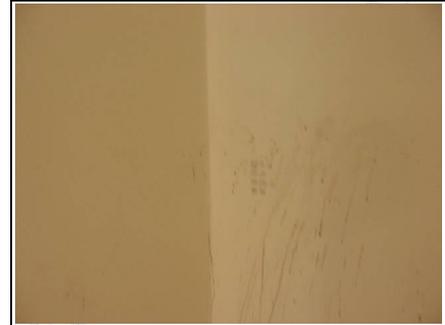
Marks on walls need redecoration

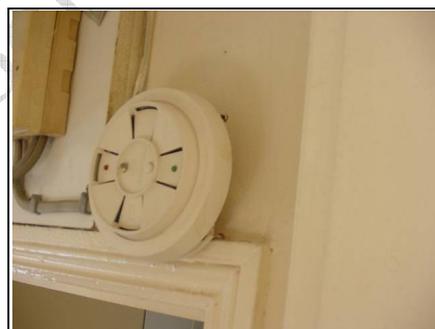
Fire alarm – needs hard wiring

We would also recommend that whilst the electrics are being carried out a hard wired in fire alarm system is added and also a security system, ideally with a door entry camera system which is particularly handy for the first floor flat and is also a good selling point from a safety aspect and fire point of view.
