RESIDENTIAL BUILDING SURVEY

**XXXX Banbury,
Oxfordshire. OX15 XXX**

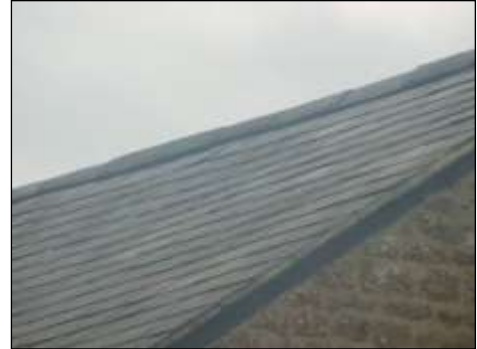
You have an older style roof with modern amounts of insulation in it the combination of the two particularly with the showers and bathrooms beneath can promote condensation.

Slate Roof

ACTION REQUIRED: To reduce the likelihood of condensation add vents to the roof – you can now buy vents that are very discreet and almost unnoticeable.

On reflection we would consider putting vents into the gable ends of the property (subject to Local Authority approval).

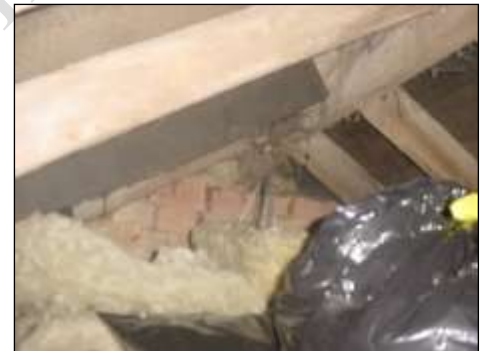
Roof space with a mass of insulation

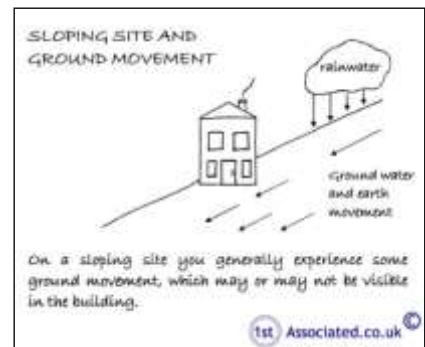
The property sits on a sloping site and therefore during periods of heavy rainfall will discharge towards the building. The outside ground level and the inside ground level are too close together we feel there may be a

Sloping site

danger of water getting into the building. Without seeing the building when it is raining it is difficult to comment further however we did note large land drains on your neighbour's property to accommodate heavy rainfall and from our question and answer session we are advised that they run under next doors' outbuilding.

ACTION REQUIRED: You may wish to consider adding a French gully around the property which interestingly was common with this sort of property many years ago. You should watch closely next time it heavily rains to see if water discharges you may wish to add a French gully.

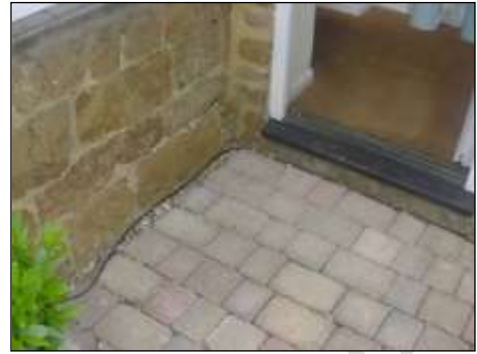
Outside ground level to close to inside ground level

We have concern over flooding in.

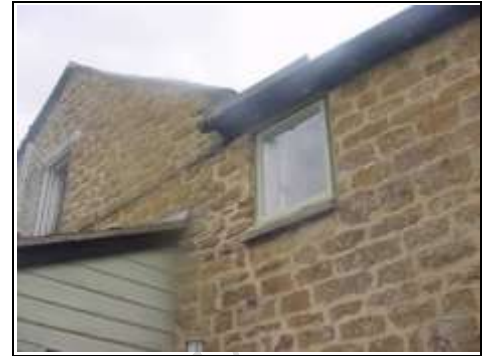
We noticed that the walls had been repointed with cement mortar this is causing spalling to areas of the stonework.

Course stonework

ACTION REQUIRED: We would recommend ad hoc repointing in a lime mortar removing any loose cement mortar and this we recommend is periodically carried out every year until the cement mortar is removed.

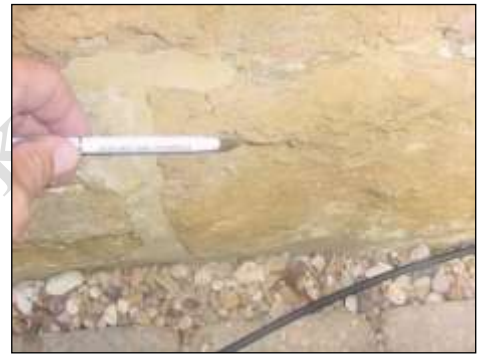
Spalling stonework

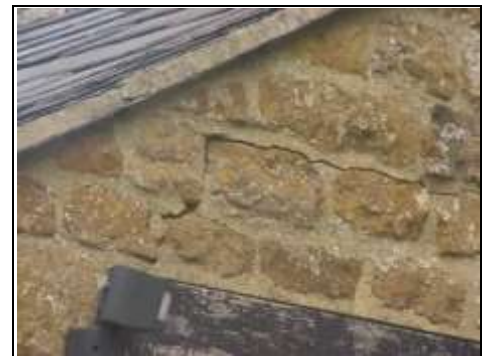
We noticed a crack had occurred between the main building and the outbuilding we believe that this is likely to be due to differential movement one having been originally designed with deeper foundations than the other – in our experience a variety of standards occur when farm buildings are built!

Cracking in outbuilding

ACTION REQUIRED: You need to repoint and monitor

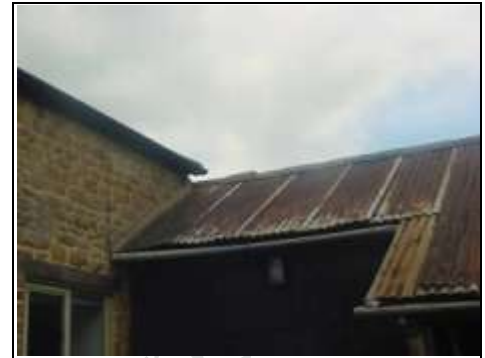
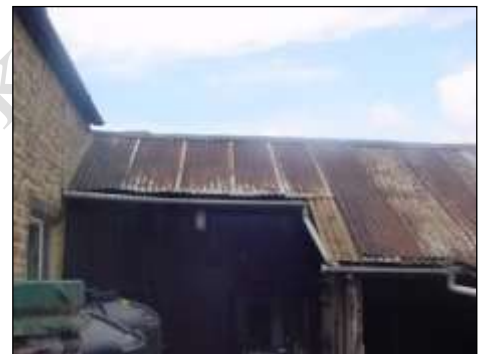
The roof would benefit from being repaired or replaced we note that next door has replaced it with a slate roof which looks very good. Material used will be dependent on what you intend to use this building for.

Roof to outbuilding

ACTION REQUIRED: Repair or replace see above.

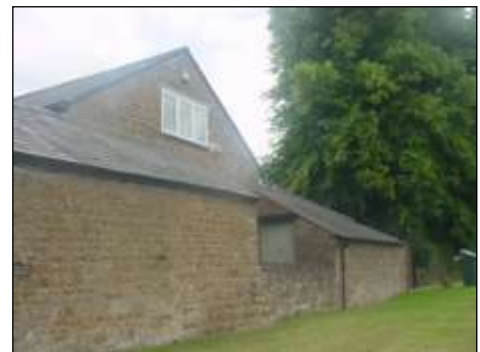
We noted that there is no gutter which will cause deterioration to the stonework if not added.

Missing guttering

ACTION REQUIRED: Add guttering

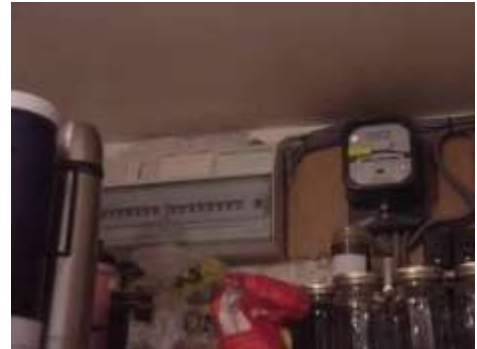
The electrics are slightly dated

Electric fuse board

ACTION REQUIRED: Ideally replace with a new fuse board

NICEIC approved contractor to carry out an IEE inspection test and all recommendations to be actioned. A new fuse board is recommended.

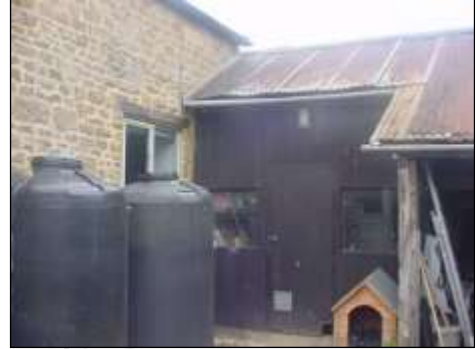
The water butts outside we believe were added due to the problems with the drains filling up during periods of rainfall as you are taking discharge from the sloping site above.

Outside water butts

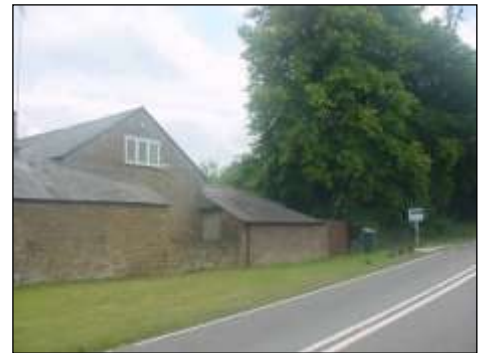
You may or may not be aware that a plan has been produced showing which trees can and cannot be removed. We would add that the trees will block natural light into the property.

Trees

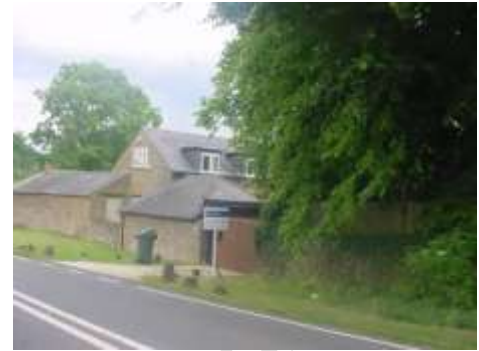
We were surprised by the amount and size of the traffic that passes the property and suggest that you revisit and make sure you are absolutely happy with this.

Property next to the road
