**RESIDENTIAL BUILDING SURVEY  
OF  
Penzance, Cornwall TR19**

**FOR  
Mr A and Ms P**

**INDEPENDENT CHARTERED SURVEYORS**

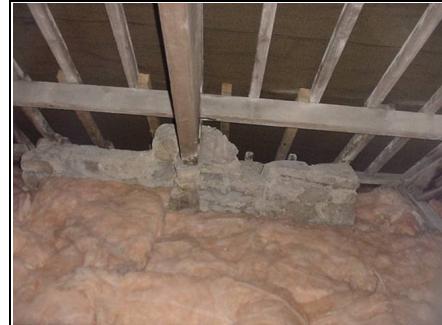
Old left hand chimney

You once had two chimneys. We often find that where a chimney has been taken down the tiles are never put back quite correctly and there can be some leaks, although there are no obvious signs in this case.

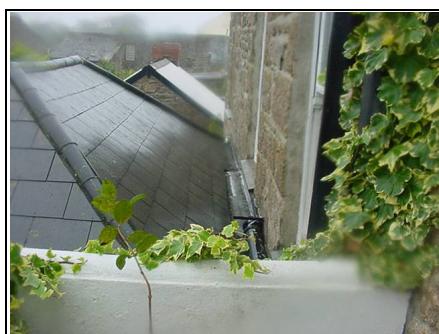
There is an awkward box gutter between the main building and the rear roof. We often find that these get blocked, although there is no obvious visual evidence internally. Unfortunately, we are unable to investigate further as we were unable to gain access to this roof area.

Box valley gutter between rear roof and the main building

**ACTION REQUIRED:** We recommend that an access panel is made to this roof area and that the timbers are duly inspected. We would be more than happy to comment on any photos if you wish to forward these to us of inside the roof space once you have gained access.

**ANTICIPATED COST:** In the region of £200 to £400 to have an access hatch formed, plus any associated costs. Please obtain quotations.

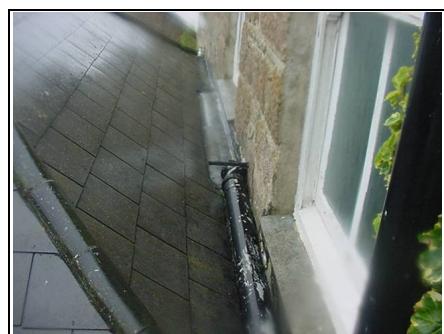
Close up of box valley gutter

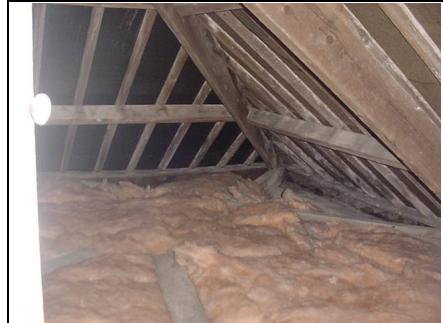
Part of the roof are insulated to modern standards, i.e. approximately 300mm. Unfortunately, in this age of property insulating to these modern standards can sometimes cause condensation. So, generally it is accepted that the roof has to be ventilated.

Mass of roof insulation

We have spoken about this with the owner and they were concerned that if vents were added to the slate areas, which we would normally recommend, that the high winds in the area could lift the slates. Taking this into consideration, we would recommend that ventilation is added to the soffits to help vent this roof. In turn, you will also need to ensure the insulation is pushed back at the perimeter of the roof to allow the air flow; this is a messy job.

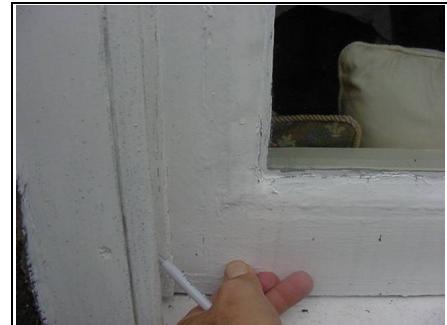
Filler to windows

**ACTION REQUIRED:** Make good. To the ground floor windows, which we inspected, there was only one or two which had had plastic wood repair work, which does tend to deteriorate more rapidly than timber. We would anticipate work to be needed in the summer of 2010 to some of the windows and to the fascias and soffits.

**ANTICIPATED COST:** We would anticipate complete redecoration of the fascias and soffits and some repair work, bearing in mind this may need scaffolding (we would always recommend that you get your own tower scaffolding (see adjoining photo) in the long term as this will always save you money. Costs in the region of £1,000 to £2,000 for use of scaffolding; quotations required.

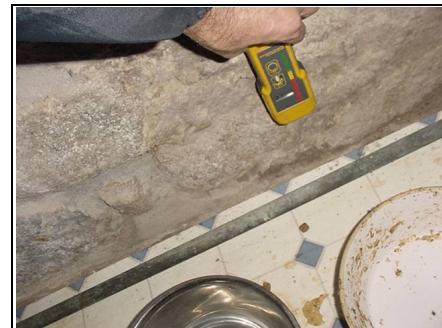
During the course of our survey we found minor rising damp, which we feel is acceptable for this age of property, providing the floors are suitably ventilated. However, some mortgage companies may find it excessive.

Checking for rising damp

**ACTION REQUIRED:** Monitor.

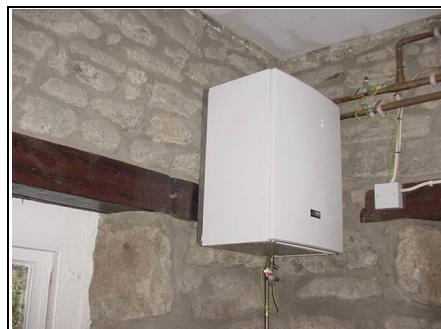
Halstead Hero 60 Boiler

The owner was not aware how to switch the existing boiler on. When questioned further she advised that she had hardly used the boiler since it was installed, with the wood burner giving enough heat. We therefore feel we have to assume it is not working and may need replacement.

**ACTION REQUIRED:** We recommend that you return and see the boiler in action, or budget for a replacement boiler system.

**ANTICIPATED COST:** In the region of £2,000 to £3,000 for a replacement boiler, plus in addition the heating engineer may recommend that you have the radiators drained or replaced, which would add £2,000 to £3,000 more onto the price. Quotations should be obtained.

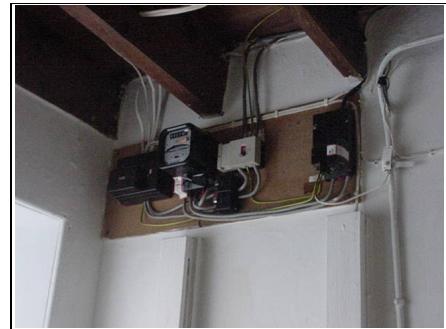
Electrics in rear left hand room

**ACTION REQUIRED:** We would have these changed with the latest fuseboard. We would also, at the same time, get an NICEIC test and report on the property by a registered IEE (Institute of Electrical Engineers) recommended contractor and carry out the work recommended.

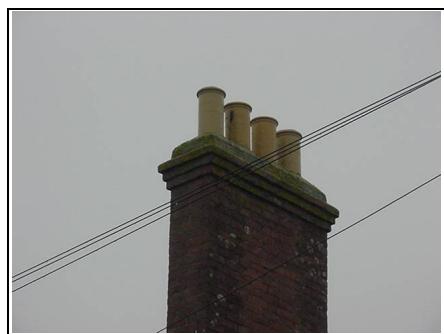
We cannot see the very top of the chimney known as the flaunching and therefore cant comment on it. However, the four chimney pots that we can see are very straight and true, which does indicate that the flaunching is probably in reasonable condition.

Top of chimney

**ACTION REQUIRED:** We recommend a close inspection within the next three years.

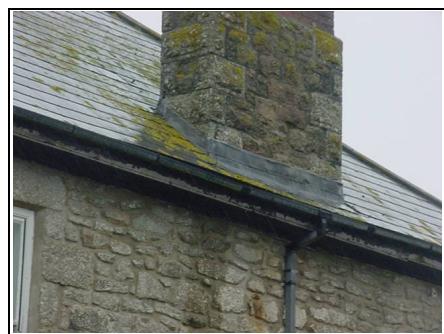
This chimney is part stone and part brick finished with a lead flashing and four chimney pots. It is likely to have originally been in a lime mortar, although it is a thin joint line mortar. The chimney has been repaired / repointed over the years.

Base of chimney

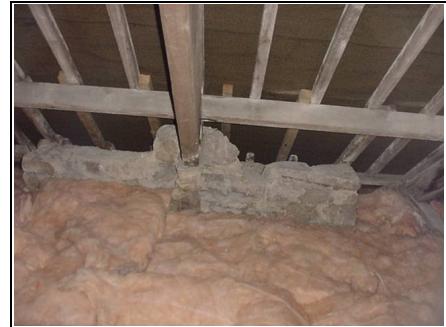
Old left hand chimney

A chimney has been removed, we term it as an "invisible chimney", as the chimney breast is still present below. Often the tiles that cover the old chimney position never bed correctly and leak.

**ACTION REQUIRED:** Carry out a check to make sure that the tiles are bedded correctly.

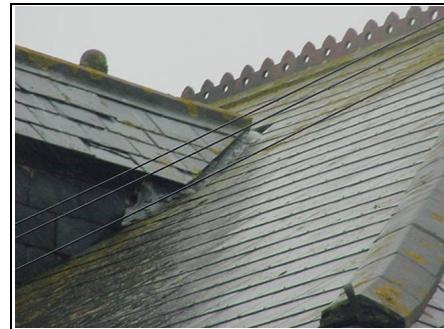
The roof is pitched and clad with a manmade slate to the front. The slates sit fairly true and are generally in average condition considering the property's age, type and style.

Manmade slates are thin and light and the wind can catch them, so it is important that the slates are fixed at the perimeter and do sit flat and are checked from time to time, both here and at the perimeter.

Close up of main roof

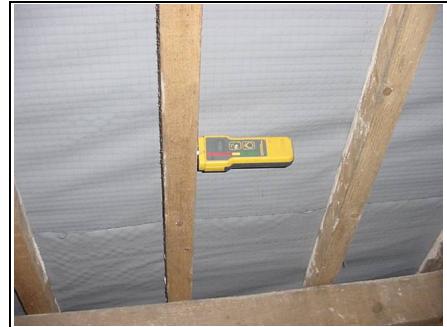
We would comment that the plastic membrane can sometimes sweat and cause damage and deterioration. With a modern protective underlayer we have completely moved away from the sealed and smothering effect that plastic underlayers give to more of a gortex breathable underlayer.

Testing for dampness, caused by sweating beneath the plastic underlayer

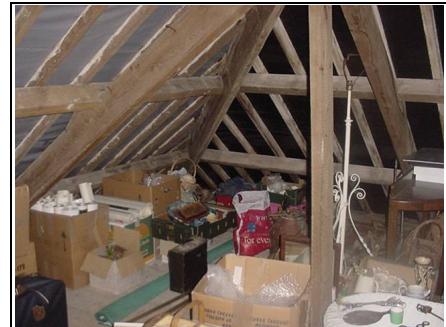
Hipped roofs are known for slippage /movement which can occur in the structure. In this case, we feel it is within acceptable limits.

Looking towards the corner of the hip of the roof, with the horizontal timbers, known as purlins. Slippage can be seen in this case, in average condition

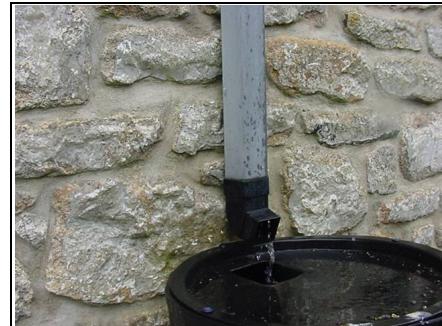
From ground level the gutters and downpipes looked to be predominantly older style plastic, with some newer plastic, and appears to be in average condition, with a few repairs.

The older style plastic is affected by sunlight and loses its colour slightly and does become brittle over the years.

Downpipe, a mixture of old and new plastics

**ACTION REQUIRED:** We would always recommend that the gutters and downpipes are cleaned out, the joints are checked and the alignment checked to ensure that the gutters fall towards the downpipes.

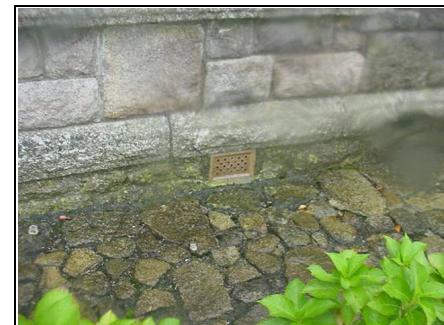
Air brick to front of property

**ACTION REQUIRED:** There needs to be a through flow of air underneath the floor. We think the rear floor is a solid floor and therefore is effectively blocking the through flow of air. Thought needs to be put into how you do get a flow of air underneath the property. When we spoke to the present owner during the question and answer session she advised that she had had to replace many of the timbers. We would say this is as a direct result of not having a good air flow under the property.

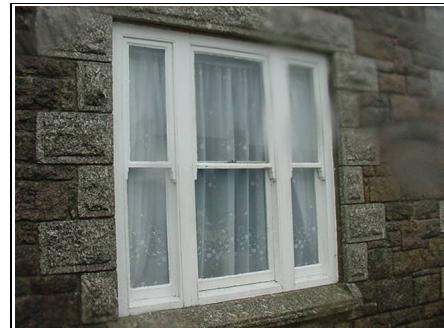
Painted timber sliding sash window

**ACTION REQUIRED:** As is common they will need some easing and adjusting from a carpenter who is used to dealing with this type of work.

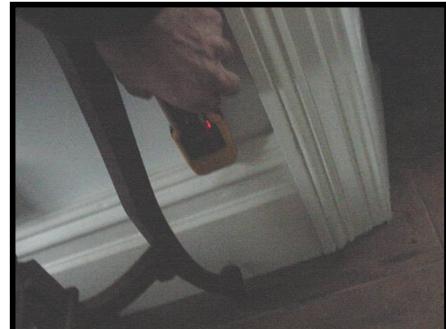
Finding minor rising damp

Please see our comments in the Executive Summary.

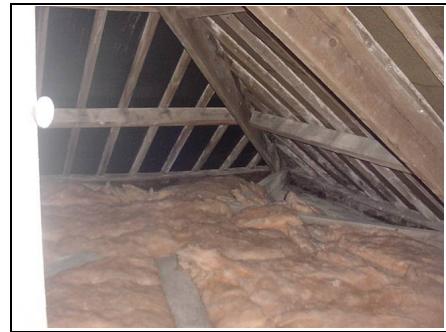
To the left hand side of the roof there is approximately 270mm to 300mm of insulation, which is what the current Building Regulations require. Please see our comments with regard to venting this area and being careful when insulating older properties.

A mass of roof insulation  
to the left hand roof

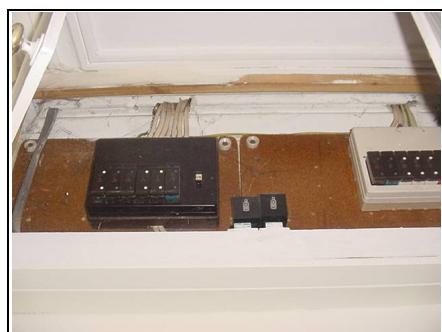
Electrics in hallway

The property has two fuse boards; one located in the hall and one located in the rear left hand room. We would date the fuse boards as being from the 1960s, possibly 1970s, when they used re-wirable fuses, which are now superseded. Far better fuse boards are now available.

**ACTION REQUIRED:** It is recommended that the installation be tested by a competent electrician (NICEIC registered) and all recommendations implemented. Thereafter, the installation should be re-tested every five years.

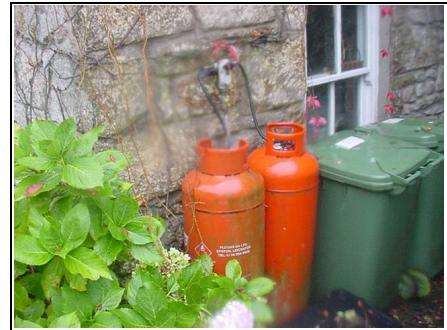
Gas cylinders

The gas supply is from cylinders located in the rear garden; these supply the boiler, a very unusual arrangement. The owner advises that she has used very little gas over the years, so little, in fact, she was unable to switch the boiler on, which we found unusual! We therefore feel you have to assume that the boiler is not working. Please see our comments in the Executive Summary.

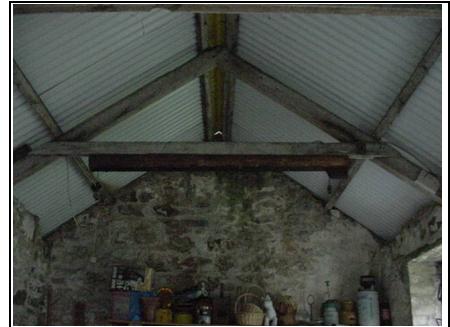
Rot to some of the roof  
timbers

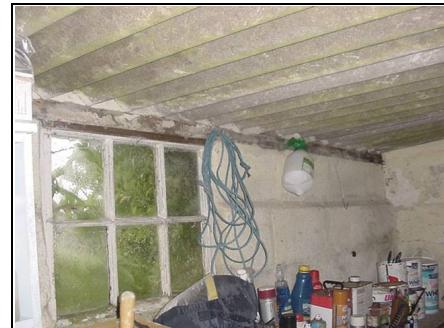
There is asbestos in the outbuilding roofs, which we recommend is removed as soon as possible. Please see our comments in the Executive Summary.

Note asbestos to the roof

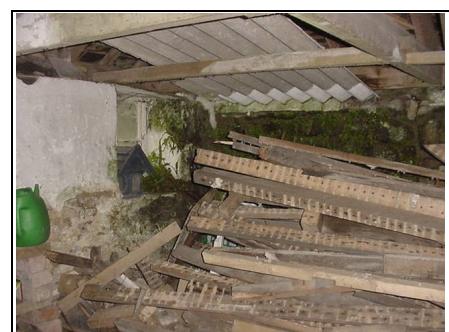
Again, note asbestos to roof
