# RESIDENTIAL BUILDING SURVEY

Pinner

Edwardian  
Semi-detached

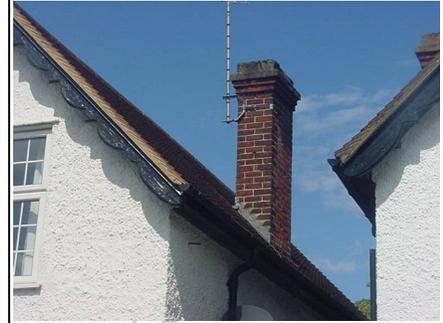
We can see the chimney at high level outside on the right hand side as you can see in the adjoining photo however the chimney is missing at ground floor level as you can see in the bottom picture. We are unable to be absolutely certain whether it is still present within the cupboards due to the mass of clothing in there.

Close up of chimney (which needs re-pointing)

**ACTION REQUIRED:** Your Legal Advisor to check and confirm what work has been carried out to support the chimney. It should have Building Regulations with regards to support for the chimney removal. We do find that a lot of chimneys have been taken out without support being added. It is often not a problem however in this case we would need the cupboard emptying out and the area opening up to be able to advise further. In the first instance your legal advisor needs to check and confirm whether there are any local authority approval and calculations with regards to the chimney being removed.

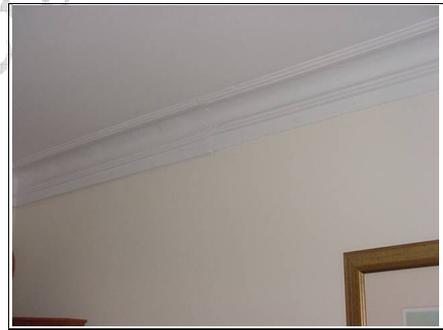
Architrave where you can see the chimney has been removed

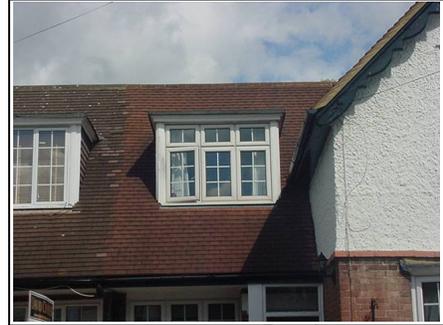
We cannot see some of the flat roof to the dormer window at the front of the property. Whilst we can't see any visible signs of dampness getting in internally we would recommend the roof is checked by the autumn of 2012.

Unable to see dormer roof

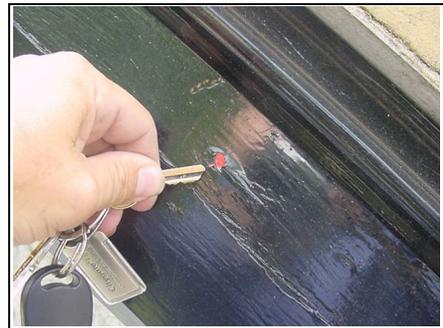
A close inspection of the black fascia showed some blistering which doesn't look like it has been prepared that well however we would also say that black is never a particularly good colour to paint a fascia board as it does tend to absorb the heat and them blister.

Fascias painted black and starting to blister

**ACTION REQUIRED:** We would recommend re-checking the condition of the fascias and soffits in the summer of 2012 and redecorating if they have deteriorated considerably.

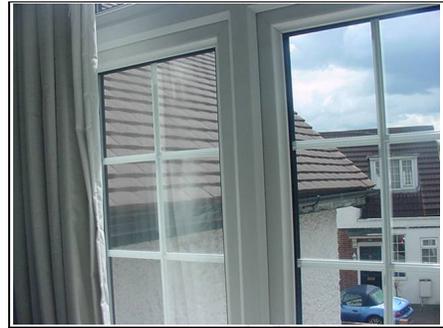
We can see some misting up occurring on some of the windows. The photo shows the double glazed window to the front left hand bedroom.

Double glazed window

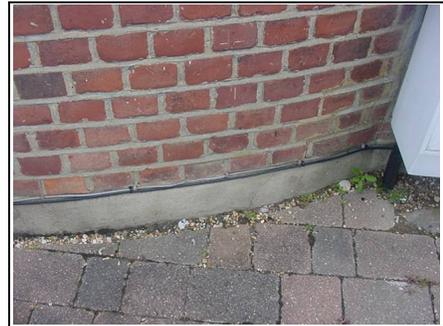
We noticed a concrete plinth to the base of the property which the surrounding properties did not have. It may relate to underpinning work that has occurred at the property, we are aware that plinths were added to this age of property as a way of resisting dampness getting into them.

Concrete plinth

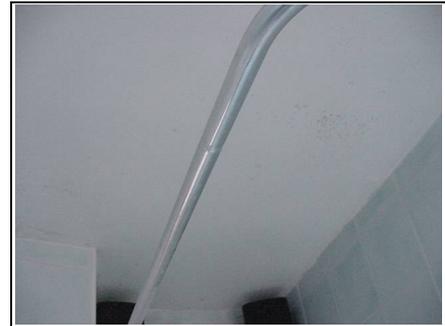
We noticed staining on the ceiling in the bathroom which we believe is condensation however there is a fan in that room. This led us to carry out further investigation within the roof above which is lined. Unfortunately we can't see how the roof is performing but we would say that we also noticed some staining to the ceiling just outside the bathroom so there could be a problem with the roof. We couldn't see the chimney side of the roof in this area particularly well. We can't be specific as to what the problem is in this particular case, it may well be condensation in a house that is occupied by a family with young children such as this. There is an outside chance it could be from the roof itself.

Staining in the bathroom

**ACTION REQUIRED:** We would recommend living in the property and redecorating the bathroom to see if the problem reoccurs. If it does we would in the first instance look to check the roof via a set of long ladders and in the second instance we would increase the fan size and add a humidity thermostat onto it to remove any moist air from this area as quickly as possible.

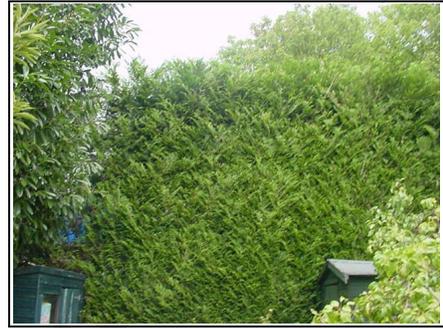
There are a lot of conifer trees to the rear of the property which is shielding you from the garage but equally it will need at some point to be cut back.

**ACTION REQUIRED:** Speak to the garage owners and see if they are happy with the conifers being so high but they will at some point need to be cut back as they may damage the adjoining garage. We noted just for the record that there is already cracking in the adjoining garage walls and around the lintels.

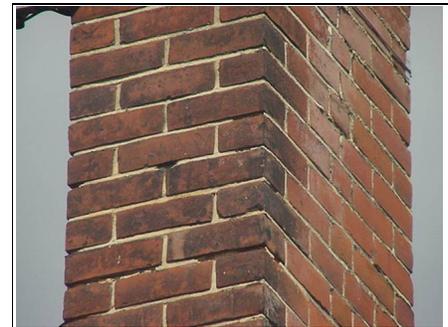
This chimney is brick finished with a lead flashing and an aerial attached at high level. It could generally do with some repointing work to stop the dampness from getting in but our main concern is that the chimney seems to have been removed at ground level. Whilst we can't see any indication that there is any structural defect within the front room nevertheless it should have had approval to be carried out.

Close up of chimney (in need of re-pointing)

**ACTION REQUIRED:** Repoint and please see our comments with regards to your solicitors enquiries in the Executive Summary.

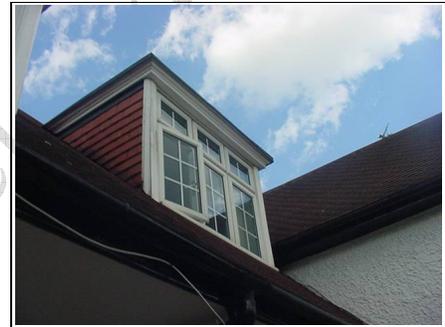
The dormer window has a flat roof which we can't see, the sides have vertical tiling and the front is plastic double glazed windows all in reasonable condition.

**ACTION REQUIRED:** Please see our comments about not being able to see the top roof.

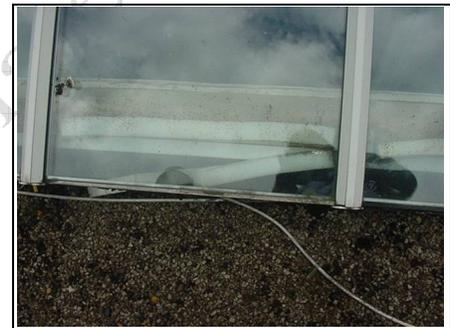
Insulation displaced

**ACTION REQUIRED:** We would recommend someone repositions the insulation/sealer. This we believe is to stop wind from getting underneath the roof light glass and lifting it.

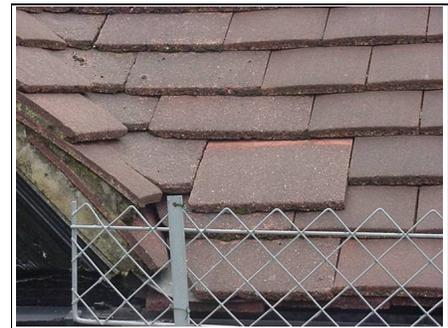
The main roof is pitched and clad with small nibbed concrete tiles. It looks in reasonable condition; we can see a few of the tiles have moved. It does look to have been re-roofed due to its lighter colour however during our question and answer session the owner advised that it hadn't been re-roofed in their time there.

Slipped tile

**ACTION REQUIRED:** Your solicitor to specifically ask if the property has been re-roofed (because it could equally be the adjoining owner's property that has been re-roofed). If it has been re-roofed then is there some form of guarantee available.

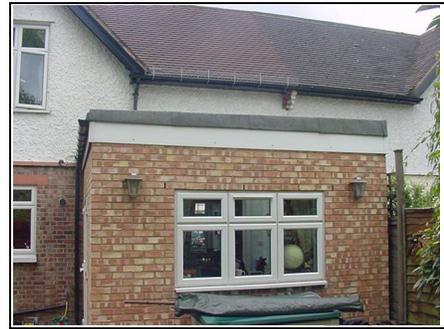
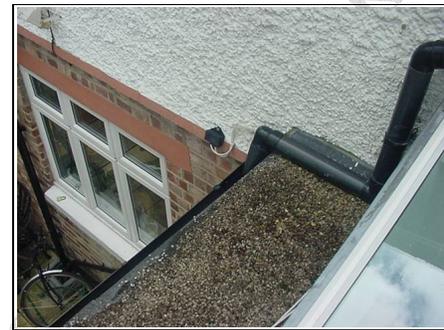
The felt is covered with a pea shingle. This felt is from the cheaper end of the market, generally we wouldn't recommend it as it is difficult to find any leaks in it when they occur. There is some moss sitting within the chippings indicating that the roof is flat as opposed to having a good fall on it which does tend to reduce the life of the roof.

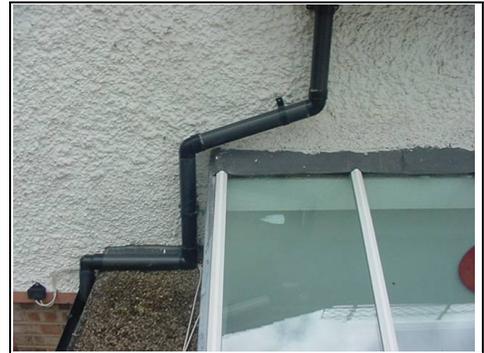
Originally this property would have had cast iron gutters and downpipes throughout. However, over the years, some/most of these have been replaced so we now have a mixture of the two different materials, which never mix particularly well and generally leak. There are some awkward runs of the plastic particularly on the rear elevation where we may have been tempted to have a diagonal downpipe. We believe the hopper head will overflow.

Awkward run of downpipe

**ACTION REQUIRED:** We would always recommend that the gutters and downpipes are cleaned out, the joints are checked and the alignment checked to ensure that the gutters fall towards the downpipes.

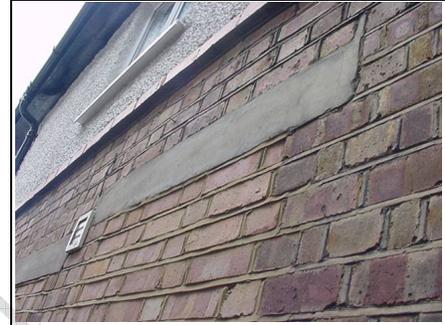
The property is built in a brick in what is known as Flemish bond brickwork. Originally it would have been bedded in lime mortar; this has been repointed in cement mortar. We can also see some areas where doors and windows have been blocked up and altered over the years.

Brickwork with the blocked up door

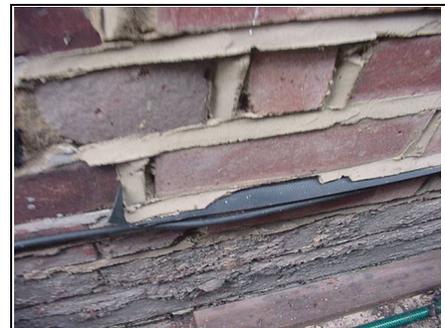
We can see that windows and doorways have been bricked up. We feel there may be a weakness in the structure at the base where the damp proof course has not been added in properly. There is very little that can be done about this without major work. You need to accept it as part of the character of the property.

Base of a door that has been blocked up

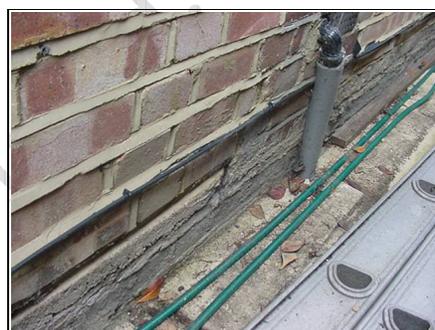
We noted a concrete plinth visible at ground level particularly on the right hand side. We are concerned that this may relate to underpinning work. We looked at the adjoining properties and none of these had a similar rendered plinth. Equally it may have been something the builders did when they were bricking up the doorways.

**ACTION REQUIRED:** Your legal advisor needs to specifically question with regard to underpinning.

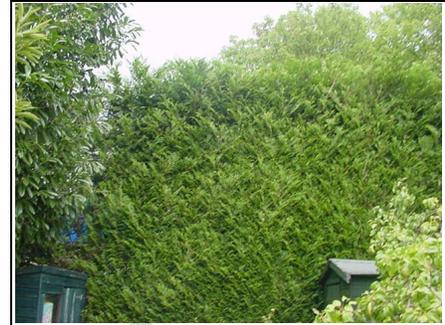
There are conifers to the rear of the garden. These are fast growing and can be problematic. Please see our comments in the Executive Summary. You do need to go and have a chat with the garage owner preferably before you purchase the property just to establish their views on it.

Mass of conifers

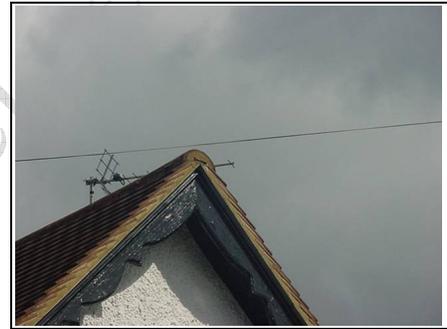
Bargeboard at the front of the property (poor quality paintwork)

**ACTION REQUIRED:** Please see our comments in the Executive Summary about likely to need redecoration.

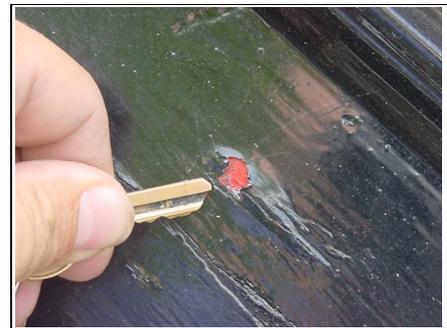
Paintwork blistering to the bargeboard

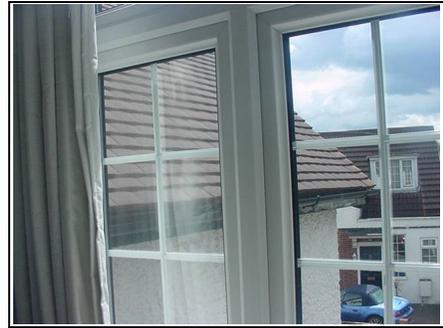
The property has plastic double glazed windows. In this case there was some misting up to some of the double glazing. We would draw your attention to the fact that sealed double glazed units can fail, particularly as a result of poor workmanship during installation. Failure of the seal leads to condensation between the two panes of glass and simply replacing the affected units may not provide a satisfactory long-term solution.

Double glazed window

**ACTION REQUIRED:** Replace misted double glazed units.

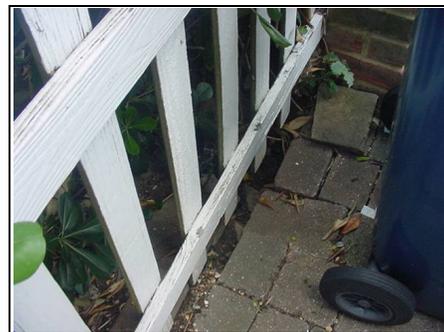
Block paving starting to unsettle
