RESIDENTIAL BUILDING SURVEY

**Pinner,
HA5**

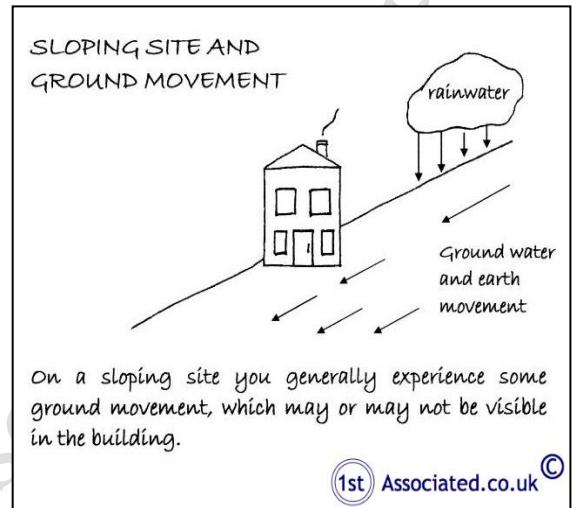
What this means is that any rainwater and surface water will transfer from the right hand side property to the left hand side with your property in the middle. This means you may get dampness and mould on the right hand side of your property.

This photo shows the difference in roof levels as viewed from the front of the property

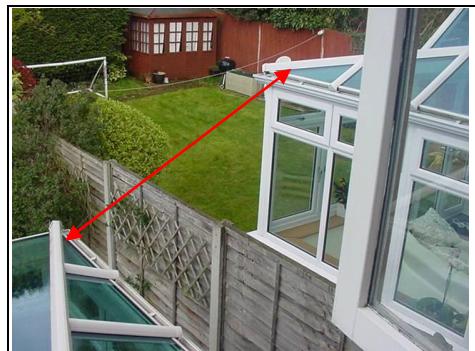
This photo taken from the rear bedroom window shows how much higher next doors conservatory

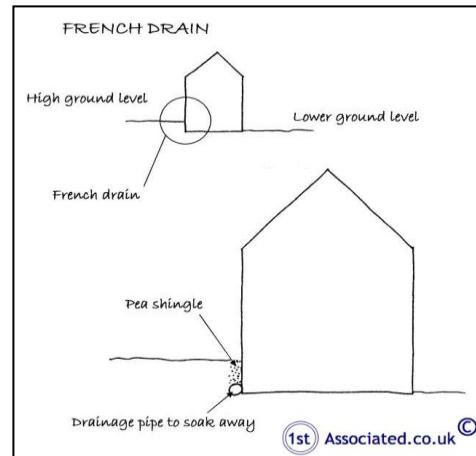
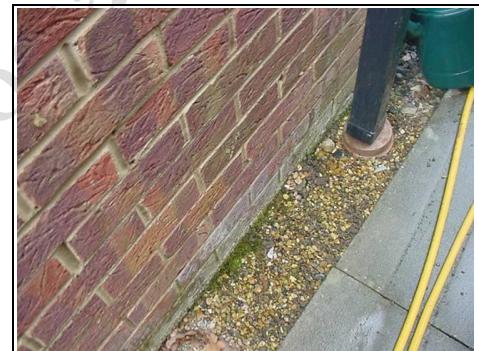
Dampness and mould to the right side of the wall

ACTION REQUIRED: Dig out the French drain and check if it's a real French drain as there could be problems in this area. We would recommend you live in this property before commencing this work and keep an eye on this area. It is well worth going outside next time it rains heavily to check it.

ANTICIPATED COST: To re-dig the French drain will cost in the region of £500 – £1,500 (five hundred pounds to one thousand, five hundred pounds); please obtain quotations. It may simply be that mud and earth over the years has settled in the French drain and is no longer filtering effectively.

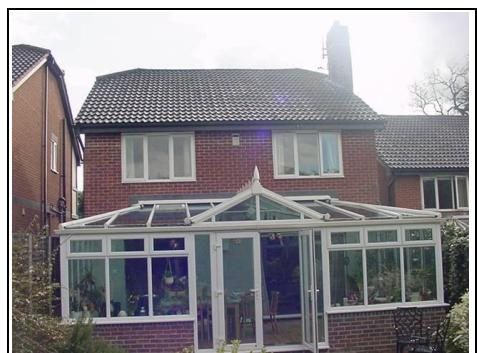
There is a risk with a conservatory of this size that it will leak. You need to ensure there is some form of guarantee that is transferred to you. We are well aware and have been involved in cases where the guarantee hasn't been transferred and there have been leaks with the conservatory. This has then caused major problems when trying to resolve the issues.

Large conservatory

This is such a large conservatory that it could be prone to failure of the joints (causing water leaks) as well as a whole raft of other things so a guarantee is the best way forward.

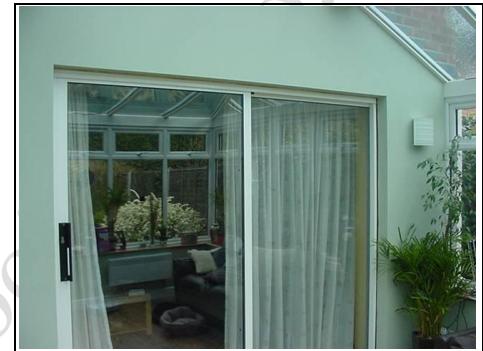
There are some large openings to the rear of the property from the conservatory. Whilst we couldn't see any openings, from where we accessed the conservatory from the rear right hand side and the rear (all directions given as you face the property), we are aware that such large openings to the rear of the property can be susceptible to movement.

Original patio doors

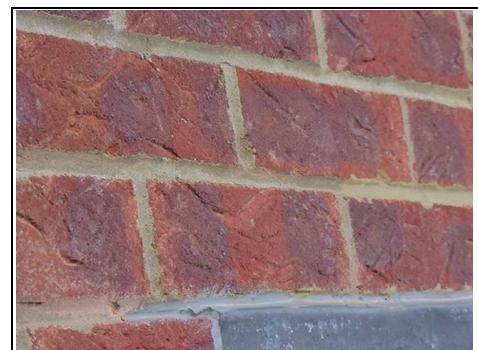
There has been some repointing carried out to the wall above where the conservatory is. Bearing in mind the possibility of movement in this area your legal advisor needs to check and confirm in writing if there has been any movement to the rear of the property.

If you look closely to the right hand side you can see a slightly different colour mortar

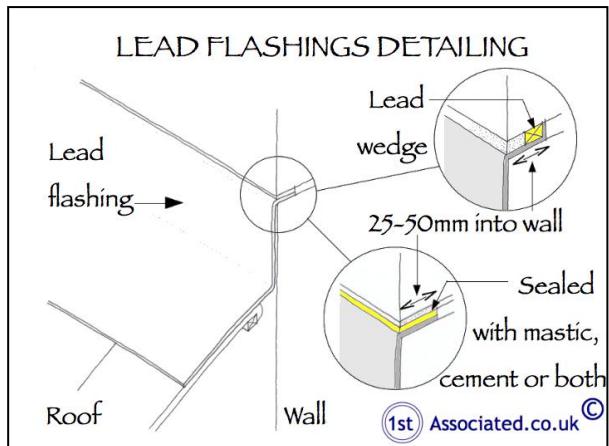
To the low level front of the property around the garage and entrance area there is lead flashing. This we assume has come away at some point and has been screwed and washer fixed back in place. This is rather unusual and in fact we have not come across it before. As far as we can see this is because the lead has not been bedded into the joints sufficiently and it has come away. This is a fairly common thing on this more modern type of property and where, we generally believe, the builders simply do not have the skills needed for older materials.

Flashing screwed in place

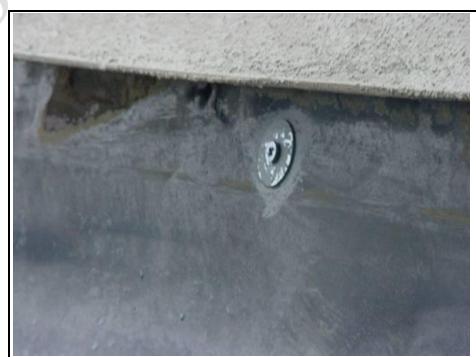
Close up of screw and washer fixing.

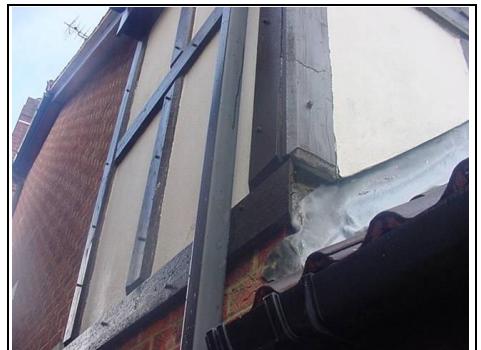
To the left hand side there is a combination of a defective lead flashing and defective timber work. This is allowing water into the left hand side of the property. This is an old leak, as we can see from the electrics in the garage that have been covered over with plastic rather than repairing the leak.

Rain getting into garage because of defective flashing

ANTICIPATED COST: We would set aside the sum of £1,000 - £2,000 (one thousand pounds to two thousand pounds) to complete this work; please obtain quotations.

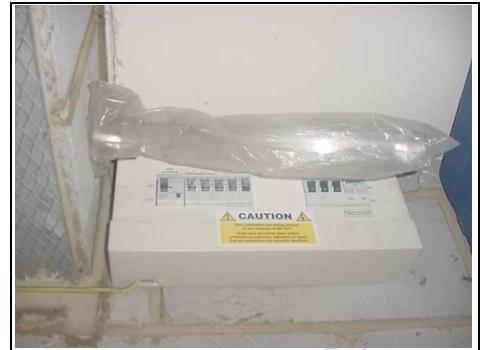
Electric box covered in plastic to protect it from water.

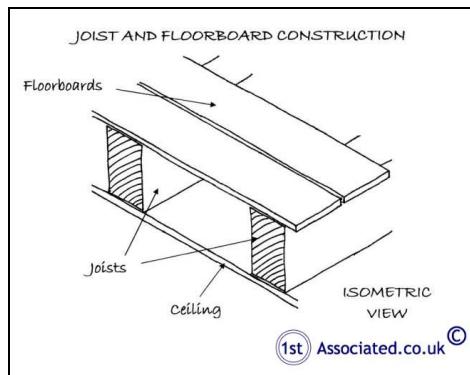
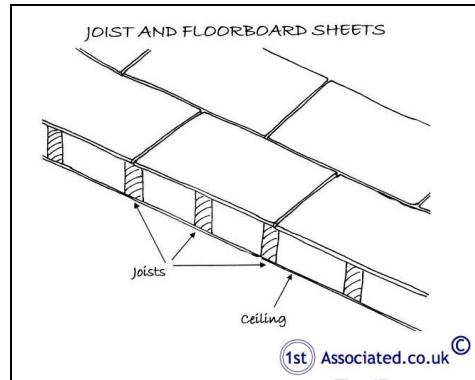
As is often the case in this age of property the first floor board sheets (assumed) creak due to it not being secured properly and also minor movement in the floor joists. The floorboard sheets work loose over the years. We believe that floorboard sheets have been used rather than the traditional floorboard strips.

Tiles on a wood floor

We can also see areas such as the main bathroom and the en-suite which have been tiled; these tiles can become loose due to this deflection.

ACTION REQUIRED: We recommend you have another walk around the property and be aware of how much the first floor creaks. To resolve this will need to secure all the boards and put hardboard over some of them. This of course will mean lifting the carpet and is an awkward job.

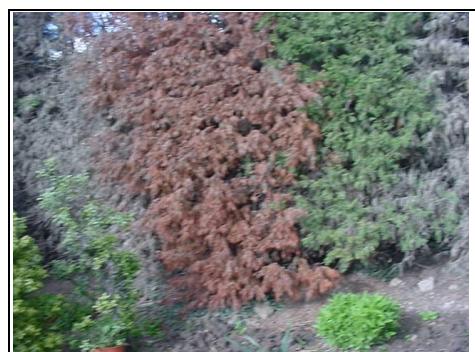
Dead section of Leylandii.

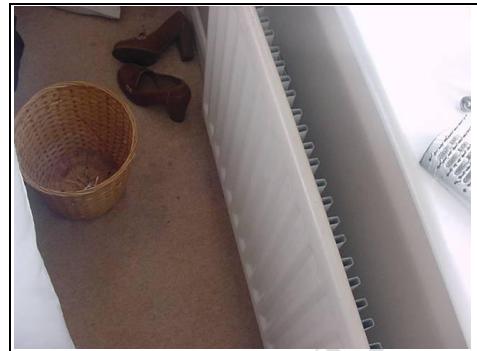
A modern property would have double panel convection radiators. This property has single panel radiators and they may not warm the property as most people would wish.

Single panel radiator

ANTICIPATED COST: To replace the single panel radiators with a modern radiator you would be looking at £125- £200 (one hundred and twenty five pounds to two hundred pounds) per radiator dependent on the size. You would also need to drain down the whole system.

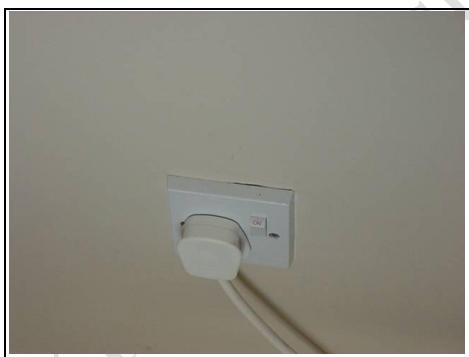
There are a lot of single power points which is usually insufficient for modern day usage of electricity.

Single power point.

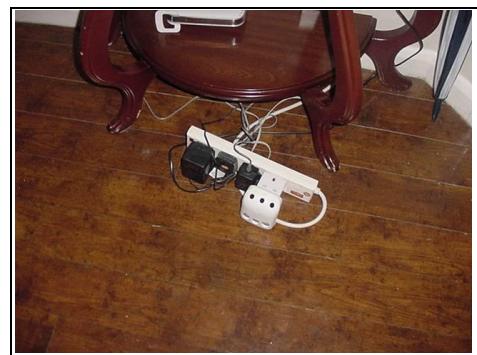
Problems associated with having single socket points.

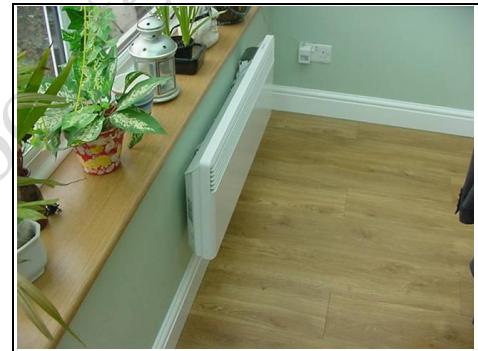
Single panel electric radiator.
You may need a better form of
heating/cooling system

ACTION REQUIRED: You may wish to add double panelled radiators. You should also budget for a good quality heating/cooling system in the conservatory as well as blinds.

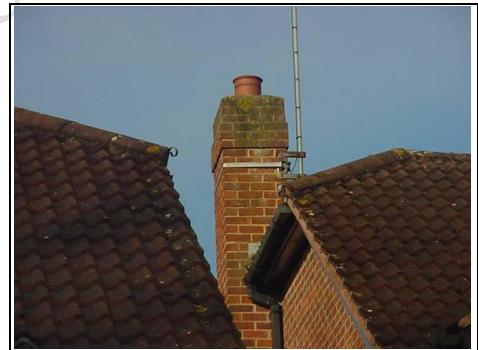
Chimney one

Although we cannot see the lead flashing properly our concern is none of the lead flashing on this property has been carried out correctly and there may be problems in this area later.

Unfortunately we were unable to see the flaunching, we therefore cannot comment upon them.

ACTION REQUIRED: We suggest that when the lead flashings to the front of the property are being repaired and fitted correctly that the one on the chimney also has a close up inspection by someone with a long ladder that can really view the chimney properly.

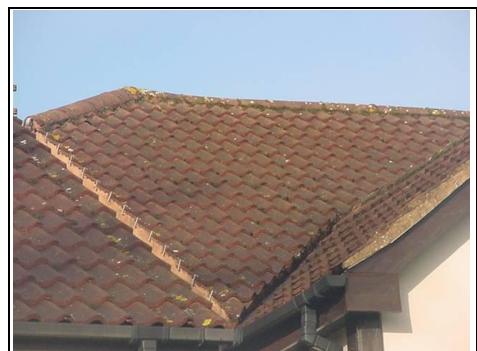
The property does have a valley gutter which is where two roofs join at the gable at the front of the property. Bearing in mind the flashing detail problems there may also be problems with other details such as the valley gutters so it is worth keeping an eye on them.

Valley Gutter

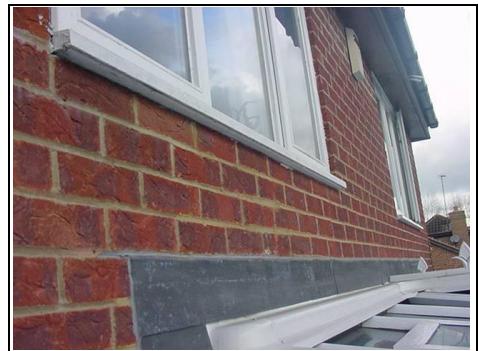
We would add that we seem to find with all large conservatories that they all leak sooner or later. Unfortunately without being in the property when it rains for a prolonged period of time we cannot confirm one hundred percent that this conservatory is watertight.

Lead flashing looks to have been bedded using mastic.

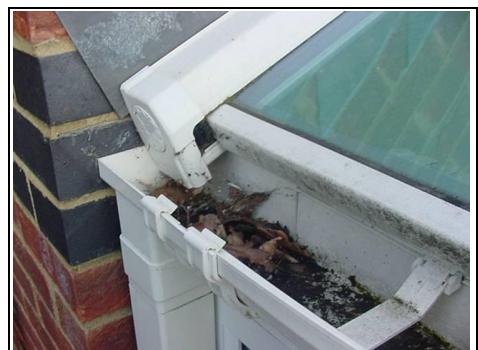
There may be some minor leaks but most people would be happy to live with these providing repairs are carried out within the next six to twelve months. In this case we believe that the clearing of moss and leaves will be beneficial.

Conservatory plastic gutter

ACTION REQUIRED: You need to clear the leaves from the gutters. We would always recommend you stand outside the property next time it rains heavily and see how well the drains cope with the rainwater particularly looking at the guttering and the joints.

We would also recommend that the gutters and downpipes are cleaned out, the joints are checked and the alignment checked to ensure that the gutters fall towards the downpipes.

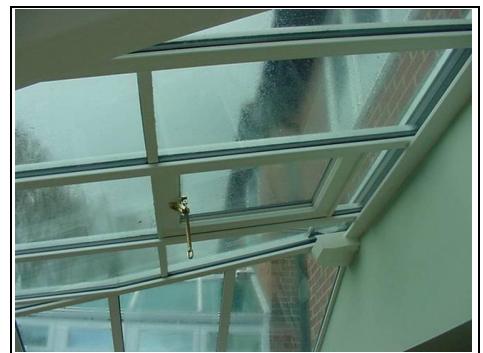
As it had rained during the survey it was difficult to see if all the glazing panels were clear. Misted glazing panels are a sign that there are problems with them. This does need to be double checked (or you can come to an agreement with the owner that they replace any misted panels).

You can see in the adjacent photo that the glazing had been covered in rain and as such we could not see if they had misted over.

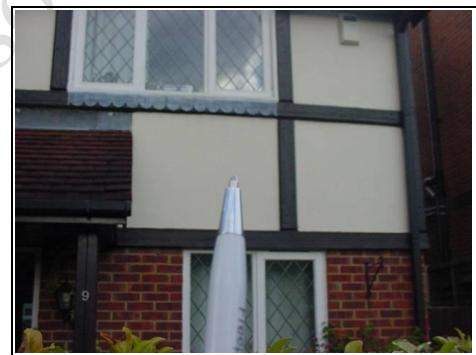
We noted some cracking in the render and we would remind you that any hairline cracks that appear need to be sealed as soon as possible to stop dampness and water getting in and causing blisters and hollow areas.

Hairline crack in render

From what we can see there appears to be block work underneath the rendered walls so it is doubly important that any hairline cracks are sealed as soon as possible as block work walls do tend to act like a sponge.

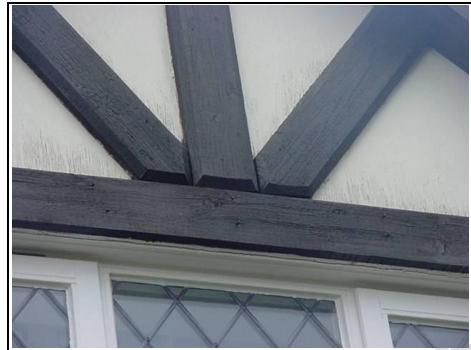
The feature timber will also need work carried out to it. It is partly this timber that is causing the defect and allowing the water into the front left hand side of the property.

Feature timbers

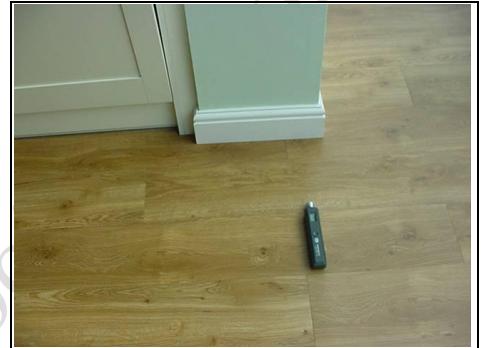
The ground floor of the property is a partly suspended floor which requires air movement to minimise deterioration. It is also partly concrete where the conservatory extension is. The levels are not exactly right and we can see a slight lift in the floor as shown in the photo by the location of the damp meter.

Slight lift in floor where extension was built

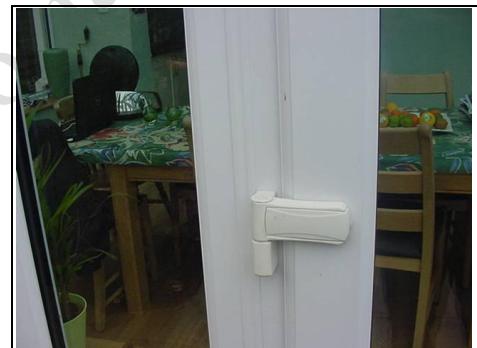
Exterior Conservatory hinges in our experience our a security hazard

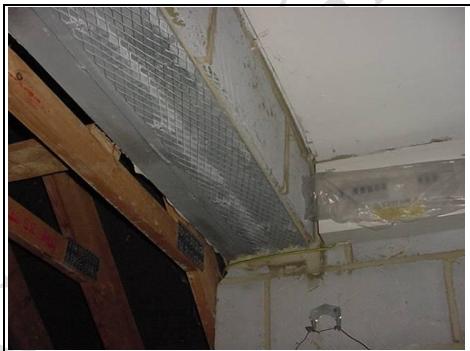
Damp coming into garage near electrics

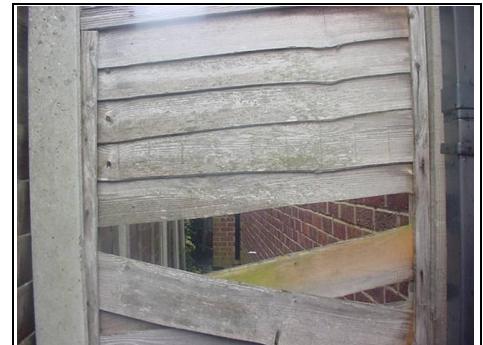
Fence needs repairs
