RESIDENTIAL BUILDING SURVEY

XXXXX
XXXXXXXXXX
XXXXXXX
Shropshire SY6 XXX

**1950's/1960's
Detached Property**

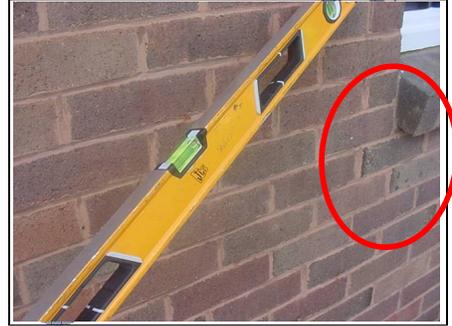
To the rear of the property on the right hand side we can see there has been some movement. We can see hairline stepped cracking around the windows, both above and below, and we can also see some cracking within the paved area.

Cracking

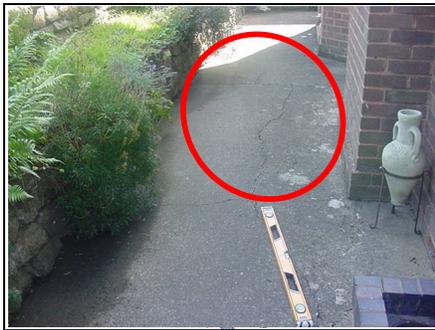
Cracking to rear

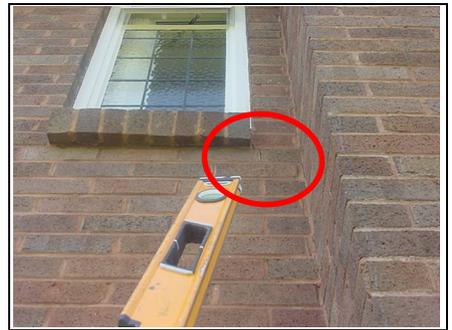
Stepped crack to rear

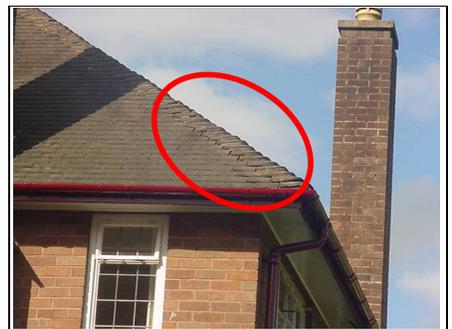
From the adjoining property (right hand side) we could also see there has been some movement in the ridge of the hipped roof.

Movement visible on roof tiles

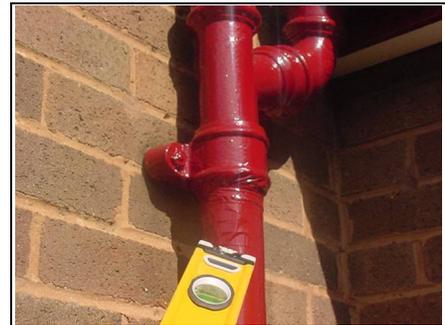
For example, we can see bandaging on some of the gutters and downpipes to the right hand side and wet rot has been painted over again on the right hand side windows. When we spoke directly to the occupier during our question and answer session they advised that they had painted over this area and was aware of this fact.

Bandaged and painted cast iron downpipe

ACTION REQUIRED: We feel you have to allow for the repair of some of the cast iron gutters and downpipes and also the repair/replacement of the windows. Please see our further comments in the windows.

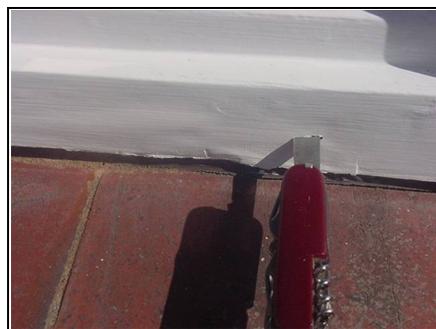
Knife test to painted over wood

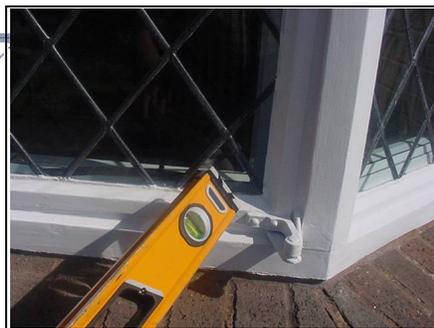
As part of our survey we opened a random selection of the windows; some of the windows we found were unopenable as they had been painted shut.

Metal window

ACTION REQUIRED: You will need have these windows regularly redecorated, as they are immaculately redecorated presently (apart from we would not paint over rotten timber and rusting metal!). It is important you repair rather than paint over problem areas.

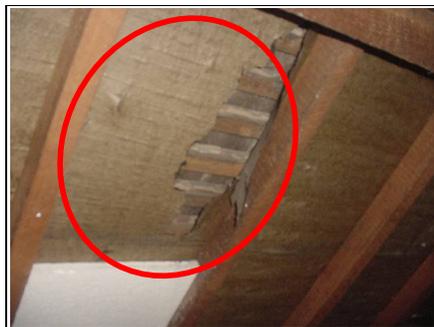
Unfortunately the building papers are now generally coming to the end of their natural life and starting to deteriorate, as in this case; approximately ten per cent deterioration. We have found that this can be accelerated by insulating or over insulating the roof, as we believe has happened in this case, without any ventilation.

Deteriorating building paper
– battens visible

ACTION REQUIRED: We recommend that the roof is ventilated to reduce the chance of condensation and slow the deterioration down to the building paper.

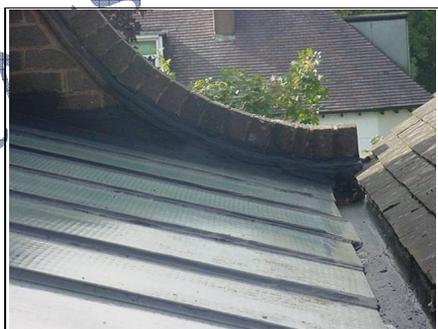
There is a glass roof, with box gutter, to the left hand side of the property. We would comment most of the glass roof panes have had repairs to them and we feel this area will be a problem area due to the difficulty of keeping the box gutter clear.

Glass roof

ACTION REQUIRED: We would expect rain to get in through the glass panes and for them to need repair, which will be difficult due to access. You may wish to look at a more traditional roof or replacing of the ceiling joists, which would be expensive.

ANTICIPATED COST: In the region of £500 to £5,000, depending upon whether you are repairing or replacing. Please obtain quotations.

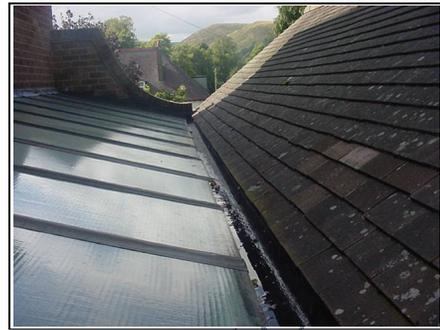
Box gutter

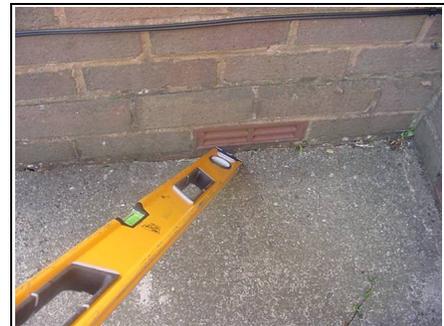
We can also see that the air bricks, that are meant to allow air flow underneath the suspended timber floor, are acting as gutters. We are surprised that we did not have high damp readings at ground level, this may well be because we have had good weather of late, or it may be that the air bricks are allowing the rainwater to go under the floor causing wet rot to the timber floor.

Airbrick acting as a gutter

ACTION REQUIRED: We recommend you open up part of the floor near to the perimeter of the property to check the condition of the timbers beneath. If the existing owners will not allow this then you will have to take on the risk and as such we would expect a reduction in the purchase price.

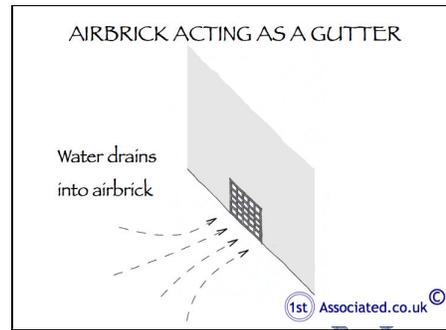
Airbrick acting as a gutter

ANTICIPATED COST: A few hundred pounds to add a surround to the air bricks; obtain quotes. The problem will be if there is damage under the floor. Please see our comments about adding a French drain to take the rainwater around the property as this property sits on a sloping site.

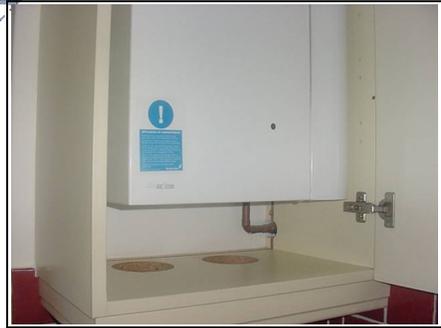
We were advised that there is a British Gas contact in place and that they have replaced most of the inside of the boiler.

Potterton Supreme boiler

ACTION REQUIRED: Your legal adviser to request documentation and invoices in relation to this work, otherwise we feel that you will have to accept it is an older style boiler with older internal sections and you should budget for a replacement boiler.

ANTICIPATED COST: Costs in the region of £2,500 to £3,500, plus possibly the replacement of radiators due the increase in the pressure that modern boilers have. Please obtain quotations.

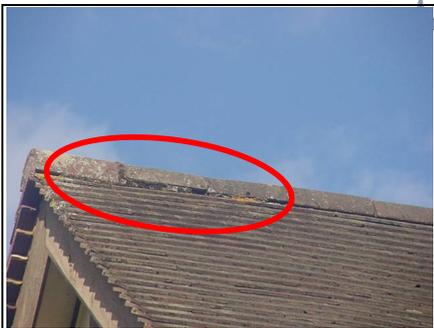
We feel there will be work needed in the next few years, particularly for example to the ridge tiles as this is a very exposed location.

Ridge tiles working their way loose

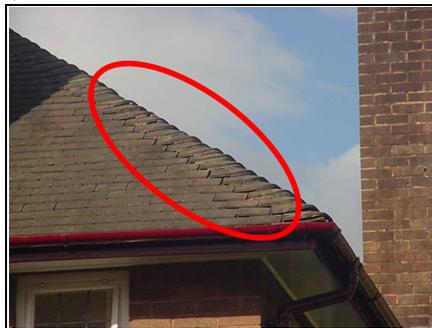
Rear right hand hip of roof where the building has settled

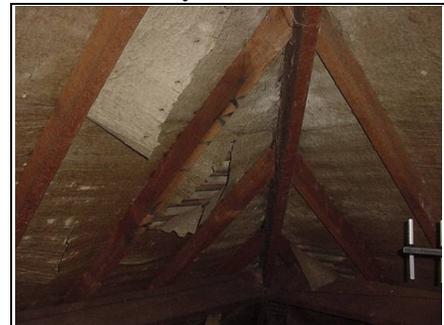
Building paper is deteriorating and we can see battens behind

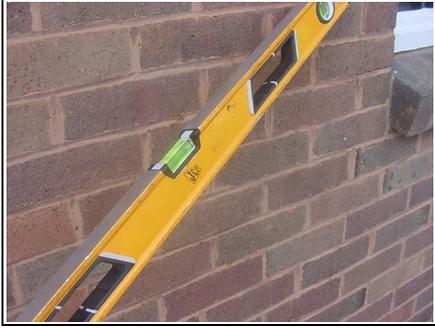
Cracking

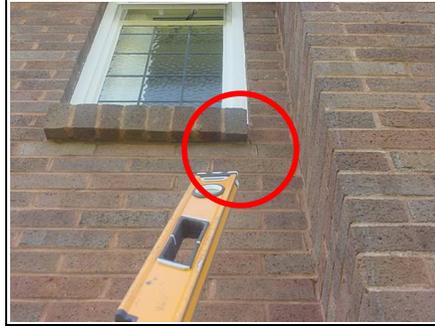
Stepped crack to rear

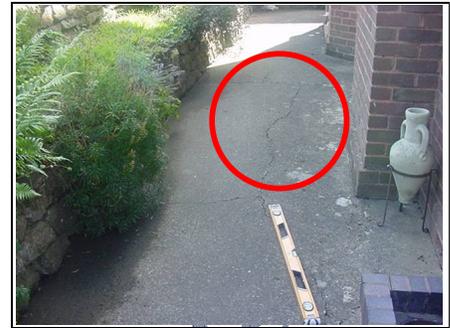
Crack to rear

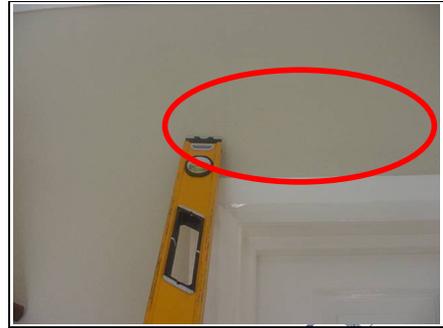
Minor hairline cracking over door

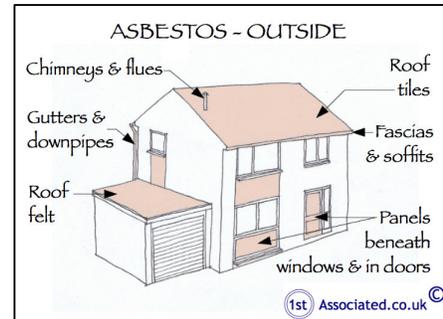
In a property of this age there may well be some asbestos. In this case we have noted a small amount of asbestos to the rear of the garage where there is an old boiler flue and this does highlight how asbestos was used very commonly. It may also be to the fascias and soffits and ductwork (please see adjoining sketch).

Asbestos externally

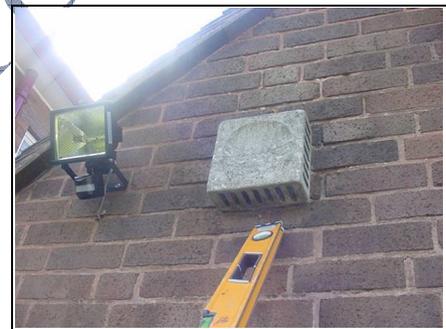
Asbestos flue on garage

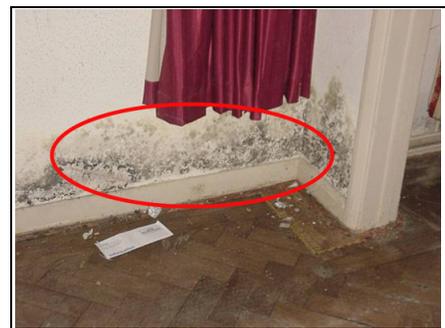
Mould caused by cold bridging
