JOB REFERENCE: XXXX

RESIDENTIAL BUILDING SURVEY

Potters Bar
Hertfordshire
EN6 XXX

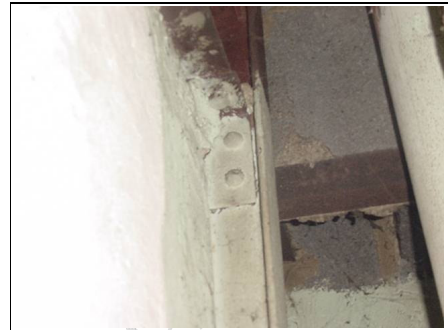
Something could go wrong with the construction system such as the metal fixings rusting although we saw no evidence of this we would have to open up the structure to confirm this. This type of construction does lead to condensation and cold bridging.

Metal fixings

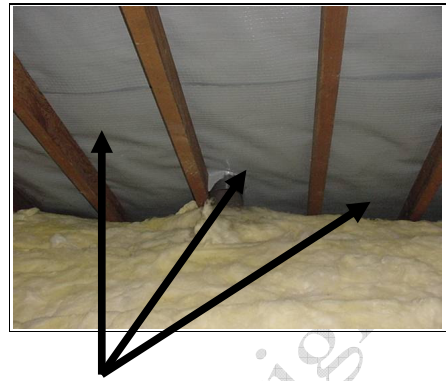
The property has a plastic protective underlayer which sweat (like a cagoule raincoat) which is certainly not ideal for this type of building as any condensation can lead to rust in the fixing points. We noted that the roof had trickle vents.

Plastic protective underlayer

ACTION REQUIRED: It is costly to remove the plastic protective underlayer as you would have to re-roof the whole property, which will be expensive. Unfortunately in this instance the plastic protective underlayer can promote condensation which is certainly an enemy with this type of non traditional construction where it is held together with metal components that can rust. We believe this would be part of a larger decision as to whether you re-build the walls which we cover in the next section.

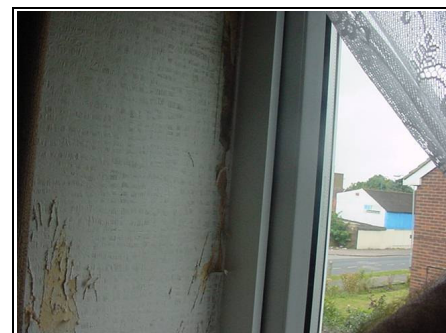
For want of a better term the property has been very lived in over the years and it looks also as if the owners smoke (the owners did not smoke during the course of our survey). This means that any redecoration will require sugar soap or similar prior to the redecoration being carried out.

Cat's damage to wallpaper

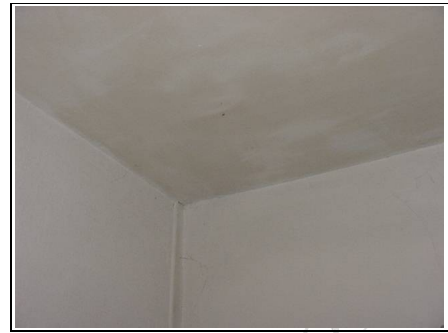
Nicotine staining to ceiling

This leads to a problem if these walls are asbestos and we are then saying that sugar soap should be used to remove the nicotine this could mean that you could disturb the asbestos and cause problems.

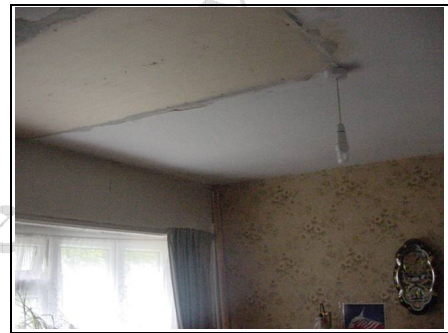
Repair to ceiling

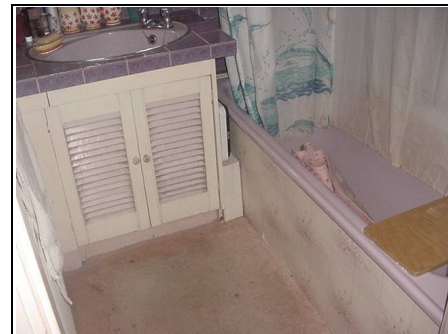
The Bathroom and separate WC area are in need of replacement/upgrade, in our opinion and we would also recommend that humidity controlled extract fans are added to both the bathroom and the kitchen to help vent the property and reduce the chances of condensation.

Bathroom

ACTION REQUIRED: Replace Bathroom and WC and completely redecorate. Add humidity controlled extract fans to bathroom, WC and kitchen areas.

ANTICIPATED COST: This will very much depend upon the type and style you prefer from £750 to several thousands of pounds; please obtain quotations.

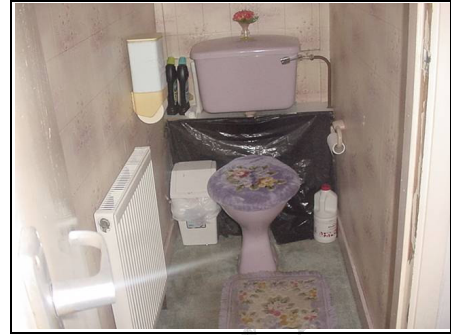
Separate internal WC

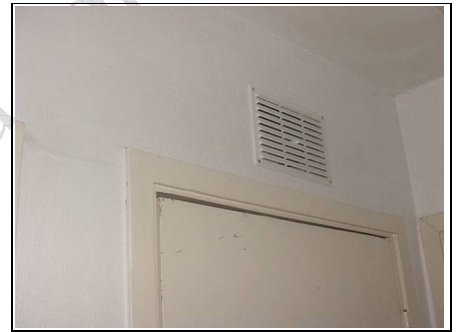
Vent in bathroom; we would prefer to see a humidity controlled extract fan

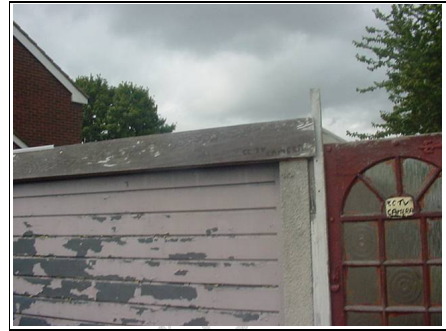
You have a pre-fabricated garage with an asbestos roof. We generally recommend removing any asbestos from houses for two reasons:-

Asbestos garage roof

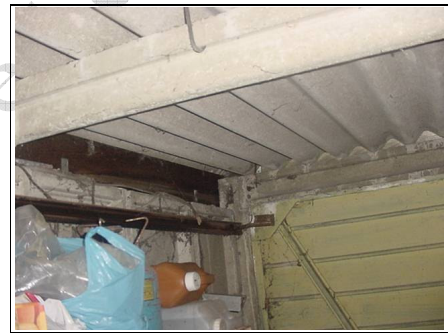
Asbestos in garage

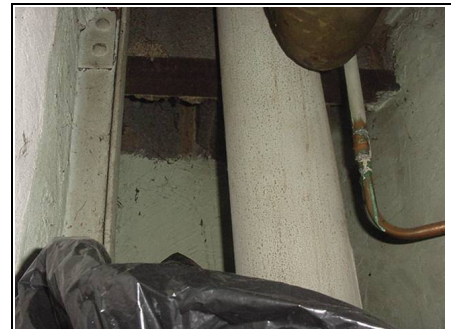
Flue from old boiler from kitchen may be asbestos

We would be more than happy to comment on an asbestos report once this has been carried out.

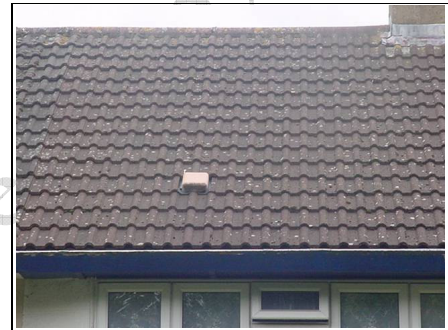
The main roof is pitched and clad with a concrete tile, replacing the original tile which from our research would have been a clay tile. The roof, from ground level, looks in average condition considering the roofs age type and style with the exception of the plastic protective underlayer underneath. However we were pleased to see trickle vents.

Main roof

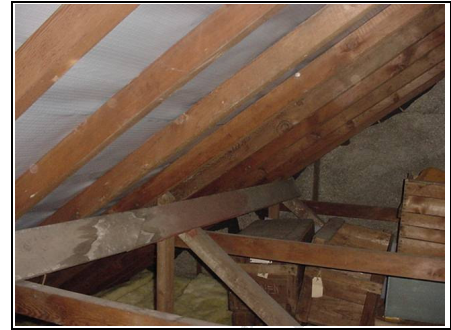
General view of roof, timber boxes may have woodworm brought in with them, unable to view closely due to mass of insulation

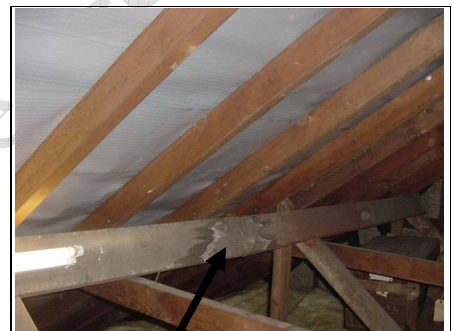
Dampness to purlin

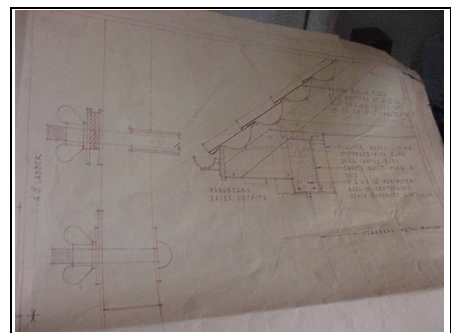
One of the drawings did show the original detail which looks like it may have contained asbestos. The asbestos may well have been removed when the property was re-roofed.

Concern roof detail being asbestos lined system

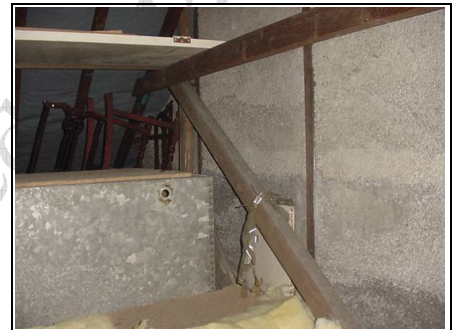
The property has a disused metal cold water tank.

Metal cold water tank

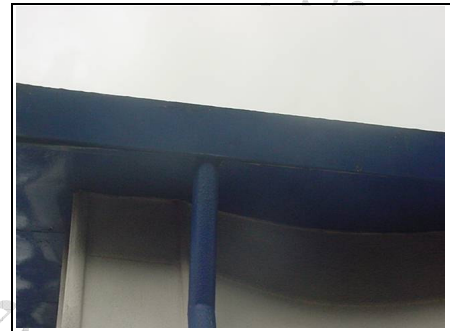
It is very difficult to confirm the type of gutters the property has as it has quite unusual timber work around the property creating a fascia and soffit detail (this may also be asbestos). From speaking with the existing owners they thought the gutters and downpipes were lead lined however we believe that this is unlikely as these non traditional houses were driven by the economics of cost.

Gutter and downpipe

ACTION REQUIRED: You need to investigate what exactly this guttering is made out of i.e. is it asbestos or not and check its condition. A set of long ladders or a tower scaffolding would be required to carry out investigation work. We would always recommend you stand outside the property next time it rains heavily and see how well the drains cope with the rainwater particularly looking at the guttering and the joints. We would always recommend that the gutters and downpipes are cleaned out, the joints are checked and the alignment checked to ensure that the gutters fall towards the downpipes.

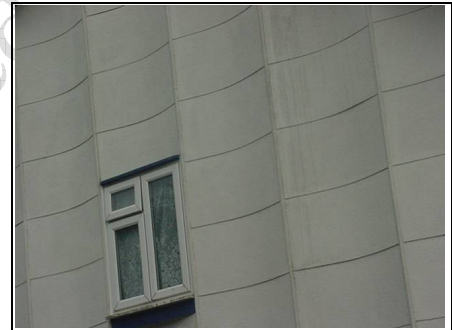
The external walls are made from concave asbestos/concrete blocks. Typically this type of construction would have been what is known as a No Fines concrete and would have been poured into jelly moulds for want of a better term. However from our research on this subject it shows that the Building Research Establishment (based in Watford), the BSE was originally a Government Body and are generally considered to be the authority on building related issues and this type of non traditional properties. The records show that the BSE have not investigated this type of construction which may be because there are so few of these buildings.

Concave asbestos/concrete blocks

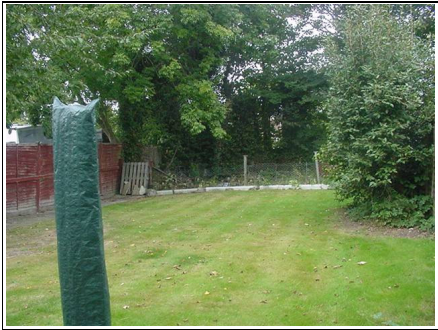
There are trees within what insurance companies would term as influencing distance of the property. We can see that a tree has been cut down you should check to see when this was cut down as this may affect the structure.

Rear garden

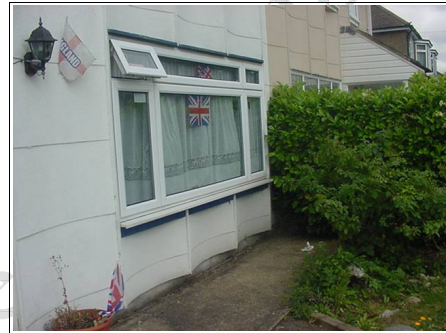
We could not view a damp proof course.

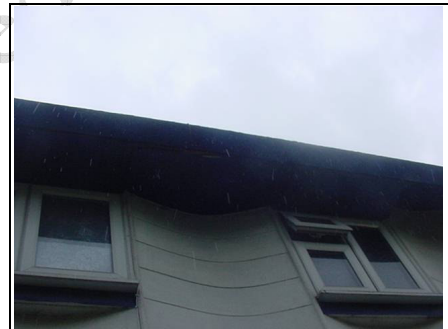
Fascias and soffits

ACTION REQUIRED: An asbestos report to be carried out.

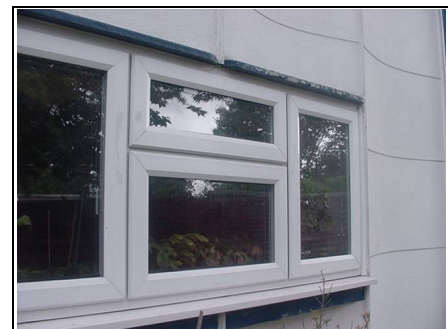
The property has plastic double glazed windows without trickle vents which generally look to be of a average quality. We would draw your attention to the fact that sealed double glazed units can fail, particularly as a result of poor workmanship during installation. Failure of the seal leads to condensation between the two panes of glass and simply replacing the affected units may not provide a satisfactory long-term solution.

Window without trickle vent

ACTION REQUIRED: Add trickle vents to windows if possible alternatively ensure that the house is aired regularly.

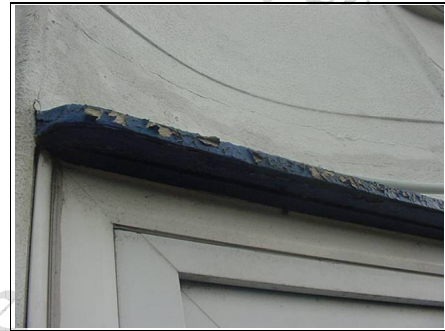
Joinery flaking

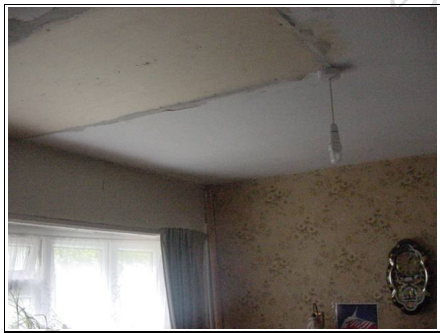
Repair to ceiling

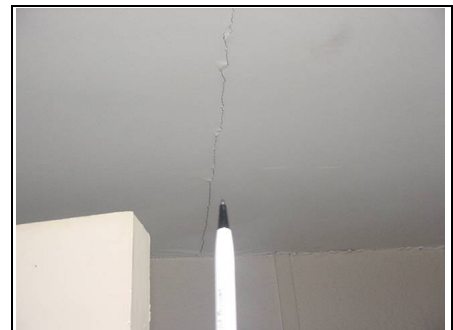
Cracking to ceiling

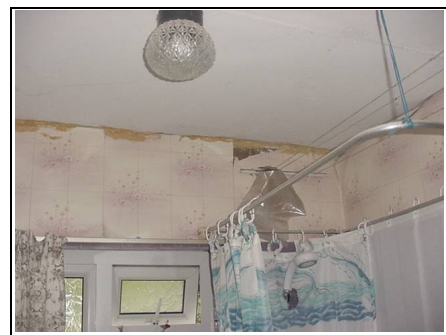
We would normally comment that it depends upon how you utilise the building however you are aware that in some of the non traditional buildings (an indeed some modern buildings that we have investigated) it is very difficult to live in them without creating condensation be it surface condensation or

Condensation in the bathroom

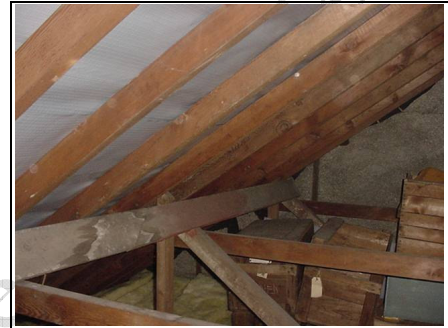
We noted timber boxes which may have brought in woodworm but were unable to inspect further due to the mass of insulation.

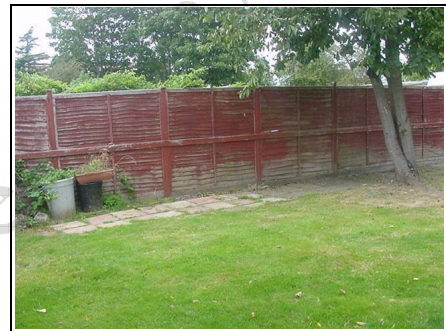
Fence requiring re-fencing/repair.
