RESIDENTIAL BUILDING SURVEY

Tewkesbury,
Gloucestershire GL20

Mr & Mrs H

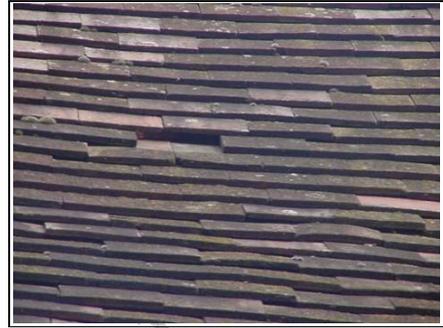
Roof tile missing

1. That he replaces the tiles on the roof (it would be a good idea to get a supply of tiles for the replacement in the future if there is not one already at the property).
2. Check the flashings and valley gutters and re-lead them where they are cement. From what we can see there is a leak to the front valley gutter. We can see this within the cupboard of the middle bedroom.
3. Reduce the ground level around the property prior to the French drain being added.
4. Clean gutters and downpipes and check the joints are joined together. In the case of the barn make sure there is a guttering all the way around it. Check the gutters and downpipes are working properly.
5. We would also suggest they put rainwater butts on any downpipes that discharge against the building and also ensure they no longer discharge against the building.

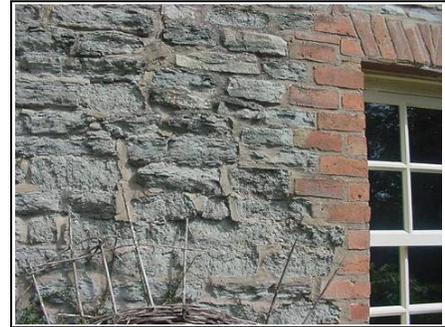
We can see that the face of the stonework is deteriorating. This we feel is due to the pointing being a cement mortar rather than a lime mortar and gutters leaking.

As we discussed with you, a lime mortar allows the property to breathe and gives a gortex type breathable structure, whereas a cement mortar has more of a raincoat type affect, causing the rain to deteriorate the stonework.

Deteriorating stonework

ACTION REQUIRED: Repoint all areas with a lime mortar rather than cement mortar.

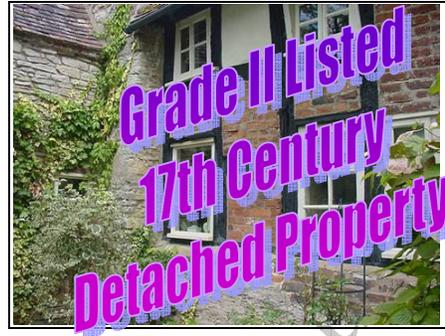
Part of the property has a timber frame structure which we feel is in need of repair, for example to the cellar area and the dining room above and the middle bedroom, all of which show wet rot defects and woodworm defects. It is also likely to be due in part to the embedded timbers, as shown in the sketch.

Timber frame structure

ACTION REQUIRED: General repairs and repointing in a lime mortar and timber repairs as necessary.

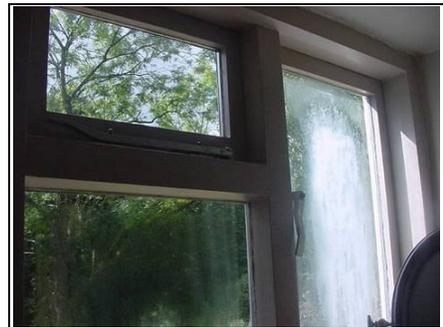
On a technical point of view some of the double glazed units are missing up. This is often due to movement in the structure which double glazing cannot accommodate.

ACTION REQUIRED: You will have to replace the double glazed units

ANTICIPATED COST: Set aside the sum of £10,000 for dealing with the worst case scenario with the Conservation Officer. They may have photographic records of how the windows were and wish you to replace them as this standard. This would be a liability in the tens of thousands.

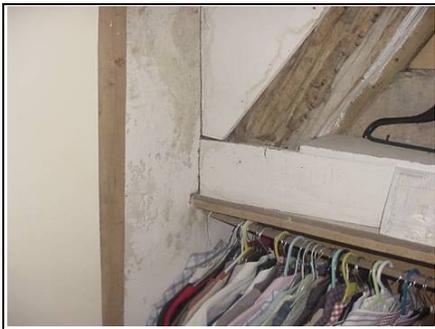
We are finding high levels of dampness. Whilst this is partly to do with the cement mortar it is also in part to do with the high ground levels around the property which we recommend are lowered and ideally a French drain is added (subject to Conservations Officer's approval), discharging into the septic tank.

Dampness coming in from main roof

ANTICIPATED COST: Set aside the sum of £10,000 to £20,000 for general making watertight repairs; please obtain quotations.

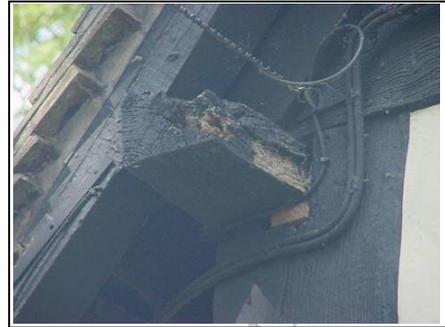
Active woodworm visible to purlins

ACTION REQUIRED: Whilst general repairs to the timbers will be needed we would also recommend adding ventilation to the roof to make the area cooler and less inviting to the woodworm and opening up the floor to check the condition of the timbers.

ANTICIPATED COST: In the region of £2,000 to £5,000; please obtain quotations. Note, we would not recommend a chemical spraying until all other methods have been tried.

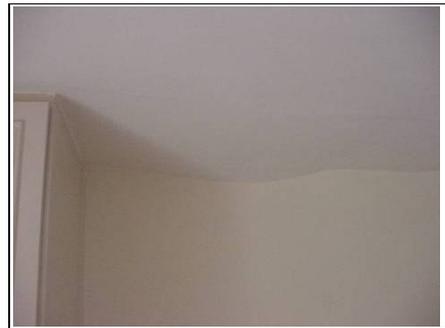
1. Condensation being caused by near by shower in the master bedroom.

Dip in ceiling in master bedroom

2. The general undulation in the ceiling we feel is due to a defective lath and plaster ceiling which has lost its key and is the reason why we did not walk in the main ceilings. It could also relate to movement on the gable end, which we talk about in the Ugly Section of this report.

ACTION REQUIRED: We feel that some opening up of the ceilings will be necessary to check the condition. To this end we would recommend additional loft hatch openings are added to the roof. This will also benefit any future inspection. We would also recommend the roof is lit throughout (and a good fire alarm system is also added in the roof).

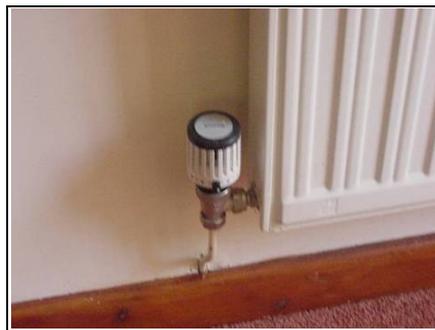
Microbore plumbing in annex

ACTION REQUIRED:
Replace all microbore pipes.

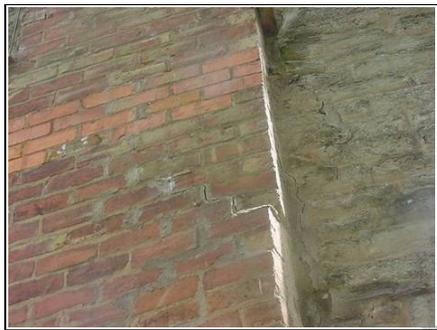
There is a visible crack externally and also internally around the chimney and we can see to the right hand side of the outbuilding a bulge in the wall.

Cracking around left hand chimney

ACTION REQUIRED: We recommend the existing owners place insurance claims, advising that a building survey was recently carried out and it identified the items above and insist that monitoring for movement is carried out on the property.

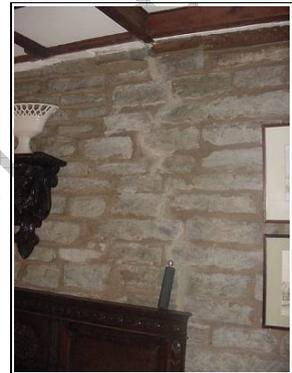
Cracking visible internally

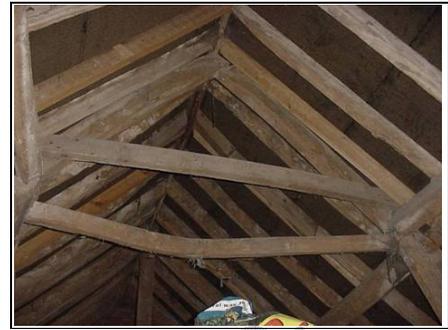
We noted damage to the base of some of the trusses and note, we only had a quick look in the outbuilding barn!

Broken cross brace where a modern timber has been crudely added

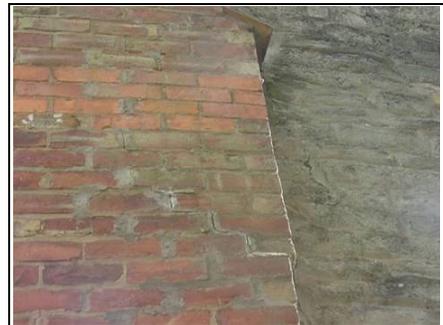
This chimney is brick built with a lead flashing. We are unable to see the top of the chimney known as the flaunchings, we therefore cannot comment on its condition. However we did note cracking and movement in the chimney breast externally. This can also be seen internally.

Crack in left hand chimney

ACTION REQUIRED: Please see our comments in the Executive Summary with regard to an insurance claim being required due to the movement that is occurring.

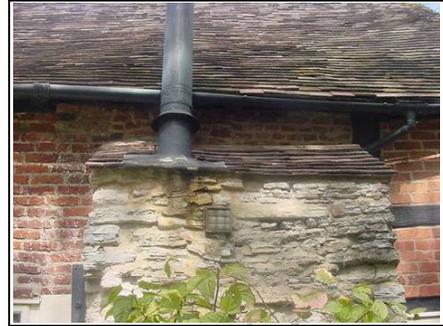
This chimney looks to have been reduced in years gone by and now only partially remains. It is built out of stone with a tile capping on it and a flue going through it.

ACTION REQUIRED: The stone needs general repair. Please see our comments in the Executive Summary.

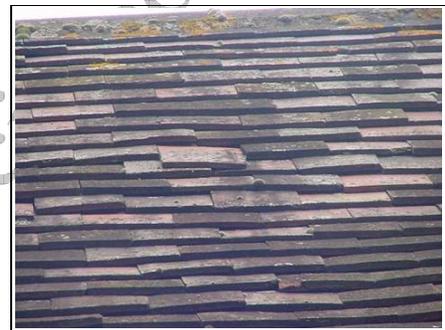
It was difficult for us to confirm 100% whether the roof was just clay tiles or concrete and clay. We were advised that the roof had been re-roofed as one of the first things the owners did when they came to the property. Nevertheless, we can see some slipped tiles.

Close of up of main tiles, with missing roof tiles

ACTION REQUIRED: Generally reposition and replace slipped tiles and make watertight.

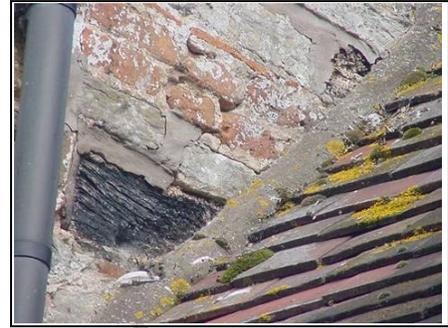
Cement flashing

ACTION REQUIRED: We would recommend these are removed and replaced with a lead flashing or a lime mortar flashing. This needs to be agreed with your Conservation Officer.

ANTICIPATED COST: In the region of £2,500 to £5,000; please obtain quotes.

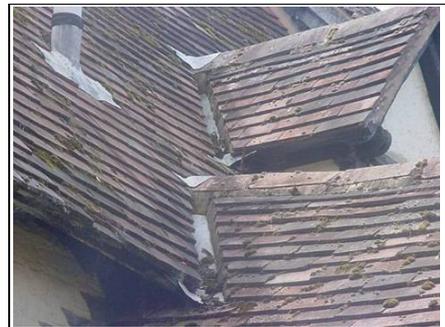
Valley gutters leaking

ANTICIPATED COST: Allow the sum of £1,000 to £2,000; please obtain quotes.

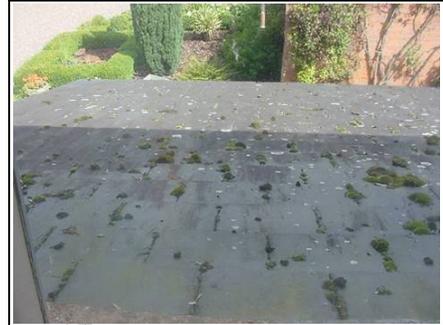
Roof over sun lounge

ACTION REQUIRED: Clear moss, making sure you do not damage the roof.

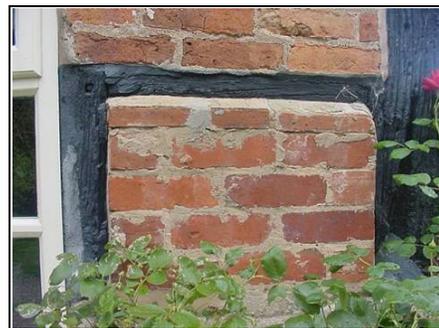
Poor cement mortar repairs to brickwork

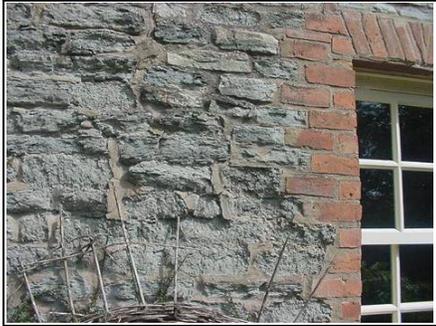
A portion of the property has been built in a relatively soft blue/grey stone. It is suffering from the cement mortar that it has been repointed in and also the leaking of gutters.

Deteriorating stonework

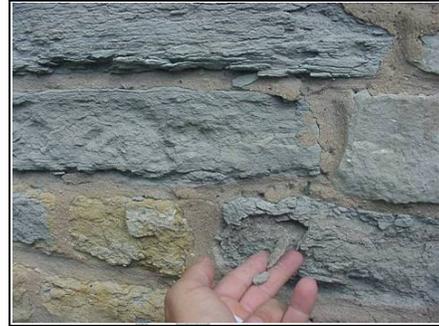
Close up of stonework deteriorating with face coming away

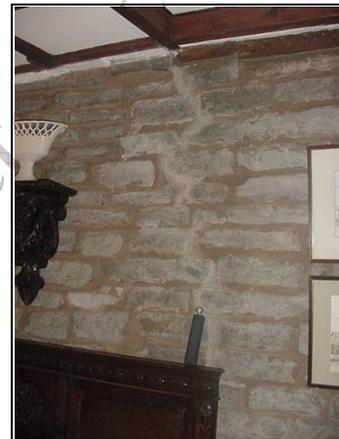
Crack internally in left hand wall

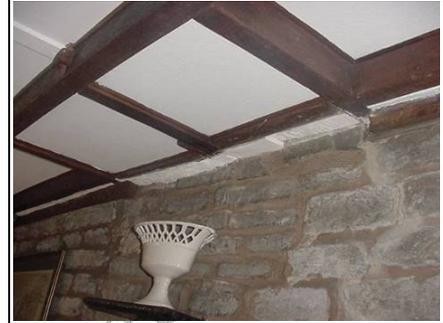
We have commented in the Executive Summary that there are problems with the left hand side chimney. Internally it looks like the chimney main part has been removed. This in turn may be the reason for its cracking. It should in theory have had Building Regulations but we very much doubt whether it will have.

Missing chimney?

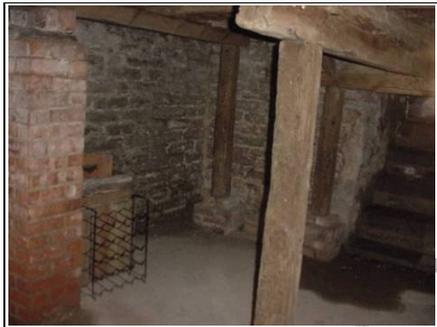
The cellar has been propped up with timbers from many years ago. We found extensive wet rot in the timbers.

General view of cellar

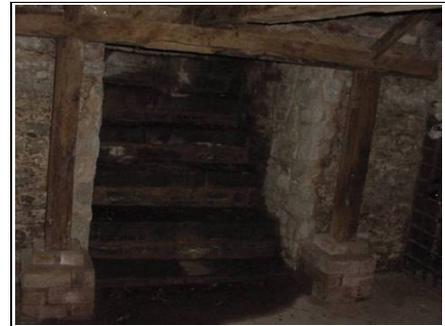
Dampness coming in through cellar flaps

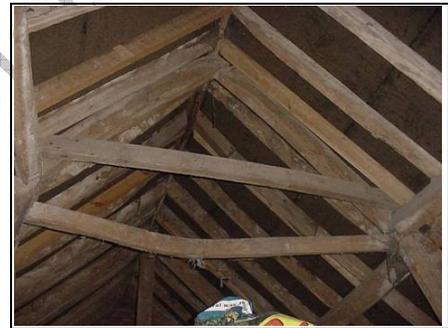
Broken collar truss in roof
