**RESIDENTIAL BUILDING SURVEY
OF
Richmond TW10**

**FOR
Mr S & Miss D**

INDEPENDENT CHARTERED SURVEYORS

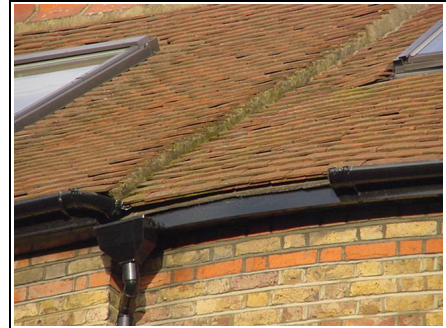
The question is how will high-level work be carried out and who will pay for it? For example, there are tiles missing and slipped into the gutter, there is a part of the gutter missing (found at the base of the staircase), there is a piece of flashing missing to the chimney and some of the fascias and soffits would benefit from redecoration. All of these are at high level and, therefore, access is difficult without scaffolding or a cherry picker lift hoist, which, in turn, means it is expensive.

Missing gutter

ACTION REQUIRED: We would recommend that your legal advisers investigate the responsibilities and liabilities in relation to these issues. As you are directly under the roof any problems will affect you first. In the long term it may be better to change some of the details, such as a deep flow gutter to ensure a better flow of rainwater without it getting blocked and, also, catch any bits of tile that may slip off (and saving them from hitting someone on the head on the pavement below – and who would be liable for that?). We also suggest that the hopper head is made larger too. There will no doubt be other things once you have a close up inspection.

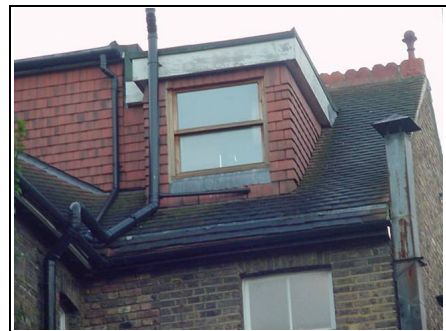
Rear dormer fascia requiring redecoration, due to their being no gutter. Also showing vent, please see item 2 below.

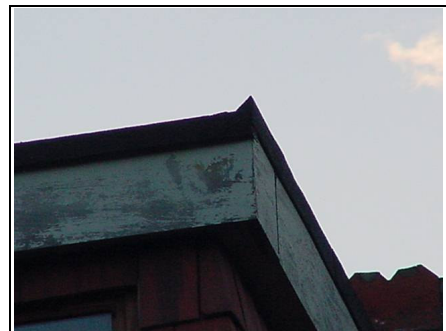
A close up of the rear dormer fascia requiring redecoration.

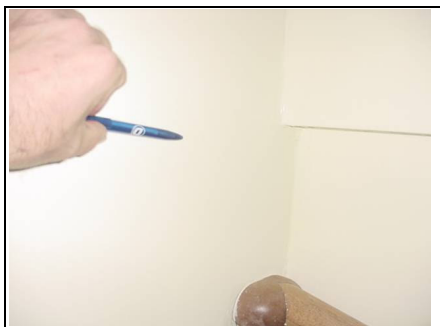
In a property such as this where there is a mixture of old and new materials and construction techniques there will be movement and this means that there will be cracks almost for ever and a day. These will need to be filled with a putty/mastic that allows for movement. We noted hairline cracking in the corner of the shower and, obviously, if this leaks it will not be the best way to meet your neighbours!

Cracks identified by a pen

ACTION REQUIRED: Fill all cracks and redecorate.

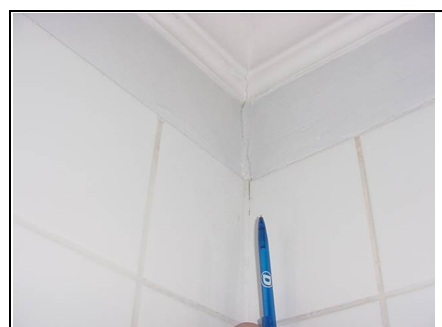
Hairline cracking in the en-suite shower room

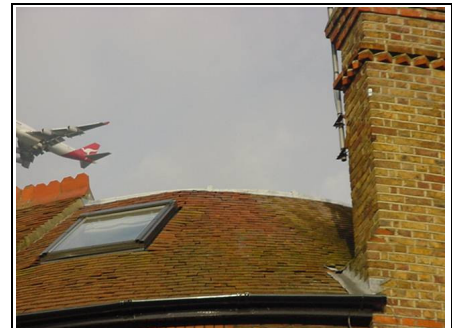
The aeroplanes do fly awfully close to the property. You need to check and ensure you are happy to live with this noise, particularly bearing in mind the previous property.

Aeroplane (left of photo) flying closely over the property.

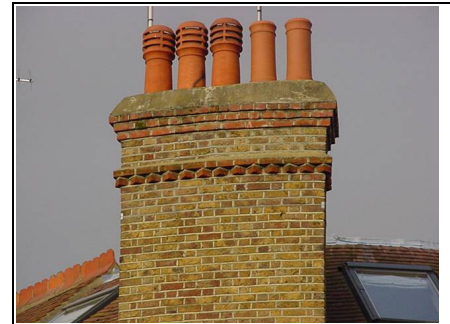
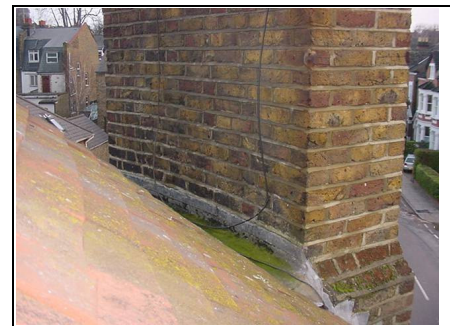
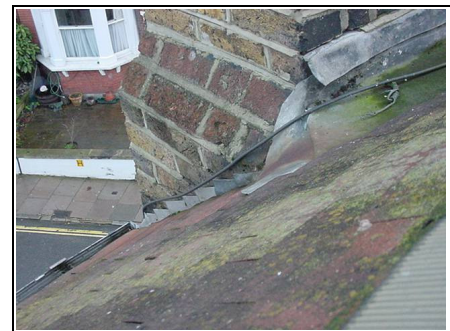
This is a close-up of the side of the chimney and you can see where the cable runs that there looks to be a flashing missing in this area. You can also see in the on the top corner where the mortar pointing is coming out of the lead – this is because it has been incorrectly bedded in to the chimney.

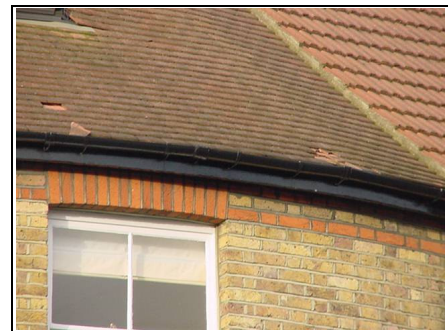
We noted that the adjoining roof has a different roof covering, this means there is a small lip, or upstand, between the roofs, which unfortunately can be a weak area allowing dampness in.

On this photo you can see the missing tiles and also the upstand, or lip, on the right hand side of the photo.

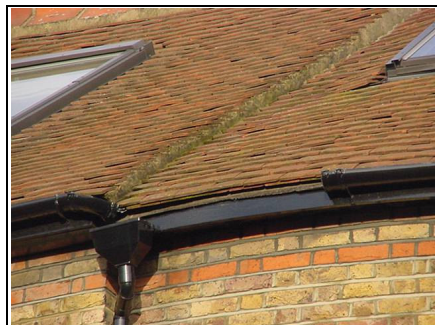
Hopper Heads

The Hopper heads may not be able to cope with heavy rainfall. We also recommend a lead flashing around them.

ACTION REQUIRED: We would always recommend that the gutters and downpipes are cleaned out, the joints are checked and the alignment checked to ensure that the gutters fall towards the downpipes.

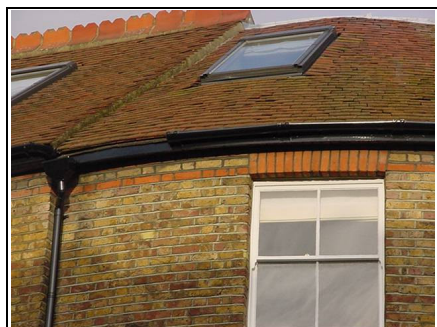
To the right hand side – again we are not certain that the guttering will catch all the rainwater. The last thing you want it to do is spill all down the property.

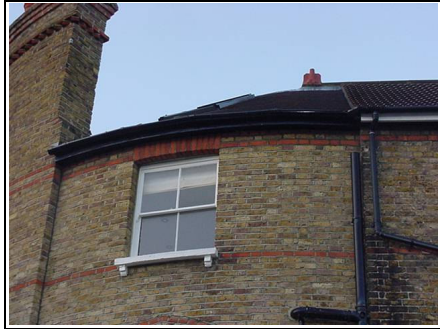
To this picture you can see that the soil and vent pipe has been cut off short; It is normal to terminate soil and vent pipes above the roof level.

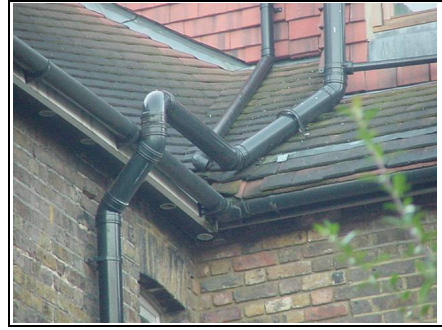
To the rear of the property, there is a soil and vent pipe that they have done everything to move it above roof level. We noted that your waste pipe from the kitchen feeds into this.

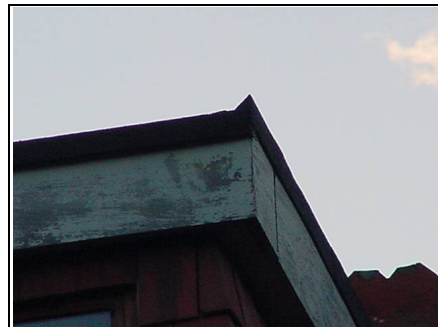
In the majority of instances on this property the fascia is hidden behind the guttering and so we could only see a limited amount. What we can see looks in reasonable condition. The exception that we need to mention is the fascia and soffit to the rear of the property and the dormer roof, which is in need of redecoration. The problem is 'how do you get to it?' - you would need several storeys of scaffolding, which is no doubt why it is in the condition it is.

A close up of the fascia and soffit.

ACTION REQUIRED: You really do need to establish if you can gain access on to the roof via the adjoining building or any future high-level work is going to be very expensive. The painting of this fascia and soffit is already overdue.
