JOB REFERENCE: xxxxxxxxxxxxxxxx

RESIDENTIAL BUILDING SURVEY

xxxxxxx,
xxxxxxxxxxx,
xxxxxx, Rickmansworth
Hertfordshire
WD3 xxx

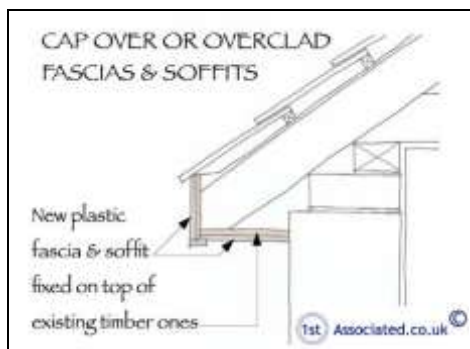
We noted the plastic fascias and soffits. We believe these to be a plastic overcladding to the original timber fascias and soffits. This is often carried out as a quick fix and whilst looks clean, neat and tidy it can cause the covered timber to sweat and cause further deterioration.

Overcladding

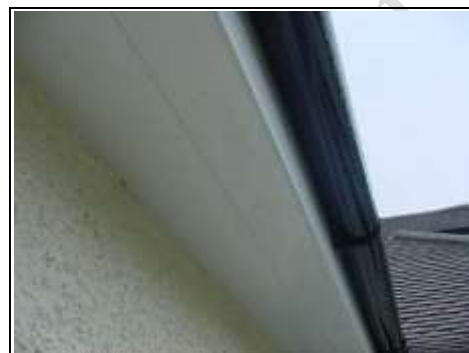
Plastic overclad fascias and soffits are stuck on rather than pinned

ACTION REQUIRED: We would recommend that sections are exposed to see the condition of the timber and replaced as necessary. We would also recommend adding a vented soffit.

ANTICIPATED COST: If the timber is in good condition then £100 or so for the inspection. If not and replacement is required then this will be several thousands of pounds. We would add that this overcladding is from the cheaper end of the market as there is not a vented soffit which is common practice today and is used to add ventilation to a roof to reduce condensation occurring; please obtain quotations.

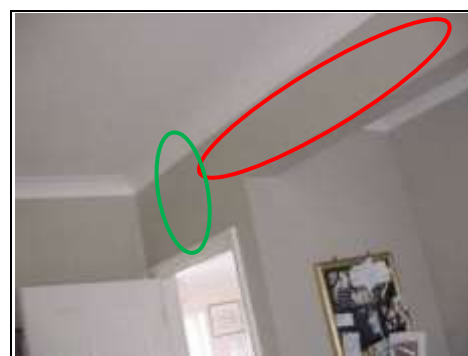
This in turn has put additional stress and strain on the pier between the alterations and the kitchen door where we can see stress cracking. We would add that this is in a relatively newly painted building.

Wall removed in kitchen
Green oval – small pier
Red oval - lintel

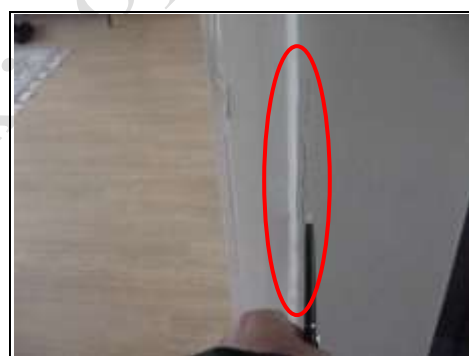
Crack next to door in Kitchen

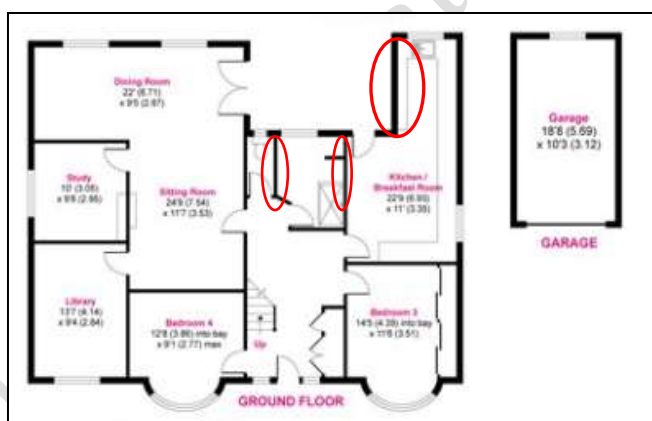
Estate agent floor plan (1) ground floor
Red oval – wall removed

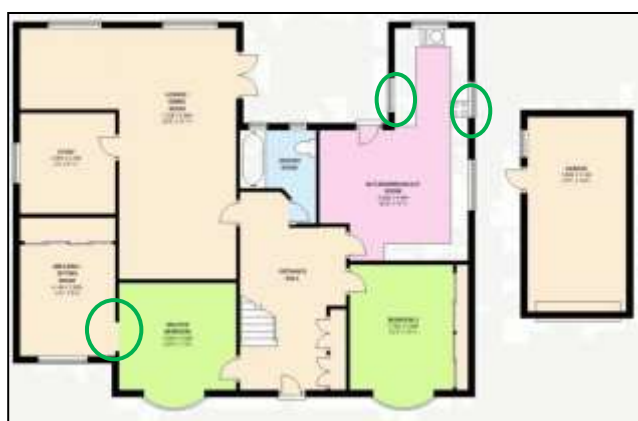
Estate Agent floor plan (2) ground floor
Green oval - Windows added in kitchen and
door opening in bedroom and dressing room

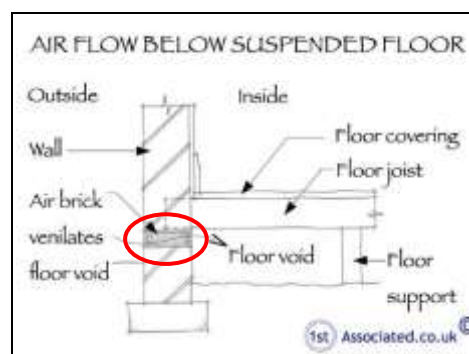
Suspended timber floor

We noted that some areas of floor felt solid underfoot where we assume that the original timber floor has been replaced with concrete.

ACTION REQUIRED: If there are not voids all the way under the floor then you need to create them. This can be done by adding vents internally or by digging up sections of the floor and adding vents externally to the rear of the property.

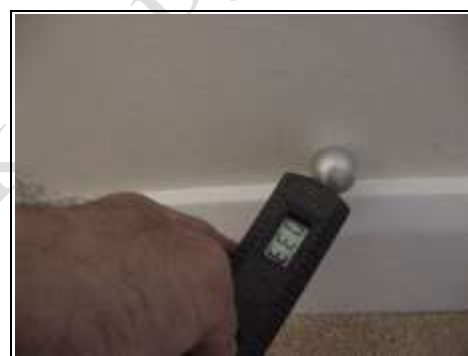
Damp meter readings indicate dampness which may relate to the floor

ANTICIPATED COST: We would allow a few hundred pounds for opening up the floors. Dependent upon what is found costs may be zero if there are no problems or a few thousand pounds if problems are found.

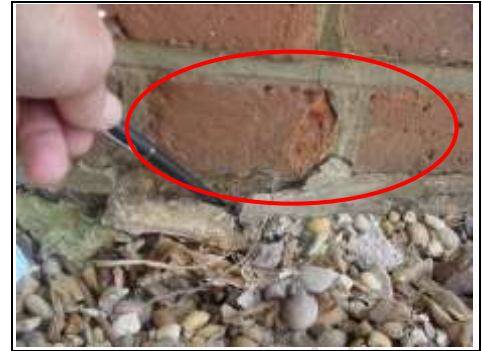
To the front of the property we can see deteriorating brickwork at ground level. Arguably the property has also been incorrectly re-pointed in a cement mortar. This effectively is smothering the building instead of allowing it to breathe.

Deteriorating brick work at ground level

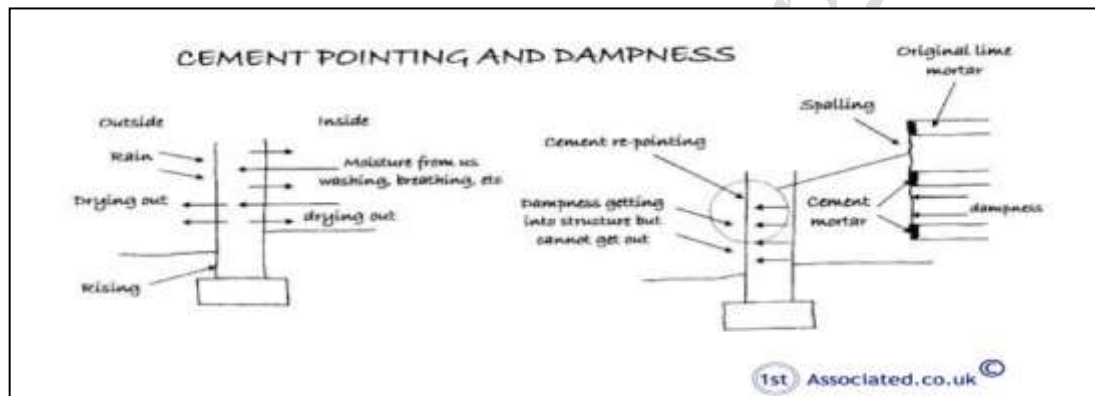
Cement pointing

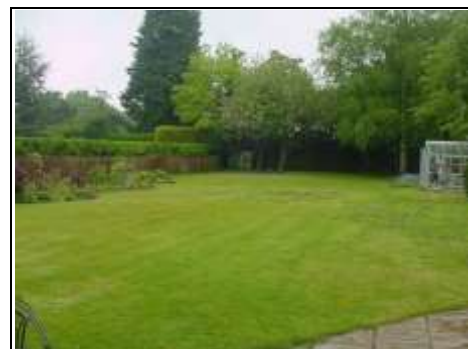
Whilst conifers do not have as large a root ball as many trees do it can often be the way they take water away via their roots that is of help to the lands irrigation system and when removed can cause problems. Other trees, we believe, also appear to have been removed from the images we have from Google Earth.

Rear garden has had numerous trees removed

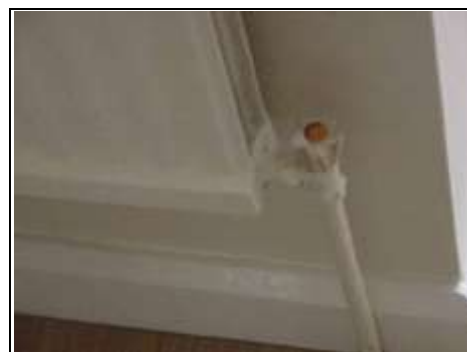
There is variety of radiators in this property ranging from single panelled radiators to older style double panelled radiators to convection radiators. The single panelled radiators may not warm the property as quickly as you would wish. We also advise that we would recommend that you set aside a budget to replace the radiators.

Old style radiator

ACTION REQUIRED: We would recommend the replacement of radiators and movement of internal radiators to position underneath window.

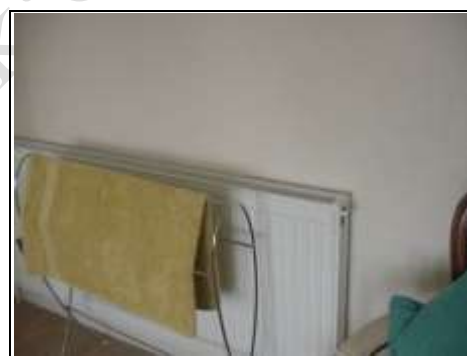
We note that the property has a number of internal radiators, which do not allow the flow of air around the property. We recommend relocation of the internal radiators to a position underneath windows.

Internal radiator

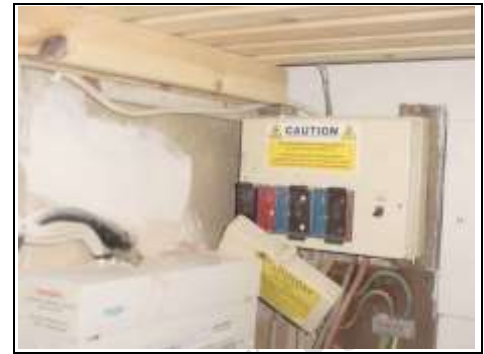
Electric fuse board

As advised the electric fuse board is dated and will need replacing. The Institute of Electrical Engineers standards (IEE) recommend a test and report whenever a property changes occupancy. This should be carried out by an NICEIC registered and approved electrical contractor or equivalent.

ACTION REQUIRED: We would recommend that you replace the electrics. An Institute of Electrical Engineers (IEE) test and report to be carried out by an NICEIC Registered and Approved engineer or equivalent.

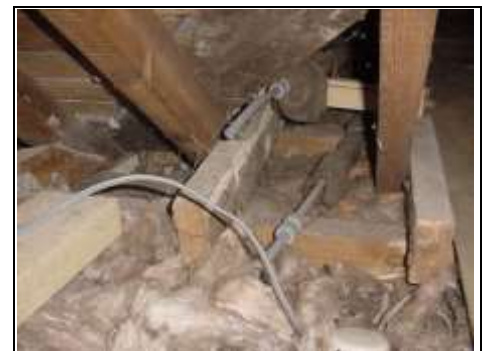
Plastic pipe joined to copper pipe

We also note that one of the plastic joints on the left side was leaking, albeit minor, and also that plastic to copper has been used which we generally find does not work particularly well on warm water pipes.

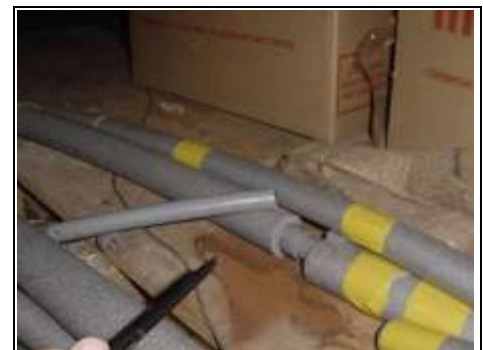
Plastic pipe leaking

ACTION REQUIRED: Carry out repairs to existing plastic pipes and

we would recommend a full assessment of the plastic piping that has been used in the roof to see if any of it needs to be replaced with copper.

ANTICIPATED COST: This is really difficult to estimate as you will probably be able to carry out repairs and fully insulate the pipes. There is a risk in our experience of mixing the plastic and copper pipes; please obtain quotations.

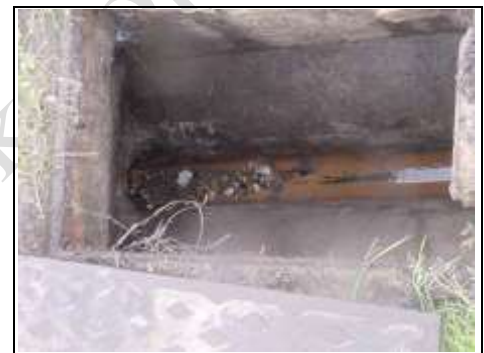
We lifted the two manhole covers to the rear of the property and found there to be very shallow drains with next to no fall.

In manhole two we found shingle within it which does lead us to believe that the manhole cover has been lifted and rodded.

Shallow drain

ACTION REQUIRED: The only way to establish the condition of the drains is to have a closed circuit TV camera report carried out.

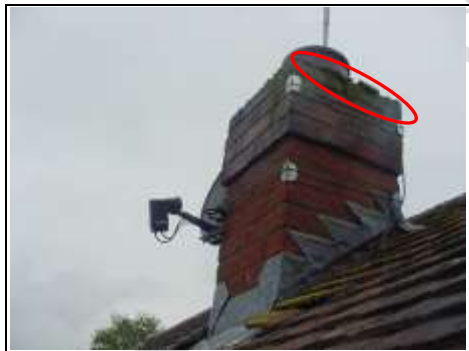
This chimney is brick finished with a lead flashing and one chimney pot. From what we could see from ground level it looked in slightly below average condition considering its age, type and style.

Chimney One
Moss on edge of
flaunching visible

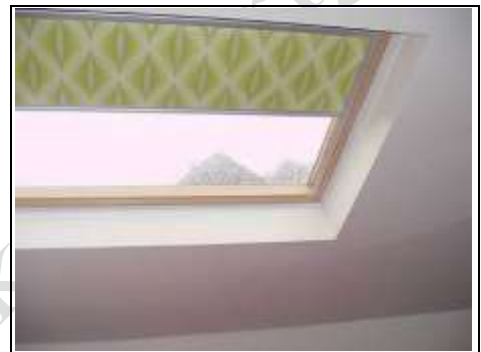
Roof window in
left hand bedroom

We would add that sooner or later they will leak. If this doesn't occur then they seem prone to condensation.

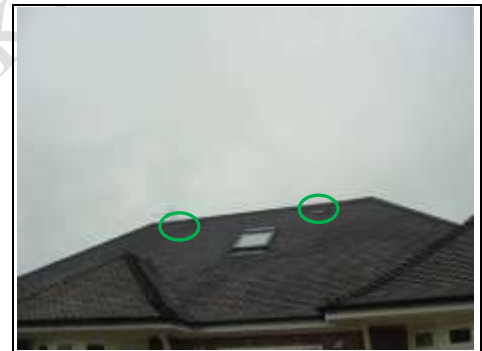
Main roof
Vents visible to the roof circled

We noted some tiles were lifting slightly around the roof window and we also noted two roof vents to the roof.

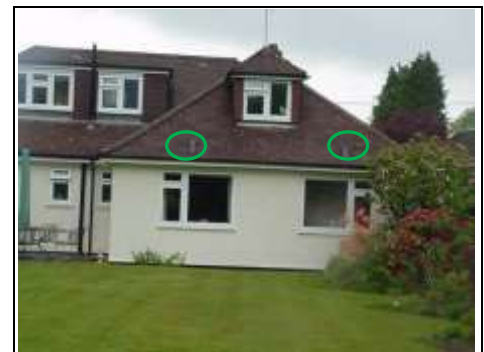
Also to the rear of the roof are two lead covered, what we believe to possibly be, lintels that are adding support to allow the open plan area of the lounge and dining area. We cannot be one hundred per cent sure of this.

Possibly lintels protruding
thorough the roof

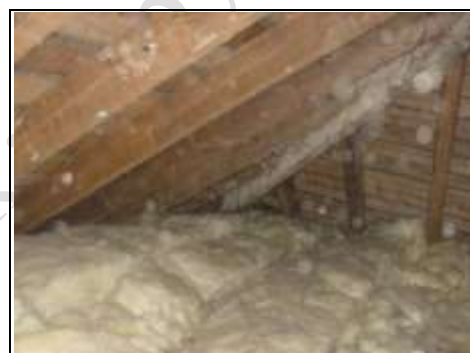
There is a mass of insulation that we are slightly concerned about where there is a close boarded roof as it can cause condensation in the roofs. Please see the Thermal Efficiency Section of this Report.

Mass of insulation

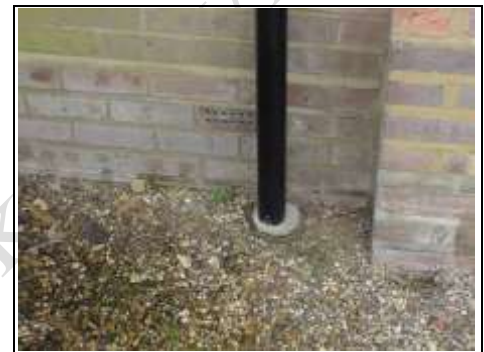
Downpipe discharges straight into drain as opposed to having a gulley

We also recommend that the gutters and downpipes are cleaned out, the joints are checked and the alignment checked to ensure that the gutters fall towards the downpipes.

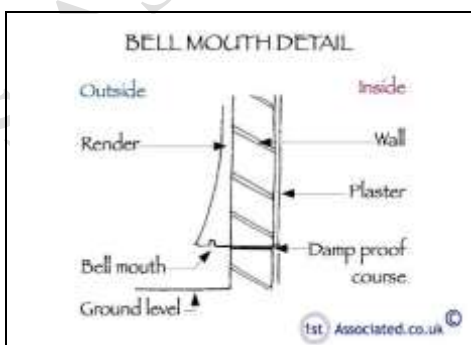
To the base of the render there is a bell mouth detail very close to the ground. We would normally expect to see this 150mm above the ground. We feel it may be bridging the damp proof course and allowing dampness to be drawn up above it as we found dampness within the kitchen area.

Bell mouth detail

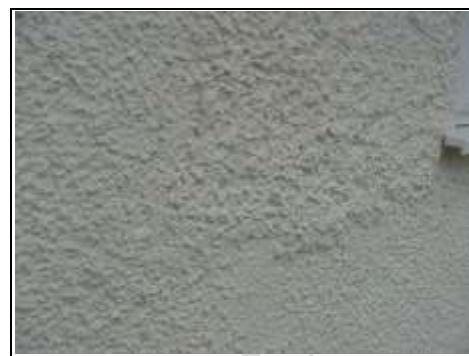
Variety of painted render finishes

Do not underestimate the amount of time/cost it will take to repaint the property particularly as there is high level work which is likely to need scaffolding which can be expensive.

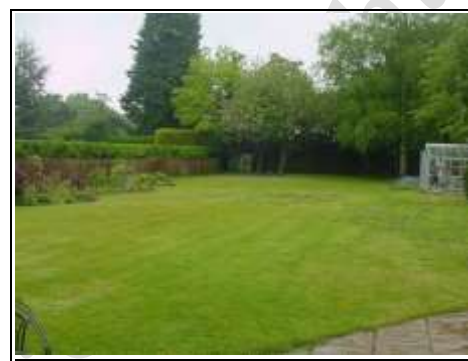
The owner advised that approximately sixty conifer trees have been removed to the rear. We thought this was a lot at the time and that we had misheard. However we now think this may have been possible. We looked at old images on Google Earth and there were also once a lot of trees to the front of the property.

Where a lot of trees have been removed professional advice needed to have been sought (an Arboriculturalist not a tree surgeon). Now the trees have been removed the ground has to cope with a considerable amount of moisture. Also rotting roots in years to come can affect the stability of the ground dependent upon the trees that were there. From looking at the images the trees to the front were of a considerable size.

ACTION REQUIRED: We would recommend you obtain more information regarding removal of the trees before you commit to purchasing this property. We spoke briefly to the owner about this but we would comment this was limited advice (he said he was pushed for time) and only related to us that there were trees removed to the rear of the property. The effects of removing trees should not be underestimated.

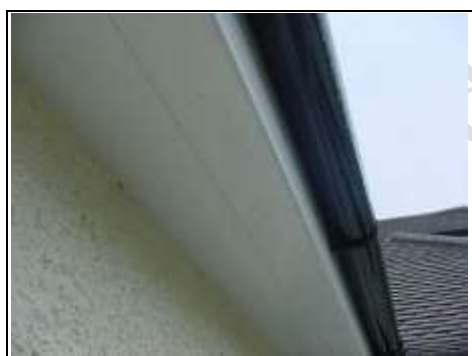
The fascias and soffits are plastic. We believe these are overcladding. Overcladding is generally not considered good practice as the timber fascia and soffit behind is left rotting and the plastic overcladding can accelerate deterioration. Also it is now considered good practice to add vents into the soffits to vent the roof.

Overclad Fascias and soffits

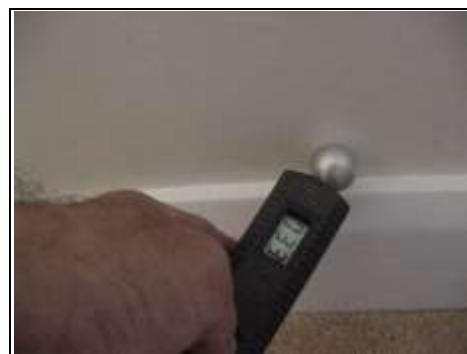
A random visual inspection and tests with a moisture meter have been taken to the perimeter walls. In this particular case we have found rising damp in the kitchen area and were expecting to find more particularly to the front of the property given the way the bricks are spalling.

Testing for rising damp

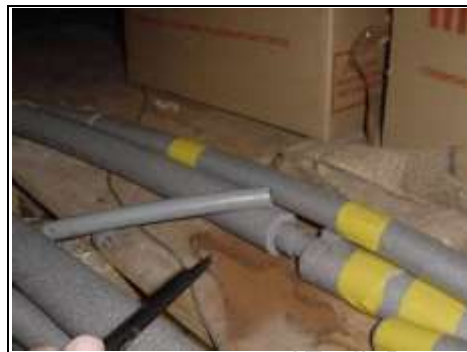
Plastic pipe leaking

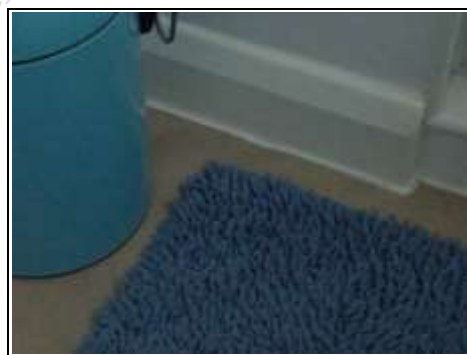
Mastic in cloakroom

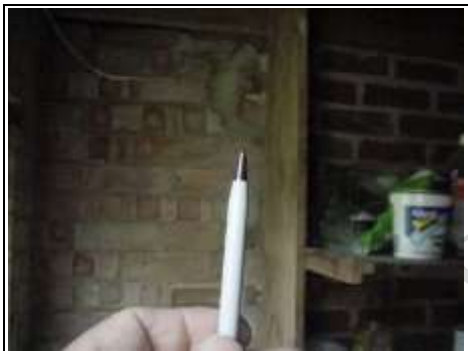
Cracks in garage

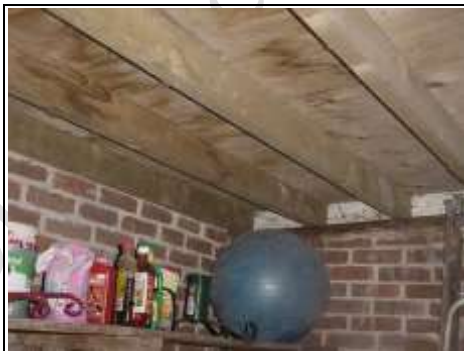
Dampness coming through roof

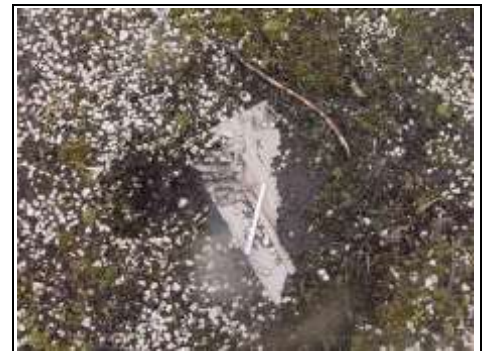
Flashband repair to flat roof
