RESIDENTIAL BUILDING SURVEY

**A Converted Mid-Terraced Victorian Property,
Shepherds Bush, London, W12**

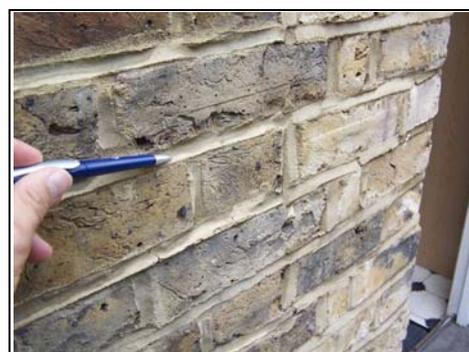
We would draw your attention to the cement mortar re-pointing that has been carried out on the exterior of the property that is not appropriate for this age of construction and can cause damage and deterioration over the long-term. Originally it will have been built with a lime-based mortar and this is what should be used for any re-pointing in the future.

The use of cement mortar causes deterioration to the brickwork and leads to the face of the bricks deteriorating, which in turn leads to dampness. This is a very important point.

ACTION REQUIRED: We suggest that periodically the external walls are rubbed with a stiff brush, or the cement will eventually fall out on its own, and it should be repointed in a lime based mortar.

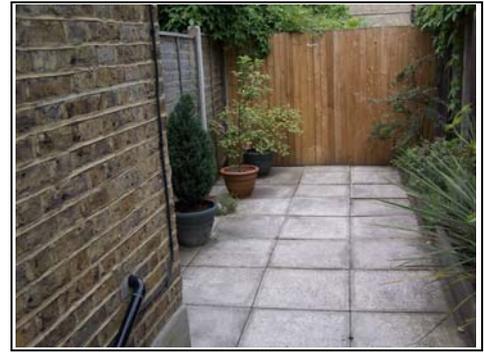
Quite unusually the ground floor rear garden is marked on the details as being shared. However, we are not quite sure how your upstairs neighbours will share it with you. As far as we could see they would have to walk through your house to use it. Although we did note a handle of some sort on the fence to the rear.

ACTION REQUIRED: Your Legal Advisor to investigate further and explain the exact nature of your shared rear garden.

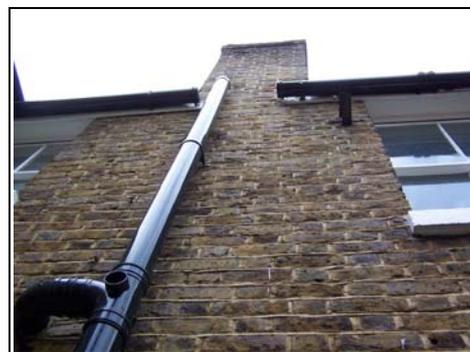
Unfortunately this chimney was very difficult to see but what we could see of it (one side) was in reasonable condition.

This is looking directly up at the chimney and is the one side we could see properly.

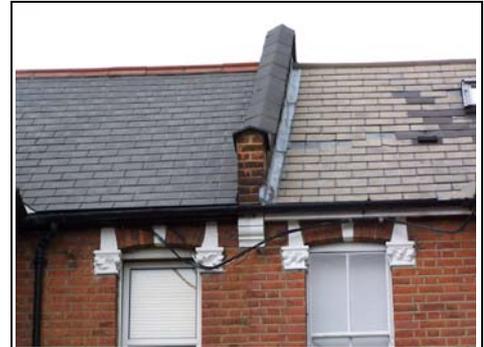
This parapet wall is brick built with a brick finish on your side, although it does look to need some repointing. It is capped with a coping stone to stop water from getting in at the top.

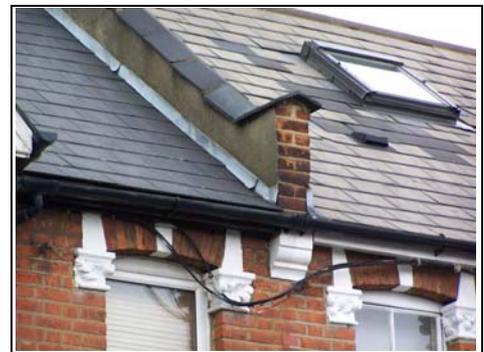
We noted that on your neighbour's side the wall had been rendered, indicating that dampness may be getting in. This will affect the upstairs property first of all, but we are sure you will have a shared cost. Unfortunately as we were unable to gain access to the upper floors we cannot comment further on whether dampness is getting in.

Here you can see the render work on your neighbour's property side

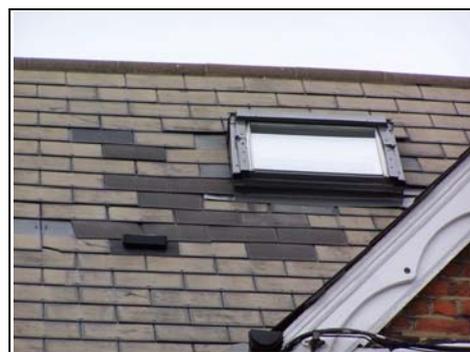
The property has modern metal manufactured roof windows. We have checked this the best that we can from ground level as we had no access to the upper apartment. It is difficult to be 100% certain with roof windows, as much is hidden. From what we could see it looked in reasonable condition.

It seems inevitable with roof windows that they will sooner or later leak, but this will be into the top floor apartment.

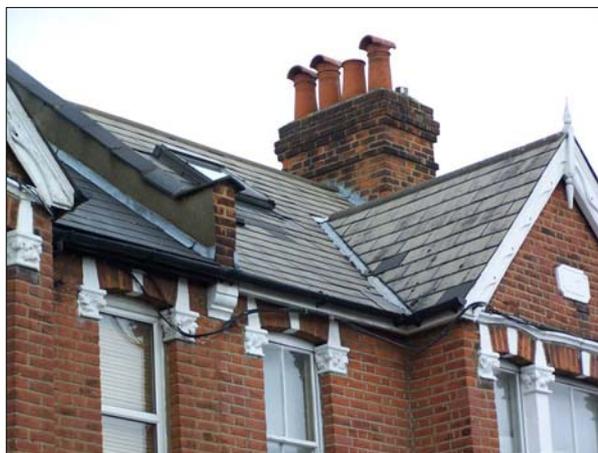
The roof is pitched and clad with what we believe to be a manmade slate, although it is very difficult to tell from ground level. There are indications that it may be a newer slate, such as the vent that we mentioned earlier and the fact that there looks to have been a loft conversion, as roofers rarely put back on the original slate if they can get away with putting on manmade slates (as these are cheaper and they can also then sell the original slates on; or are we becoming very cynical in our old age, or watching too many 'Rogue Traders' type of programmes on the television!)

There does look to be one or two slates displaced around the valley gutter areas, which do need repositioning before winter. This is normally a shared cost.

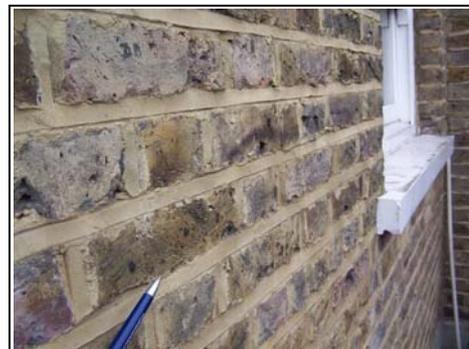
The property is brick built in a Flemish bond construction using a soft red brick to the front and a London stock yellow brick to the rear. Originally the property was pointed in a lime mortar, which has been repointed in a cement mortar. Please see our comments in the Executive Summary. The damage with regard to the pointing will be evident to the softer red brick to the front of the property.

Soft red bricks are also prone to spalling when repointed in a cement mortar. Please see our comments in the Executive Summary.

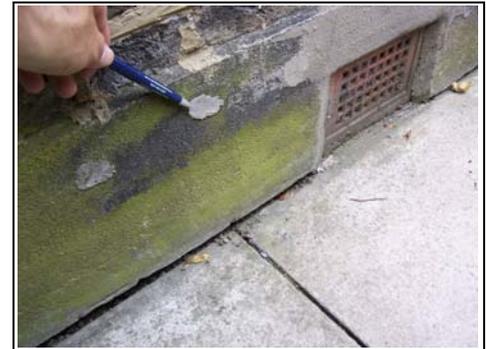
The area where the damp proof course is usually viewed (about 100 to 200mm off the ground) is hidden by a render plinth. In properties of this age it is likely that a basic damp proof course would have been built in originally, such as slate. However, often these fail and then have additional damp proof courses added in at a later date, as would appear to have happened in this case. If you look at this photo you can see we are indicating with a pen that an inserted damp proof course has been put into the property. We would comment that we found minimal dampness throughout.

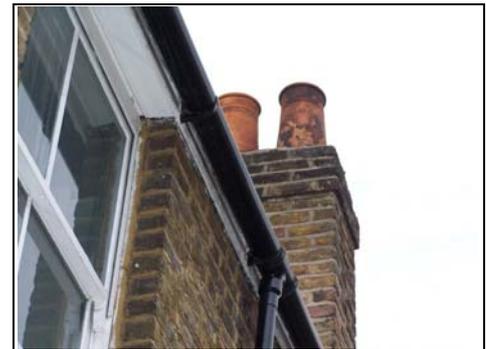
Much of the fascia is hidden behind the guttering in this instance and so we cannot see it. However, it is common for this type of detail to have some deterioration to the timber, particularly in this case where we can see the gutters have been replaced.

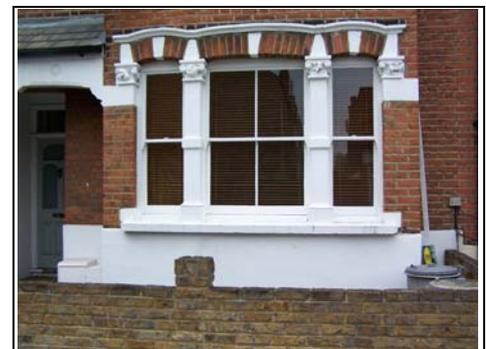
This property predominantly has modern sliding sash windows, which are single glazed and have a painted timber finish and are in reasonable condition. We would specifically comment that we have tested them with a knife and soft rot is minimal.

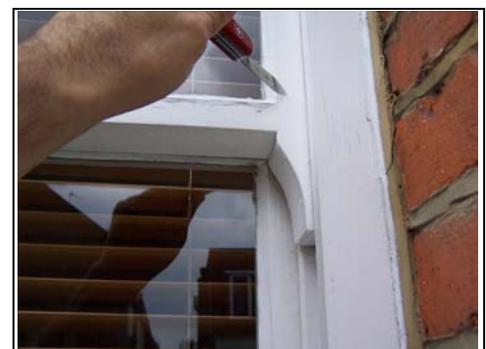
We would add that there is sometimes movement to this type of property due to the size of the windows and any evidence of this may have been covered up with the repointing.

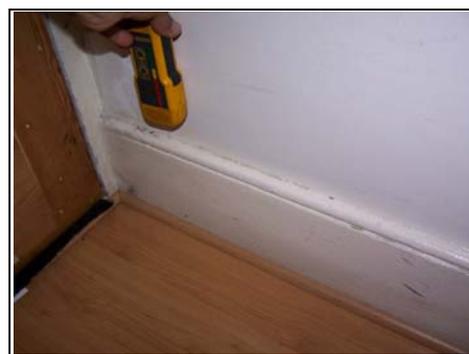
We have carried out tests with an electronic damp meter to a random selection of areas where we would expect damp to be if the property had it and we are pleased to advise that no significant dampness was found.

Testing for Dampness.

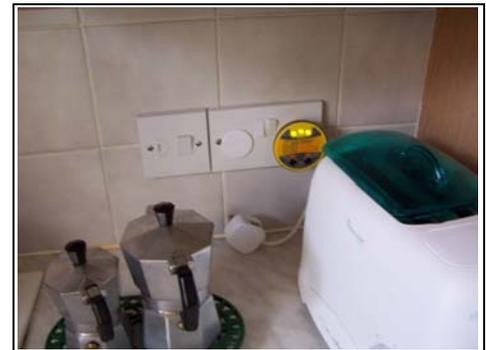
We carried out an earth test in the kitchen area to the socket point that is normally used for the kettle, this proved satisfactory.

ACTION REQUIRED: Please see our comments in the Executive Summary where we recommend the fuseboard is updated and a full test of the electrics is carried out, unless recent test certificates are available - less than five years old.

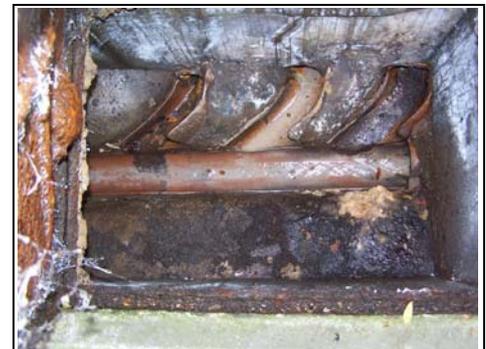
We duly lifted the cover and found it to be free flowing at the time of our inspection.
