# RESIDENTIAL BUILDING SURVEY

**A Converted Mid-Terraced Victorian Property,  
Shepherds Bush, London, W12**

Mr H

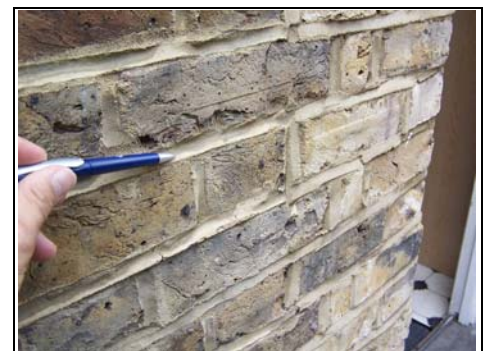
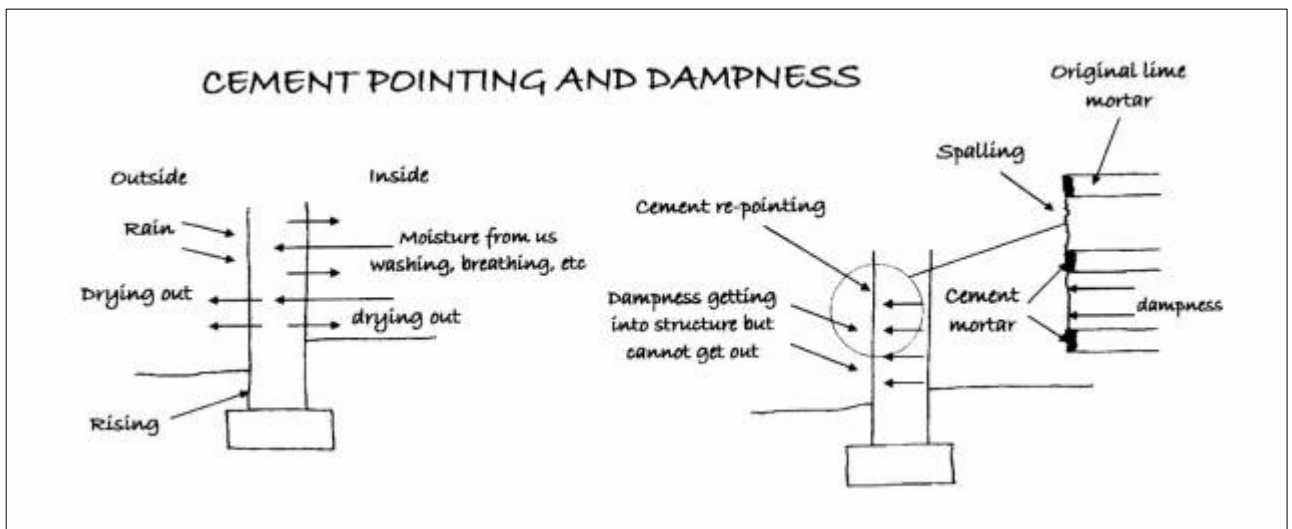
We would draw your attention to the cement mortar re-pointing that has been carried out on the exterior of the property that is not appropriate for this age of construction and can cause damage and deterioration over the long-term. Originally it will have been built with a lime-based mortar and this is what should be used for any re-pointing in the future.

The use of cement mortar causes deterioration to the brickwork and leads to the face of the bricks deteriorating, which in turn leads to dampness. This is a very important point.

Using lime mortar will limit further damage to the brickwork, which is almost impossible to repair successfully. However, we would add that many, if not most, of the properties that we come across are repointed wrongly; it is only in recent years that we have discovered the problems that can occur from it.

**ACTION REQUIRED:** We suggest that periodically the external walls are rubbed with a stiff brush, or the cement will eventually fall out on its own, and it should be repointed in a lime based mortar.

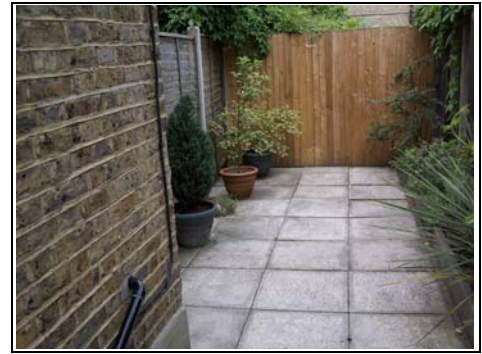
Quite unusually the ground floor rear garden is marked on the details as being shared. However, we are not quite sure how your upstairs neighbours will share it with you. As far as we could see they would have to walk through your house to use it. Although we did note a handle of some sort on the fence to the rear.

**ACTION REQUIRED:** Your Legal Advisor to investigate further and explain the exact nature of your shared rear garden.

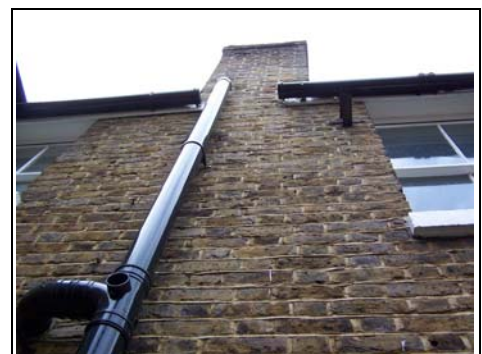
### Chimney Two – Located to the Rear Middle of the Property

Unfortunately this chimney was very difficult to see but what we could see of it (one side) was in reasonable condition.

This is looking directly up at the chimney and is the one side we could see properly.

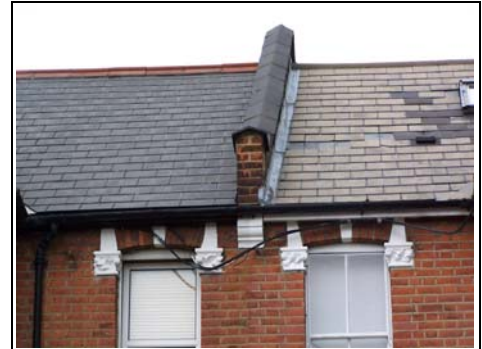
This parapet wall is brick built with a brick finish on your side, although it does look to need some repointing. It is capped with a coping stone to stop water from getting in at the top.

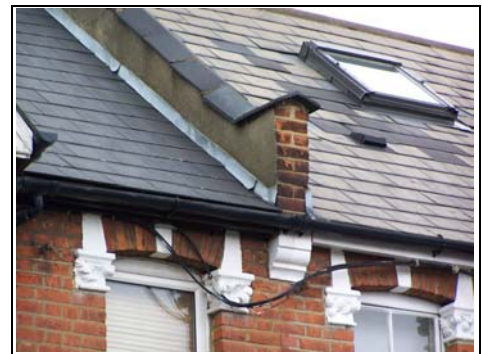
We noted that on your neighbour's side the wall had been rendered, indicating that dampness may be getting in. This will affect the upstairs property first of all, but we are sure you will have a shared cost. Unfortunately as we were unable to gain access to the upper floors we cannot comment further on whether dampness is getting in.

Here you can see the render work on your neighbour's property side

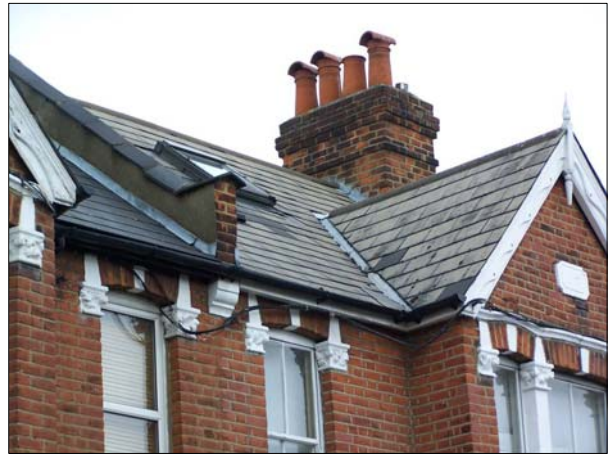
The roof is pitched and clad with what we believe to be a manmade slate, although it is very difficult to tell from ground level. There are indications that it may be a newer slate, such as the vent that we mentioned earlier and the fact that there looks to have been a loft conversion, as roofers rarely put back on the original slate if they can get away with putting on manmade slates (as these are cheaper and they can also then sell the original slates on; or are we becoming very cynical in our old age, or watching too many 'Rogue Traders' type of programmes on the television!)

There does look to be one or two slates displaced around the valley gutter areas, which do need repositioning before winter. This is normally a shared cost.

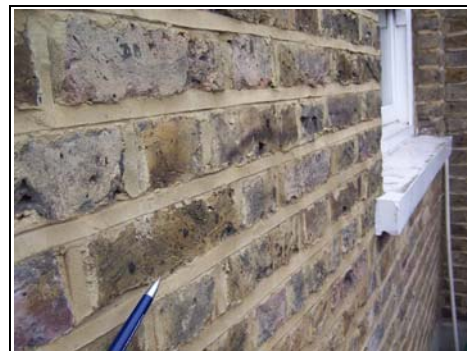
The property is brick built in a Flemish bond construction using a soft red brick to the front and a London stock yellow brick to the rear. Originally the property was pointed in a lime mortar, which has been repointed in a cement mortar. Please see our comments in the Executive Summary. The damage with regard to the pointing will be evident to the softer red brick to the front of the property.

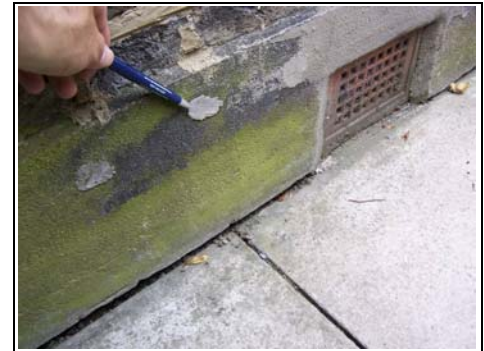
The area where the damp proof course is usually viewed (about 100 to 200mm off the ground) is hidden by a render plinth. In properties of this age it is likely that a basic damp proof course would have been built in originally, such as slate. However, often these fail and then have additional damp proof courses added in at a later date, as would appear to have happened in this case. If you look at this photo you can see we are indicating with a pen that an inserted damp proof course has been put into the property. We would comment that we found minimal dampness throughout.

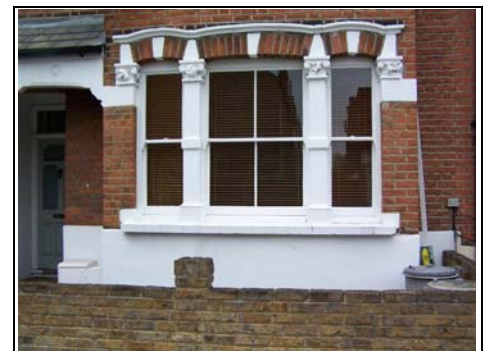
This property predominantly has modern sliding sash windows, which are single glazed and have a painted timber finish and are in reasonable condition. We would specifically comment that we have tested them with a knife and soft rot is minimal.

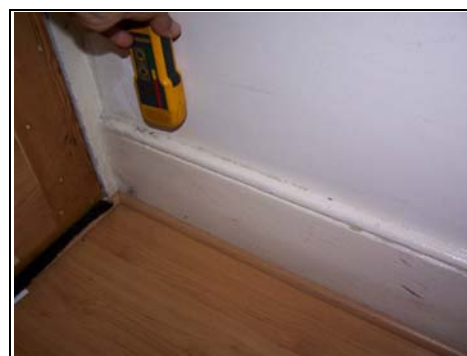
We have carried out tests with an electronic damp meter to a random selection of areas where we would expect damp to be if the property had it and we are pleased to advise that no significant dampness was found.

Testing for Dampness.

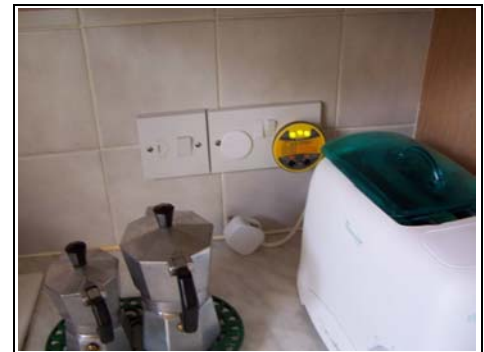
We carried out an earth test in the kitchen area to the socket point that is normally used for the kettle, this proved satisfactory.

**ACTION REQUIRED:** Please see our comments in the Executive Summary where we recommend the fuseboard is updated and a full test of the electrics is carried out, unless recent test certificates are available - less than five years old.

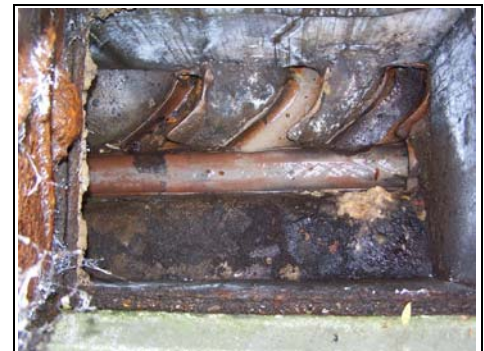
We duly lifted the cover and found it to be free flowing at the time of our inspection.
