RESIDENTIAL BUILDING SURVEY

**A Modern Detached Property, Somersham,
Cambridgeshire**

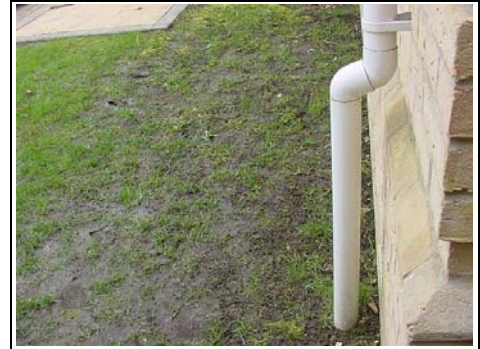
We were concerned about the dampness to the front right hand side of the property and are concerned that this may be a leak to the drain in the area. Whilst we have not carried out a proper drainage test we have seen photos provided by the owner of the original drainage being put in place. We also tipped water down the nearby drain to check that it was carrying on through the manhole and the water did carry through.

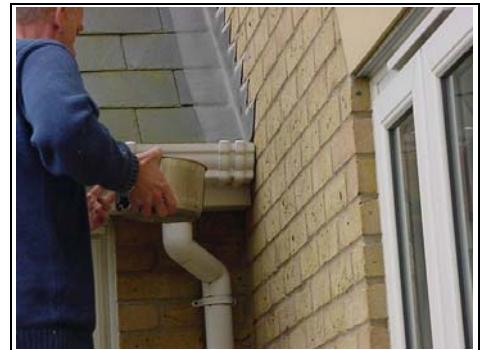
Whilst we cannot be conclusive with our comments we do feel that the dampness is more likely to be a feature of the site than leaking pipework.

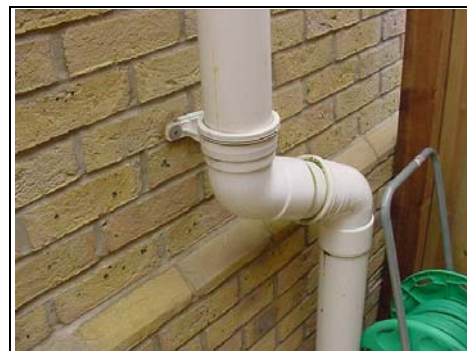
There is a bend in the soil and vent pipe to the right hand side of the property, which is very unusual as, as far as we are aware, the Building Regulations require a straight run to a soil and vent pipe in the waste section. This may lead to slowness of waste water or possibly a blockage.

ACTION REQUIRED: Unfortunately there is very little that can be done without major work being carried out to dig up the mains and put in a straight run. Your Legal Advisor needs to check that the property has been built to Building Regulations, making specific enquiries in relation to the drains, both for the soil and vent pipe and also the rainwater pipe that we mentioned in the item above, where we discussed the damp area to the front of the property.

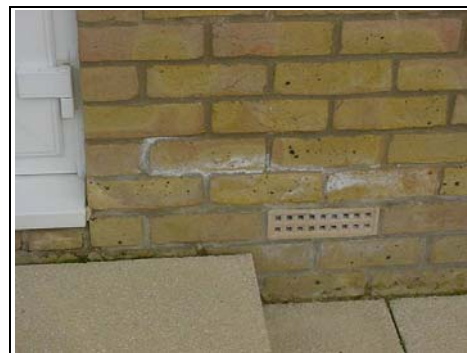
Efflorescence to brickwork often means that the brickwork was built during rain or wet weather, although during our question and answer session, when we asked the owner about this, he advised that this was not the case and that no brickwork laying was carried out during inclement weather.

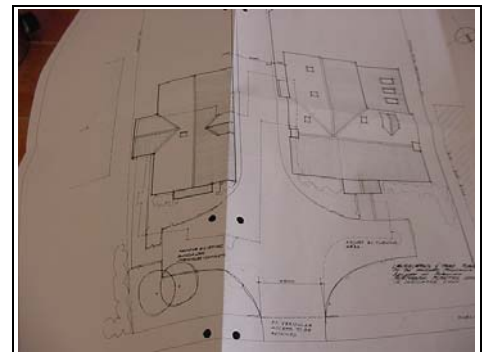
Plan of both houses showing central shared driveway.

ACTION REQUIRED: Your Legal Advisor needs to establish ownership, liability, maintenance and costs in relation to the shared driveway.

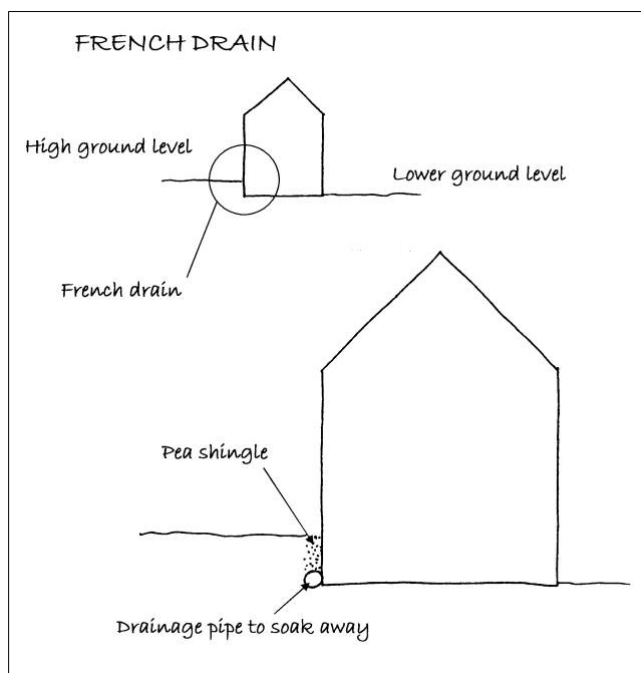
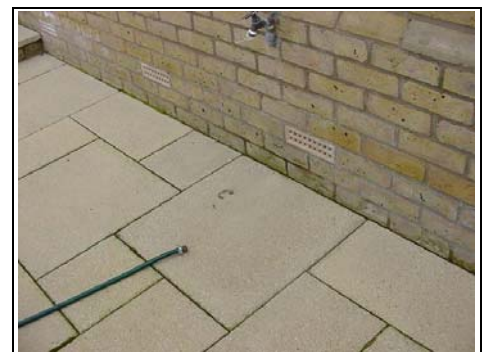
Does the patio fall towards the house or away from the house? It is very difficult for us to tell from a visual inspection. We would comment that there looked to be moss to the base of the wall underneath the kitchen area, which does indicate that possibly it falls towards the wall.

ACTION REQUIRED: We would much prefer to see a French drain detail in this area to keep the water away from the wall.

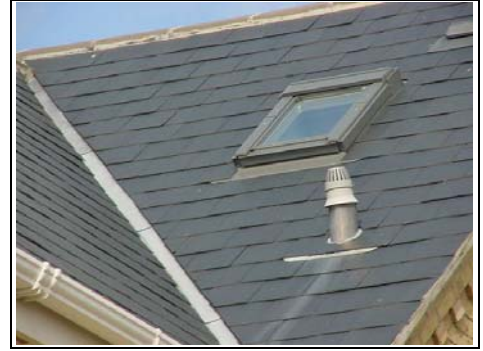
We believe there are four roof windows in total. These are factory manufactured metal roof windows. The weak area around these type of windows is the flashing; where we could see the flashing it looked in good condition.

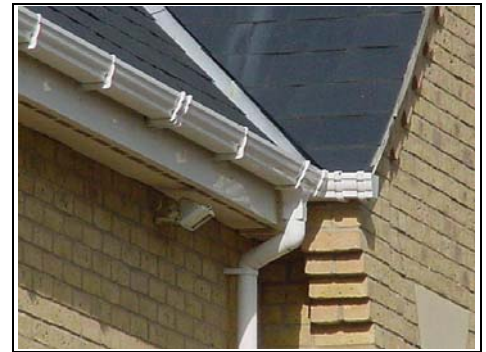
Problems can occur with the valley getting blocked or what is known as 'surcharging', where the amount of water coming down from the roofs into the valley and then into the gutter at the bottom overflows past the gutters.

Bottom of the valley gutter where the water can discharge over the gutters during periods of heavy rain fall.

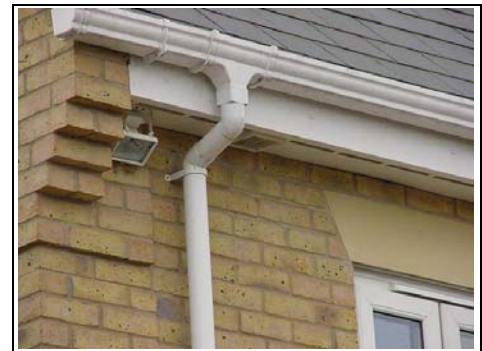
From ground level the gutters and downpipes looked to be what is known as profile plastic, which means they are shaped. The gutters and downpipes are in an 'as new' condition and there were no obvious signs of staining indicating leaks to them.

ACTION REQUIRED: We would always recommend that the gutters and downpipes are cleaned out, the joints are checked and the alignment checked to ensure that the gutters fall towards the downpipes.

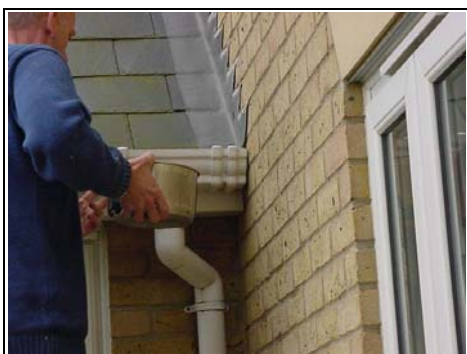
Just to reiterate, we were concerned about the damp patch to the front of the property and we tested as best we could for this. The only way to be 100 percent certain is to put a close circuit TV camera down the drains. Please see our comments in the Executive Summary.

We tipped water down the downpipe

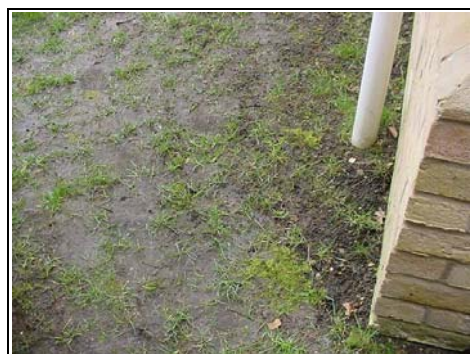
Wet patch of earth

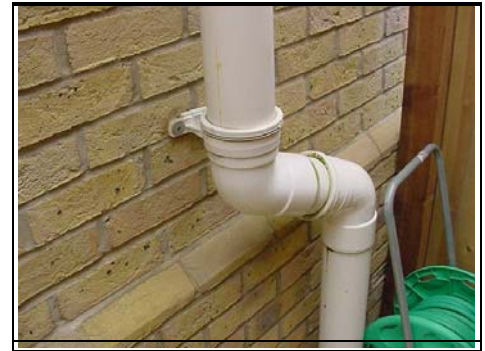
We could see a plastic soil and vent pipe. Generally the waste pipes and soil stack appeared to be satisfactory (apart from the bend in the pipe) where a surface inspection is possible, although for the most part they run in ducts and cannot be inspected.

As far as we are aware the plastic soil and vent pipe should have a straight run for the waste, however the pipe has a bend in it. Please see our comments in the Executive Summary.
