RESIDENTIAL BUILDING SURVEY

Southwark, London

Victorian mid-terraced
property

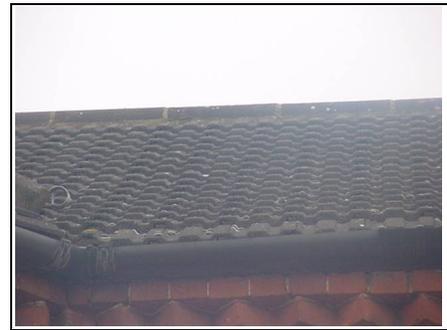
Originally this roof is likely to have been slate covered; it has been replaced with a concrete tile at some point in time (normally the 1970's). We can see that they had difficulty marrying up the thicker concrete tile with the original roof that was made for a slate roof. They look to have missed the tilting fillet at the bottom which may in turn mean that the rainwater misses the gutter.

No tilting fillet

ACTION REQUIRED: Next time it rains you need to stand outside the property and check to see how much rain is actually going into the gutter rather than going down the face of the wall. We can see that the face of the wall is being damaged by rain but this may be due to other factors.

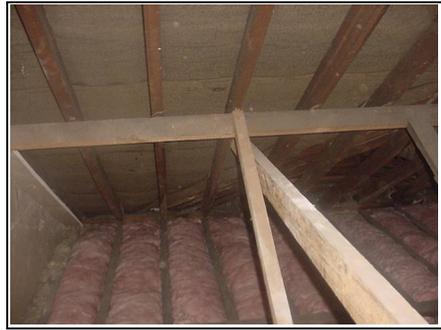
We can see that work has been carried out to the original roof structure with the addition of new timbers. The original slate roof would have been lighter than the modern heavier concrete tile roof which replaced it. We were pleased to see that props have been added to the main roof however there looks to have been some awkward work where the firewall is to the right hand side which has been formed in plasterboard.

New timbers have been added in the main roof

ANTICIPATED COST: We would set aside the sum of £2,000 - £4,000 for a worse case scenario; quotations required.

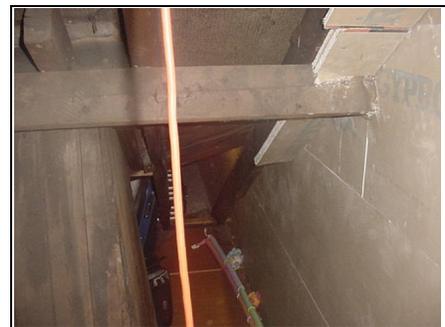
Terrible cutting in to the purlin – recommend adding extra struts where this has occurred.

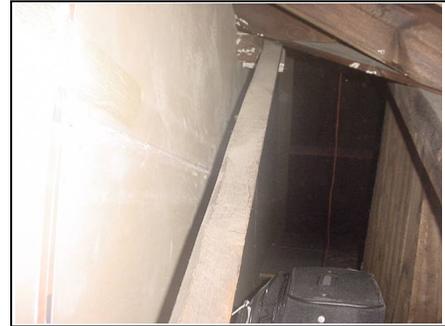
Squeeze through gap to get into main roof

In relation to the above work we would recommend that an additional access to the roof is provided (this is because the existing one is located near the bathroom so you have to squeeze by the lightwell and this isn't the easiest thing to do) particularly if work is being carried out in that roof space.

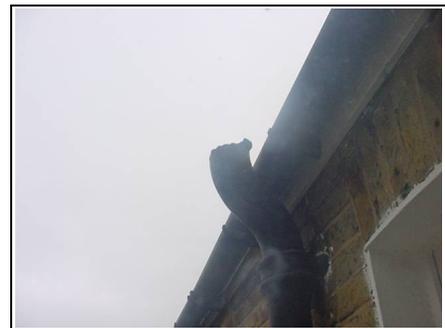
We noted that the soil and vent pipe didn't extend above the roof level, normally it is considered good practice to extend it approximately a metre above the eaves level. It looks like it has broken off which also gives us an indication of the general condition of the soil and vent pipe.

Missing bit of soil and vent pipe – it should be a metre above the roof line

ACTION REQUIRED: We think that work is required to the entirety of the soil and vent pipe using something like a rust stop paint and then an overall redecoration. In a worst case scenario it may be necessary to replace.

ANTICIPATED COST: Set aside the sum of a £100 - £200 to repair and redecorate; quotations required.

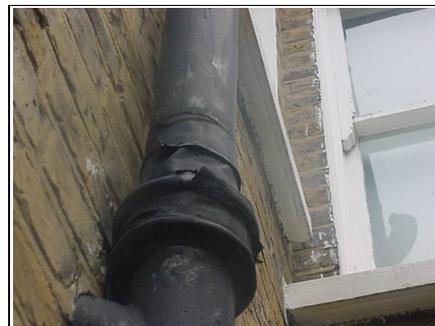
Low down it has had a bandage repair

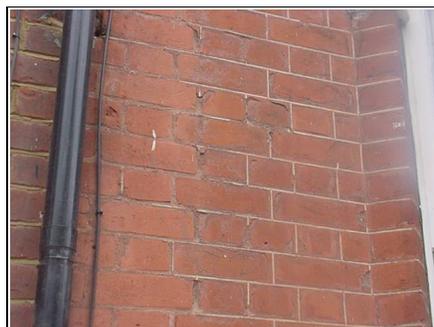
Spalling to the brickwork being caused by leaking gutters

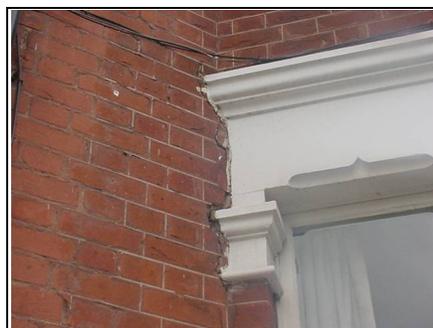
We can see there has been some movement to the front bay. This is not that unusual in this age, type and style of property as the bay area typically doesn't have any foundations or very little and therefore moves. We believe from the movement seen this has moved within acceptable parameters for this property.

Movement to bay

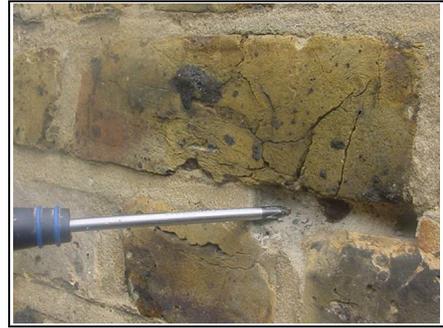
Ad hoc repointing is required to the walls. To the rear the property has been repointed in a cement mortar which in our opinion needs to be removed gradually over the years and replaced with a lime based mortar which will help with the general movement of the characteristics of this building. We would add that cement pointing stops the building from breathing and causes dampness so the gradual removal will generally improve the condition of the property.

Original lime pointing which has been pointed over with cement

ANTICIPATED COST: We would recommend that this is carried out over many years where you spend £100 - £200 every year on having the cement mortar removed and repointed; quotations required.

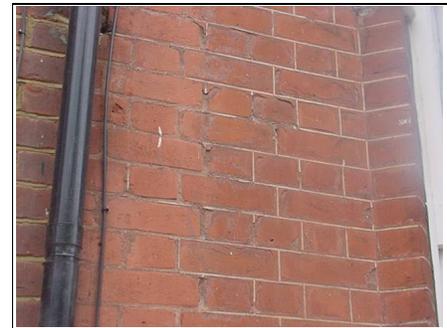
To the front of the property there is tuck pointing. This is a relatively skilled operation putting a white line into the joints. Originally it was used on poorer quality brickwork so you do need to ensure that you get a skilled bricklayer to carry this out.

Tucked pointing

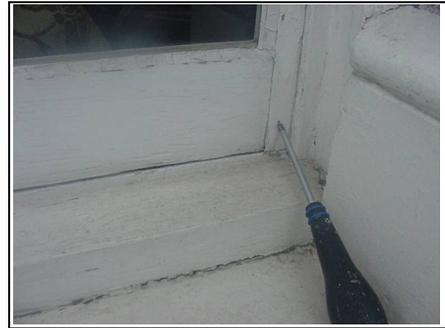
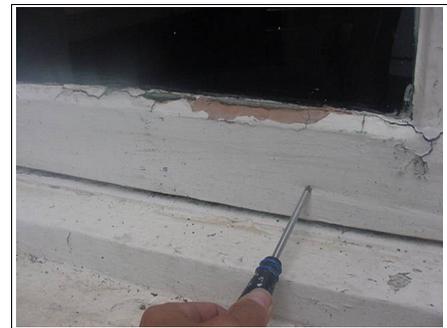
The timber sliding sash windows have started to deteriorate and are in need of repair via redecoration. On the ground floor window that we could see, there wasn't any need for major work however often we find that the most work is required to the upper windows as these are not regularly seen and are more difficult to get to.

Windows in need of repair

ACTION REQUIRED:
Repair/redecorate ideally this summer.

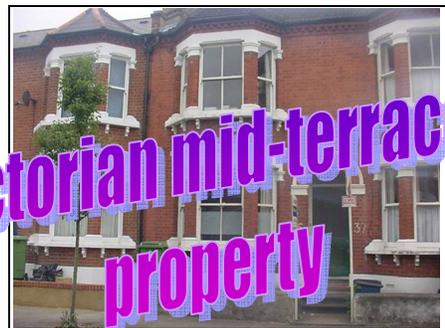
There are trees to the front and the rear of the property. The front tree looks to have been replaced, this often occurs with Local Authority trees in our experience where they think it is in danger of causing damage however equally we have found that problems can occur where a large tree is taken out and then the roots no longer take the water out of the area so movement takes place. This may be why there has been some damage to nearby front walls and possibly in addition could be the reason why your bay window has moved.

Tree to front

ACTION REQUIRED: We would recommend an arboriculturist comes to have a look at the trees (not a tree surgeon) and that you lift the decking to see what is occurring beneath it.

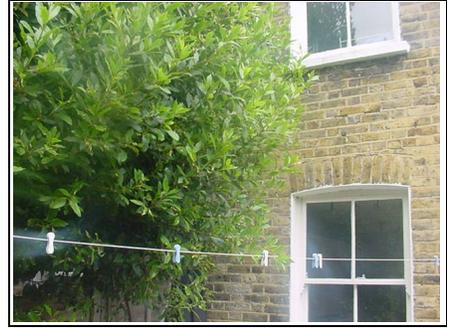
To the rear there is a larger tree which we would recommend that you have a chat with your neighbour about. The roots will certainly be affecting the property. Our view unfortunately has been limited by the decking but we would add that this decking undulates and doesn't sit level and true.

Tree to rear

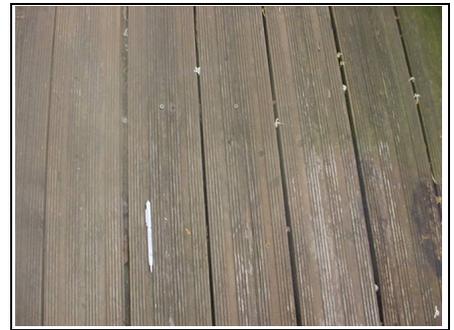
We have already spoken about the timber decking and how it may be hiding problems with regards to the tree. We would add that the timber decking is not level, it could be poor workmanship or the tree is damaging it or old age as we are now tending to find problems with decking; we have found mice, etc living underneath them.

Timber decking

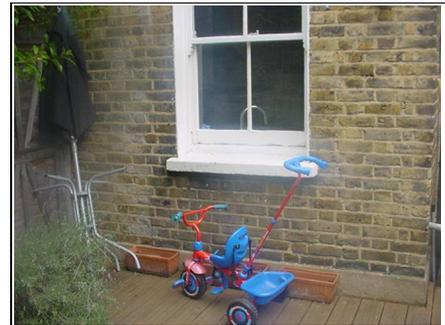
We would add that the decking may be contributing to dampness getting into the property as it abuts the building. We always recommend that there is an air gap left between decking and the building.

Decking abuts building

ACTION REQUIRED: Add an air gap.

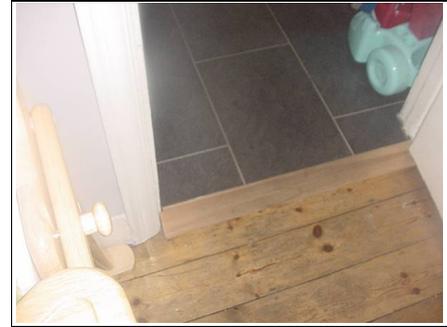
Are tiles on a timber decking or a cement decking – it is difficult to tell

ACTION REQUIRED: We would ideally recommend you take up a section of the floor to check what is happening underneath as this is an unusual floor construction.

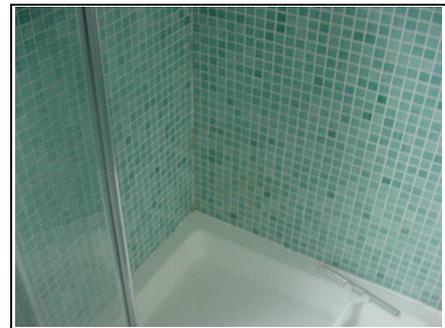
We can see some paint flaking above the shower unit in the rear bathroom (which unfortunately is not visible in the photo we took); we think there will also be some mould to the shower. We believe that the problem relates to excessive humidity/lack of extraction in the area.

Condensation and mould to shower

ACTION REQUIRED: We would recommend that an extract fan is put in with a controlled humidity thermostat.

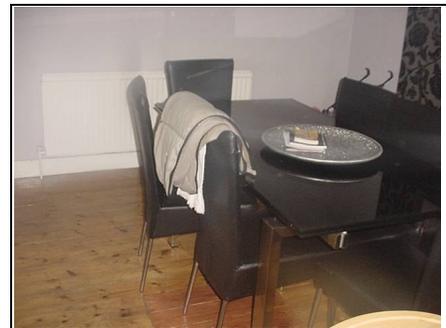
We have also noted that some of the radiators are internal and ideally should be under the windows.

Internal radiator to the dining room

ACTION REQUIRED: We would recommend that the system is drained down, the radiators repositioned and a service carried out on the unit and an approximate guess given by the heating engineer as to how much longer the boiler has got. Do remember that some plumbers are more salesmen than plumbers (luckily still most are not).

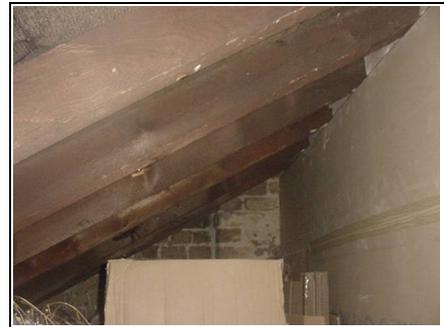
This is probably the most difficult chimney to view. We can see as much inside the roof as we could see outside. There looks to be some dampness.

Rear chimney viewed within the roof

ACTION REQUIRED: We would recommend a close up view by long ladders by the end of the summer.

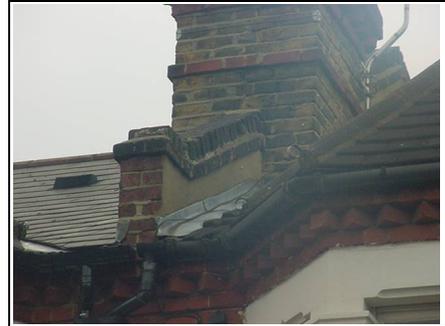
The parapet wall is built in a soft red brick which has got a brick coping stone and has been rendered to the side with a lead flashing. This to us indicates that there have been problems with dampness getting through.

Close up of parapet wall

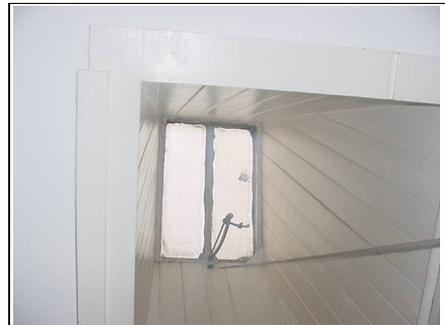
In this case it has what looks like the original roof window made from metal which means it is like to have deteriorated over the years as they are difficult to access to maintain.

Roof window to lightwell

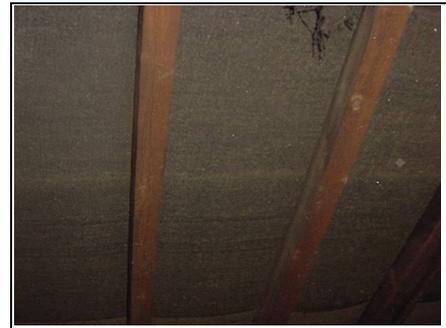
When we inspected the loft space we found a Hessian base Bitumen membrane. This type of membrane has been used since the 1960s. We generally found it to be in average condition, it's damaged in a few more places than we normally find.

Sarking felt

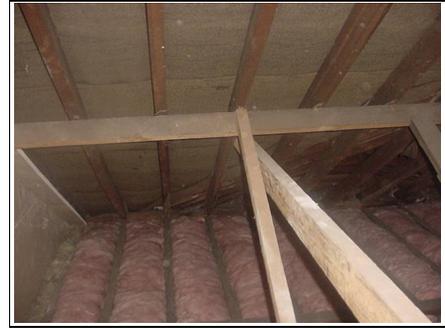
New timbers have been added in main roof

Our examination was limited by the general configuration of the roof, the insulation and stored items. What we could see was found to be in generally average condition, the pitch is shallow which tend to get condensation.

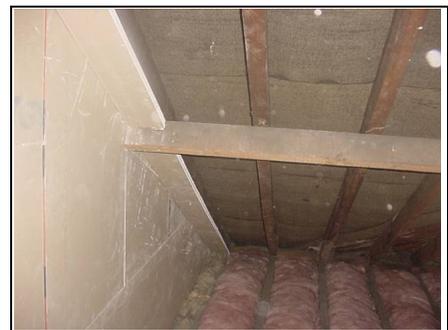
The property has a plasterboard firewall dividing it from the adjoining property; this should have a half hour fire resistance, which requires two layers of plasterboard, which is not possible to tell without opening up.

Plasterboard firewall to right hand side

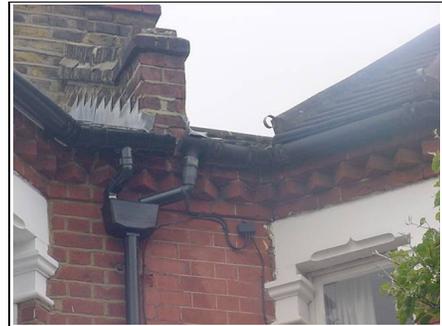
From ground level the gutters and downpipes looked to be plastic and appeared to be a mixture of different ages of plastic and are in average condition. There are a few repairs.

Much of the plastic gutters and downpipes are the older style which is affected by sun light and loses its colour slightly and does become brittle over the years.

Gutters, downpipes and hopper head

We would always recommend that the gutters and downpipes are cleaned out, the joints are checked and the alignment checked to ensure that the gutters fall towards the downpipes.

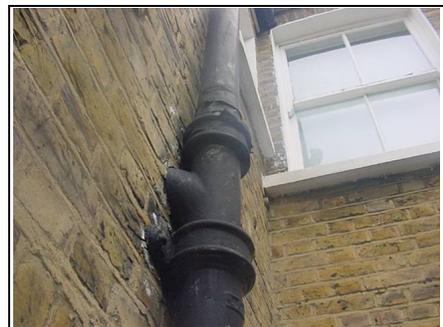
There is a cast iron soil and vent pipe that has been repaired and is broken at the top. Please see our comments in the Executive Summary.

Soil and vent pipe repaired and in need of work

ACTION REQUIRED: Please see our comments within the Executive Summary

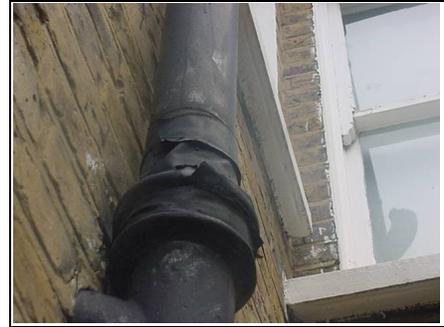
Close up of repair to soil and vent pipe

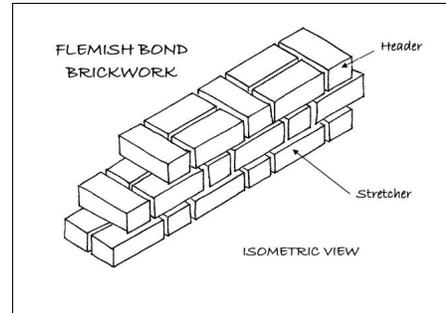
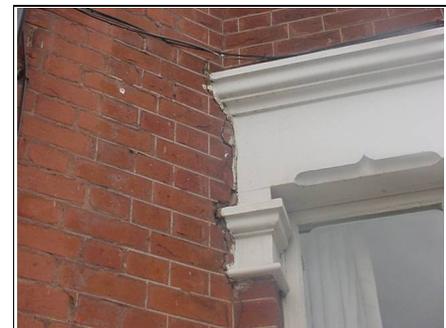
Spalling to brickwork

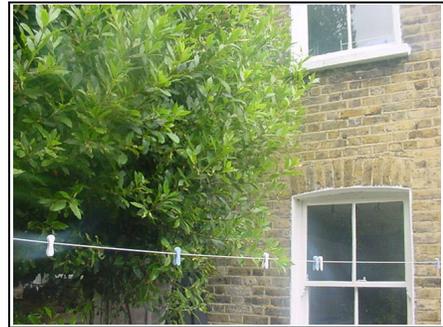
Bush in back garden needs cup of tea meeting with next door as it is taking up a lot of garden

Please see our comments within the Executive Summary and have a discussion with your next door neighbour over a cup of tea!

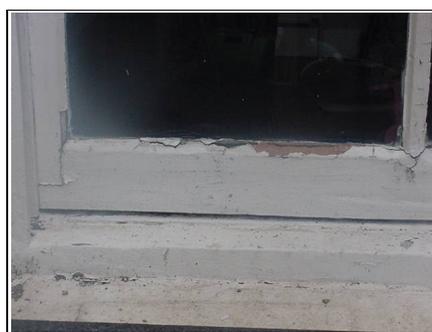
The property has single glazed timber sliding sash windows which are in need of repair, in below average condition but saveable. Please see our comments in the Executive Summary. The sooner they are redecorated the better.

Windows in need of repair

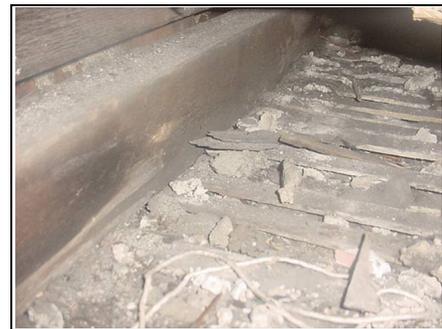
Lath and plaster ceiling deteriorating – viewed from the loft space

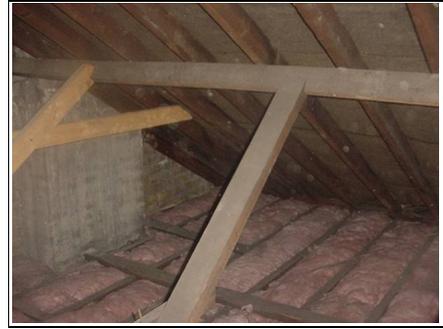
Within the property a visual inspection was carried out and tests were taken with an electronic conductivity meter at selected points to walls. No significant penetrating/lateral dampness was seen or detected considering the properties age, type and style. However within the roof we believe there is some dampness coming in. Please see the adjoining photo.

Dampness getting in via parapet wall to left hand side

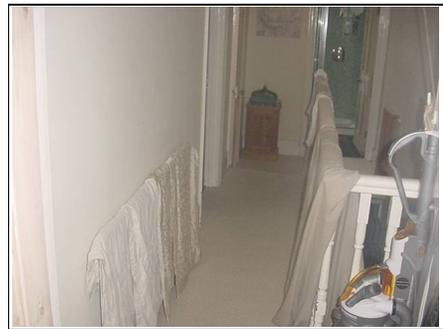
Internal radiators drying clothes – condensation likely

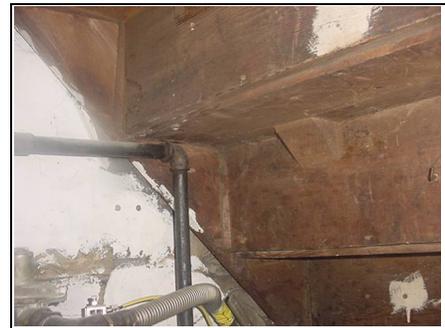
Underside of stairs not lined

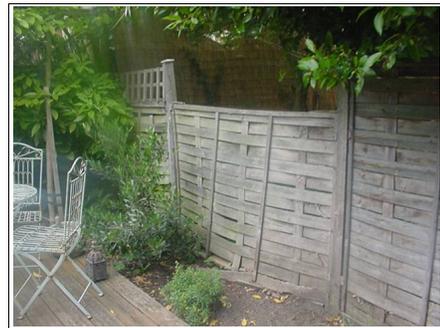
Garden fence is in need of straightening up and general repair
