# RESIDENTIAL BUILDING SURVEY

Southwark,  
SE22

**INDEPENDENT CHARTERED SURVEYORS**

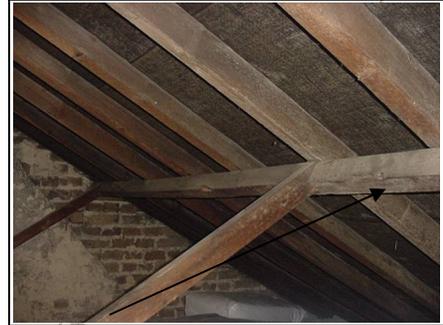
The timbers in the roof particularly the purlins are not the size we would expect. We rarely come across such small supporting timbers in a Victorian property. We would recommend support although you did mention that you are looking at a loft conversion.

Thinner than expected purlins  
(horizontal timbers)

**ACTION REQUIRED:** If you decide not to carry out your loft conversion then we would recommend additional strengthening work is carried out in the roof.

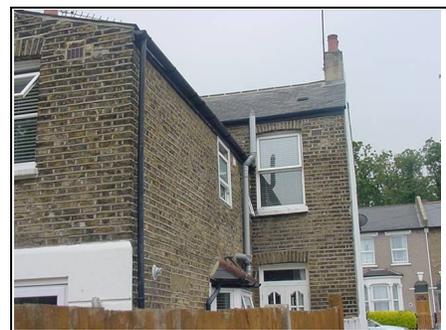
We can see that the left hand side wall (all directions given as you face the front of the property) is bowing which is probably due to joist ends rotting. Many properties of this age have similar problems and have been tied back in place using tie bars. Some have had more recent invisible tying back to the structure; we can see neither in

Bowing wall

this particular case. We can comment that the brickwork and the proud pointing doesn't look to have had any recent movement.

**ACTION REQUIRED:** As it is always better to be safe than sorry we would recommend opening up the first floor to check the joist ends against the wall and tie them back if necessary.

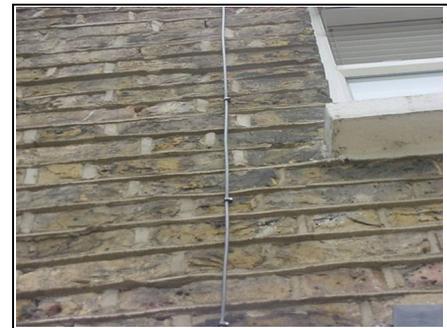
Proud pointing

**ACTION REQUIRED:** Ideally we would recommend that the cement pointing is removed over many years using a soft brush and repointed in an appropriate lime mortar.

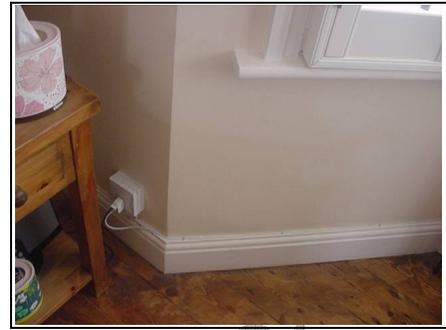
We found rising damp particularly to the reception room and it may well be in the kitchen as well, hidden by the kitchen cabinets.

Rising damp

**ANTICIPATED COST:** In the region of £1,000 - £3,000; quotations required.

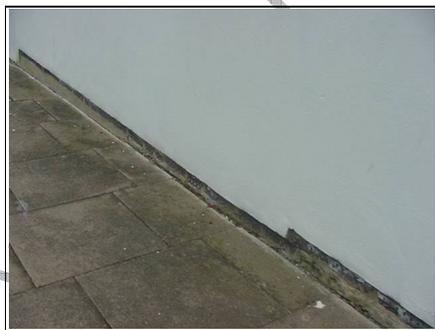
Base of rendered wall

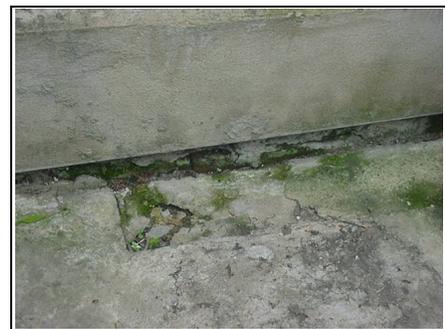
Signs of water sitting at the base of the property

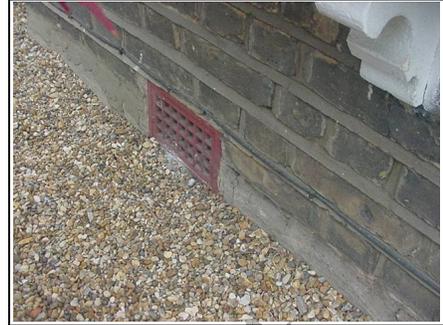
The airbricks are acting as gutters whenever it rains and this means it is very damp under the floor which we feel contributes towards the cupping of the timber and the general soft feel of the timber. Unfortunately this makes it ideal for woodworm and wet rot and general deterioration.

Airbricks acting as gutters

**ACTION REQUIRED:** We would recommend a section of the floor is lifted ideally before you proceed with the purchase to check the condition underneath and that there is no woodworm present or wet rot. We would be more than happy to comment on any photos taken.

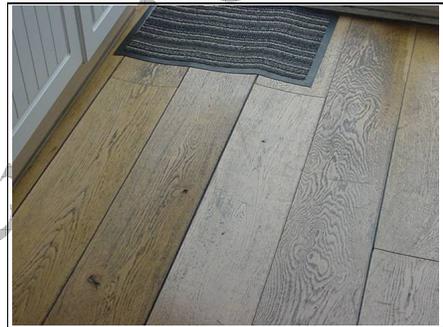
Cupping of timber floor in kitchen

**ANTICIPATED COST:** To repair the woodworm or wet rot can range from a few hundred pounds to many thousands of pounds depending upon the extent of the problem; quotations required.

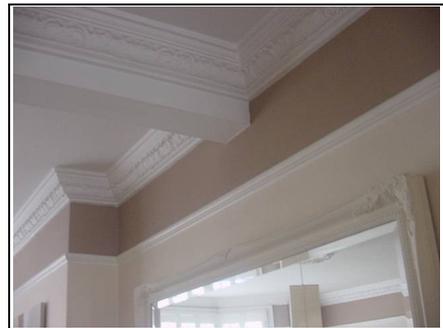
We can see due to a lack of pier support that the wall that has been removed has either not been removed to Building Regulations or was removed before Building Regulations generally came into force nationally in 1948; although having said that there were Building Acts in London for many years.

Wall that has been removed in front lounge without pier support

**ACTION REQUIRED:** We would comment that it has stood the test of time. The area was decorated as new so it may well be hiding latent defects. If cracking does occur then a pier will need to be put in.

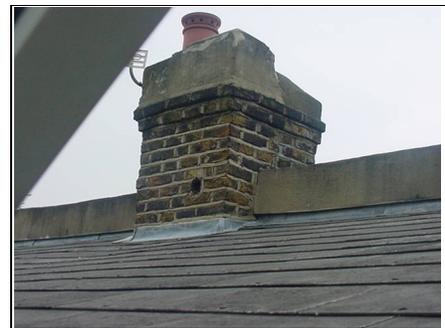
This chimney is brick finished with a rendered top and a lead flashing. We would prefer to see the lead flashing bedded in Plumbers Mate or a similar mastic. We do find that cement does become brittle over time and come out.

Rear chimney

**ACTION REQUIRED:** You need to periodically check the chimneys to ensure that the flashings have not come loose.

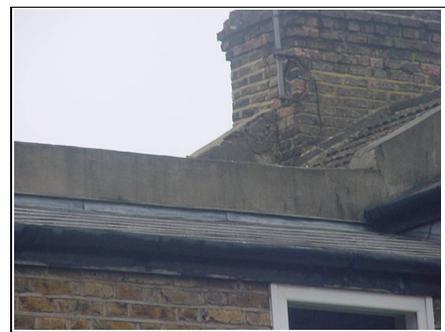
There is a front and rear parapet wall, both are rendered. We were pleased to see a coping stone to the front parapet wall and we would prefer to see one to the rear as we find that without them that water sooner or later gets into the property. Unfortunately we were not able to view the rear roof.

Rear parapet wall

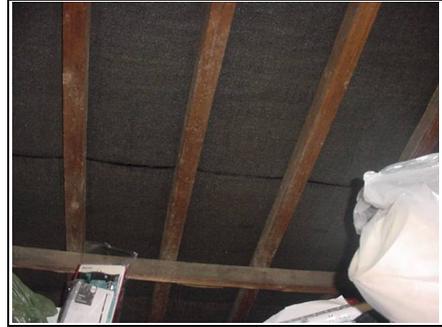
When we inspected the loft space we found a Hessian base Bitumen membrane. This type of membrane has been used since the 1940s. We generally found it to be in average condition, it's damaged in a few more places than we normally find.

Protective membrane

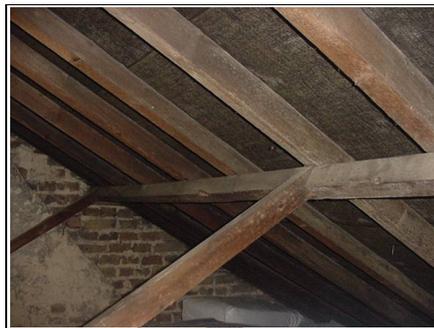
Thinner than expected purlins  
(horizontal timbers)

Where we could see, we found the supporting purlin timbers to be thinner than we would expect although they are supported with struts and it could be argued they have survived the test of time but do need to be checked from time to time. Our examination is usually limited by the general configuration of the roof, the insulation and stored items.

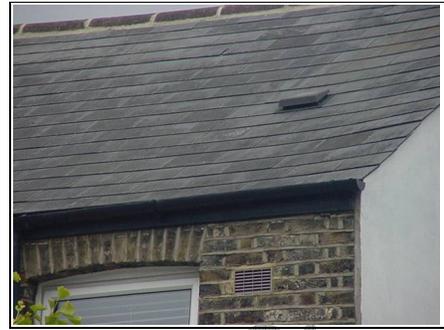
External air vent

**ACTION REQUIRED:** We would recommend that the air vents are checked and/or proper air vents are added.

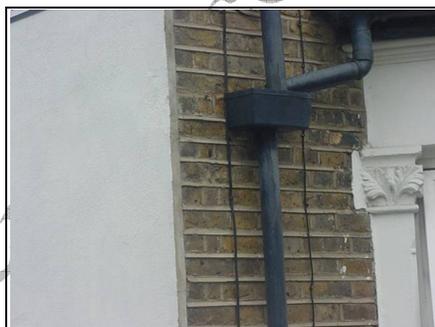
From ground level the gutters and downpipes looked to be plastic and appeared in average condition. There are a few repairs which we feel that most people could live with.

The plastic used is the older style which is affected by sunlight and loses its colour slightly and does become brittle over the years.

Plastic gutters and downpipes

**ACTION REQUIRED:** We would always recommend that the gutters and downpipes are cleaned out, the joints are checked and the alignment checked to ensure that the gutters fall towards the downpipes.

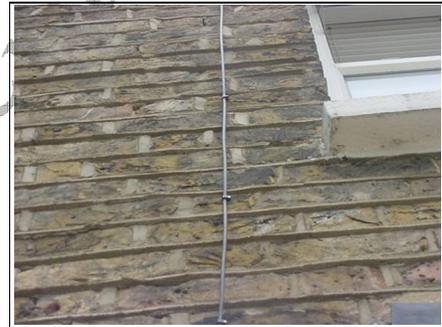
The property is brick built in a London stock brick originally in a lime mortar in what's known as Flemish bond brickwork, which has been poorly repointed in a cement mortar in what we would term as proud pointing (please see the sketches and diagrams in the Executive Summary).

Proud pointing

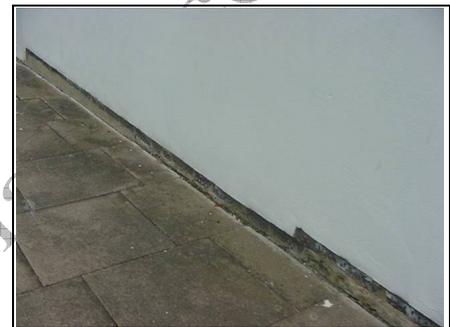
A good indication of the quality of rendering, we have found over the years, is by the quality of detailing above the windows and to the base of the property. The detailing on this property has been carried out to a poor standard. Good detailing would have had drips to appropriate areas and a bell mouth to the base of the property.

Side render that needs bell mouth

**ANTICIPATED COST:** In the region of £1,000 - £3,000; quotations required

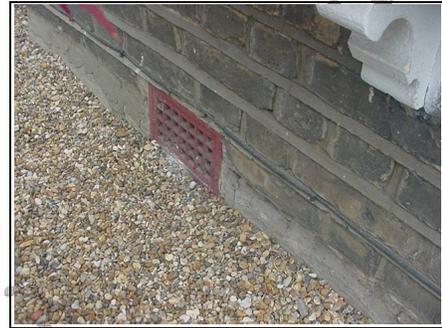
Airbricks too low

**ACTION REQUIRED:** We would recommend bricks are bedded around the airbricks to stop rainwater getting into them.

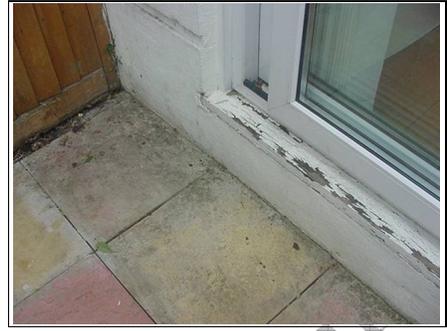
Timber deterioration around rear doors

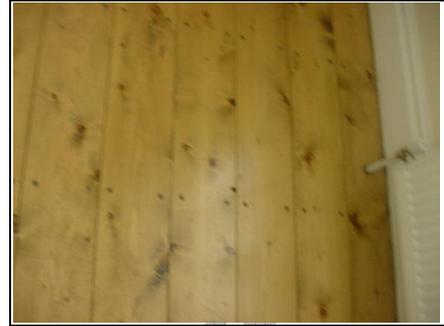
Again the floorboards are visible in some areas indicating that the joists run from the front to the rear of the property which is why the left hand gable wall has bowed as there is no tying in with rafter feet. This is why it is important to open up this area to check what has happened.

We can see that floorboards have been taken up in very consistent screw fixing points

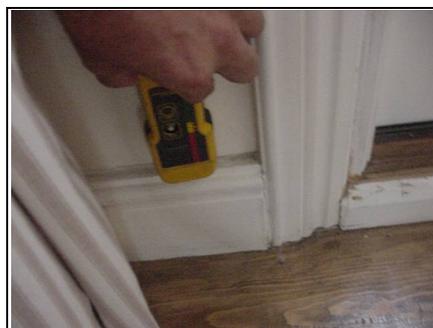
The readings we obtained indicated that there is dampness in the property. This is likely to be due to the reasons we have stated in the Executive Summary.

Checking for rising damp
