RESIDENTIAL BUILDING SURVEY

A 1960's Detached Property, St Albans, Hertfordshire, AL3

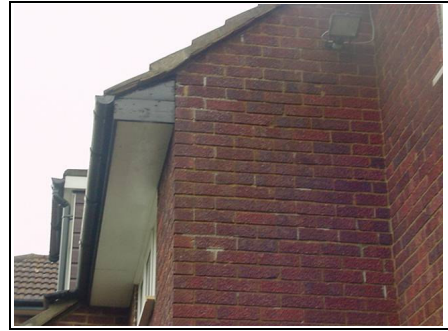
Asbestos was commonly used in this age of property. We believe that the soffits are asbestos and there may also be other elements of asbestos in the property.

ACTION REQUIRED: Use a specialist company to carry out an inspection identifying the type and condition of the asbestos – we are not asbestos surveyors.

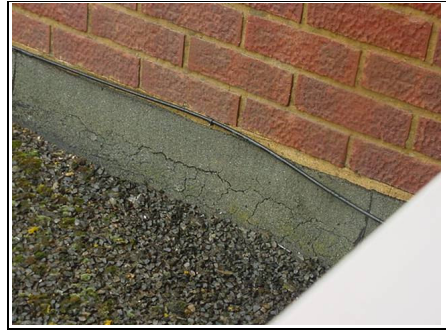
The roof over the entrance porch we could see had moss sitting on it indicating that it is flat rather than having a fall of approximately twelve degrees. Water sitting on a roof will reduce its life span. We anticipate that the flat roof over the porch roof will have five more years of life particularly the flashing detail that is in felt which you can see is starting to crack; this may even go sooner.

Flat roof to front of property showing signs of deterioration

ACTION REQUIRED: Budget to replace within the next five years. We recommend using a high performance felt and you must ensure there are 'falls' on these roofs. A good way to do this is to add an insulation cut to fall and then finish with a high performance felt.

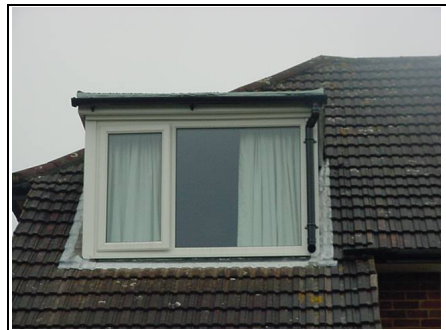
We can only assume that the dormer roof is of a similar age and will also require re-felting in five years (we have checked it inside the property using our electronic damp meter to the walls where they meet the roof and found no dampness in these areas).

Dormer roof with flat roof above

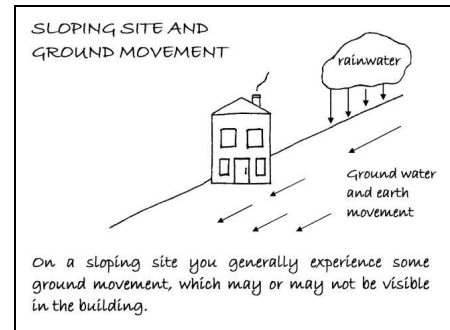
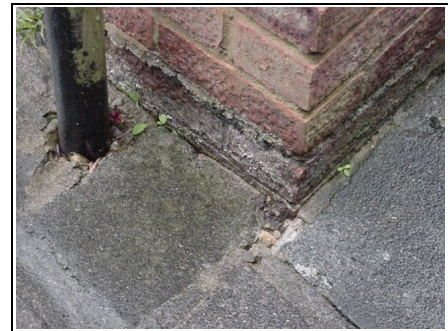
We noted that the damp proof course to the rear of the property was slightly low on the rear left hand side (it should have two courses of brickwork between the ground level and the damp proof course and it only had one). This was causing some spalling to the brickwork.

Damp proof course is slightly low to the rear right hand corner of the property.

ACTION REQUIRED: We recommend that you have a look the next time there is a heavy downpour of rain just to see how the rainwater passes from the rear of the property to the front to see if there is any obvious signs where it can/is causing damage and deterioration and then take appropriate action.

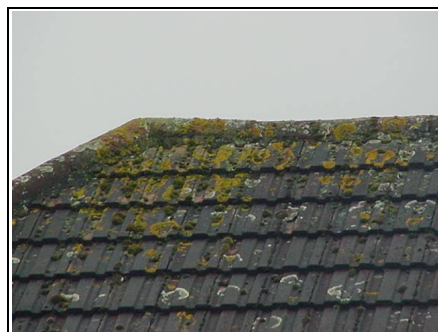
We could see moss on the concrete tiles; this can cause problems with damage to the tile surfaces and/or block gutters.

ACTION REQUIRED: Once moss has built up we would recommend that it is cleared.

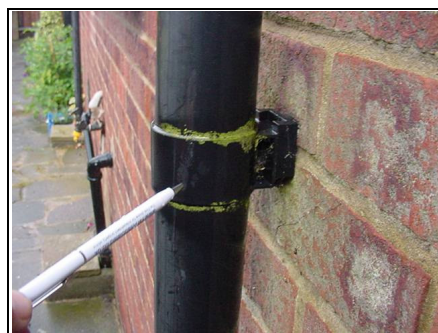
The adjoining photo shows a downpipe with green moss coming out of the joints which indicates that it may have been blocked; it is a back up which is notoriously difficult to clean. This needs to be checked when it next rains.

ACTION REQUIRED: We would always recommend that the gutters and downpipes are cleaned out, the joints are checked and the alignment checked to ensure that the gutters fall towards the downpipes.

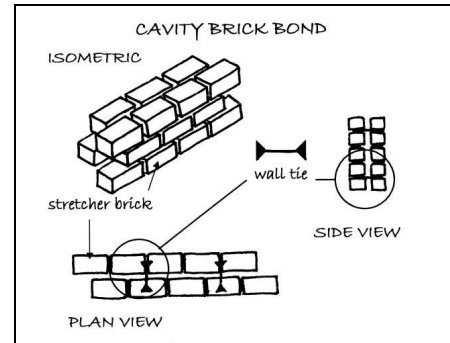
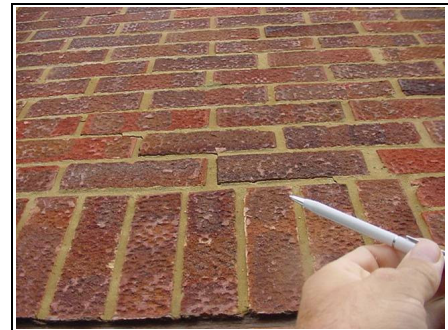
The brickwork needs some repointing with a suitable mortar, which will reduce the likelihood of any dampness getting into the structure. We generally found the brickwork and pointing in average condition considering the properties age and type.

ACTION REQUIRED: Repoint in a like for like mortar

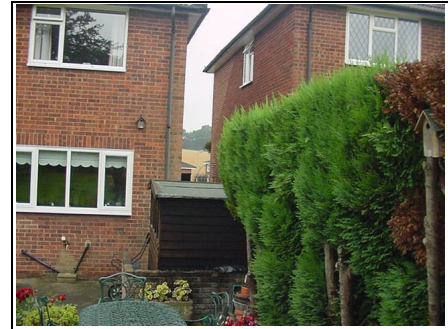
You have a few conifers surrounding the property it should be remembered that trees in general need regular maintenance. The conifers can grow very quickly.

ACTION REQUIRED: Ensure trees are regularly maintained. Please see our comments in the Executive Summary.

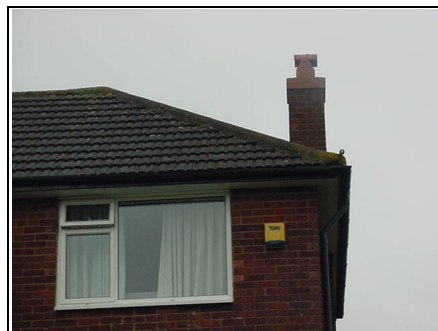
The property has painted timber fascia boards and probably asbestos soffits; these are in average condition, (which means there is likely to be some rot) although much of the fascia is hidden by the guttering.

ACTION REQUIRED: Please see our comments on asbestos in the Executive Summary and the Other Matters Section of this Report.

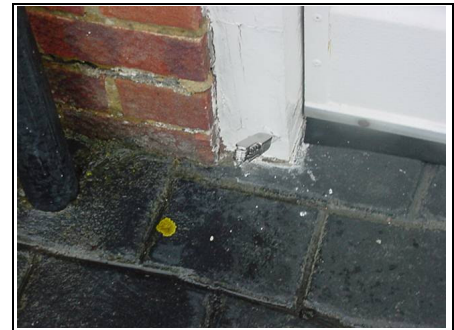
We can see to the base of the garage door that new timbers have been cut and spliced in. The new timber is not in particularly good condition and we would imagine you would have to do this again within the next five years.

Base of garage door has been previously replaced.

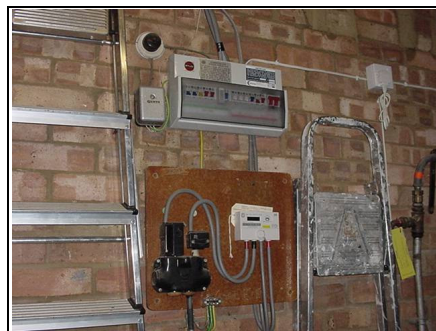
The electric fuses and consumer units were located in the garage. We would date the fuse board as being from the 1980/1990s (although the owner was adamant it was newer).

ACTION REQUIRED: As the property is changing occupancy an IEE report should be carried out by a NICEIC registered and approved electrical contractor.
