RESIDENTIAL BUILDING SURVEY

Great Ashby, Stevenage, SG1

GEM Associates Limited
INDEPENDENT CHARTERED SURVEYORS

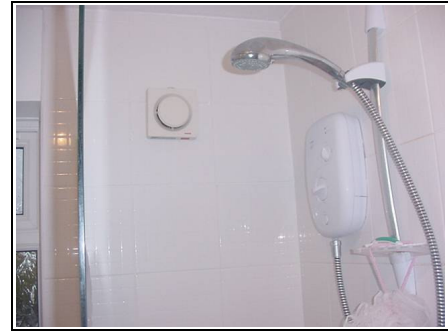
We noticed some mould growth in the bathroom. We were unable to get the extract fan to work (nor was the owners although they did say that it had been working earlier in the week). We also noted the original timber windows had been replaced with plastic double glazed.

This can add to condensation if the windows are not open and in addition to this the present owners have two young children and this lifestyle tends to create above average levels of moisture with higher heating levels and lots of baths and washing.

Extract fan that wasn't working

ACTION REQUIRED: The fan that is connected to the light is in working order but should also over-run after the light has been switched off to allow a full air change of the moist air in the bathroom. Generally open the windows more and air the property.

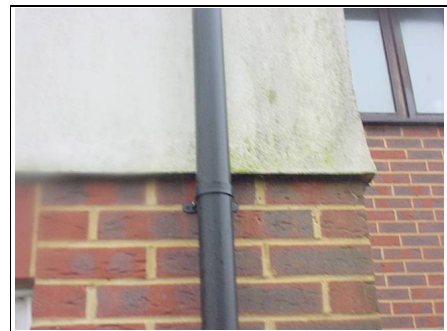
2) Mould to the render

The render was starting to get mouldy indicating that the paint surfaces are no longer offering a protective layer.

Moss to the render

ACTION REQUIRED: Redecorate in the summer of 2010

ANTICIPATED COST: In the region of £1,500 - £2,500 as access scaffolding may be required; quotations required.

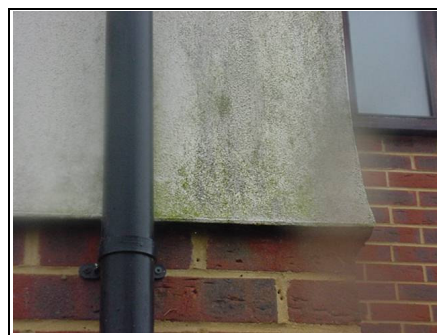
Close up of moss to render

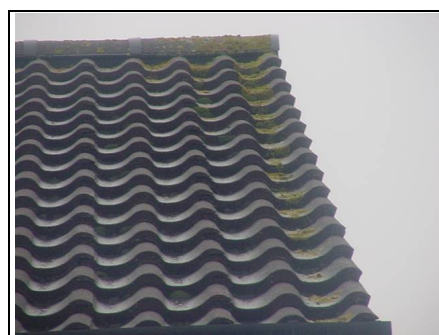
Roof tiles

The roof is pitched and clad in a concrete tile. From what we could see the concrete tiles are lying level and true and look in reasonable condition. Sometimes we find that deterioration occurs to the ridge and exposed areas such as the perimeter and so you should periodically check these areas, there is some moss present.

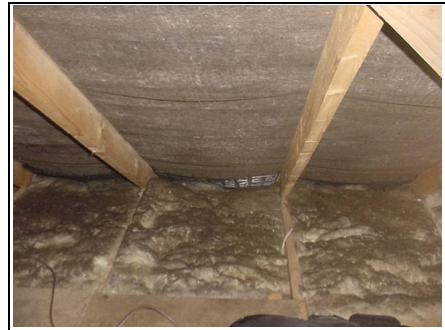
Hessian underlayer

When we inspected the loft space we found a Hessian base Bitumen membrane. This type of membrane has been used since the 1960s. We generally found it to be in average condition, it is damaged in a few more places than we normally find.

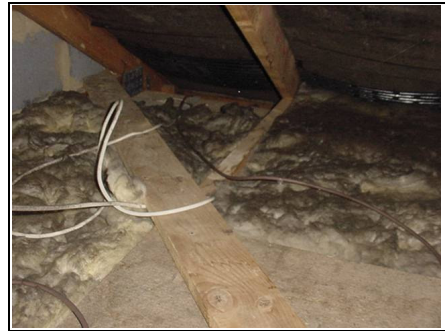
We were slightly puzzled about the dark areas of insulation that we noted. It is as if it parts of the felt are deteriorating and falling onto the insulation. This may be being caused by condensation. It is very difficult to know without analysing what is on the insulation as we haven't come across this previously.

Darkness to insulation

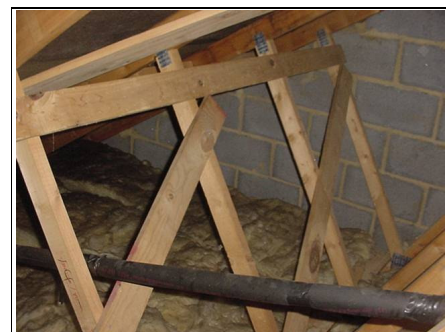
We found the roof timbers generally in average condition considering their age. We have inspected the roof structure for:

General view of the roof

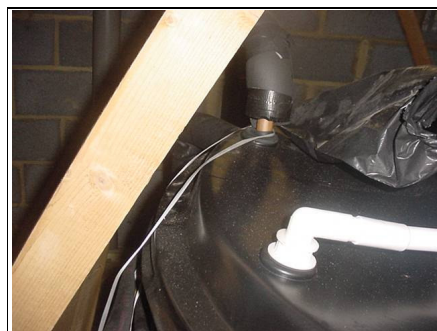
Water tank

The water tanks are insulated and, from what we could see, they looked to be formed in plastic. Care has to be taken with roofs and water tanks to allow some warm air so that they don't freeze.

We would always recommend that water tanks be drained down and cleared of any debris etc. (we have seen dead birds and other unmentionable things in these tanks).

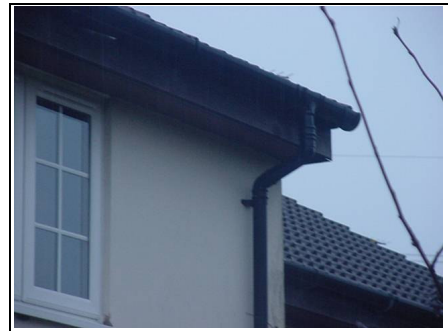
From ground level the gutters and downpipes looked to be plastic and appeared in reasonable condition. They may need a few repairs, but we feel that most people would be happy with getting these carried out.

ACTION REQUIRED: We would always recommend that the gutters and downpipes are cleaned out, the joints are checked and the alignment checked to ensure that the gutters fall towards the downpipes.

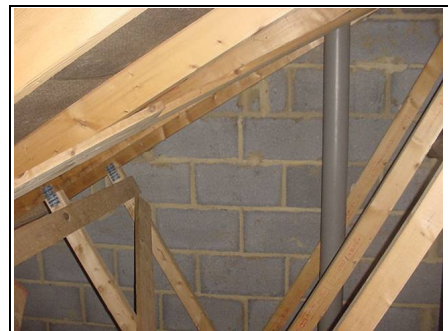
Soil and vent pipe in the loft

The property has a plastic internal soil and vent pipe. Generally the waste pipes and soil stack appear to be satisfactory where a surface inspection is possible, although for the most part they run in ducts and cannot be inspected apart from at roof level.

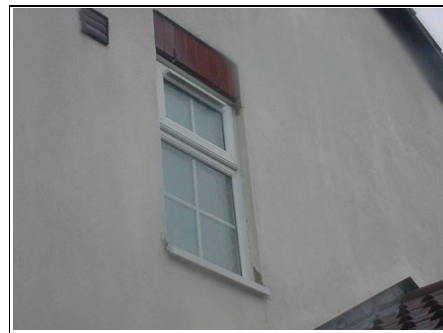
Render

Please see our comments in the Executive Summary about the mould to the render.

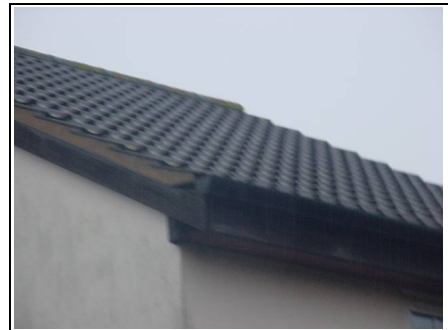
The property has stained timber fascias /soffits / bargeboards; these are in slightly below average condition. We do find in modern properties that the quality of timber used is not very good and tends to deteriorate quickly unless regularly maintained.

Fascias in slightly below average condition

ACTION REQUIRED: Redecorate in the summer of 2010.

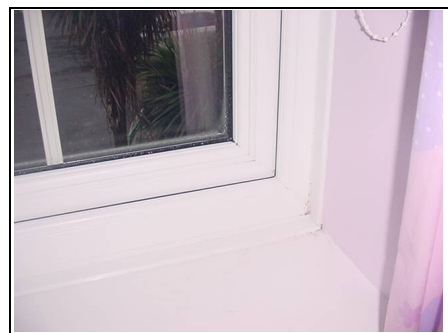
Close up of window

We would draw your attention to the fact that sealed double glazed units can fail, particularly as a result of poor workmanship during installation. Failure of the seal leads to condensation between the two panes of glass and simply replacing the affected units may not provide a satisfactory long-term solution. In this case they are in average condition.

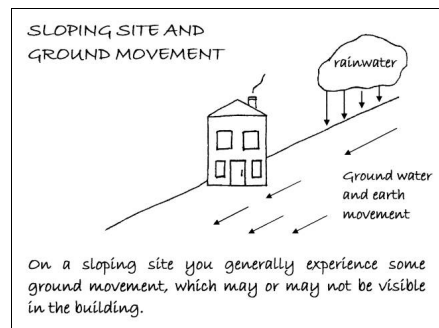
Any property on a sloping site albeit slight as this case, is more susceptible than one on a flat site; it is simply the laws of gravity. Foundations normally allow for such occurrences, particularly in newer properties, although there can still be some minor movement.

There is a running gully in front of the garage due to the slight slope.

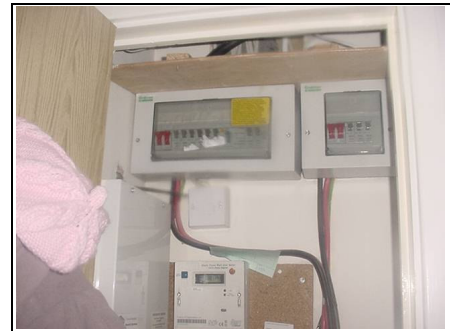
Fuseboard

The electric fuses and consumer units were located in the cupboard to the left hand side as you enter the property. It is not the best available now as standards keep improving, however it is reasonable.

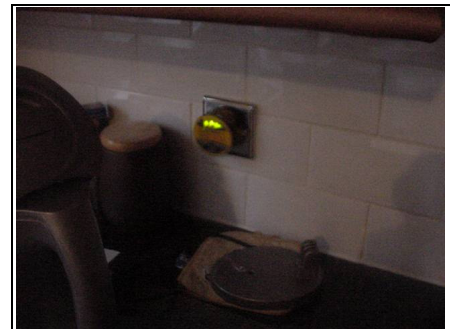
Earth test

We carried out an earth test in the kitchen area to the socket point that is normally used for the kettle and this proved satisfactory.

ACTION REQUIRED: As the property is changing occupancy an IEE report should be carried out by a NICEIC registered and approved electrical contractor. If there is no record of an electrical test having been undertaken within the last five years, it is recommended that the installation be tested by a competent electrician (NICEIC registered) and all recommendations implemented. Thereafter, the installation should be re-tested every five years.

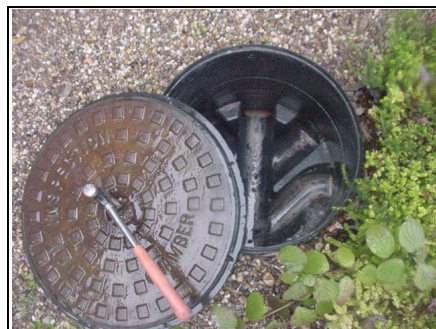
We duly lift the man hole/ inspection chamber cover and found the drain to be clear, and pre formed in plastic.

Manhole we could lift at front of property

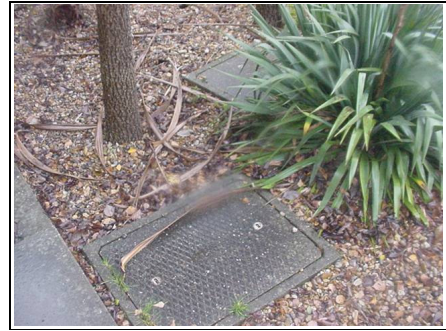
We have been unable to lift the man hole covers as they have concrete lids.

Manhole we couldn't lift

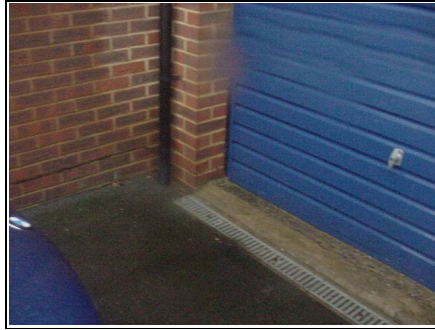
Running gully in front of garage
due to the slight slope

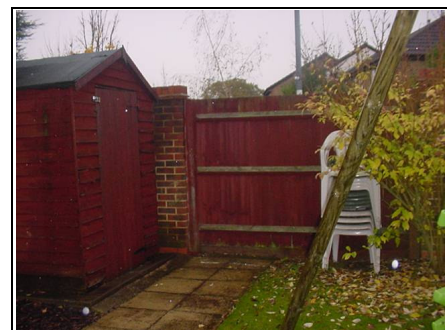
Fence requires some redecoration
and minor repair
