RESIDENTIAL BUILDING SURVEY

Hertfordshire

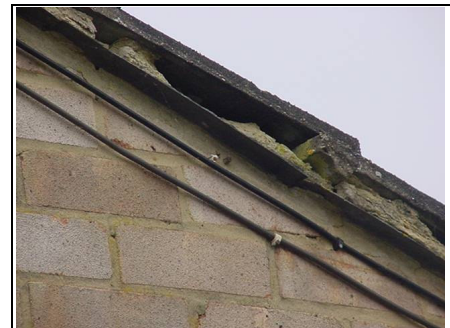
This has deteriorated to the left hand side of the property adjacent to the garages and needs re-cementing to stop water getting into the cavity and causing deterioration. Alternatively a plastic verge may be worth considering.

ACTION REQUIRED: Repoint the verge, use a plastic cover.

ANTICIPATED COST: A few hundred pounds plus the cost of getting access to the area. With scaffold this is likely to be quite expensive. This is an example of where you may be able to do the work off a tower scaffold. We would double if not treble the cost for scaffolding. Obviously we would recommend you obtain quotations.

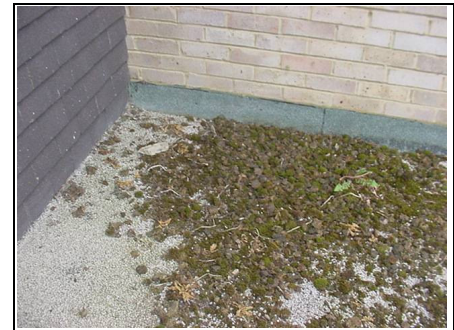
The front roof is very flat and literally has plants growing from it. Budget for repair work to this roof within the next three years.

Moss on front flat roof

ACTION REQUIRED: As a minimum the roof should be cleared and then patch repaired. We would recommend that this work is carried out although it isn't overly important as it doesn't cover a habitable area.

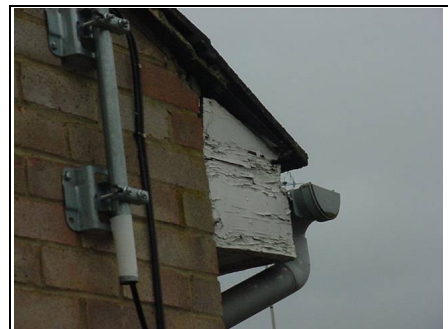
The fascias and soffit boards at high and low level are in need of redecoration. The high level fascia and soffit boards have flaking paint in need of attention. We would highlight that whilst the areas we could see looked to be timber there may well have been some asbestos used; you need to be aware of this.

Fascias and soffits in need of repair

ANTICIPATED COST: In the region of £500- £1,000 plus access scaffold. Again we would refer you to our comments with regards to a tower scaffold. Quotations required.

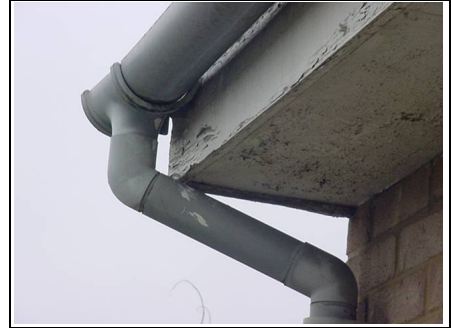
Flaking fascias and soffits – fascia is possibly timber, we cannot be absolutely certain what the soffit is, it could be asbestos.

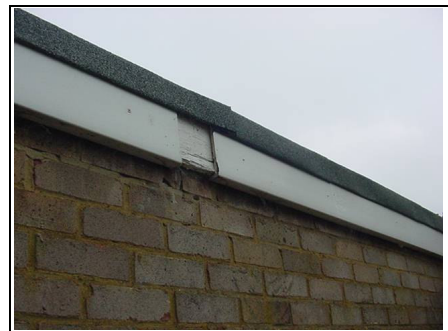
As mentioned overcladding has taken place to the fascia boards to the garage. Ideally this should be taken off completely and replaced in either timber or plastic. Please see earlier comments.

Please see the Fascias and Soffits Section of this Report.

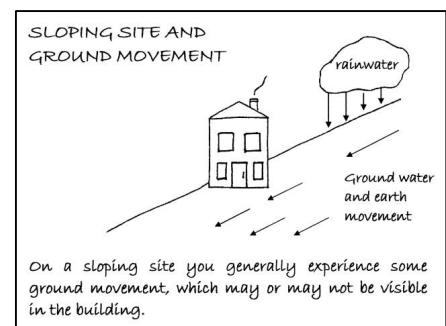
3.2 Running gulley

The property sits on a sloping site with a stream not too far away from the bottom of the garden. As discussed the rainwater and surface road water is trying to get from the top of the hill to the bottom and your house is in the way. We therefore recommend a French Drain is added around the property to transfer the water from one side to the other.

ANTICIPATED COST: In the region of £250 - £750; quotations required. We would recommend this work is carried out prior to the winter of 2011. We would also recommend that you stand out in the next heavy rainfall and see how the rain is flowing.

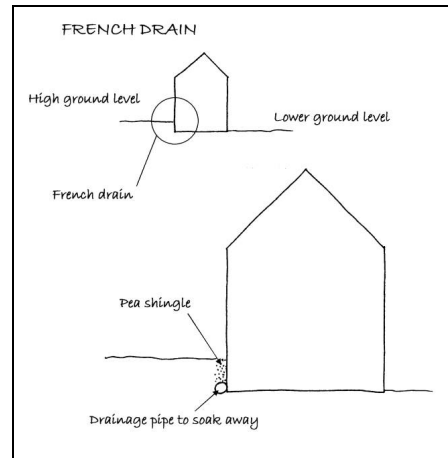
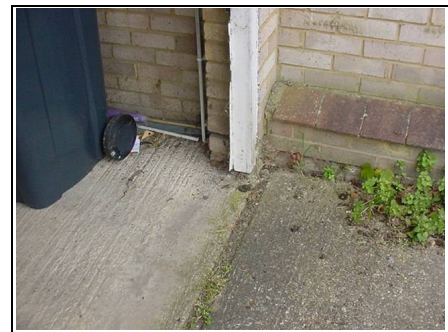
Entrance to garage may be a possible location for running gulley

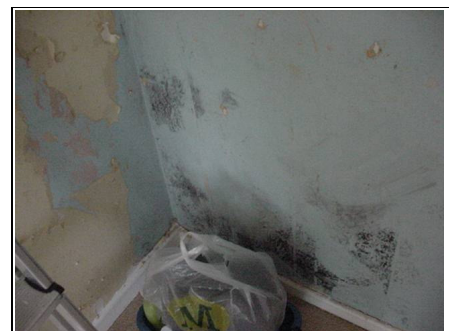
The dampness that we could see within the property, we would advise is condensation. This we believe is being caused by a combination of the previous occupier's lifestyle, the wallpaper/plastic paints that have been used give a cagoule type effect (these walls need to breathe so you need to use water based paints on the walls).

Mould within the study

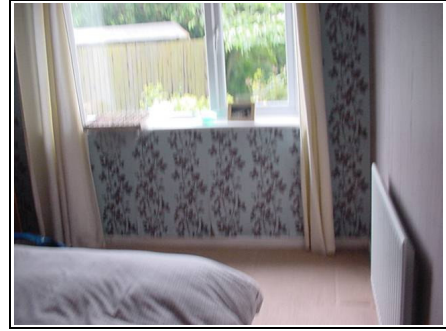
Ideally all/some of the radiators should be relocated underneath the windows as radiators underneath windows help air circulation as the heat rises it joins the colder air from the windows and circulates around the room.

Radiator within bedroom for example which should be moved from an internal wall to under the window

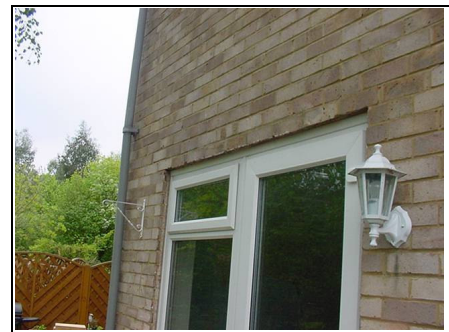
The windows didn't have any trickle vents. Ideally these should be added. We believe that they can be retro-fitted although we have never actually seen it. From the thermal imaging that we carried out (although the environment wasn't ideal) did show them to be quite successfully retaining heat.

No trickle vents to windows

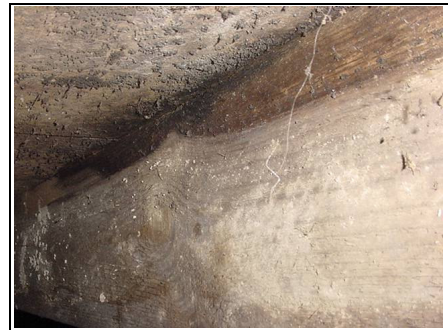
You have had a tiled floor put on top of the suspended timber floor. In our experience these two never work well together even where there is an expansion joint which we couldn't see. A suspended timber floor moves differently to a harder tiled floor, we normally find that tiles end up cracking at the joints and allowing water to leak thorough which inevitably gets spilled in a bathroom.

In this case as you know, we opened up the floor by cutting a hole in it, we could see that the floorboard was damp through. This does not seem to have affected the joists beneath from our view from this access point.

ACTION REQUIRED: We believe that the floor is probably saveable but you will only know this when you take up all the tiles. It then may dry on its own however you do have to consider that you may have to put new flooring down using a WBP quality floor covering. We would then also recommend vinyl flooring in this situation with all the seals being sealed and forming a skirting of approximately 150mm to make sure any spills of water don't get behind it.

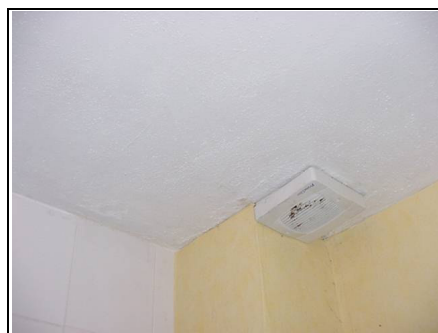
As already recommended we would increase the size of the extract fans in these areas that are fitted to a humidity thermostat control that switches on automatically when the level of humidity reaches a certain level. Internal bathrooms are often prone to dampness.

Extract fan in internal bathroom
should be bigger

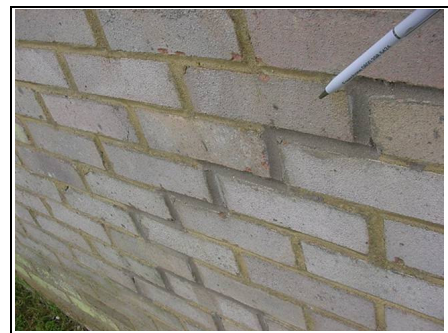
We can see that there has been movement to the property. If we had been advising you before you purchased the property we would have recommended you to gain a reduction in price due to movement in the structure as a property with any movement always concerns purchasers. We would have also recommended that the existing

Stepped cracking to your neighbours garage

We would recommend that a claim is made with regards to the movement in the property as a safety measure and we recommend that you then methodically work through the items we have mentioned.

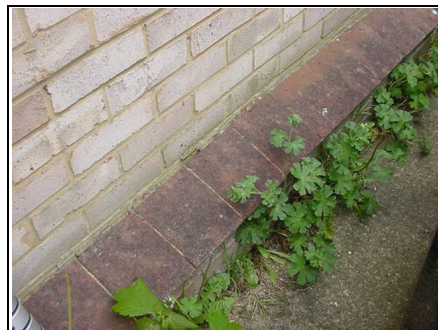
Unusual brickwork to the left hand side

We noted cracking as I am sure you have between the main building and the garage and also to the garage gable end of the adjoining neighbours property. Also we are slightly suspicious with regard to the unusual brickwork to the base of the property on the left hand side.

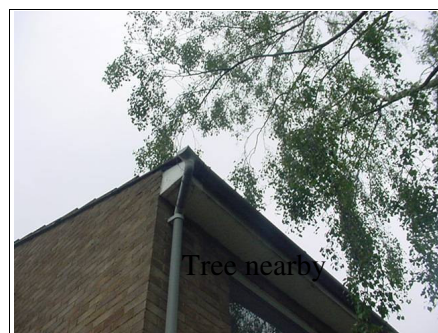
As discussed there is a tree far too close to the property for the likings of insurance companies. We cannot see any direct consequences in the form of movement within the brickwork of the tree being in this location and as discussed it is probably holding the bank of the sloping site together, nevertheless it does need regular maintenance.

Tree nearby

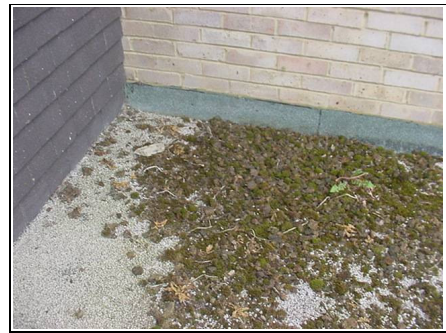
The flat roof has a flat felt finish, the problem is that the roof is too flat. The roof is finished with loose stone chippings which are to resist frost attack and reduce the degrading affect caused by the sun. Care should be taken when walking on the roof. This type of roof covering has not been generally used for many years.

Extensive moss on front flat roof

ACTION REQUIRED: Please see our comments within the Executive Summary. To some extent the damage that can be caused is limited to your property as it doesn't sit over a habitable room however it may cause dampness into next doors property.

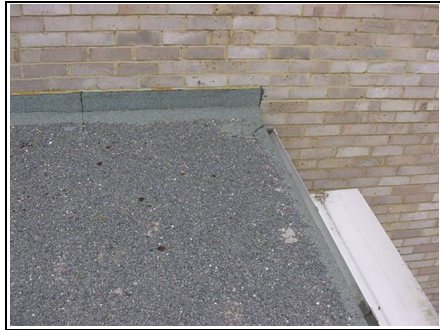
The roof has a felt roof, whilst the felt is in reasonable condition and looks to have been renewed within the past five or so years, it is poorly detailed being predominately flat.

Garage roof

ACTION REQUIRED: Inspect annually.

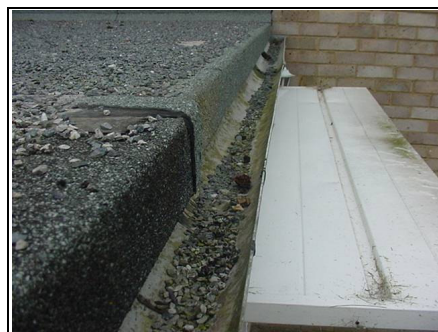
From ground level the gutters and downpipes looked to be plastic. Generally they appear in average condition although they needed a clean. We did note when we put our ladder against them that they were thinner than we normally see, there is not much that can be done about this than replacing them.

Gutters full of stones, etc

ACTION REQUIRED: We would always recommend that the gutters and downpipes are cleaned out, the joints are checked and the alignment checked to ensure that the gutters fall towards the downpipes. The front gulley would also benefit from cleaning.

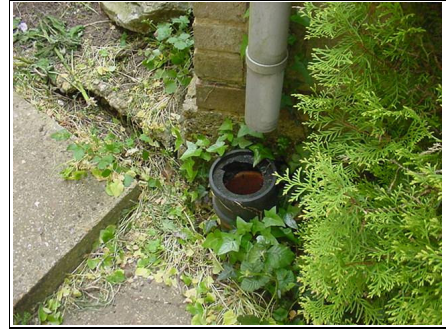
We did note that next doors downpipe was not fitted correctly. This is well worth a 'cup of tea' chat with your next door neighbour advising them that you would be happy to arrange for it to be fixed or they can come round and fix it. Ultimately it is likely to cause damp into their building. We would also comment that as you are aware, it seems that your own downpipes are not that great And you just need to make sure that they don't end up looking like this one.

Downpipe that doesn't fit correctly that is in your garden. Be neighbourly and fix it.

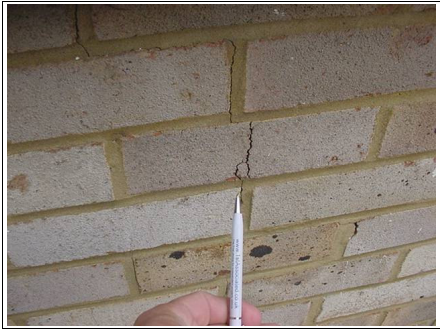
Cracked brickwork

ACTION REQUIRED: Please see our comments within the Executive Summary.

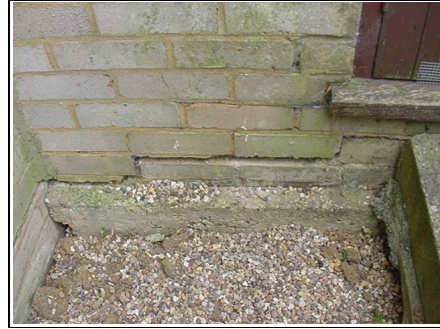
Cracking to brickwork in garage

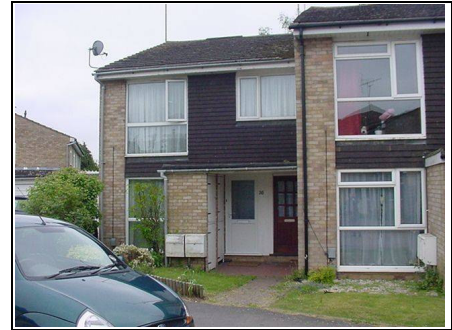
Whilst the majority of the vertical tiling is on your neighbours property, as you saw from our thermal imaging there was a lot of heat coming out of it. You may have a shared responsibility for it. Vertical tiles may be fixed directly to a wall or battens, or indeed counter battens. It is necessary to nail all tiles and it is also good practice to use an underfelt and lap the tiles to approximately two inches (30 mm). Without opening up the structure we cannot confirm this.

Vertical tiling

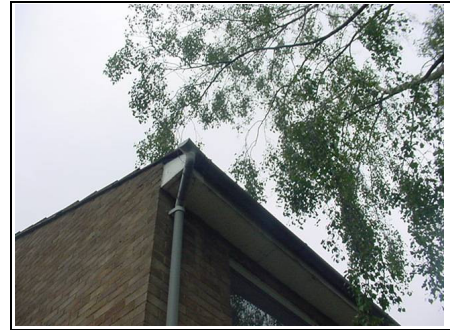
You have a tree very close to the rear of the property. As mentioned the tree forms many functions including holding the bank together, it does however need to be maintained, it looks to have had a lack of maintenance. If it is left to overgrow it can equally attack drains as well as damage the property. Properties with trees nearby will always be susceptible to movement.

ACTION REQUIRED: We would recommend maintenance as soon as possible and advice from an arboriculturist (not a tree surgeon).

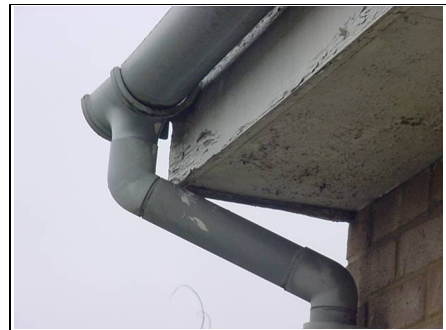
Flaking fascias and soffits – fascia possibly timber, not certain about soffits

ACTION REQUIRED: Please see our general advice on asbestos on our web site 1stAssociated.co.uk. Redecorate the sooner the better. If upon close inspection you decided to replace the fascias and soffits, we would recommend vents are added to the soffit that will allow ventilation to the loft space to help reduce condensation. Please also please see our comments with regard to overcladding to the garage fascia board.

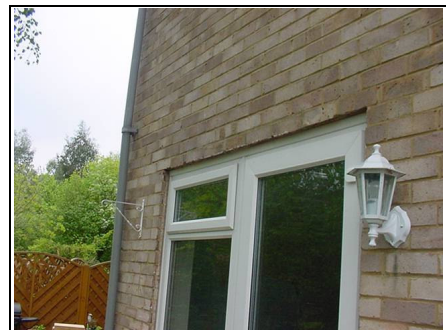
You have plastic windows which we would term as being from the cheaper end of the market as there are no trickle vents. Ideally these should be added. As you are aware when we thermal imaged the windows they are holding the heat in relatively well (a lot better than the vertical tiling).

Windows have no trickle vents

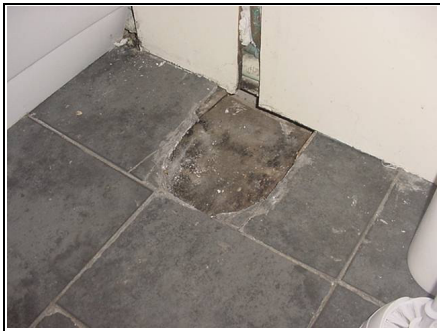
Sinking bathroom floor

ACTION REQUIRED: Please see our comments in the Executive Summary with regards to putting a vinyl over this floor rather than a tile.
