# RESIDENTIAL BUILDING SURVEY

**Studham,  
Near Dunstable,  
Bedfordshire LU6**

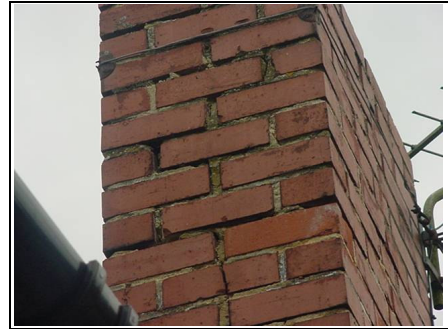
We can see that this is in a poor condition and in need of repair and re-pointing. If the work is not carried out it will ultimately allow dampness into the structure and/or collapse.

Chimney needs repair/repointing

**ACTION REQUIRED:** Repair and repoint and check overall condition, including the flaunchings and the flashings.

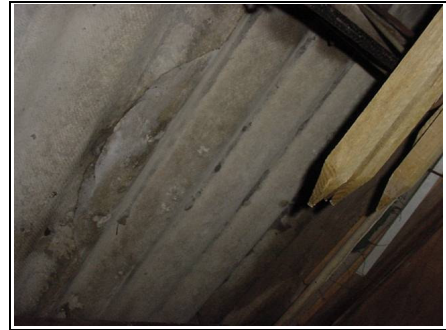
There is an asbestos garage roof that is starting to degrade.

Asbestos garage roof

**ACTION REQUIRED:** We always recommend removal of any asbestos as we feel, whether it is dangerous or not, it does put people off buying a property and the regulations are becoming stricter as to its removal. If you do remove it you will need an approved asbestos contractor and the local authority has lists of these. You could also encapsulate the asbestos using an appropriate paint and lining.

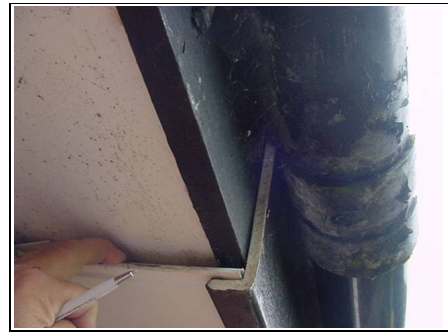
The fascias and soffits have been overclad. This can lead to problems in future years with the degrading of the timber cladding behind. We normally find that the timber cladding was already in a poor state which is why the overcladding has been used. Unfortunately further problems are caused by overcladding.

Overcladding

**ACTION REQUIRED:** Remove overcladding, checking the condition of the fascia and repair as necessary. Then either replace with a solid plastic fascia and soffit or with a repaired or new timber fascia and soffit. We also recommend adding vents for the roof.

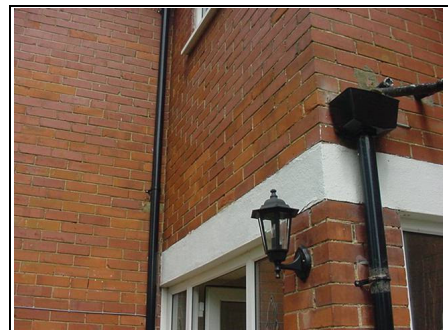
Concrete lintel can cause cold bridging

However, we noted concrete lintels which can cause cold bridging (please see the article in the Appendices of this report) and we can see the double glazed plastic windows do not have trickle vents and this can add to problems. In addition to this, there is no extract fan in the bathroom. All of these mean that an occupied property could suffer from condensation, depending upon how you use the property.

**ACTION REQUIRED:** You need to add an extract fan to the bathroom and ensure the property is well vented. If problems occur then we would recommend adding trickle vents to the windows.

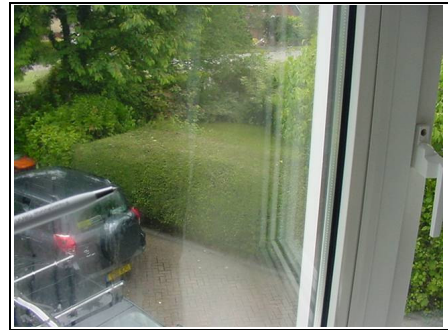
As an aside, some deterioration to the double glazed units has occurred in that we can see that some of the sealed units are misting over and in our opinion need replacing.

**ACTION REQUIRED:** Replace misted over windows.

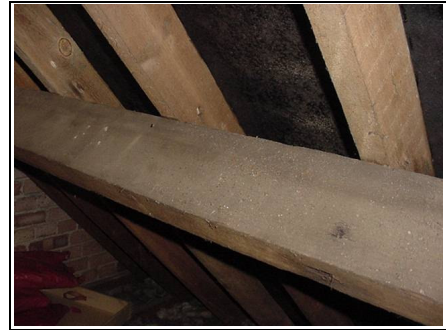
We did not manage to identify a significant source of flight holes that looked relatively new and this is why we would comment that there is a slight possibility of woodworm.

Frass just visible

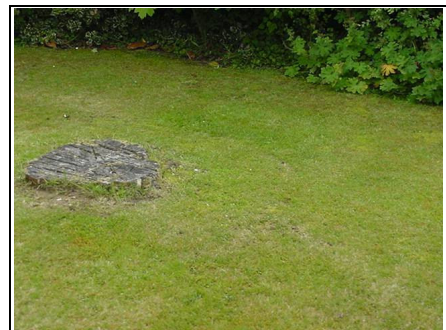
The owner advised that he has had the trees in the garden cut down without seeking any professional advice. We are aware that owners can be unhappy with trees where they block the light to the property, however they do also serve a purpose of helping to drain land. The present owner advises these trees were cut down approximately two years ago by himself.

Cut down tree stump

**ACTION REQUIRED:** Bearing in mind there is a large tree to the front of the property, we would recommend you seek professional advice from an arboriculturist (not a tree surgeon).

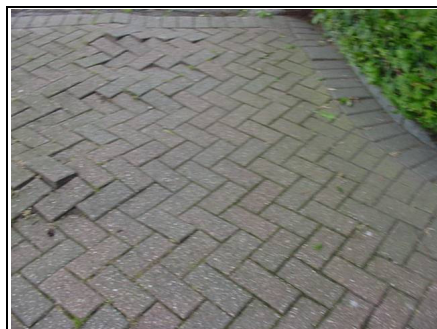
Lifting being caused by tree to front

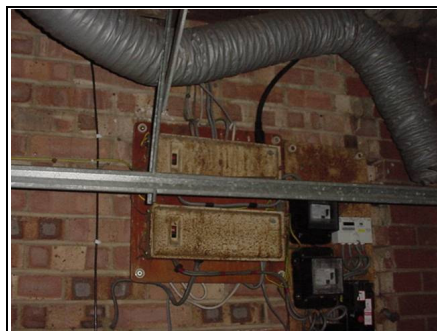
The electrics are dated. We recommend an Institute of Electrical Engineers test and report on the property and we believe that a new fuseboard will be required. The property may also benefit from some additional socket points.

Old electrics

**ACTION REQUIRED:** As the fuseboard is old we would recommend a check to the Institute of Electrical Engineers (IEE) standards by an NICEIC registered and approved electrical contractor.

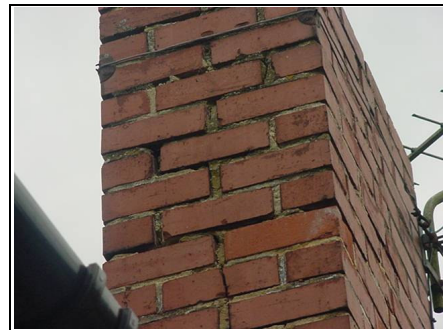
This chimney is brick finished and is in a poor condition. Please see our comments about the repairs in the Executive Summary.

Chimney needs repair

**ACTION REQUIRED:** Please see Executive Summary.

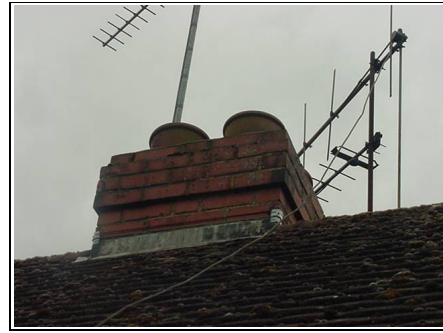
This is a brick built chimney, with pots and a lead flashing. It looks to be in average condition but we would take the opportunity to view it when the work is being carried out to the side chimney. We can see there are various aerials on it which may be causing damage as well as it being in an exposed location.

Central chimney

**ACTION REQUIRED:** We recommend this chimney is checked when the work is carried out to the left hand chimney.

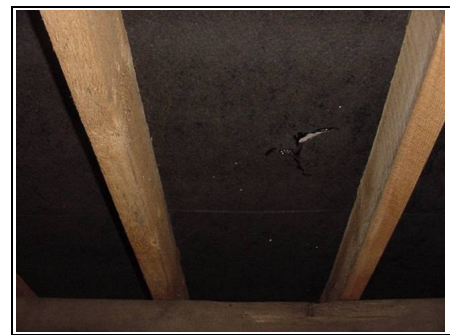
In the main roof we found a Hessian base Bitumen membrane. This type of membrane has been used since the 1960s. We generally found it to be in average condition, although it is damaged in a few places but this is not unusual considering its age.

This photo shows the common rafters (the ones that form the pitch of the roof) and the dark area between is the Hessian underlayer.

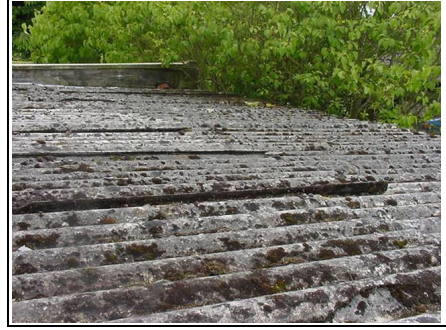
Asbestos roof

**ACTION REQUIRED:** We recommend that all asbestos is removed from the house. This work must be carried out by an approved expert and so we recommend contacting the Local Authority for a list of approved contractors. Disposal certificates should be obtained to ensure the asbestos is disposed of safely.

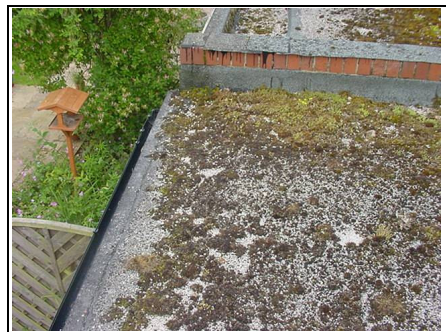
The roof has a felt roof, whilst the felt is in a poor condition and is also predominately flat. We can see it has had repairs, we suspect due to dampness coming in around the parapet wall area in particular.

Rear flat roof

**ACTION REQUIRED:** Please see the comments in the Executive Summary. Ideally insulation cut to falls and new performance felt would be recommended on this roof, the sooner the better. Please note our comments about the possibility of leaks to the roof and latent defects.

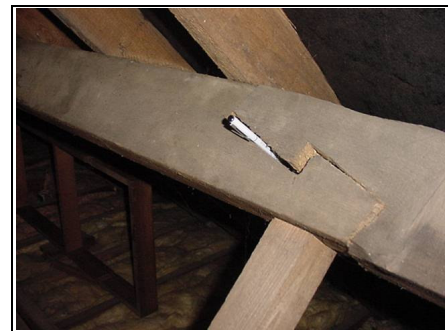
Movement to the structure  
within the purlin

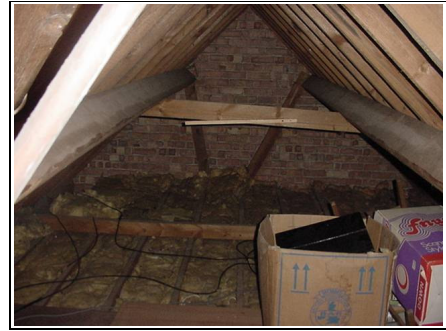
General view of roof

Whilst our examination is restricted by the general configuration of the roof, the insulation and stored items, what we could see we found in generally average condition, with the exception of minor splits and some movement to the roof. Please also see our comments on the possibility of woodworm.

**ACTION REQUIRED:** We would recommend ventilation is added as we suspect condensation is occurring in this roof.

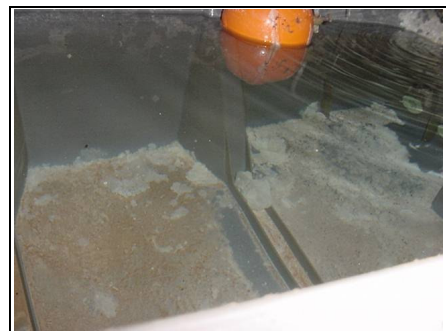
Looking into water tank debris can be seen on the base of it

The photo on the previous page shows the debris in the water tank. We would always recommend that water tanks be drained down and cleared of any debris etc. (we have seen dead birds and other unmentionable things in these tanks). As you are cleaning your teeth with this water it is best that it is as clean as possible!

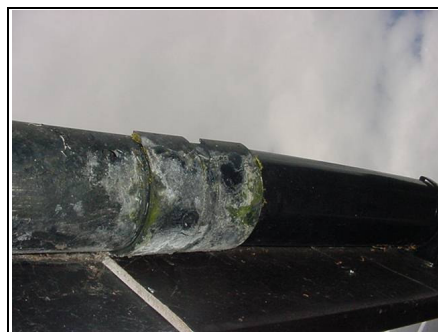
Leaking gutter

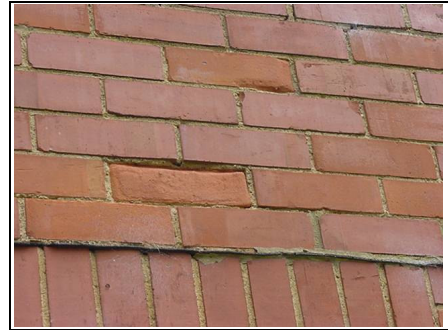
Spalling brickwork

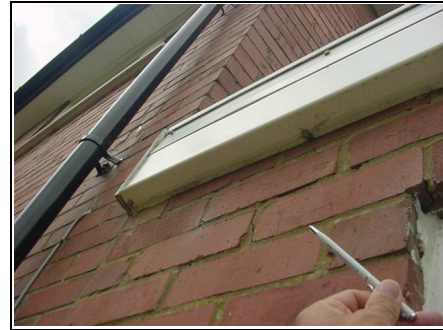
There are some signs that there has been movement in the property from the movement we could see in the roof structure to the hairline raking crack between the main building and the garage and there is a slight undulation in some of the brickwork. This could relate to trees growing nearby, trees being removed, leaking gutters, etc.

Hairline cracking between main building and garage

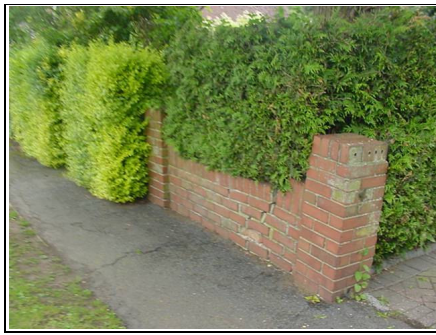
There are various trees surrounding the property, for example a large tree to the front of the property, which is causing some damage to the front wall. There are large trees to the rear of the property and also several trees that have been removed.

Damage being caused by tree  
to front

**ACTION REQUIRED:** We recommend you instruct an arboriculturist to comment (not a tree surgeon). Please see our comments within the Executive Summary.

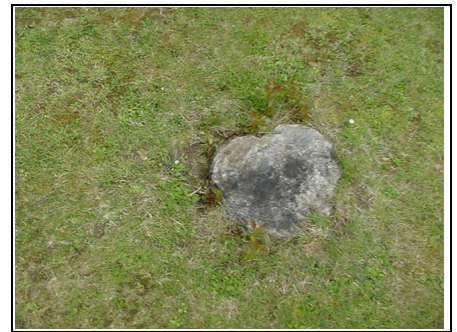
Tree stump to rear  
- they look to have been quite  
substantial trees

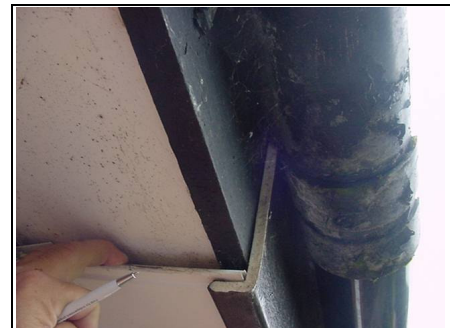
This is a poor system used to look as if the fascias and soffits have been replaced / repaired. The plastic is usually stuck on and, as there is no ventilation in this area, rot can occur.

Overcladding

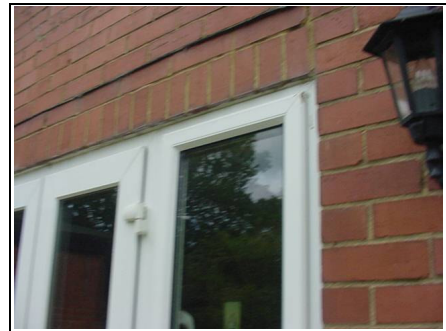
Some of the glazed units are misting over and you may wish to replace them.

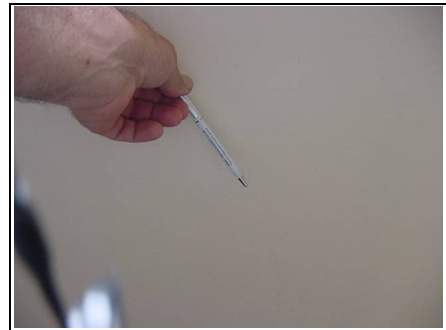
It was interesting that there was hairline cracking internally. The owner advised when we questioned him on this, that there had been re-plastering throughout. It is unusual to see such hairline cracking. We would comment that the plaster is also new and therefore could be hiding latent defects.

Hairline cracking in plaster

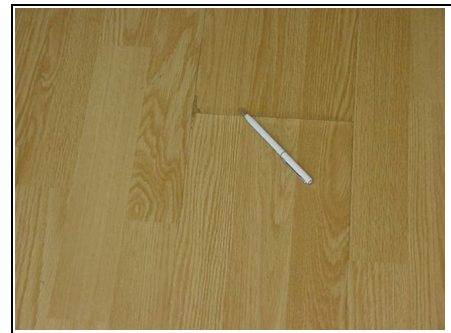
The floors felt solid underfoot so we have assumed they are formed in concrete, however, we have not opened up the floors or lifted the laminate or floor tiles. We would comment that the laminate is starting to degrade, particularly in the hallway.

Deteriorating poor quality timber floor in hallway

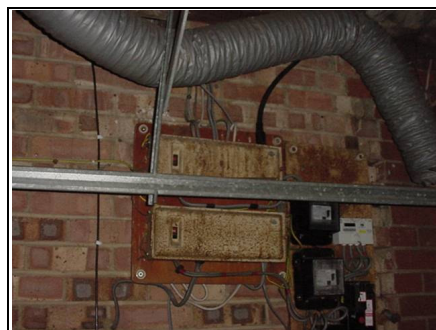
Dated electrics

**ACTION REQUIRED:** Replace fuseboard. Please see our comments in Executive Summary.

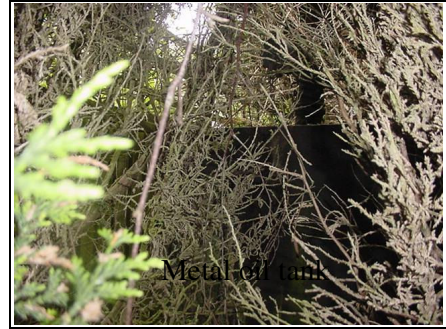
The oil tank looks in reasonable condition with minimal rust. It really is not possible for us to establish if the oil tank is leaking from a one-off inspection, although there were no obvious visible signs of this.

**ACTION REQUIRED:** Have the oil tank checked by an independent OFTEC registered heating engineer prior to committing to purchase the property. You may have to replace with a plastic tank.

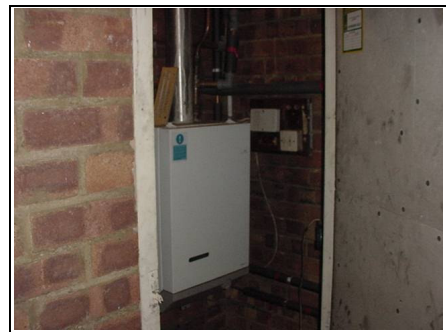
Dated Potterton boiler
