RESIDENTIAL BUILDING SURVEY
OF
Sudbury, Suffolk CO10

FOR
Dr S

Prepared by:
INDEPENDENT CHARTERED SURVEYORS

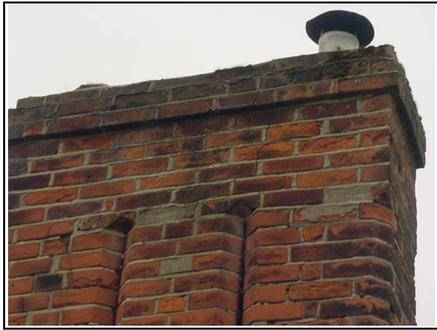
The property has a large red brick (a soft brick) chimney, which is in need of repointing and general work. The repointing should be carried out in a lime mortar to minimise further deterioration in the chimney. There appears to be some cement mortar from past "repairs". Unfortunately, it has caused accelerated deterioration to the brickwork. There is also a cement flashing rather than a lead flashing. If these items are left dampness will start to come into the property.

Close up of top of chimney

ACTION REQUIRED: Repair and repoint the chimney appropriately and add a lead flashing.

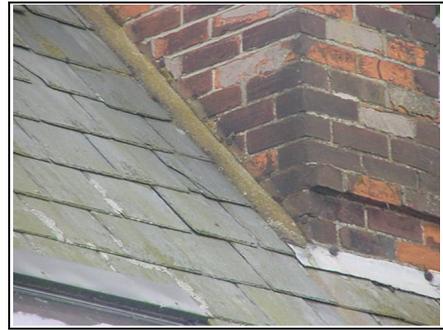
Close up, where a lead flashing is needed

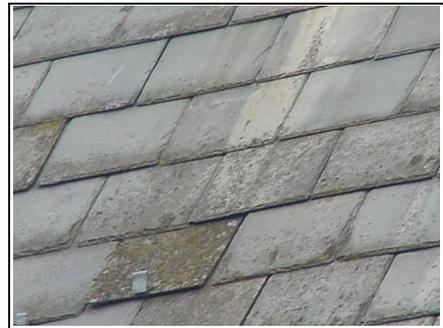
You have an older style slate roof, which does not have an underfelt. This indicates that it was carried out 40 plus years ago, or it was carried out more recently and not to current standards! The lead tingles would indicate that the nail fixings are rusting and failing, as tingles are commonly used where this problem occurs. It is known, in a worst case scenario, as nail sickness.

Slate roof, with lead tingles

The property may have nail sickness. However, the roof does look very flat and true.

ANTICIPATED COST: We would recommend setting aside a budget to buy slates to match the ones on the roof so that the repairs can be carried out immediately. Remember, there is nothing underneath the slates other than your roof insulation, some plasterboard and your bedrooms.

ANTICIPATED COST: A new roof to this property with associated scaffolding and roof over the top would be £5,000 to £10,000, assuming the existing slates can be re-used. We feel that some part replacement will be necessary in the not too distant future and we would set aside a budget of £2,000 to £3,000. Please obtain quotations.

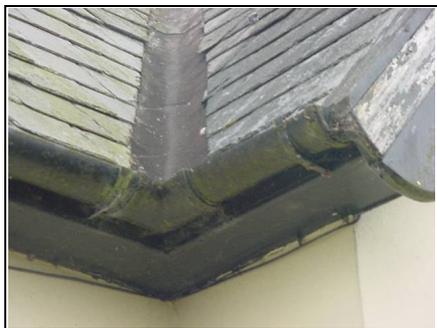
The front valley gutter is leaking. This looks to have been a problem for some time, as the lead valley has then been tarred. There are no obvious signs of splits in the leads, but these are often difficult to see when they have been tarred. Therefore, there may be defects in the lead, or alternatively, the leaves may have collected in the gutter and the valley gutter and built up and allowed water to pass around the valley gutter and into the roof.

Valley gutter

ACTION REQUIRED: We would recommend for this winter that a bitumen coating is added and redecoration takes place within the room. The warm interior of the property is likely to draw out more moisture during the winter months, if this is not significant then the problem has been resolved. It is a matter of clearing the gutter and keeping them clear more regularly.

If dampness does come in we would recommend the entirety of the valley gutter is removed and replaced with a lead valley gutter.

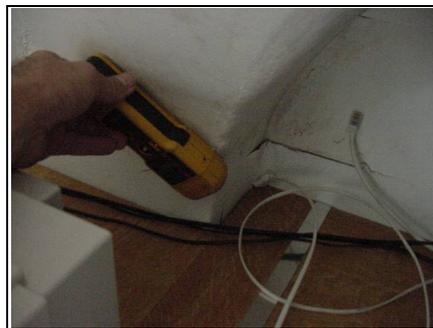
Dampness from valley gutter

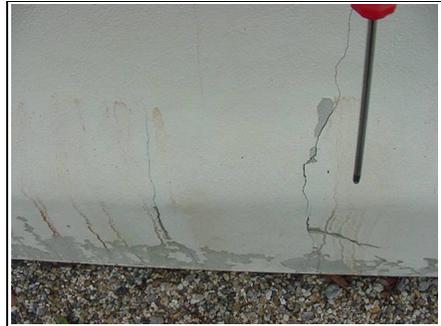
This property, whilst originally old and, what we would term as a “breathable structure”, has had modern materials added to it, such as the cement based render. This resulted in differential movement between the two types of property (it is not usually a good idea to mix old and new materials). The hard cement render cannot adapt to the movement taking place in the building and is therefore cracking.

Hairline cracking

We have no idea what is underneath the render, it could be a part timber frame structure, it could be a brick structure with binding timbers; both of which cause problems to cement based renders. Again, this is an element of risk with buying this age of property.

ACTION REQUIRED: You need to constantly fill any hairline cracks to stop water getting into the structure.

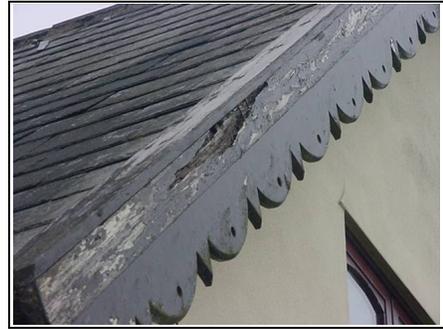
We believe the property has been “painted to sell” in some areas, without the necessary repair work being carried out to the timber. This has then resulted in the paint peeling quite quickly in some areas.

Deteriorating fascia board

ACTION REQUIRED: From your tower scaffolding, or appropriate safe access, you need to remove any deteriorating timber areas, replace and redecorate.

ANTICIPATED COST: In the region of £1,500 to £3,000, depending upon the amount of repair work required and replacement work, which can only really be estimated when you are up high having a very close inspection. Please obtain quotations.

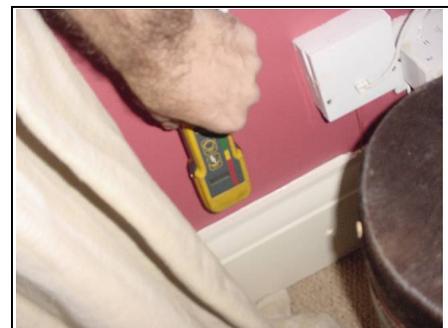
To the front of the kitchen the floor is a suspended timber floor. This requires an air flow underneath to help prevent wet rot. In this case rising damp was found in the wall, which in turn will cause dampness to the wooden floor beneath.

Checking for rising damp, Kitchen right hand internal wall

ACTION REQUIRED: It is very difficult to sort this problem out without major work. We recommend, as a helpful preventative measure, that additional air bricks are added externally and also internally a running vent is added.

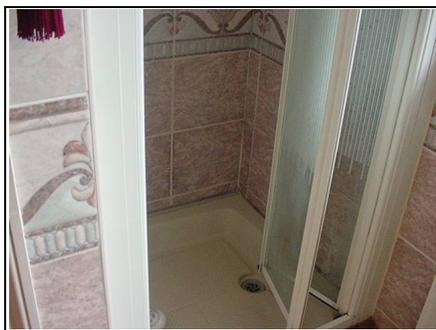
These are not up to modern standard and the showers are fairly cramped. We do feel that the bathroom may promote condensation, as there is no extract fan in this area (make sure you use the windows to minimise condensation), and we can see that some is present within the shower unit. Please note the bath looks to be a short bath.

Plastic shower tray

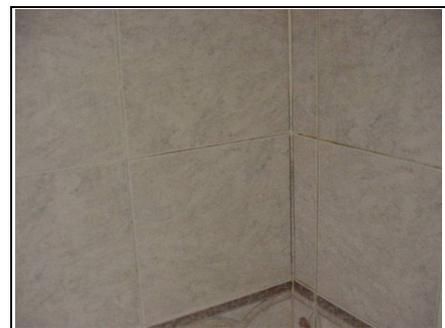
Mould in the shower

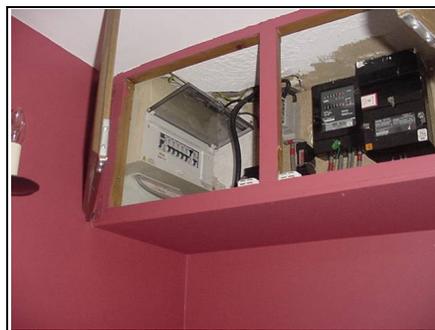
1970's fuseboard

ACTION REQUIRED: As the property is changing occupancy the Institute of Electrical Engineers (IEE) recommend an NICEIC (or equivalent) registered and approved electrical contractor carry out an inspection, test and report.

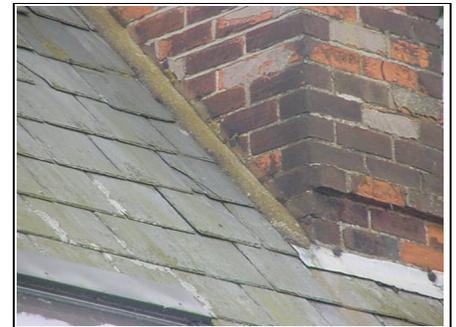
Close up view, with cement flashing to the left and a lead flashing to the base of the chimney

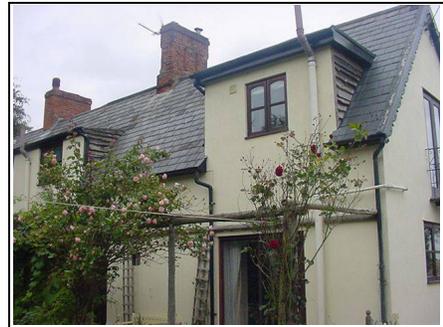
We can only see the very edge of the roof, which looks like it is felt. The cheek sides are in a shiplap timber boarding, which would benefit from being re-stained. We are not certain from the edge of the type of felt, but from discussions with the owner they thought it was a felt with bitumen and impregnated chippings. Generally, this is an older style or cheap style of doing a flat roof.

Rear left hand side dormer

ACTION REQUIRED: We would therefore be looking to replace the flat roof prior to carrying out any alterations and improvements within the en-suite.

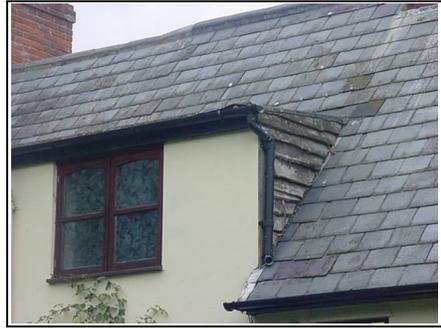
We would say a very similar comment to before; we would add that where the downpipe comes down the side it is causing deterioration to the fascia board adjoining it. The water is surcharging or overflowing the gutter.

Dormer to rear

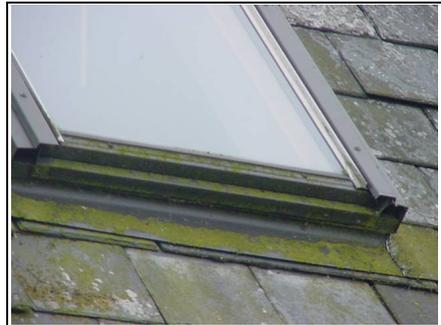
These are a modern metal type, with timber internally and look in reasonable condition, with the exception of the moss that is starting to gather and would therefore benefit from being cleaned.

Roof window, note moss starting to gather

However, we would add that it seems inevitable with roof windows that they will sooner or later leak. If this doesn't occur then they seem prone to condensation. Keep a cloth handy!

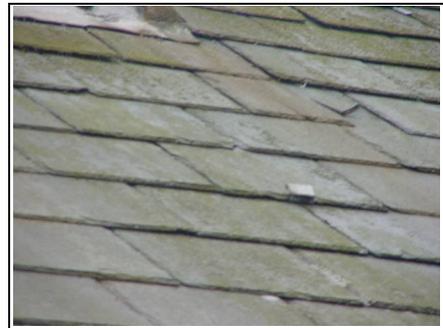
The roof is pitched and clad with quarried slate. The slates sit fairly true and are generally in average condition considering the property's age, type and style.

Slate tiles, with some lead tingles

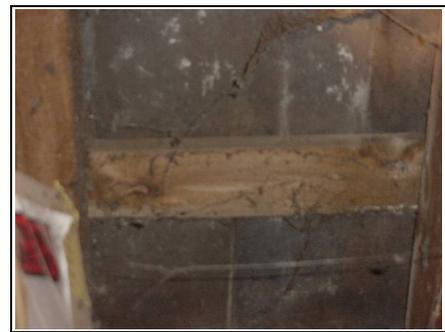
The roof does not have a protective underlayer. We could see the backs of the slates and daylight in some areas, when we were in the roof/attic space.

This photo shows the backs of the slates.

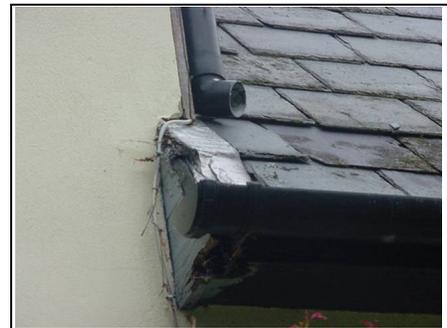
The property has plastic gutters and downpipes. They could do with some rearrangement and modification and we think, as mentioned earlier, the downpipes of the dormers are causing the gutters to overflow and cause deterioration.

Overflowing downpipe

ACTION REQUIRED: We would always recommend that the gutters and downpipes are cleaned out, the joints are checked and the alignment checked to ensure that the gutters fall towards the downpipes.

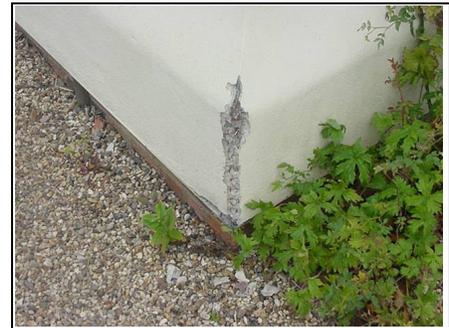
The majority of the property is finished in a smooth faced painted render. This is a cement based render, and is not ideal for this age of property, in fact many people would say that it should not be used on this type of property, and this is what we would agree with. However, we are where we are.

Impact damage from a skip; the owner present owner will resolve

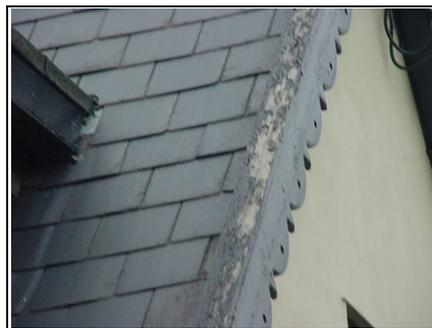
The fascias and soffits look unsightly where the paint is flaking off the woodwork. In some areas it is further than this and there is rot in the timber as well. You will need new timbers and redecoration, which in turn will mean the associated fascias and soffits close by will need redecorating.

Deterioration to fascia board

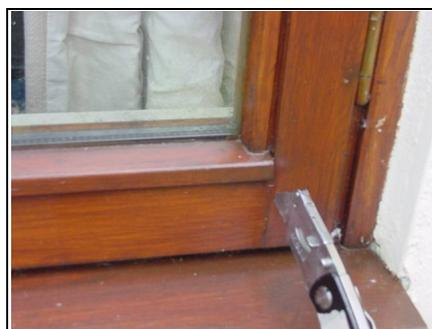
The property has timber double glazed windows without draught seals and trickle vents. We carried out a knife test to a selection of the ground floor windows and found them in reasonable condition. It would however make sense to redecorate them when you are carry out a general redecoration of the property.

Knife test to check quality of the windows

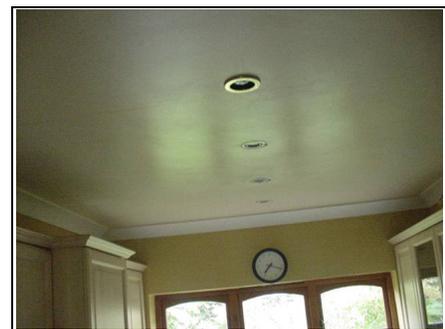
It looks like you have some classic 1970's lights. These were known for giving heat off the back and, in some cases, causing problems. We are aware of a fire that was once caused, whilst we were carrying out a survey on a pub, due to these lights. Whilst we are not suggesting that there is anything like that degree of problem, it is very much worth an electrician checking and replacing them for a newer light that does not give off as much heat.

1970's ceiling lights

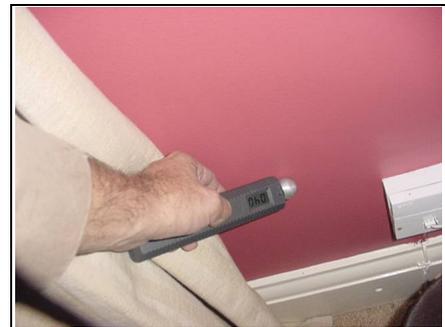
We tested for rising damp using an electronic damp meter and dampness was found. Please see our comments in the Executive Summary.

Checking for rising damp

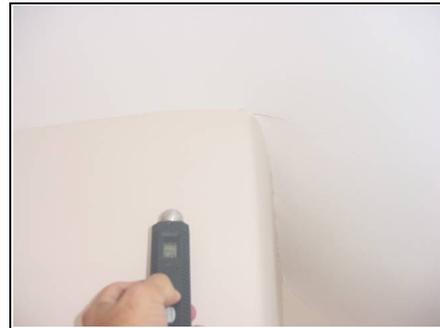
Tests were taken with a moisture meter at random points to internal walls, floors and other surfaces. Our readings were in line with what we would expect for this age of property, i.e. minor dampness. No evidence of any significant lateral dampness was detected, however, if the hairline cracking to the render is not dealt with then you will have lateral dampness and also if the gutters overflow there is likely to be some lateral dampness.

Checking for lateral dampness

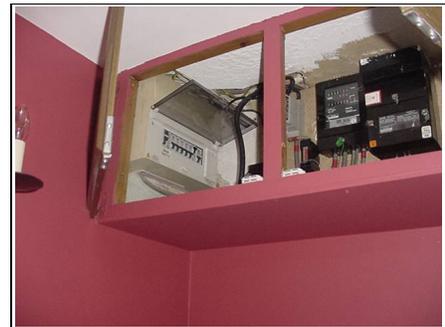
Dated fuseboard

ACTION REQUIRED: An NICEIC approved contractor to carry out an IEE (Institute of Electrical engineers) inspection test and all recommendations to be actioned. Most electricians would recommend a new fuse board.

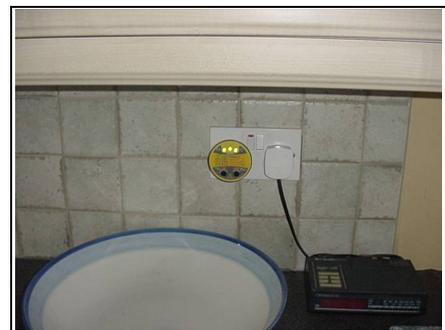
We carried out an earth test in the kitchen area to the socket point that is normally used for the kettle and this did not caused the electrics to trip.

Earth test

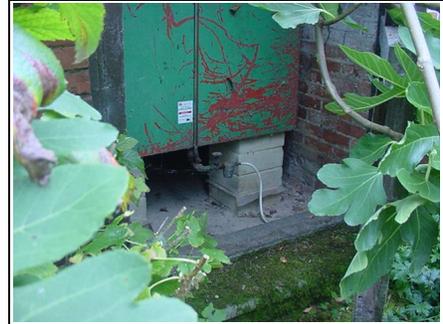
The oil tank looks in reasonable condition. To the part that we could see of it was minimal rust (approximately 30 per cent). It really is not possible for us to establish if the oil tank is leaking from a one-off inspection, although there were no obvious visible signs of this.

ACTION REQUIRED: Have the oil tank checked by an independent OFTEC registered heating engineer prior to committing to purchase the property. You may have to replace with a plastic tank.

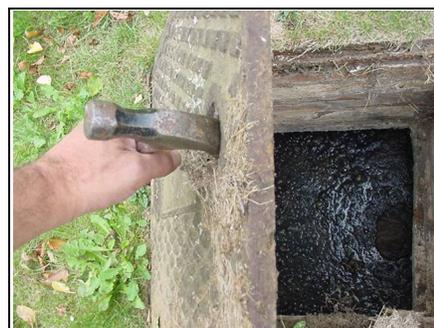
It appears that the property's foul drains discharge to a cess pit, traditionally an underground chamber designed for the storage of foul water. Once the chamber has filled it will require pumping out by the Local Authority or a private contractor.

Septic tank
