RESIDENTIAL BUILDING SURVEY
OF
Swindon, SN2

FOR
Ms R

INDEPENDENT CHARTERED SURVEYORS

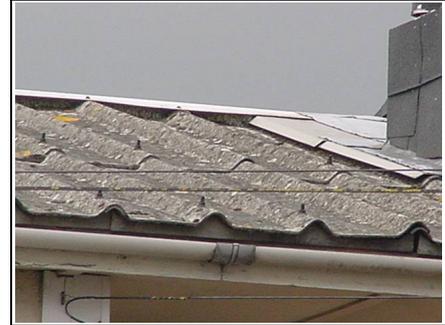
Asbestos Roof

The roof is clad with asbestos sheets. Asbestos comes with various health warnings. In our experience it also puts people off purchasing properties. There are several ways to deal with the asbestos. One is to remove it, another is to seal it or further to encapsulate it (cover). All have various levels of expense. It also means that you would not be able to have tenants in the property whilst this work is being carried out.

ACTION REQUIRED: We have had general discussions with the Local Authority and they advised that they over clad the roof, rather than remove the asbestos. They also advise that they believe that there is asbestos elsewhere in the property. We left a message for the Project Manager of the Local Authority, John Black whom we are advised carried out similar work in the past, but as of yet have not received a reply to our call.

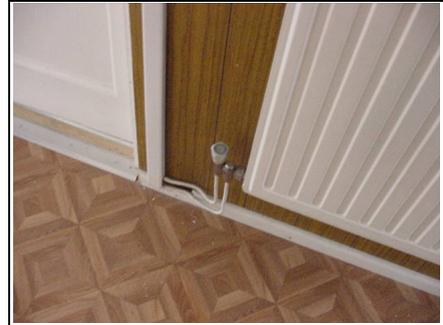
Microbore Pipes to Radiators

We also noted that the radiators have microbore pipes. During our experience these tend to not function as well as the traditional wider diameter pipes.

ACTION REQUIRED: An overhaul of the entire central heating system would be recommended although it possibly has a life of five years. You may wish to wait until it literally breaks down.

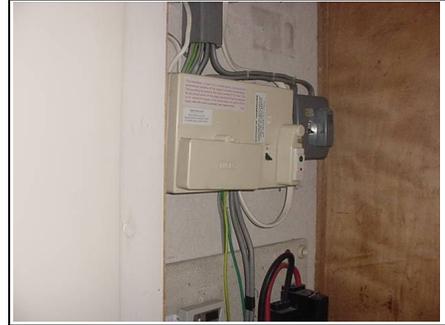
Fuseboard

There is a 1960's if not earlier fuseboard.

ACTION REQUIRED: Replace the fuseboard. You should also take the opportunity to have an Institute of Electrical Engineers Test and Report carried out by and NICEIC approved contractor.

ANTICIPATED COST: We estimate costs to be in the region of two hundred and fifty to five hundred pounds for the new fuseboard, plus any work which is identified in the test.

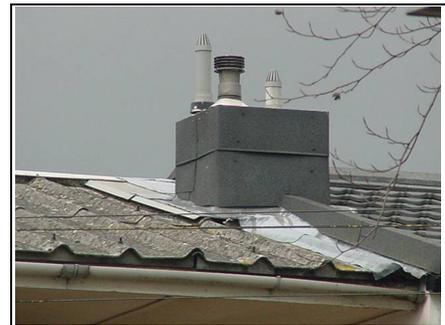
Chimney

This property has one chimney, which is located on the party wall. This is felt covered and obviously we cannot see what is beneath it. We also noted a metal flashing which we believe to be lead.

The original chimney is likely to be covered in felt, as there are defects to it possibly allowing water into the structure.

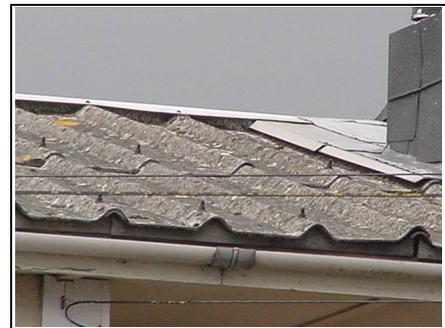
Asbestos Roof

This roof is what we believe an asbestos sheet clad roof and, as the name suggests, it consists of asbestos fibres. The dangers of asbestos have been well documented (you should research the internet to find further information). The amount of asbestos content varies dependent upon sheet type

ACTION REQUIRED: Please see our comments in the Executive Summary. The asbestos should be removed.

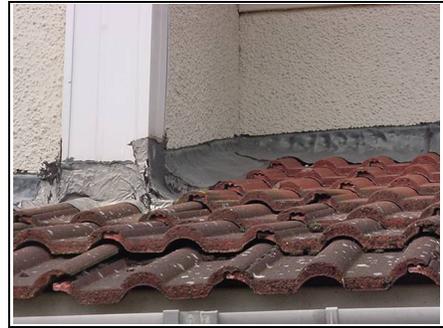
This roof is a pitched and clad in a similar material to the main roof. Where it meets the main building it has a lead flashing although in some areas we did notice a product called flash band which does tend to be used as a temporary repair method.

Poor Flash band Repair to Front Roof

ACTION REQUIRED: Replace flash band.

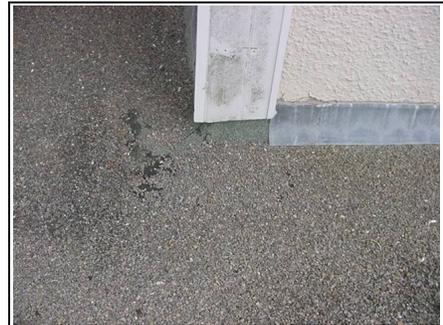
This looks to be a fairly modern (last 30 years) felt roof with a lead flashing. We did note that the flat roof is flat and therefore water may sit on it which will reduce its life.

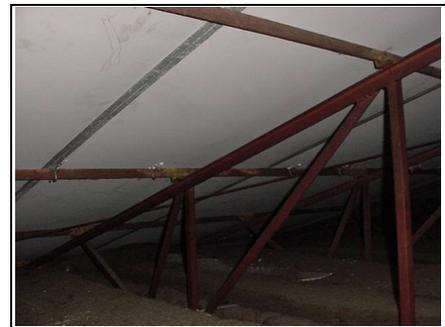
When we inspected the loft space we found what we believed to be asbestos sheet (although it's difficult to confirm by eye). It is also possible that during periods of heavy and prolonged driving rain some water penetration could take place through the roof coverings. This does sometimes occur with sheet roofing.

This photo shows the underside of the roof. The red sections are the metal framed roof.

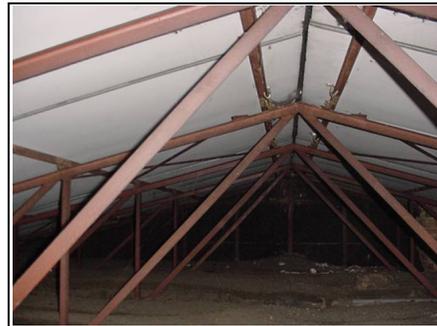
Metal Framed Roof Structure

The property has a quite unusual metal prefabricated roof more commonly seen in commercial properties. We have had a limited inspection of the roof, but noted that the metal frame requires a rust stop agent applied, although this is far easier said than done. It is also important that the roof is ventilated to minimise condensation.

Our examination was limited by the general configuration of the roof, the insulation and the boarding. As mentioned what we could see was generally found to be in average to below average condition considering its age, however we did note some rusting. It is, however, feasible that there are problems in the roof that are hidden. The only way to be 100 per cent certain is to have the roof cleared and checked

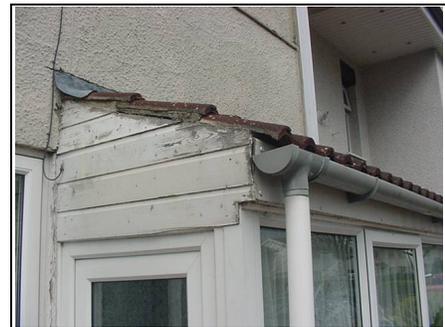
Gutter and Downpipe

From ground level the gutters and downpipes looked to be plastic and appeared in reasonable condition. There may be some minor leaks, but we feel that most people could live with these.

ACTION REQUIRED: To the rear on the left hand side, the downpipe has come away from the gutter. We would always recommend that the gutters and downpipes are cleaned out, the joints are checked and the alignment checked to ensure that the gutters fall towards the downpipes.

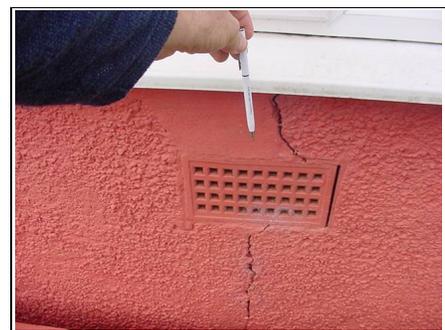
Vertical Crack to Front Panel

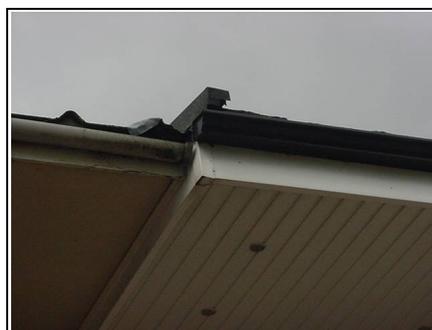
There is a possibility that you have asbestos to your fascia and soffit boards.

The left hand side is your fascia and the soffit board to the right belongs to next door

ACTION REQUIRED: Please see our comments in the Executive Summary

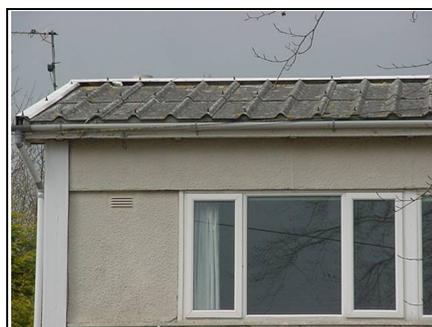
Double Glazed Window

The property has plastic, double glazed windows, which generally look to be of a reasonable quality. We did not see any trickle vents but they may well have been hidden.

We would draw your attention to the fact that sealed double glazed units can fail, particularly as a result of poor workmanship during installation. Failure of the seal leads to condensation between the two panes of glass and simply replacing the affected units may not provide a satisfactory long-term solution. In this case they are in average condition.

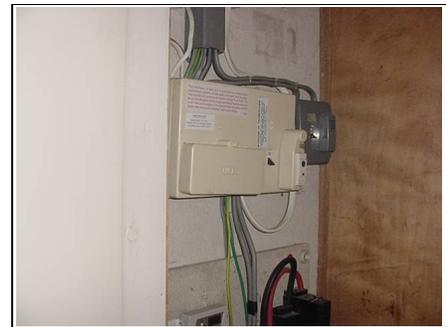
Fuse Board

The electric fuses and consumer units were located in the entrance area (in a rather unusual area to the right hand side of the property). We would date the fuse board as being from the 1960s. Rewireable fuses are now superseded. Far better fuse boards are now available.

ACTION REQUIRED: Replace the fuseboard as soon as possible.

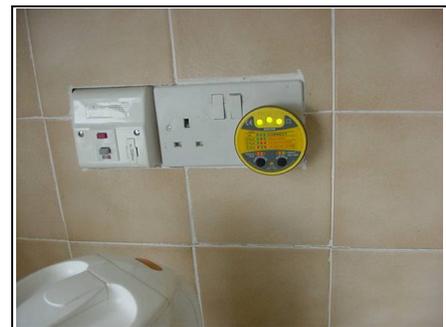
Earth Test

We carried out an earth test in the kitchen area to the socket point that is normally used for the kettle and this proved satisfactory.

ACTION REQUIRED: As the property is changing occupancy an IEE report should be carried out by a NICEIC registered and approved electrical contractor.

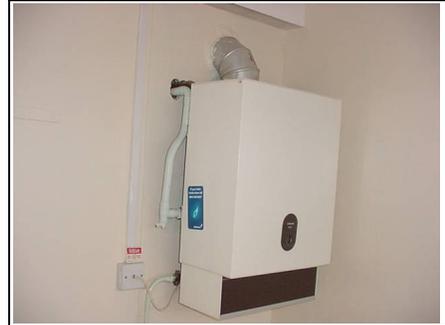
Glow worm Boiler

The boiler was located in the entrance area. It is wall mounted and is made by Glow worm, which is a commonly found make, and looks dated likely to need replacement in the next five years.

ACTION REQUIRED: We would replace it sooner rather than later

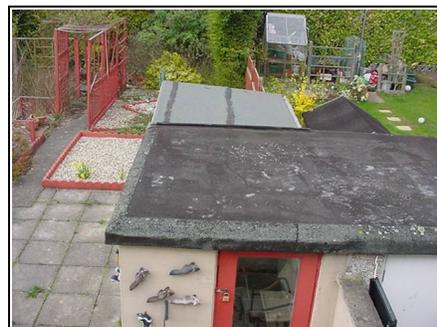
There is an outbuilding to the rear of the property. This is a concrete rendered outbuilding with unusually a concrete roof with an asphalt and felt finish to the top. To the rear of this there has been an extension (in slightly dilapidated condition).
