RESIDENTIAL BUILDING SURVEY

Tewkesbury,
Gloucestershire GL20

Mr & Mrs H

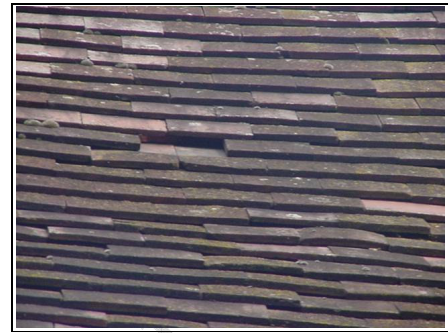
Roof tile missing

1. That he replaces the tiles on the roof (it would be a good idea to get a supply of tiles for the replacement in the future if there is not one already at the property).
2. Check the flashings and valley gutters and re-lead them where they are cement. From what we can see there is a leak to the front valley gutter. We can see this within the cupboard of the middle bedroom.
3. Reduce the ground level around the property prior to the French drain being added.
4. Clean gutters and downpipes and check the joints are joined together. In the case of the barn make sure there is a guttering all the way around it. Check the gutters and downpipes are working properly.
5. We would also suggest they put rainwater butts on any downpipes that discharge against the building and also ensure they no longer discharge against the building.

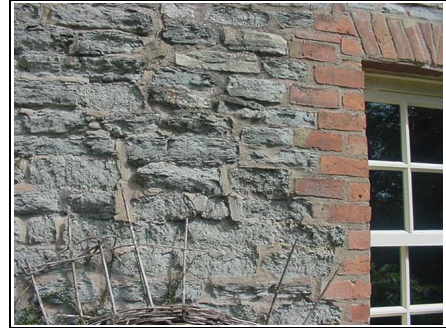
We can see that the face of the stonework is deteriorating. This we feel is due to the pointing being a cement mortar rather than a lime mortar and gutters leaking.

As we discussed with you, a lime mortar allows the property to breathe and gives a gortex type breathable structure, whereas a cement mortar has more of a raincoat type affect, causing the rain to deteriorate the stonework.

Deteriorating stonework

ACTION REQUIRED: Repoint all areas with a lime mortar rather than cement mortar.

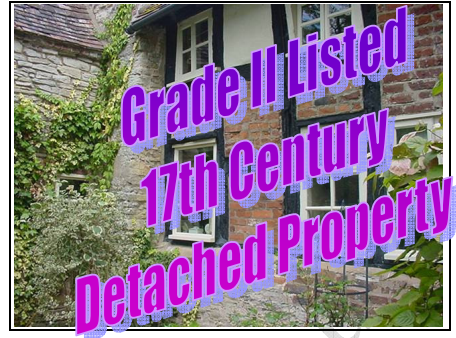
Part of the property has a timber frame structure which we feel is in need of repair, for example to the cellar area and the dining room above and the middle bedroom, all of which show wet rot defects and woodworm defects. It is also likely to be due in part to the embedded timbers, as shown in the sketch.

Timber frame structure

ACTION REQUIRED: General repairs and repointing in a lime mortar and timber repairs as necessary.

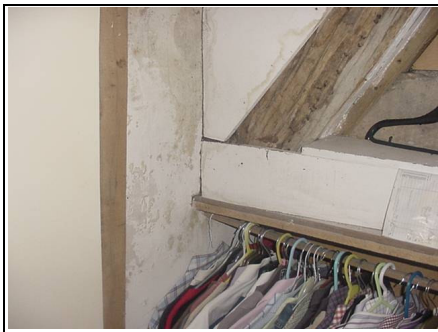
We are finding high levels of dampness. Whilst this is partly to do with the cement mortar it is also in part to do with the high ground levels around the property which we recommend are lowered and ideally a French drain is added (subject to Conservations Officer's approval), discharging into the septic tank.

Dampness coming in from main roof

ANTICIPATED COST: Set aside the sum of £10,000 to £20,000 for general making watertight repairs; please obtain quotations.

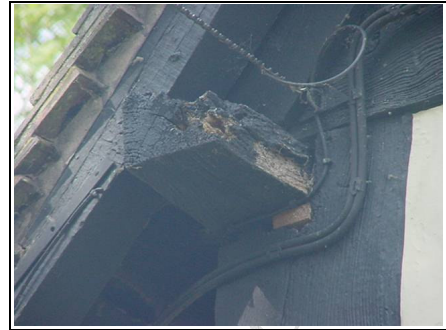
Active woodworm visible to purlins

ACTION REQUIRED: Whilst general repairs to the timbers will be needed we would also recommend adding ventilation to the roof to make the area cooler and less inviting to the woodworm and opening up the floor to check the condition of the timbers.

ANTICIPATED COST: In the region of £2,000 to £5,000; please obtain quotations. Note, we would not recommend a chemical spraying until all other methods have been tried.

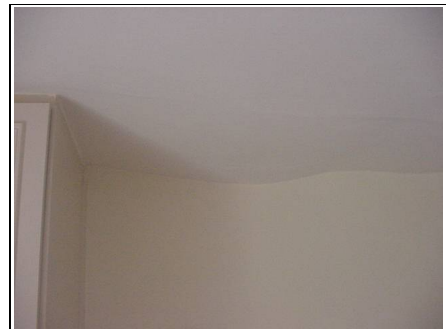
1. Condensation being caused by near by shower in the master bedroom.

Dip in ceiling in master bedroom

ACTION REQUIRED: We feel that some opening up of the ceilings will be necessary to check the condition. To this end we would recommend additional loft hatch openings are added to the roof. This will also benefit any future inspection. We would also recommend the roof is lit throughout (and a good fire alarm system is also added in the roof).

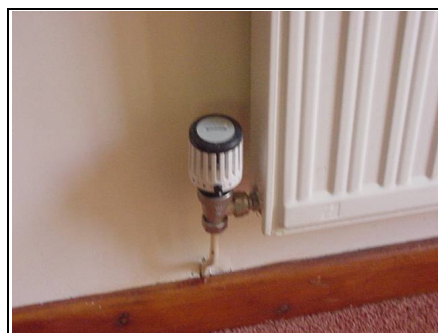
Microbore plumbing in annex

ACTION REQUIRED:
Replace all microbore pipes.

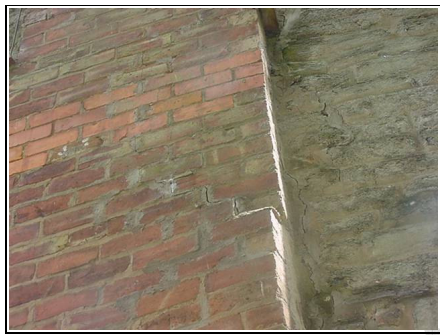
There is a visible crack externally and also internally around the chimney and we can see to the right hand side of the outbuilding a bulge in the wall.

Cracking around left hand chimney

ACTION REQUIRED: We recommend the existing owners place insurance claims, advising that a building survey was recently carried out and it identified the items above and insist that monitoring for movement is carried out on the property.

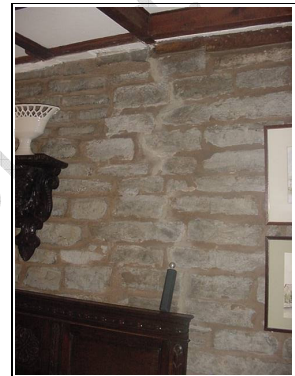
Cracking visible internally

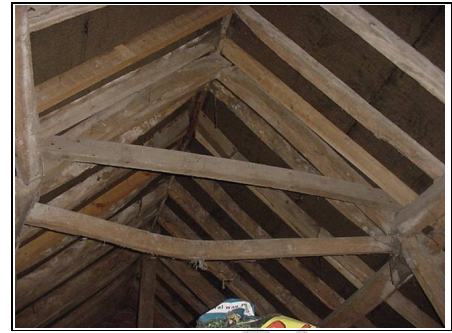
We noted damage to the base of some of the trusses and note, we only had a quick look in the outbuilding barn!

Broken cross brace where a modern timber has been crudely added

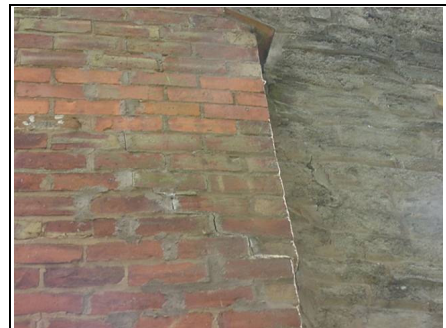
This chimney is brick built with a lead flashing. We are unable to see the top of the chimney known as the flaunchings, we therefore cannot comment on its condition. However we did note cracking and movement in the chimney breast externally. This can also be seen internally.

Crack in left hand chimney

ACTION REQUIRED: Please see our comments in the Executive Summary with regard to an insurance claim being required due to the movement that is occurring.

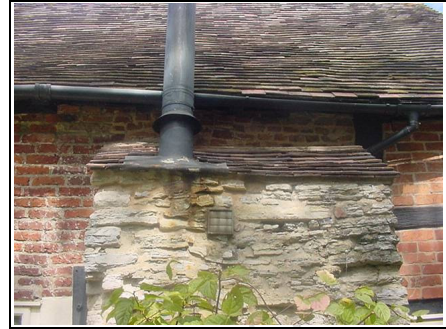
Front right hand chimney

This chimney looks to have been reduced in years gone by and now only partially remains. It is built out of stone with a tile capping on it and a flue going through it.

ACTION REQUIRED: The stone needs general repair. Please see our comments in the Executive Summary.

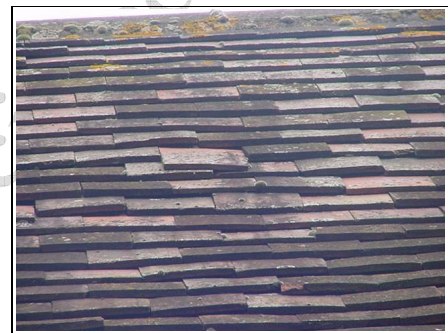
It was difficult for us to confirm 100% whether the roof was just clay tiles or concrete and clay. We were advised that the roof had been re-roofed as one of the first things the owners did when they came to the property. Nevertheless, we can see some slipped tiles.

Close of up of main tiles, with missing roof tiles

ACTION REQUIRED: Generally reposition and replace slipped tiles and make watertight.

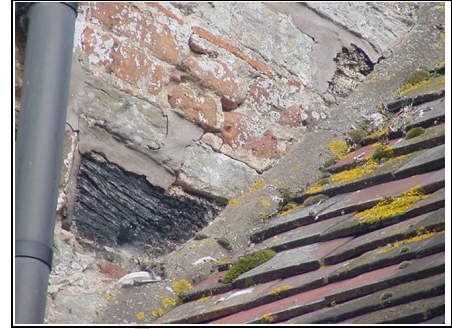
Cement flashing

ACTION REQUIRED: We would recommend these are removed and replaced with a lead flashing or a lime mortar flashing. This needs to be agreed with your Conservation Officer.

ANTICIPATED COST: In the region of £2,500 to £5,000; please obtain quotes.

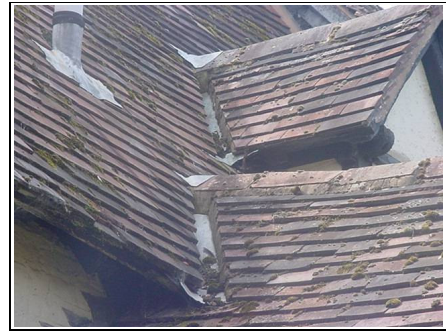
Valley gutters leaking

ANTICIPATED COST: Allow the sum of £1,000 to £2,000; please obtain quotes.

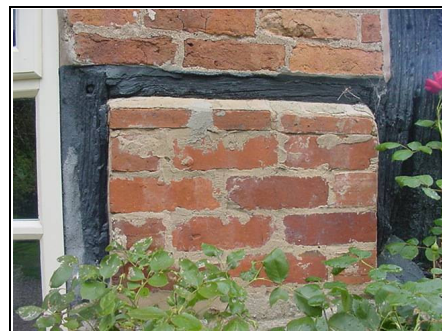
Poor cement mortar repairs to brickwork

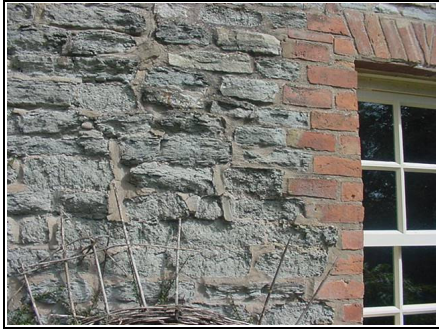
A portion of the property has been built in a relatively soft blue/grey stone. It is suffering from the cement mortar that it has been repointed in and also the leaking of gutters.

Deteriorating stonework

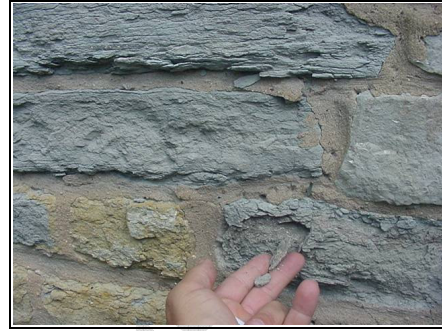
Close up of stonework deteriorating with face coming away

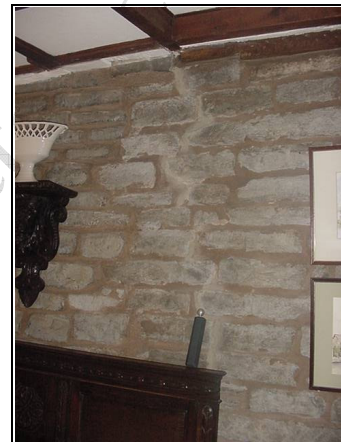
Crack internally in left hand wall

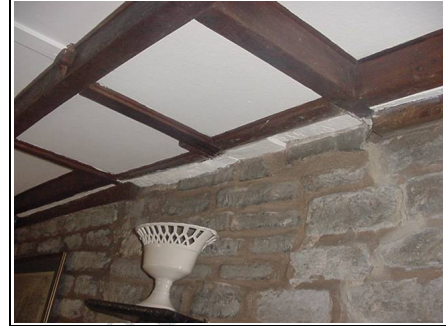
We have commented in the Executive Summary that there are problems with the left hand side chimney. Internally it looks like the chimney main part has been removed. This in turn may be the reason for its cracking. It should in theory have had Building Regulations but we very much doubt whether it will have.

Missing chimney?

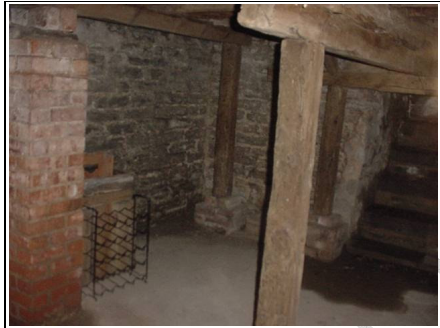
The cellar has been propped up with timbers from many years ago. We found extensive wet rot in the timbers.

General view of cellar

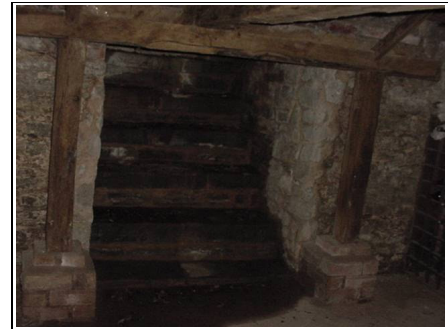
Dampness coming in through cellar flaps

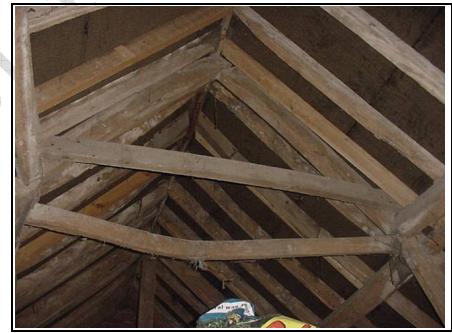
Broken collar truss in roof
