RESIDENTIAL BUILDING SURVEY
OF
**A Terraced Victorian Property, Tilbrook,
Cambridgeshire**

Mr.T

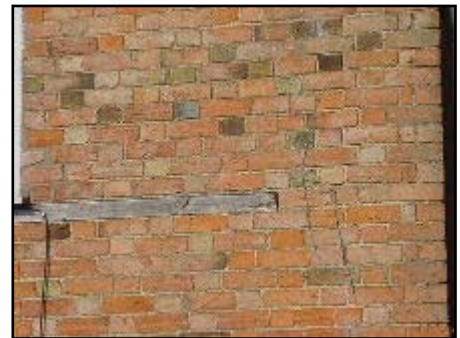
3) Damp Throughout

We believe that the entirety of the property has rising damp to the walls and to the floors. This would put many people off the property; most Mortgage Companies would also be put off insisting that it is rectified. We believe that the property could be made a lot better by reducing the ground level around the property to allow water to disperse and also removing all of the cement mortar and replacing it with lime mortar. The property will still have some rising damp even when this work is carried out which may, in years to come make it difficult to sell.

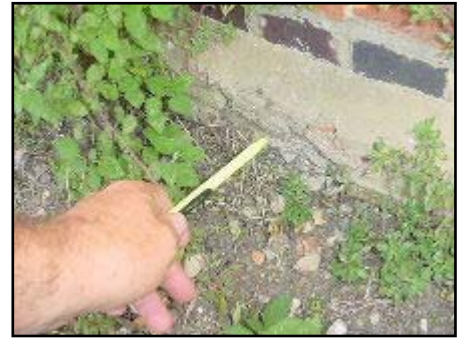
The ground level needs to be lowered and also ideally the cement plinth needs to be amended.

ACTION REQUIRED: Remove cement mortar and add lime mortar and reduce ground levels, also vent false walls where dampness is being hidden or remove completely and re-plaster with a lime based plaster.

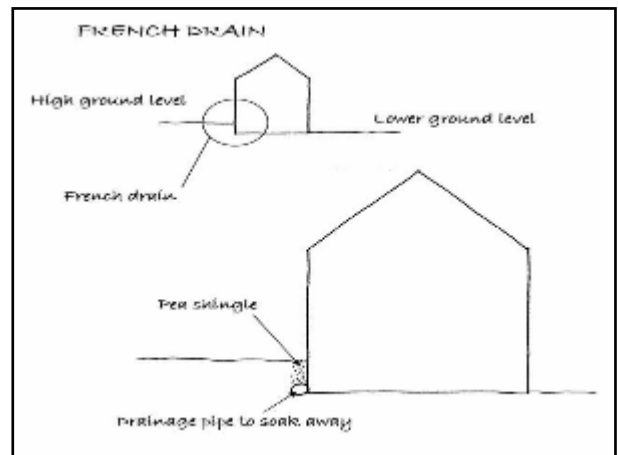
Lateral Dampness

There is also a fair amount of dampness coming through the wall, higher than we would expect. Again, re-pointing of the mortar in a lime mortar and removed the cement mortar would aid this together with a lime mortar internally.

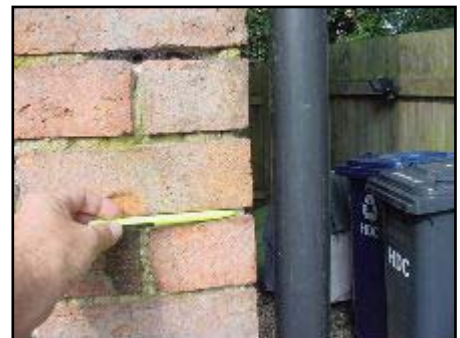
During the course of the survey you mentioned an Estate Agent who said what had happened to the dampness in this property. The dampness is being hidden in the living room area by a false wall being added in front of it. From personal experience, unless these walls are vented wet rot occurs which could lead ultimately to dry rot.

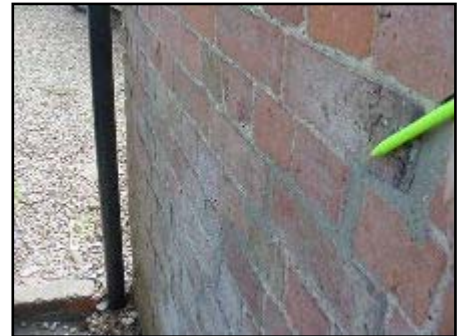
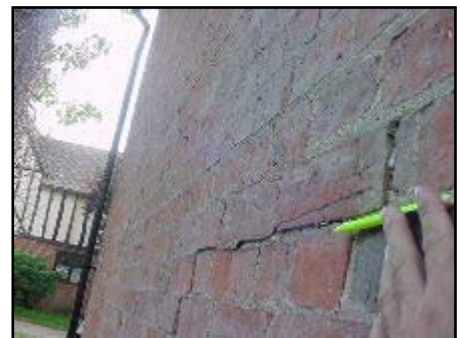
Cracks and Movement

There are physical cracks visible to the layperson on the property. This will mean that future purchasers will often look for discount. There is visible movement to the rear and also internally and also to the front right hand corner. We feel that the contributing factors are the trees and the rainwater discharging directly into the ground.

ACTION REQUIRED: Expert opinion needs to be obtained on the tree and the rainwater gutters and downpipes checked to see where they go. If they go directly into the ground then a soak away needs to be added which is expensive. It will also change the dynamics of the ground and may in turn affect how the tree reacts.

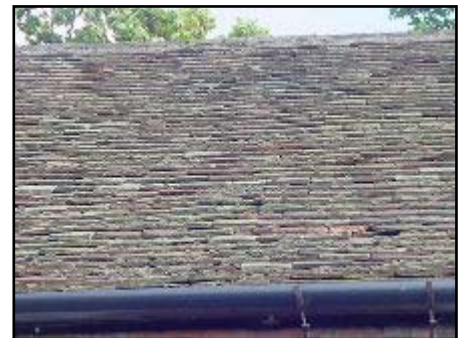
The roof is pitched and clad with a small clay tile. From ground level this looks in reasonable condition. With this age of roof, there will usually be a few missing or displaced tiles, this is nothing unusual. Weak areas are the ridge and perimeter where tiles can be displaced by the wind.

A general view of the roof.

The pitch roof indicates it was likely to have been a thatched roof.

ACTION REQUIRED: Carry out periodic inspections and maintenance of the roof such as removal of the moss. If the moss is allowed to grow too much it will end coming loose and then blocking the gutters.

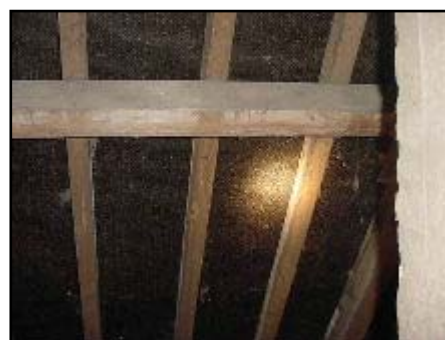
When we inspected the loft space we found a Hessian base Bitumen membrane. This type of membrane has been used since the 1960s. We generally found it to be in average condition, it is damaged in a few places but this is not unusual considering its age.

This photo shows the common rafters (the ones that form the pitch of the roof) and the dark area between is the underlayer.

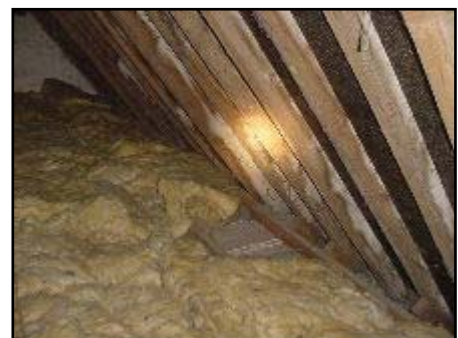
We have inspected the roof for serious active woodworm and found some and also inspected a structurally significant defect to the timber together with dry rot and wet rot. We found condensation staining to the roof indicating that it needs venting.

Note the white staining, which is condensation.

In this instance we would recommend that the roof be vented, as condensation staining is visible internally. When the property was built ventilation was not a requirement. However, now, where there is a protective under layer and insulation to a roof, cross ventilation is now recommended and required under the current Building Regulations. This is to stop condensation occurring within the roof, which can affect the timbers and also cause dampness.

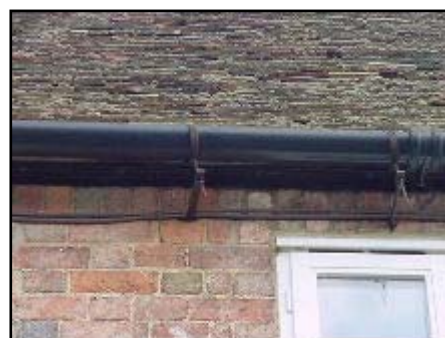
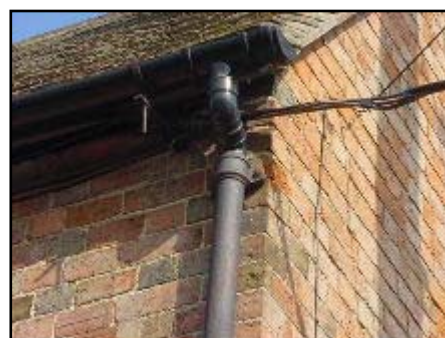
The property has a mixture of the original cast iron gutters and downpipes and the more modern replacement plastic gutters and downpipes. What we found was in typical condition for this sort of mixture materials. There are some leaks where the two different materials join and there is some corrosion of the cast iron, however we feel that most people could live with this.

A close up of the plastic gutter leading into a cast iron downpipe.

ACTION REQUIRED: We noted that the rainwater goods discharge directly into the ground, a practice that we are not keen on as they are often prone to blockages. Ideally, they should be changed to a gully system.

We would always recommend that the gutters and downpipes are cleaned out, the joints are checked and the alignment checked to ensure that the gutters fall towards the downpipes.

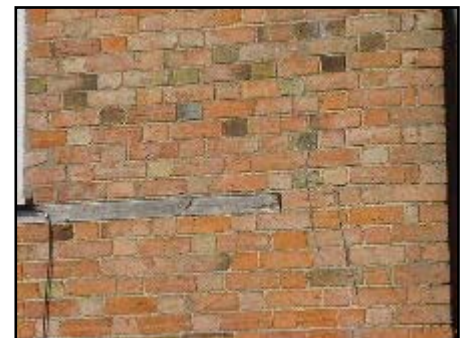
Before the 19th Century, the practice of building timbers into external walls was almost universal. These were known as bonding timbers. They are of course prone to rot as solid walls allow dampness through. Unfortunately, without opening up the structure, we are unable to confirm if this is the case.

Flemish Bond brickwork to the gable end and also the bonding timbers.

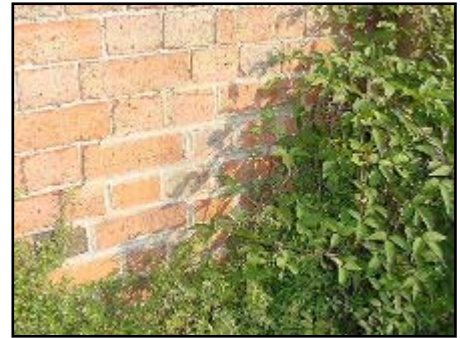
Movement was identified throughout the property. For example, to the rear of the property where there is a diagonal crack which has previously been repaired some four metres in length. To the right hand front corner of the property there is also extensive re-pointing indicating movement in this area. There is also movement on various internal walls to the kitchen area, to the bedroom and to the landing area. Most of these co-inside with the external cracking indicating that there has been structural movement rather than superficial movement in this property.

Structural movement to the front right hand corner.

ACTION REQUIRED: Please see our comments in the Executive Summary.

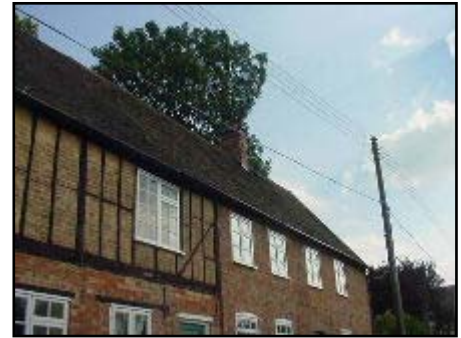
As you are aware there is a large tree directly next to the property and another not that far away from that, both within a few metres of the property, what we would term influencing distance. We believe that these trees are affecting the property

See the tree above the house.

ACTION REQUIRED: You need to obtain advice from an arboriculturist (not a tree surgeon).

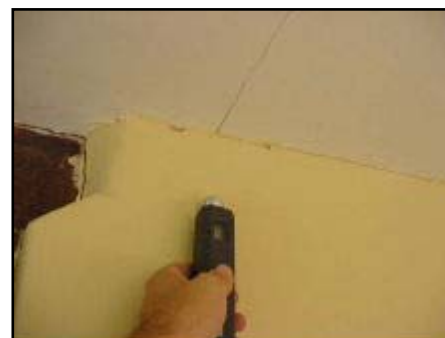
Hairline cracking between the plasterboard – fairly typical.

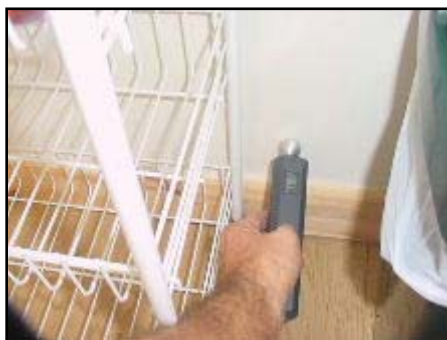
Testing for damp

A random visual inspection and tests with a moisture meter have been taken to the perimeter walls and some internal walls. The readings we obtained indicated that there is a lot of dampness in the property.

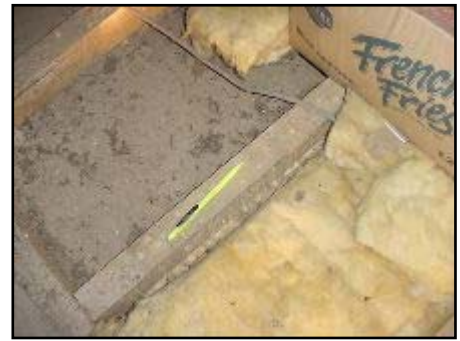
The frass from the woodworm around the pencil

ACTION REQUIRED: You are strongly advised, prior to exchange of contracts, to engage the services of a reputable specialist timber treatment contractor to carry out a full inspection of the property and provide a report and quotation for any necessary remedial treatment works. The contractor should be prepared to issue a long term insurance backed guarantee on completion of the work.

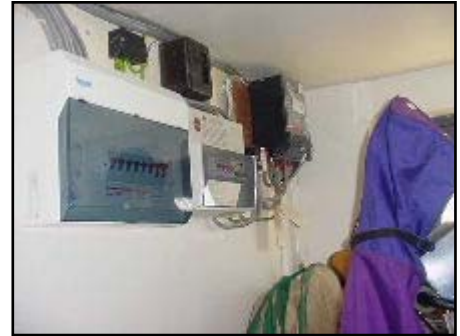
The electric fuses and consumer units are located in the utility room. The fuse board looked newish. Nevertheless, it is not up to current standards.

We carried out an earth test; this proved not satisfactory and tripped the electrics.

If there is no record of an electrical test having been undertaken within the last five years, it is recommended that the installation be tested by a competent electrician (NICEIC registered) and all recommendations implemented. Thereafter, the installation should be re-tested every five years.
