RESIDENTIAL BUILDING SURVEY

Bedfordshire

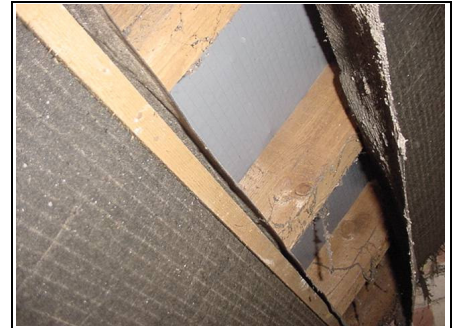
Grey plastic underlayer and black reinforced hessian

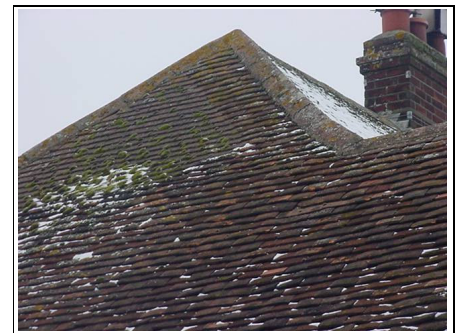
We can see moss is starting to form on the pitch of the roof which often indicates that the face of the tile is starting to deteriorate. Any moss on a roof will accelerate deterioration. We can also see that some areas have been displaced. Internally we can see a 1970's plastic underlayer (behind the hessian underlayer) which leads us to believe that the property was re-roofed, probably in the 1970's or 1980's however the original tiles we believe were re-used with an inter-mixing of newer tiles, you can see a slightly redder colour in the roof.

Close up of roof

ACTION REQUIRED: We recommend a roofer spends two days overhauling the roof. This would involve such things as replacing tiles that are cracked and broken and also re-securing tiles and putting into place any slipped tiles.

ANTICIPATED COST: £500 - £1,000 depending upon what they find, it may be higher. We would also recommend that you set aside a supply of tiles as there will come a time when damage occurs to the roof that urgent repair will be needed so if you have the tiles it makes this so much easier; quotations required.

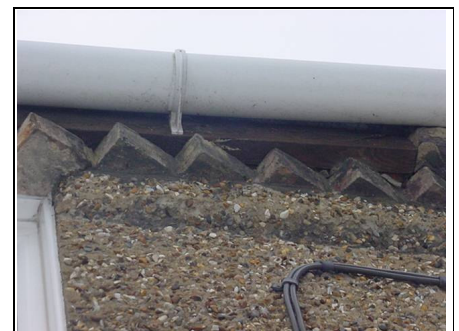
We would comment that there was unusually timber visible on the left hand side which looked to be part of the roof structure as opposed to a normal fascia board that we would expect.

Unusual timber detail

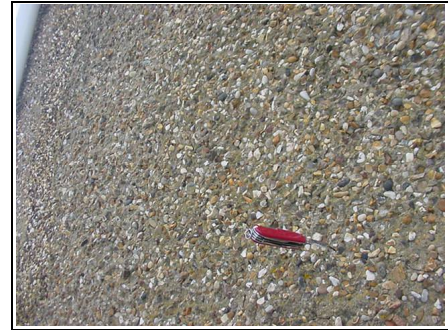
To the older render we can see hairline cracking which means that dampness is getting in which means that further render damage will occur.

Render with knife in crack

ACTION REQUIRED: You need to resolve this problem as soon as possible, we recommend the Spring of 2011. You may be at the point where re-rendering is a cheaper alternative in the long term than repairing what is there.

We would also recommend looking at improving the detailing around the windows and to the base of the property particularly in the newer side of the property where the detailing is not present.

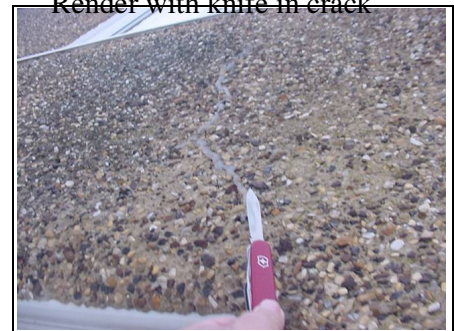
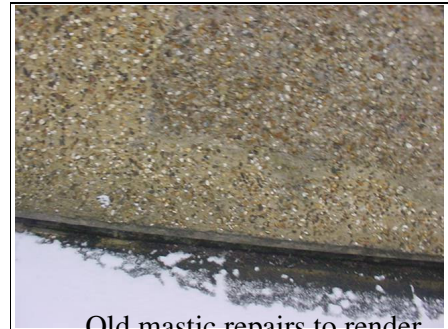
Old mastic repairs to render

Previous repairs to render

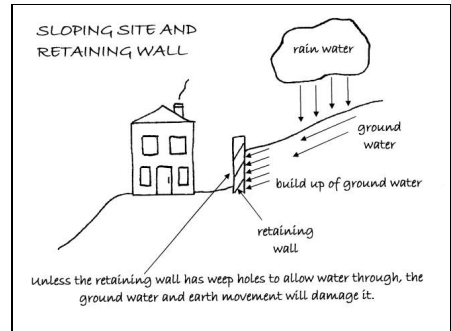
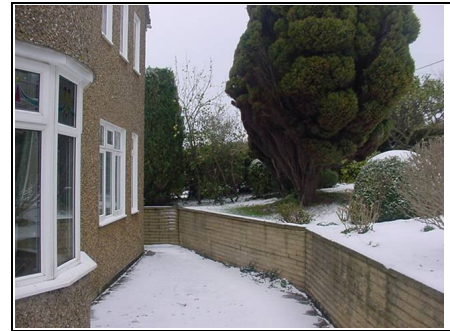
As the property sits on a sloping site there are retaining walls around it. We noted that these don't have weep holes in them which has resulted in cracking and minor movement in them. We would recommend that weep holes are added.

Retaining wall with no weep holes

ACTION REQUIRED: Add weep holes. We would recommend core diamond drilling.

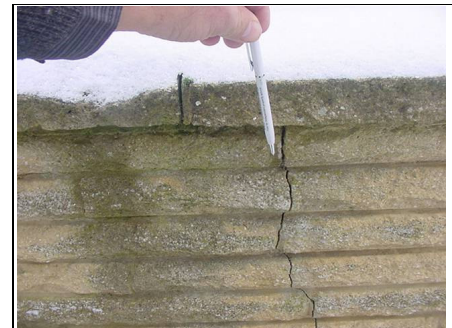
Crack to retaining wall

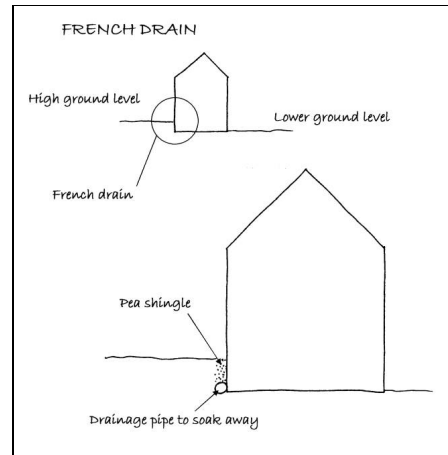
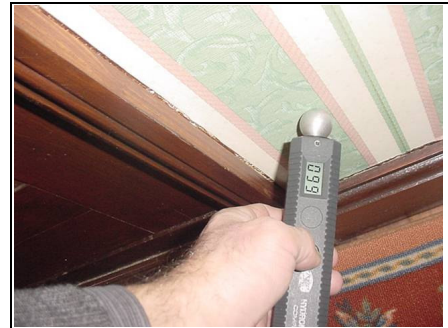
We have found and recorded damp readings to the front of the property. This we believe is due to the sloping site and the poor render detailing is allowing water to come in. We would recommend a French Drain is added. Our concern is that the timber floor beneath has been affected with this and there is an element of rot on it. Whilst we couldn't detect any major deflection we are aware that much of the floor was covered with wood blocks and carpeting.

Dampness at front of property – meter readings are typically between 30 and 60 on this type of property, here we have readings of 99

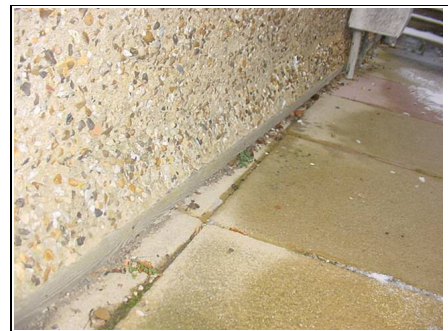
Need for French Drain at base of older render

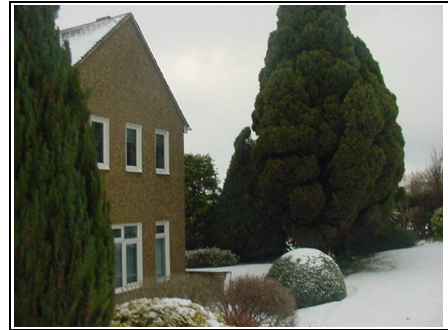
Large trees nearby

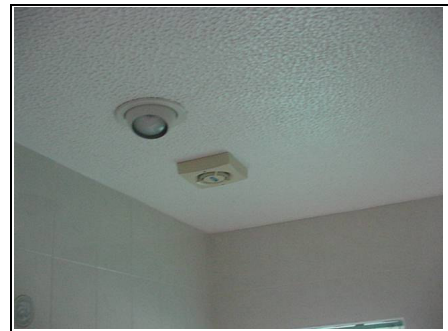
These older style 1970's lights tend to give off a lot of heat at the back which in turn can go into the floor or roof space and could ultimately cause a fire.

ACTION REQUIRED: We therefore recommend that they are changed.

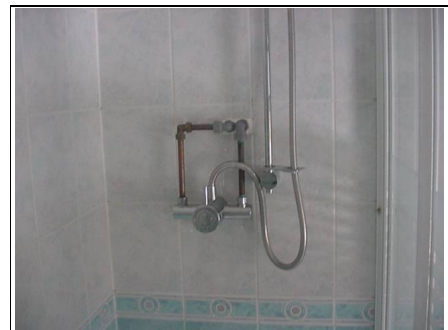
DIY Plumbing in shower room in right hand side bedroom

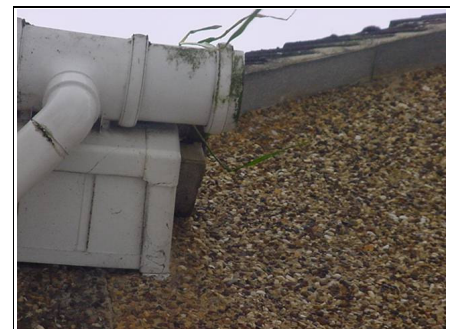
Generally they appear in average condition with the exception of one area where we could see plants growing out of it.

Grass coming out of gutter via leaks on joints

ACTION REQUIRED: We would always recommend that the gutters and downpipes are cleaned out, the joints are checked and the alignment checked to ensure that the gutters fall towards the downpipes.

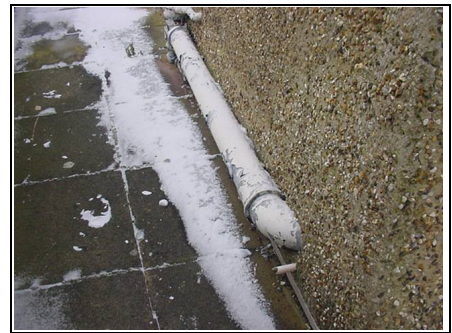
You have both traditional soil and vent pipes on the left hand side of the building and an air inlet valve to the right hand side within the roof. There is a part of the soil and vent pipe which has a minimal fall which is not ideal.

Soil and vent pipe which is running horizontally which is not ideal

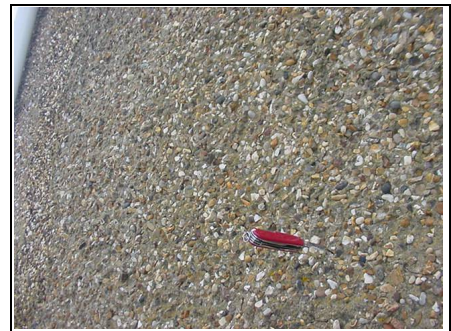
We noted mastic in lots of areas on the render which has been used to fill cracks in and stop further water getting in which is good practice. However it is only a temporary repair method but in this case seems to have been used as a permanent repair method!

Knife into crack in render

ACTION REQUIRED: Repair in a like for like material, ideally repair immediately. Please see our comments in the Executive Summary.

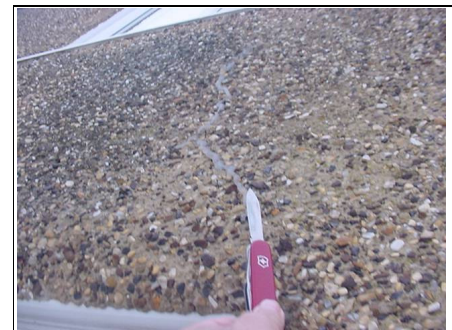
You can see the clear mastic which has been used in the past

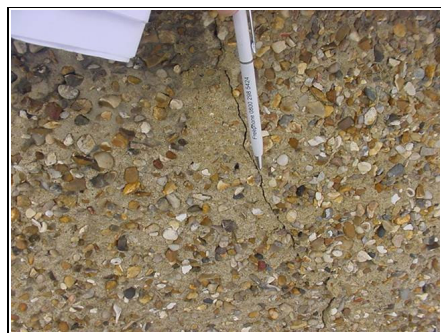
Crack in render

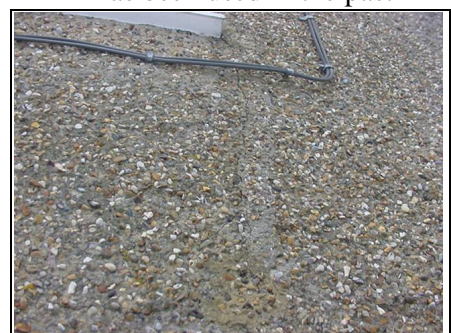
Extensive hairline cracking

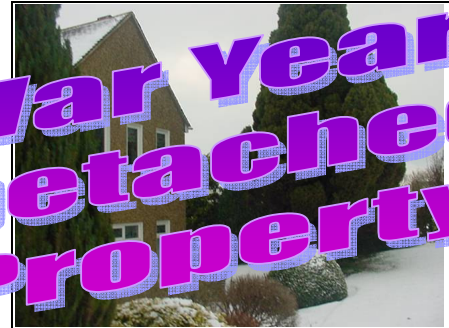
Damage to foundations and underground services can be caused by trees and shrubs. There are a number of these in the vicinity of the building, what we term within influencing distance, and we believe that these trees may be affecting the property.

Trees close to property

ACTION REQUIRED: You need to obtain advice from an arboriculturist (not a tree surgeon). Please see our comments within the executive summary.

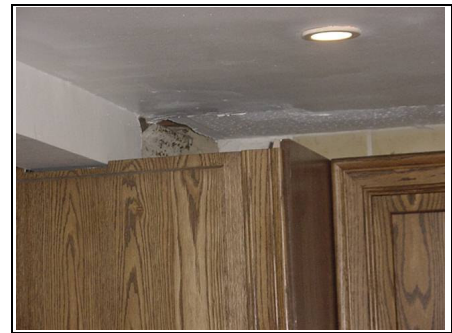
Unfinished ceiling

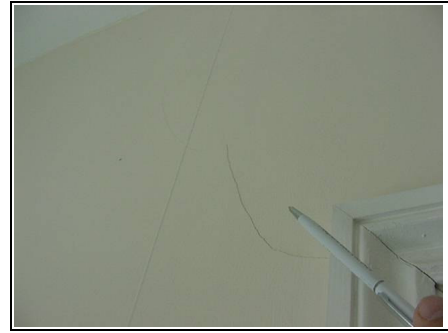
Cracking to walls

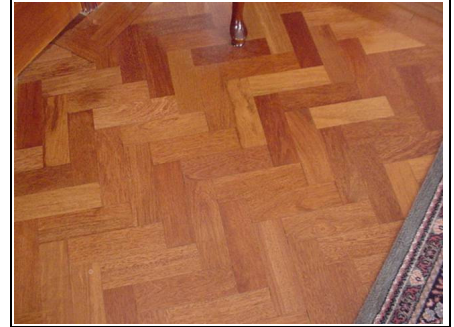
The ground floor construction is still a mystery to us. From the airbricks outside and the general age of property we would expect to find a suspended timber floor however due to the woodblocks internally and the carpet, etc. we have not been able to confirm this. We have expressed our thoughts that we believe the floor is probably predominately a timber floor although it is not out of the question it could have been replaced by concrete. This type of floor needs air circulation under it to reduce deterioration from wet rot and dry rot which we simply can't see enough airbricks; please see our comments in these sections.

Woodblock flooring

ACTION REQUIRED: The only option is to take up a section of the floor to check its condition.

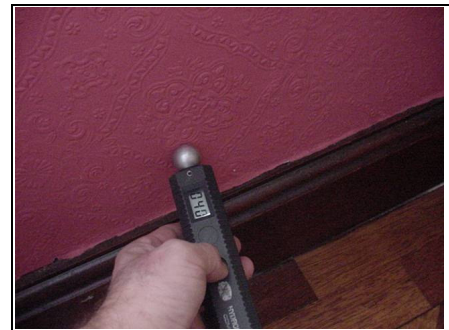
The readings we obtained indicated that there is some dampness in the property. It is located mainly to the front of the property. The whole of the property needs rechecking, it has to be remembered that it was snowing at the time of our inspection.

Reading at rear of property

ACTION REQUIRED: Please see our recommendations in the executive summary.
