RESIDENTIAL BUILDING SURVEY

A 1980's Detached Property, Tring, Hertfordshire, HP23

Mr L

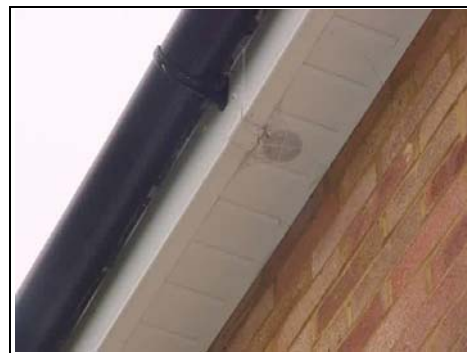
We noted that the property has plastic fascias, soffits and bargeboards and we think that these over-clad the original timber. This is a system used by what we can only term 'cowboy builders' to look as if the fascias, soffits and bargeboards have been carried out in plastic. The plastic is usually stuck on and, as there is no ventilation in this area, rot can occur.

ACTION REQUIRED: Carry out a sample by drilling into the fascia to see if there is wood below. If wood is present, strip off the over cladding and check the condition of the timber beneath. Ideally you should add a vent to the soffit and repair and redecorate as necessary.

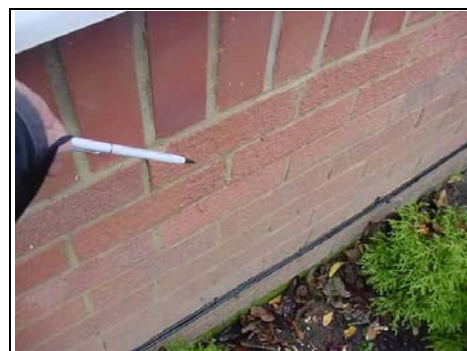
To the front right hand side of the property there is hairline stepped cracking visible in the mortar both above and below the ground floor window, running for approximately one to one and half meters in length. These cracks appear to be long standing but from a one-off inspection it is not possible to be 100% certain. Normally insurance companies require monitoring for approximately one year, as recommended by the Building Research Establishment (BRE).

Stepped cracking

ACTION REQUIRED: We would therefore recommend, and have agreed this with the owners / vendors, that an insurance claim is made by themselves with their insurer, Legal and General, and that the purchasers utilise the services of the same insurance company. If you would like any further clarification on this matter please do not hesitate to contact us.

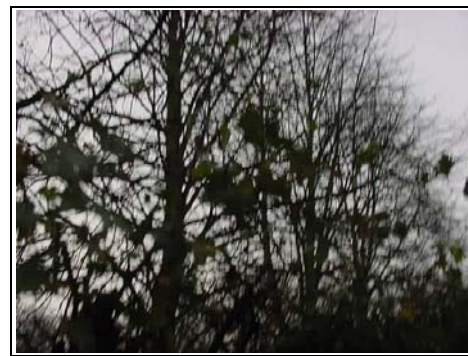
- i. the adjoining trees that are close by within the school grounds;

Trees may be causing movement?

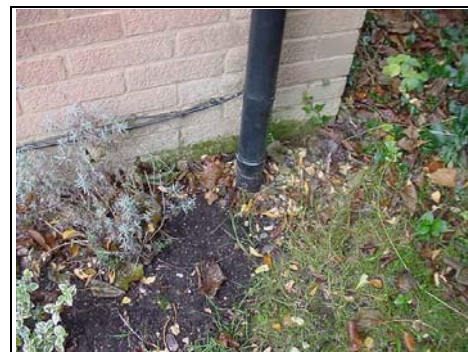
- ii. the downpipe to the right hand corner may be discharging directly into the ground rather than into a soak-away.

Downpipe discharging into the ground may be causing movement?

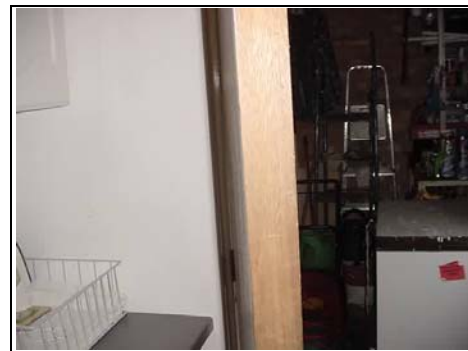
Door to integral garage

The garage is considered a high risk area due to the petrol and other things often stored within it. Therefore, current Building Regulations require a fire door. The current door, although it is thicker than a normal door does not appear to be a fire door as there is no intumescent strips around the frame.

ACTION REQUIRED: We would recommend that this door is replaced with a fire door, but this is not a retrospective requirement.

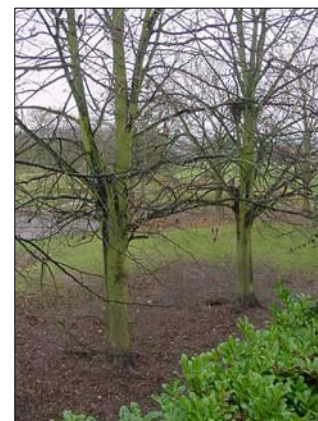
One problem we do foresee with the adjacent trees is that they are not on your property and therefore not within your control and that the school will have to maintain them. Whilst we find that most Local Authorities / County Councils are well aware of their responsibilities and have the skills to carry out such work, they often run short of budget.

ACTION REQUIRED: We recommend that you ensure that the Local Authority / County Council are aware of the trees and establish what maintenance programme they will be carrying out on them.

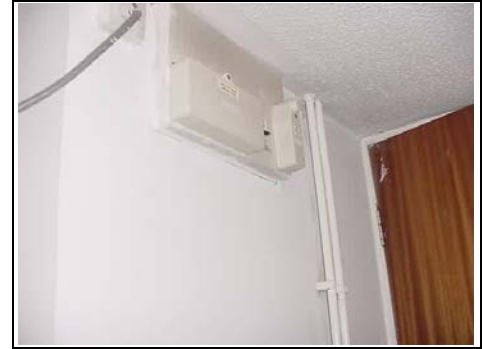
The fuse board is dated and it looks to be original and from our discussions with the owner we understand that there have been various minor alterations and modifications made.

ACTION REQUIRED: We would recommend that a new fuse board is added at a minimum.

We would also recommend at the same time that the entirety of the system is checked. We have carried out a basic earth test within the kitchen and found this to be satisfactory, but it does not represent an appropriate check which should be carried out by an NICEIC registered and approved electrical contractor or similar to the Institute of Electrical Engineers current recommendations.

ANTICIPATED COST: New fuse board will cost in the region of £250 - £400 plus the cost of the test and any recommended work which may amount to in the region of £500 - £1,000. We would also recommend that you have extra power points added as we use far more electricity today than we did when the property was originally built.

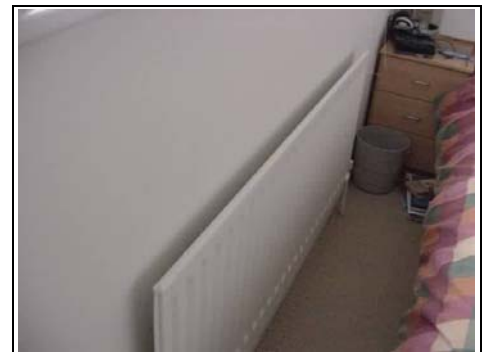
The property has a dated wall mounted boiler, which we believe has passed its useful life. Also, the radiator system has single panel radiators, which may not heat the property as quickly as you may wish and certainly won't heat as quickly as the modern double panel convection radiators that we discussed.

We would also add that when the heating was turned on it was slow to warm some of the radiators, which may indicate that it needs draining and cleaning (not forgetting to put an anti-corroder into the system when it is re-filled, such as Fernox) or that some of the valves are stuck.

ANTICIPATED COSTS: We would set aside the sum of £2,000 for a new boiler and another £1,000 - £2,000 for the renewal and replacement of radiators, thermostatic radiator valves and thermostat.

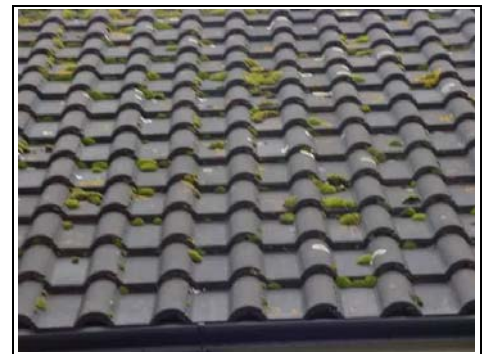
Moss, on concrete tiles, this can cause problems, with damage to the tiles surface and or blocked gutters.

ANTICIPATED COSTS: A few hundred pounds. As this is high level work we would not recommend it as a DIY job.

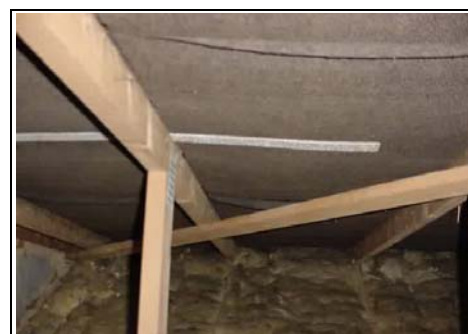
When we inspected the loft space we found a Hessian base Bitumen membrane. This type of membrane has been used since the 1960s. We generally found it to be in average condition with damage in some areas.

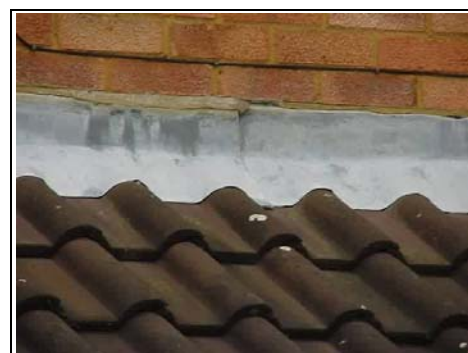
Where the roof meets the main building it has a lead flashing. Generally the flashing is in reasonable condition, although we did note areas where it has been repointed; this normally occurs because the original lead is not bedded in deeply enough to the brickwork. It is generally now recommended to bed-in with a mastic rather than a cement mortar.

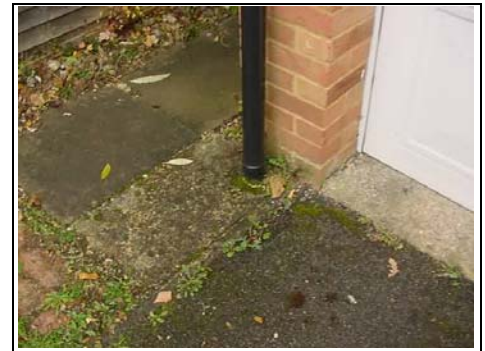
From ground level the gutters and downpipes looked to be older style plastic, which does get brittle with age and sunlight, at present it is in reasonable condition. There may be some minor leaks, but we feel that most people could live with these.

Please see our comments in the Executive Summary regarding the downpipes discharging into the ground.

ACTION REQUIRED: We would always recommend that the gutters and downpipes are cleaned out, the joints are checked and the alignment checked to ensure that the gutters fall towards the downpipes.

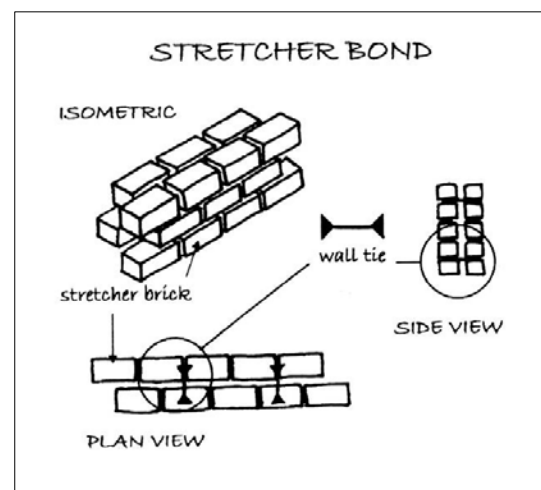
Step Cracking

Please see our comments in the Executive Summary.

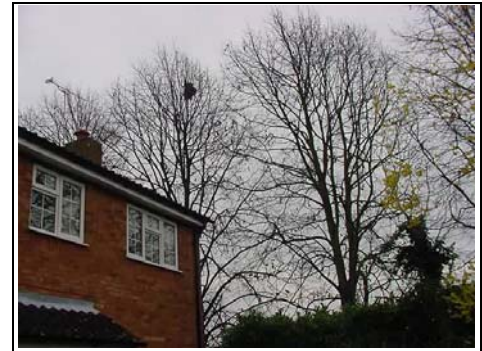
Damage to foundations and underground services can be caused by trees and shrubs. Whilst you don't have any trees in your garden, we have found trees adjoining the house which we believe are owned by the Local Authority / County Council and are 'within influencing distance' of the property.

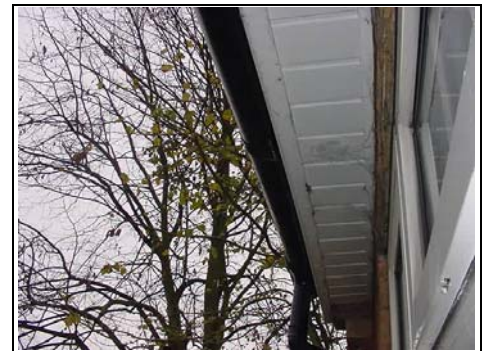
We noted that the property has plastic fascias, soffits and bargeboards and we think that these over-clad the original timber.
