# RESIDENTIAL BUILDING SURVEY

Notting Hill,  
London,  
W11

**INDEPENDENT CHARTERED SURVEYORS**

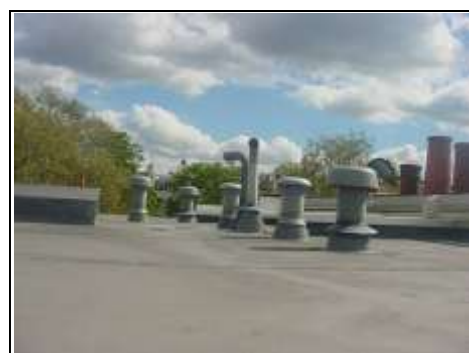
Single ply roof with vents

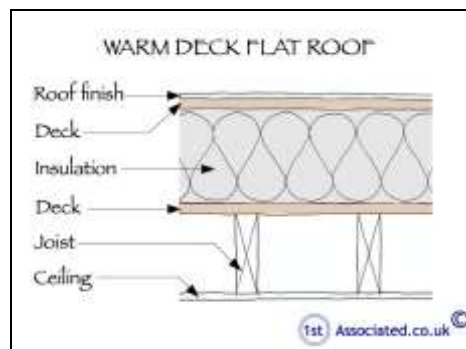
Regarding the rear roofs that we accessed; we believe water has got underneath the single ply roofing system and into the insulation as we can see a repair on it. This is over the wet room area so there may be problems in this area in the future.

The pen indicates a small circular repair to the roof similar to a bike puncture repair kit

**ACTION REQUIRED:** To change the roofs will be very expensive as this is high level roof work and will require scaffolding. We would therefore suggest that you keep the existing roof until problems occur and then take the opportunity to replace it with a high performance felt roof that has a good fall on it. We feel that from the roofs we have seen the most likely roof to need replacing will be the one over the wet room.

**ANTICIPATED COST:** We could only hazard an educated guess that to scaffold up to the higher levels to the rear of the property for the roof repairs would be in excess of £50,000 (fifty thousand pounds) possibly closer to £100,000 (one hundred thousand pounds). We stress that the roof on a visual inspection seems to be performing satisfactorily ;

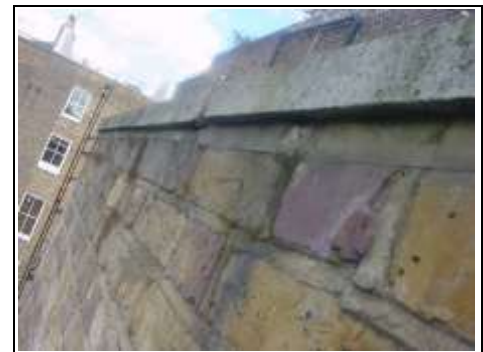
We can see that the coping stones to the rear have been wrongly positioned into the wall structure and without a drip which means that dampness will be getting into the wall. In theory there is no need to have a drip as the entirety of the inside wall is sealed however we would prefer to see this to stop deterioration of the joints

Moss and lichen are starting to grow on the rear side of the wall

**ACTION REQUIRED:** We would recommend a new coping stone is added and a check to ensure there is a damp proof course underneath.

**ANTICIPATED COST:** In the region of £2,500 - £5,000 assuming it can be carried out from on the roof. Please note the single ply roof will have to be well protected or the builders walking on it will damage it; please obtain quotations.

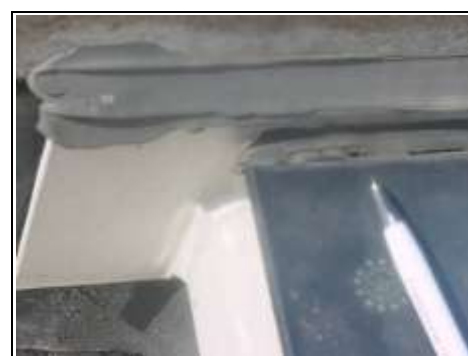
Perishing mastic to the roof.

**ACTION REQUIRED:** We would recommend you have a skilled and an experienced person to check all the different mastic seals around the property before the winter of 2012 and seal as necessary.

**ANTICIPATED COST:** £2,000 - £4,000 (two thousand pounds to four thousand pounds) to have the work carried out properly. This could be more if a specific problem is found; please obtain quotations.

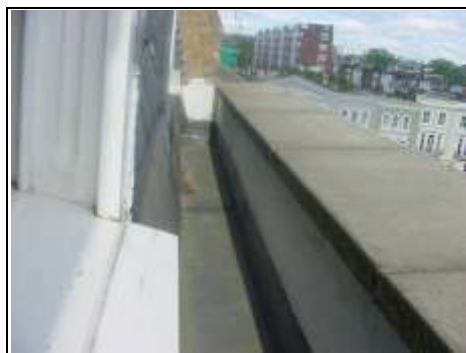
The box gutter to the front of the property is renowned for problems. It looks as if additional masticing had been carried out in this instance. We can't see any damage but then we wouldn't with this type of construction

Box gutter detail to front of property

**ACTION REQUIRED:** This is a very difficult problem to resolve as the box gutter needs a fall to make sure all the water gets to the hopper head end and a suitably sized outlet to make sure the water gets transferred to the downpipes. It looks from the deterioration that the downpipe is not taking the water away quickly enough. This may relate to a blocked box gutter but generally we find it relates to a poorly detailed box gutter and poor workmanship. The best way forward is next time it rains heavily is to have a look at the box gutter to see if there are any visual problems.

**ANTICIPATED COST:** Unfortunately you can try to rectify box gutter problems for ever and a day. We personally would recommend relining in a lead. This is a tried and tested method of having a waterproof box gutter; please obtain quotations.

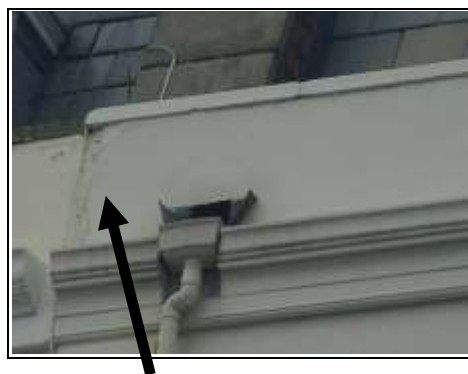
Front of box gutter- water damage to render,

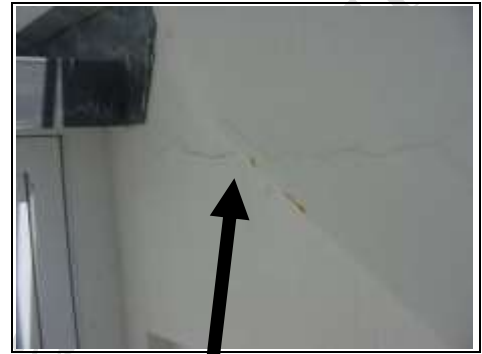
We noted in the front courtyard area that there was cracking to the render and also rusting to the angle beads. These areas we find are always very difficult to manage and make watertight as they are the low areas of the property. We will often find, as in this case, that dampness is coming in through the stairs into the cupboard underneath the stairs.

Cracking to the render

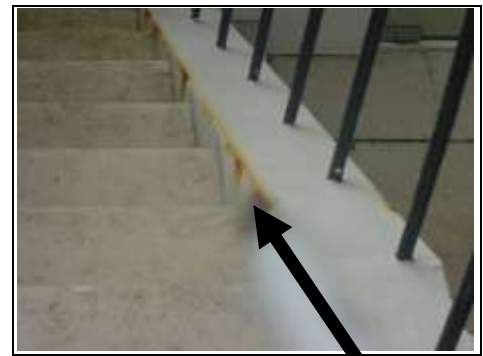
Rusting visible to the angle beads on stairs leading to the courtyard

**ACTION REQUIRED:** We can see that there is rusting visible to the angle beads (this is normally where internal angle beads have been used rather than external angle beads). We recommend these are removed and replaced. Our biggest concern is whether dampness is coming in through the walls. We simply do not know due to the way the walls have been constructed with the dry lining.

**ANTICIPATED COST:** In the region of £1,000 - £2,000(one thousand to two thousand pounds) to replace the angle beads and to carry out re-rendering work; please obtain quotations.

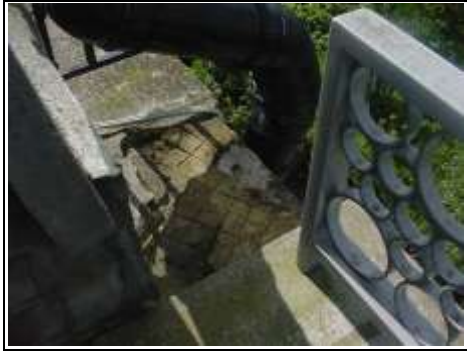
There is also a parapet wall to the rear balcony. We noticed a coping stone was missing where your balcony joins the neighbour. We would suggest one is added. You should also keep an eye on the near vertical stones as we are not keen on these as they seem to be defying gravity!

Coping stone missing

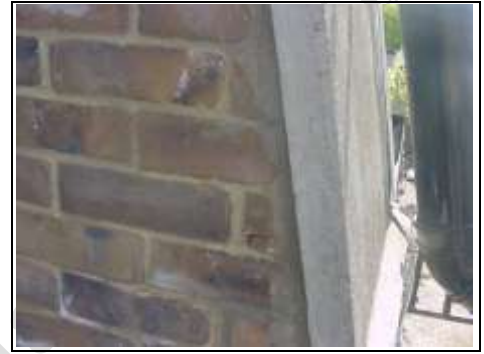
Near vertical coping stone (we are not keen on these)

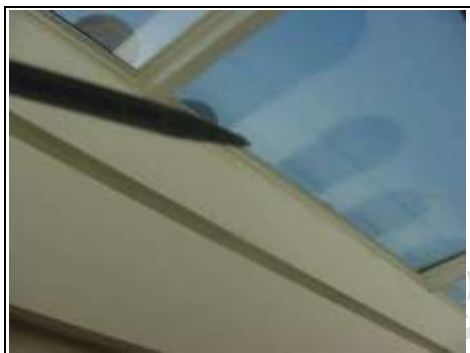
We noted that the roof light over the stairs is leaking. This may have been due to the roof being open when it was raining

We found a leak in roof window over the stairs on the top floor

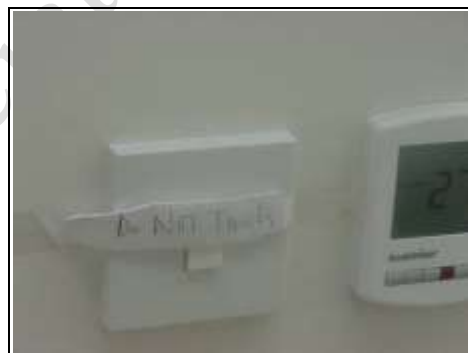
We were advised not to try to open the roof window on the top floor above the stairs

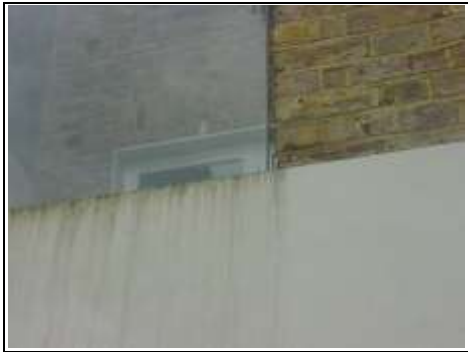
Ground Floor Rear balcony, poor detail has caused staining.

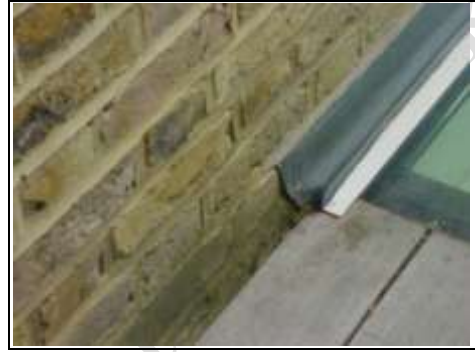
Poor detailing needs improving

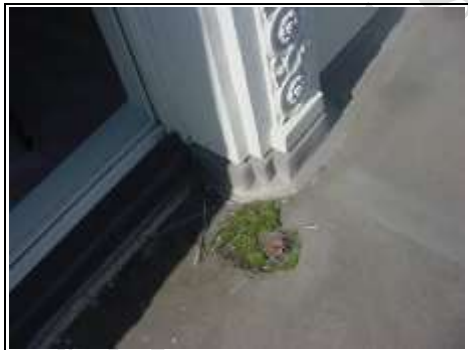
The front gutter from the balcony does take a torturous route with a ninety degree bend to travel around the new glazed roof area and we would expect this to leak once it is unblocked at the balcony level.

Gutter needs unblocking

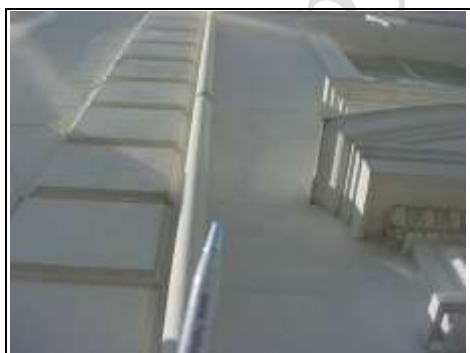
Cracking in render to front of property

We would remind you that any hairline cracks that appear need to be sealed as soon as possible to stop dampness and water getting in and causing blisters and hollow areas.

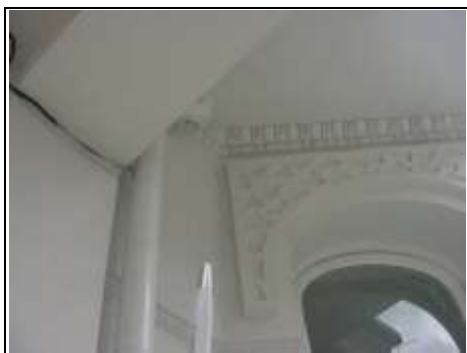
Cracking to bay

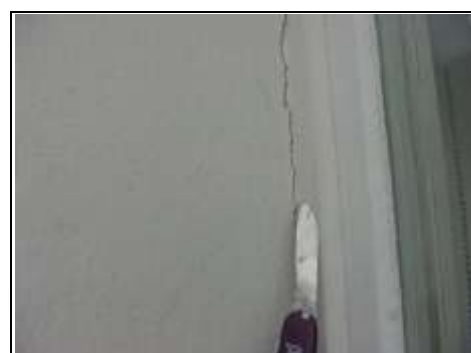
Cracking in hard modern render against the timber (more mastic required)

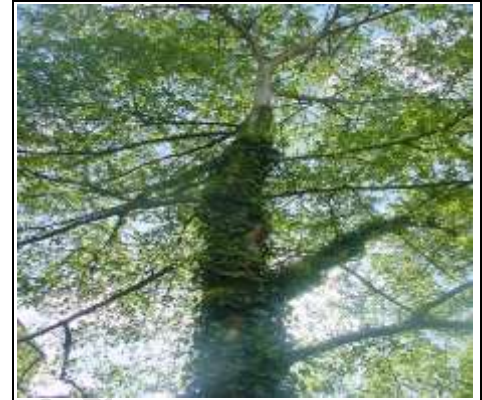
There are trees within what insurance companies would term as influencing distance of the property. It would be worth enquiring to who the current insurance company is or alternatively checking any insurance liabilities with your preferred insurance supplier.

Trees are located to the rear

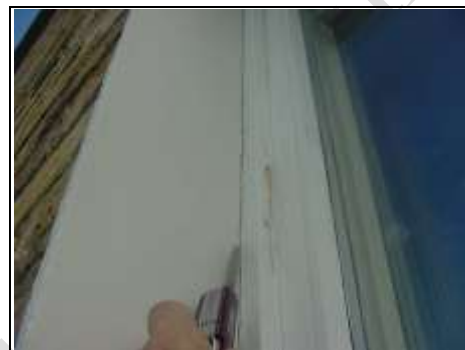
We can see some of the windows are deteriorating with flaking paint. We would recommend redecorating in the summer of 2013. Obviously access would be difficult with this size of property.

Paintwork starting to deteriorate on windows - decorate summer 2013

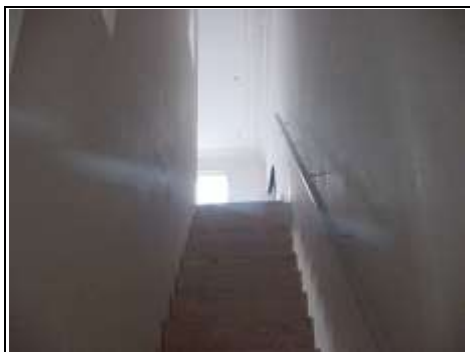
Ground floor to first floor stairs are slightly narrow

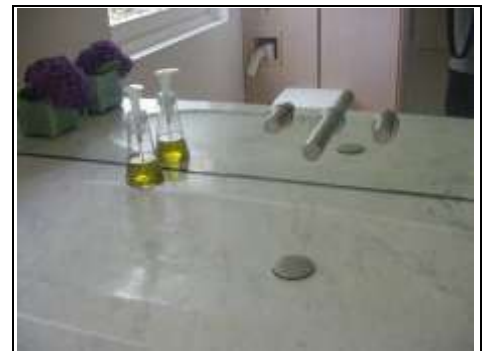
Shallow sink ground floor cloakroom
