**RESIDENTIAL BUILDING SURVEY  
OF  
Wadebridge, Cornwall, PL27**

**FOR  
Mr S**

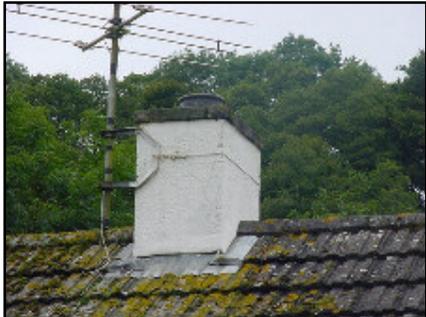
This is a centrally positioned chimney with a painted render finish, which looks in reasonable condition. There is a lead flashing, which we consider to be the best type of flashing available.

We would comment that unfortunately we were unable to see the flaunchings or the chimney pot at its base. However, in this age of property they are likely to need some work in the next five or ten years.

Note the lead flashing to the base of the chimney, which is a good detail

**ACTION REQUIRED:** Check the flaunchings and the chimney pot and recheck the whole chimney when work is carried out to the rear roofs, commented upon later on in this report.

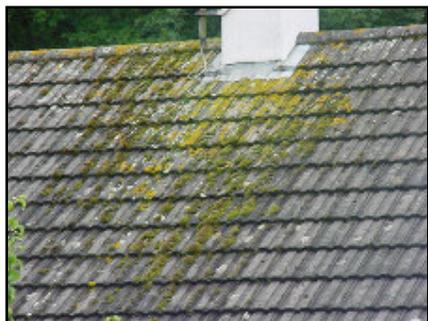
There is a very minor amount of moss growth present on roof slopes. This can, in extreme cases, impede the run-off of rainwater, lead to gutter blockages and cause water penetration, which in turn may lead to rot or other defects in nearby timbers.

Layer of moss, this is not unusual on concrete tiles.

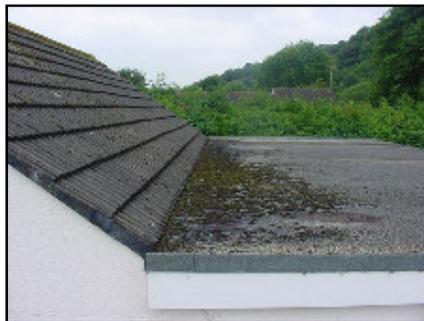
This property has a bituminous felt covering with a mineral felt to the perimeter. Flat roofs with bituminous felt coverings have a limited life expectancy dependent on standards of workmanship, the quality of materials and the degree of exposure. A life span of 10-15 years, possibly longer up to 20 years, can normally be anticipated though failure can occur earlier. In this instance you are ten years through this life expectancy.

We would comment that the roof is not particularly good quality. This is based on the deflection that we found in it when we were standing upon it, which is above average for what we typically find (and the lack of fall).

General view of rear extension roof

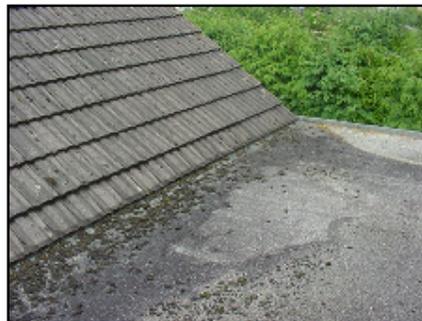
There are various bald areas to the flat roof as can be seen in this photo.

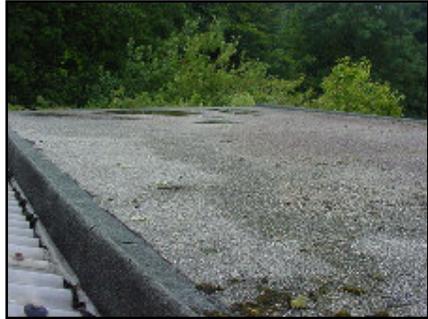
This has moved on to the next stage on the garage roof where ponding was visible (there was light rain during the course of our survey). Ponding is literally puddles on the roof, this then leads in the winter months to freezing of the water which changes the expansion and contraction characteristics around it, which in turn causes splitting in the roof. We therefore would comment that the garage roof has an even shorter life span.

General view of garage roof, note the ponding (puddles) to the far end of the roof.

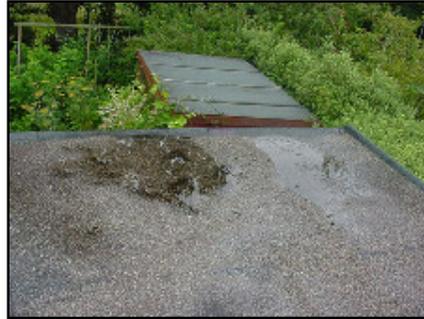
Close up of the ponding.

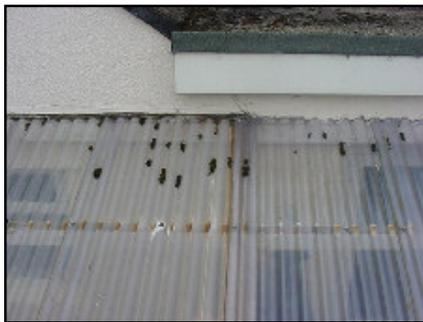
Photo of link between the two flat roofs.

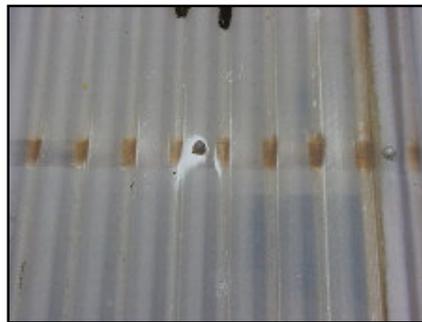
Close up shows that some of the fixing points are starting to leak.

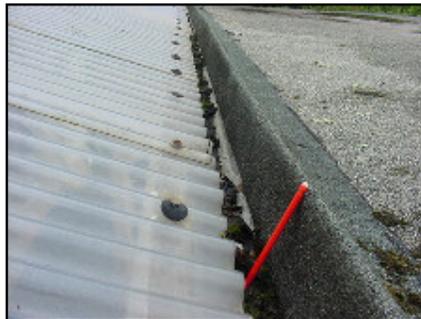
Our main concern is the gutter detail that is caused between this roof and the garage roof, which will need regular cleaning to avoid it leaking. This is a very poor design detail and it would, in our opinion, have been better for the water to have discharged onto the flat roof.

The pencil indicates where the valley gutter is. This is a poor detail and will need regular cleaning to stop water coming in through the roof in this area.

**ACTION REQUIRED:** Clear valley gutter regularly.

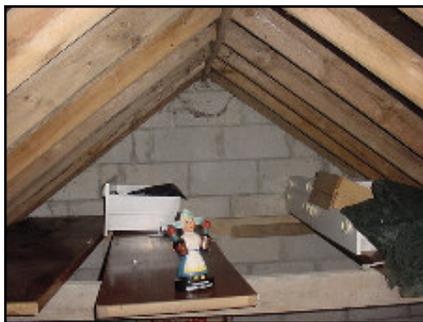
General view. Note the blockwork to the end gable indicating that this is a blockwork built property

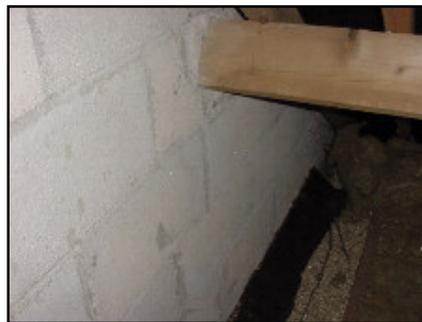
This is the end of the purlin, often a weak area, in this case no dampness was found.

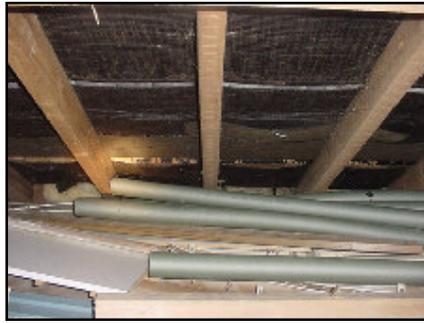
This shows where the pitched roof meets the flat roof, which can be a problem area, again nothing was found.

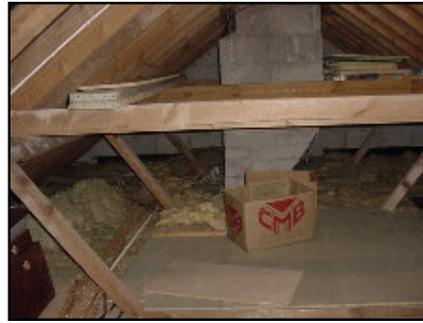
Another general view of the roof showing the chimney in the centre built of blockwork and the brace to the 'A' frame of the roof.

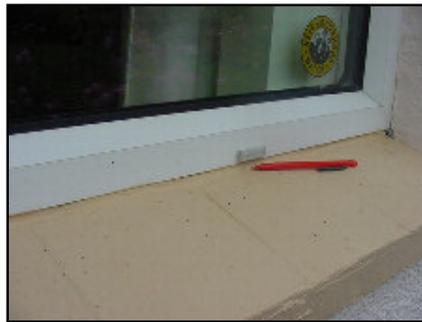
The pencil indicates the trickle vent.

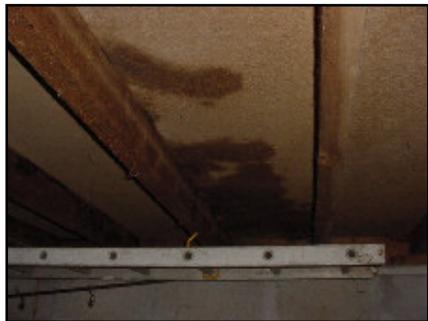
This appears to be old staining.

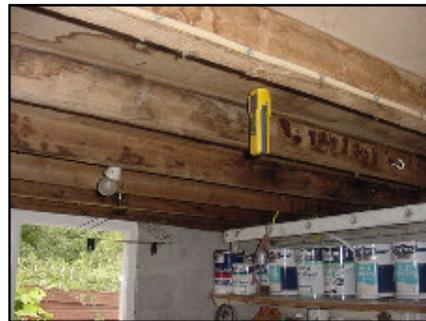
You can see the yellow damp meter has been used in the centre of this photo to check the dampness. We found no readings over and above those we would normally expect.
