JOB REFERENCE: XXXXXXXXX

RESIDENTIAL BUILDING SURVEY

XXXX
Warlingham
Surrey
CR6 XXX

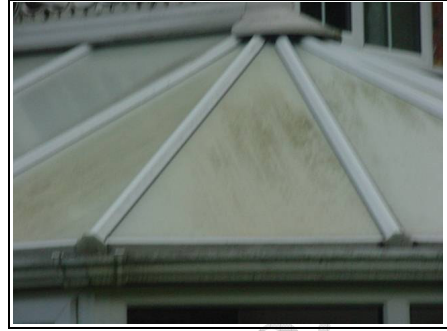
Any kitchen/ conservatory of this size is likely to experience thermal heat gain in the summer and heat loss in the winter months and this will impact the house as a whole. We noted that the conservatory does not have blinds nor high level vents which we prefer to see as these allow a better climate control.

Moss starting to occur on conservatory roof

ACTION REQUIRED: We recommend to improve thermal gain/heat loss is to add good quality blinds/curtains and a roof vent if possible. Also for cosmetic reasons you may wish to clean the polycarbonate roof.

ANTICIPATED COST: It will depend upon what you wish to carry out but we have found that roof blinds seem to be particularly expensive; please obtain quotations.

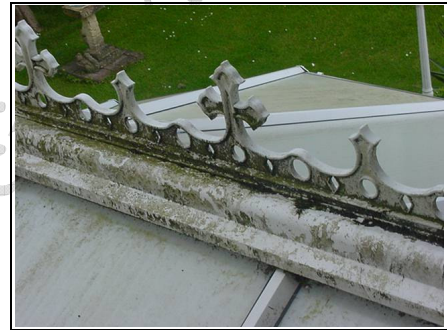
Mould to conservatory roof

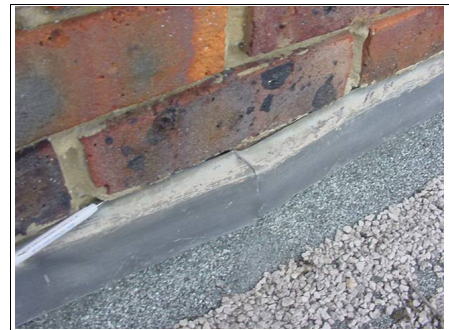
3.0) Flat right hand side roof flashings coming away and roof leaking

The flashing is coming away to the right hand side flat roof (all directions given as you face the property). The felt roof is deteriorating and within the utility room there are signs of a leak.

Flashing coming away to the right hand side

ACTION REQUIRED:
Replace/re-bed flashings. Budget to re-roof or patch repair.

ANTICIPATED COST: To patch repair a few hundred pounds; please obtain quotations.

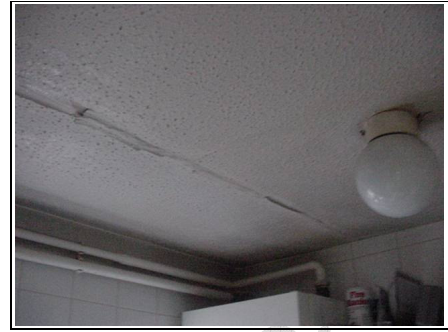
Leak in utility room

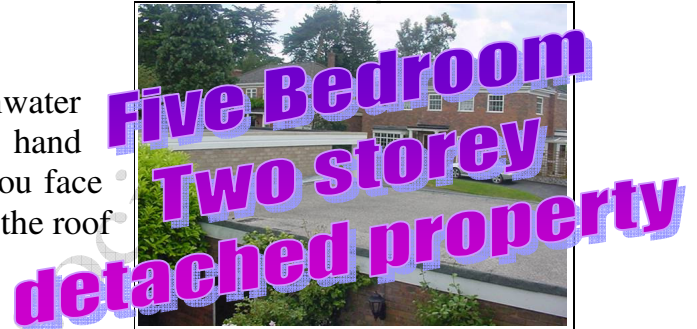
General view of garage roof

The garage roof is letting in rainwater particularly to the rear right hand corner (all directions given as you face the property). From viewing on the roof itself this leak is directly over the gully that is within the flat roof.

ACTION REQUIRED: Re-roof and partially replace the decking.

ANTICIPATED COST: In the region of £3,000 to £5,000; please obtain quotations.

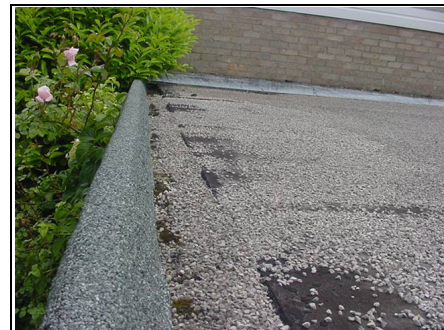
Rear leaking gutter to tree end

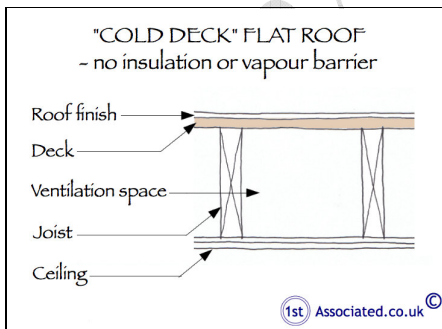
There is no plasterboard in this particular instance

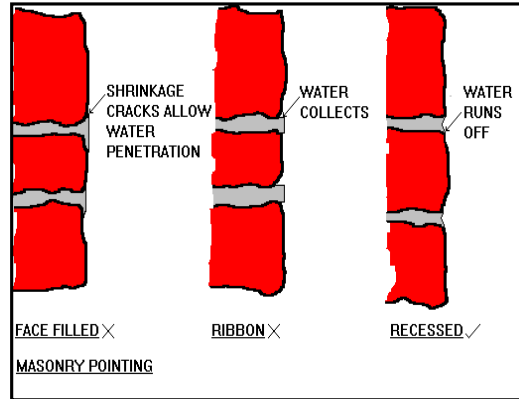
The property has messy pointing to the brickwork which requires re-pointing. It looks like the perpendicular ends (known as the “perp ends”) have been carried out at a later date.

ACTION REQUIRED: Carry out ad hoc re-pointing work over the next few years.

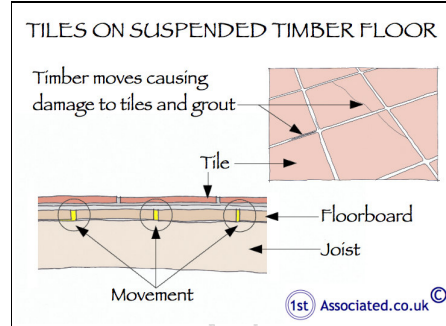
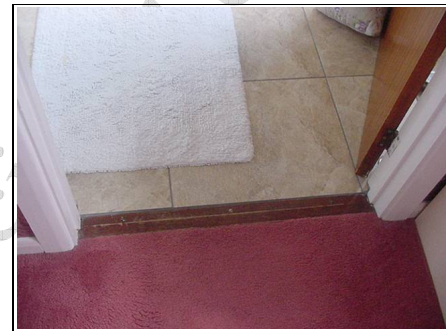
In the family bathroom the tiles have been installed onto a wooden floor which is prone to movement and therefore cracking of the joints.

Tiles to wooden floor in family bathroom at first floor level

ACTION REQUIRED: Check for movement and remove grout and replace when cracking to joints occurs.

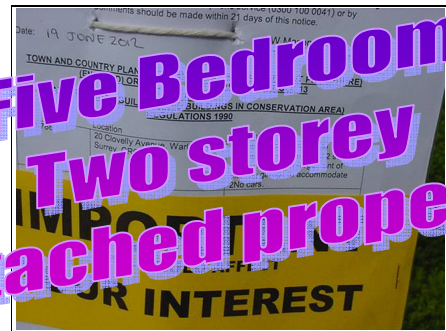
At the time of our survey we noted a Planning Application Notice regarding XXX

ACTION REQUIRED: Your Legal Advisor to check and confirm details regarding this Planning Application.

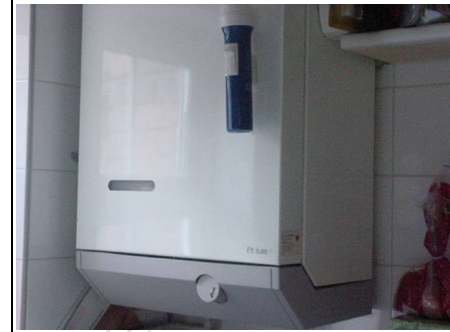
Potterton Boiler

The property has an original wall mounted Potterton boiler which is dated with more energy efficient boilers now being available.

ACTION REQUIRED: These boilers can last a fair amount of time, it depends upon the maintenance carried out however ultimately you do need to start saving/budgeting for a replacement boiler and a power flush of the radiators. Possibly you may have to change the radiators as the pressure in the newer boilers tends to be greater than that in the older boilers.

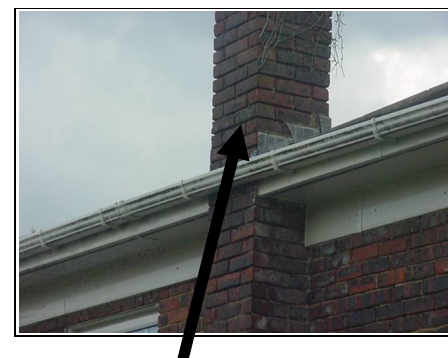
The brickwork on this property has a very deep recess, far deeper than we are keen on as it allows rainwater to sit in it and this is particularly so at high level.

Re-pointed required

ACTION REQUIRED: We would recommend re-pointing work to be carried out to the chimneys and would suggest this is carried out in the summer of 2014. Periodically inspect the chimney.

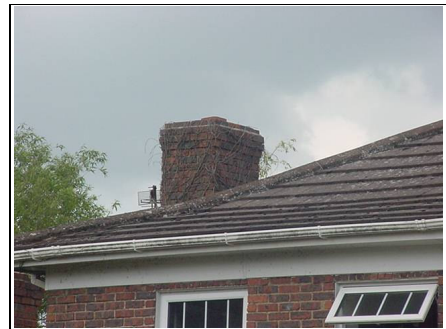
Chimney Two

We noted that ivy has been present at one time which has been cut back.

ACTION REQUIRED: Periodically inspect the chimney, re-point in due course.

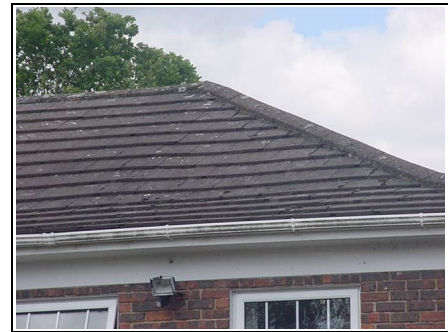
Main roof

The main roof is pitched and hipped being clad with concrete tiles and, from ground level, this looks in average condition considering the roofs age type and style. With this age of roof there will usually be a few missing or displaced tiles, this is nothing unusual.

ACTION REQUIRED: Carry out periodic inspections and maintenance of the roof, as required.

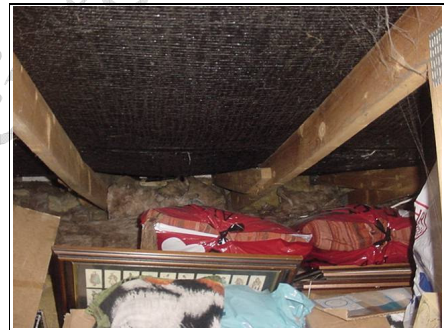
When we inspected the loft space we found a Hessian base Bitumen membrane. This type of membrane has been used since the 1960s. We generally found it to be in average condition, with damage in some areas which is what we typically find.

This photo shows the common rafters (the ones that form the pitch of the roof) and the dark area between is the protective underlayer.

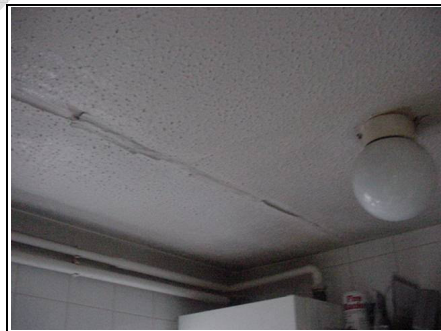
Leak in utility room

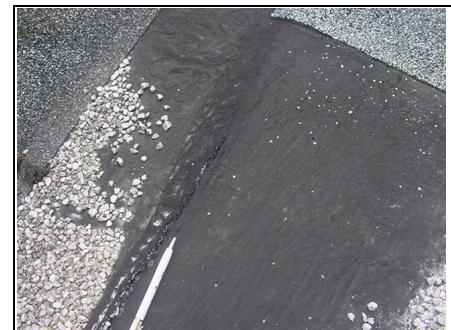
Splitting starting to occur

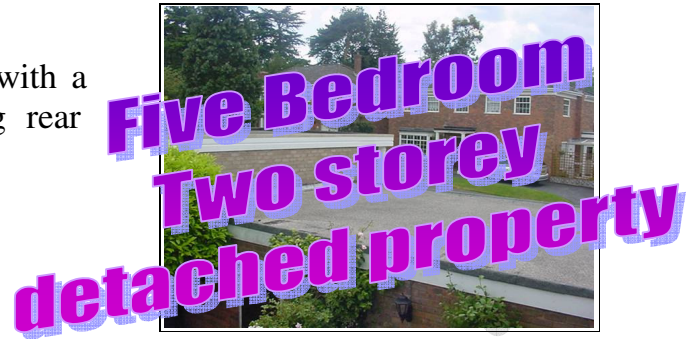
General view garage roof

The property has a double garage with a flat felt roof. There is a leaking rear gutter.

ACTION REQUIRED: Please see our comments in the Executive Summary.

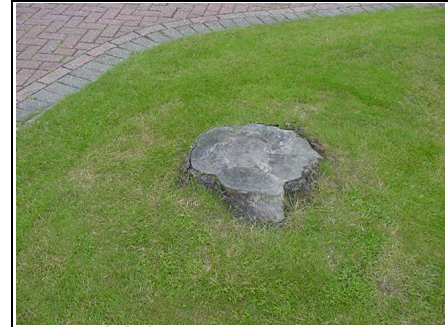
There is a tree within what insurance companies would term as the influencing distance of the property which we are advised by the present owners was cut down approximately six years ago.

Tree cut down to the front of the property

ACTION REQUIRED: Seek advice from an aboreturist not a tree surgeon as the root system is still in place which could affect the property.

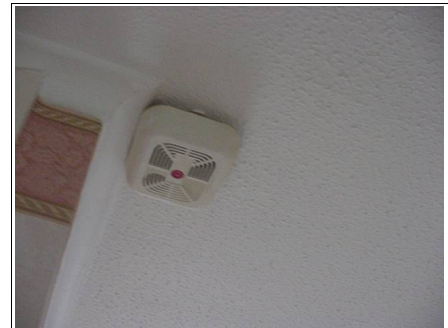
Battery operation smoke alarm

ACTION REQUIRED: We would recommend, for your own safety, that smoke detectors be installed. We would always recommend a hard wired fire alarm system and are also aware that some now work from a wireless signal which may be worth investigating. Whilst fire is relatively rare it is in a worst case scenario obviously devastating.

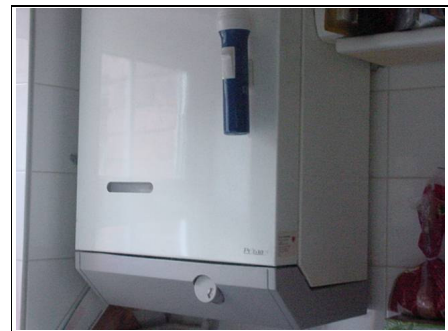
Potterton boiler

Our limited inspection of the hot water and central heating system revealed no evidence to suggest any serious defects but we would nevertheless recommend that the system be tested and overhauled before exchange of contracts and that a regular maintenance contract be placed with an approved heating engineer.
