RESIDENTIAL BUILDING SURVEY
OF
A 1960's End of Terrace Property, Welwyn Garden City,
Hertfordshire

FOR
Mr G and Ms T

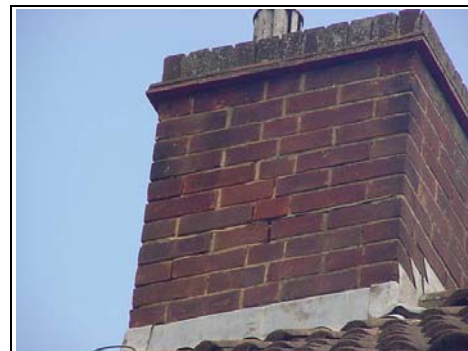
We could see that the pointing is deteriorating slightly to the rear of the chimney, which will ultimately lead to dampness getting in via the chimney.

ACTION REQUIRED: In the next few years some re-pointing will be necessary.

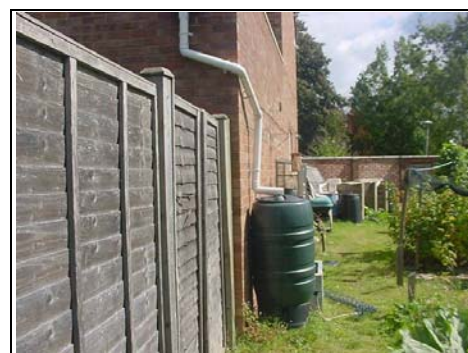
Presently the rainwater discharges through a downpipe and into a water butt located on the allotment. This is known as permanent trespass and this is where you use someone else's land for your own purposes.

An extension such as this should have a soak-away located three to four meters away from the property. We find that builders often miss these out, although they would have to have had one to get Local Authority and Building Regulation Approval.

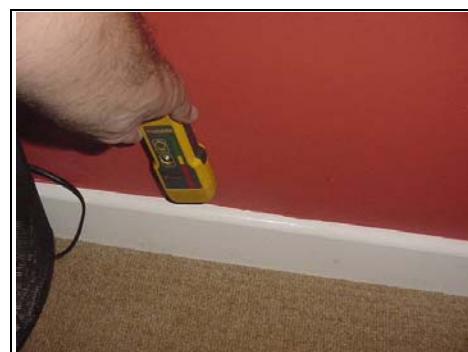
Surprisingly we found rising damp to the rear extension of the property.

We believe this is for a combination of reasons. Partly the decking that sits against the wall that will help draw dampness into the property, very much like blotting paper, and partly we believe there is condensation within the shower room due to the extraction system being poor.

ACTION REQUIRED: Add a larger extract fan; we would like the fan to be at least six inches in diameter. Also we suggest you move the decking away from the wall. Once this has been carried out you then need to get the property re-checked by a damp proof company as there is an outside possibility that the original damp proof course and damp proof membrane has failed for some reason. In a worse case scenario this could be very costly as it would involve lifting up the floor to correct it.

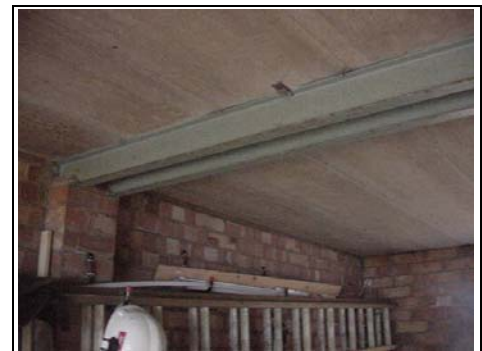
The underside of the garage roof looks to be asbestos (it is almost impossible to be 100 percent certain by eye), which was commonly used in properties of this age. We could see in the underside of the garage that an asbestos roof has been used. On the top of the roof it has been covered with a mineral felt.

Much is written about the dangers of asbestos; this related to the fibres that occur when it is deteriorating. In this instance the condition is reasonable within the garage, but our insurance company requires us to advise you that we are not specialist asbestos surveyors.

ACTION REQUIRED: You should note that work involving products containing asbestos is covered by Health and Safety legislation and you are recommended to seek the advice of the Local Authority Environmental Health Officer before proceeding with any such work.

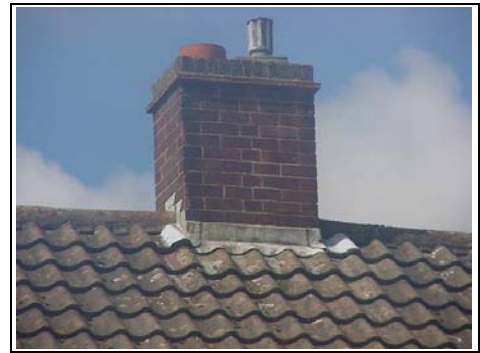
This chimney is built in brick with a metal flashing believed to be lead and has one chimney pot and one flue. From what we could see the chimney needs repointing and we would also recommend that the flashing is checked at the same time. We were unable to see the very top of the chimney known as the flaunching, we therefore cannot comment upon it.

ACTION REQUIRED: Please see our comments in the Executive Summary.

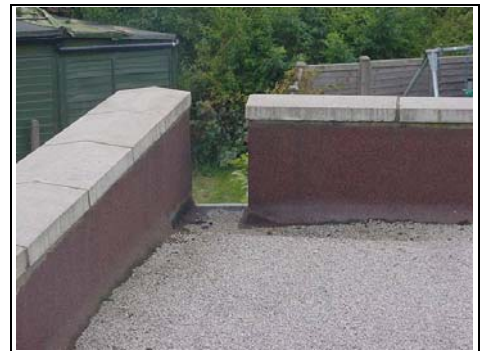
In this case there are parapet walls to the rear flat roof extension. The flashing to the parapet walls is felt; we would much prefer to see a lead flashing as lead moves and adjusts with the building much better whereas a felt flashing tends to deteriorate over the years. Having said that there should be a reasonable amount of life left in the felt, albeit that we could see that the parapet walls have been built in a different colour brick, which may mean that there have been problems.

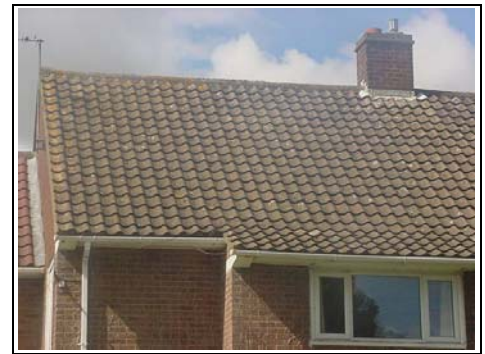
The main roof is pitched and clad in a nibbed concrete tile. From what we could see the concrete tiles are lying level and true and look in reasonable condition. Sometimes we find that deterioration occurs to the ridge and exposed areas such as the perimeter and so you should periodically check these areas.

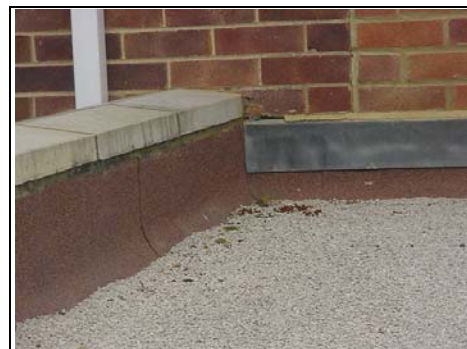
The rear flat roof has a felt covering, whilst the felt is in reasonable condition it is poorly detailed being predominately flat and having a felt flashing to the parapet walls, although there is a lead cover flashing where it meets the main building (please note that this is not the same as a lead flashing).

ACTION REQUIRED: Please see our comments in the Executive Summary. We would also recommend a lead flashing is added.

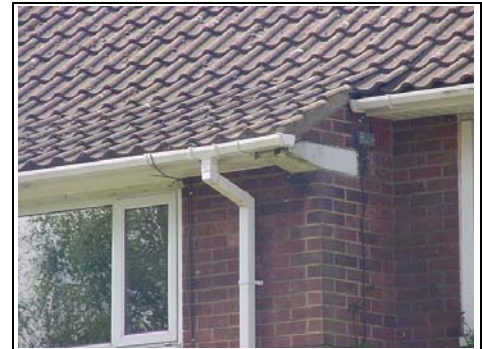
The property's gutters and downpipes are fairly typical of what we see and are in average condition. There may be some minor leaks, but we feel most people would be happy to live with these.

ACTION REQUIRED: We would always recommend that the gutters and downpipes are cleaned out, the joints are checked and the alignment checked to ensure that the gutters fall towards the downpipes.

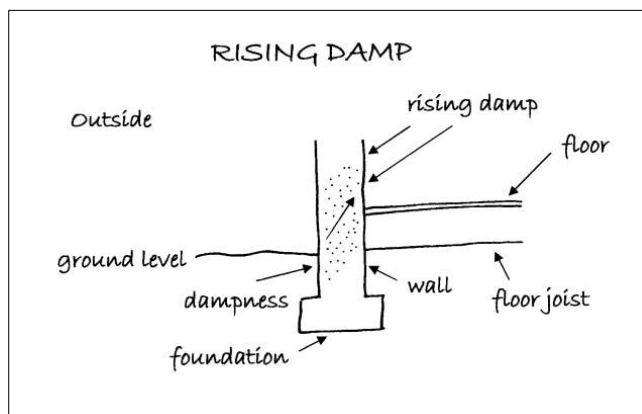
We carried out tests with our electronic damp meter and were surprised to find rising damp.

ACTION REQUIRED: Please see our comments in the Executive Summary.

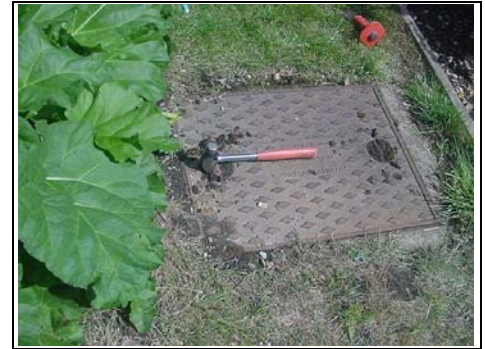
Inspection Chamber / Manhole Two – to the Left Hand Side in the Allotment

We were unable to lift this manhole.
