RESIDENTIAL BUILDING SURVEY

Weybridge, Surrey KT13

INDEPENDENT CHARTERED SURVEYORS

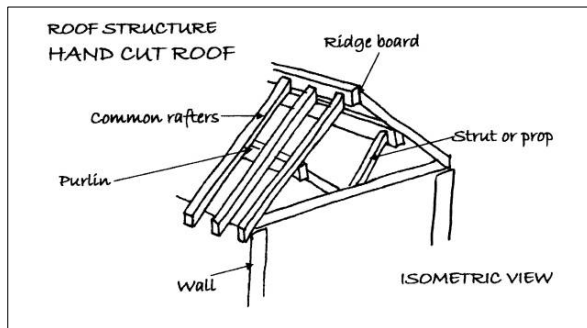
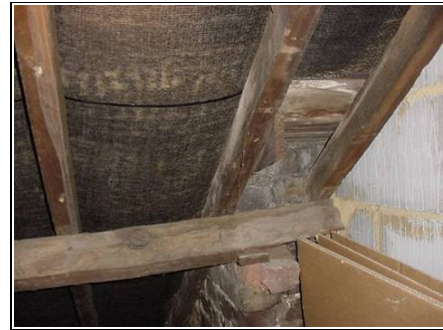
The roof space requires ventilation and the purlin close to the firewall needs additional support.

Close up of the purlin to the front of the property that needs a prop.

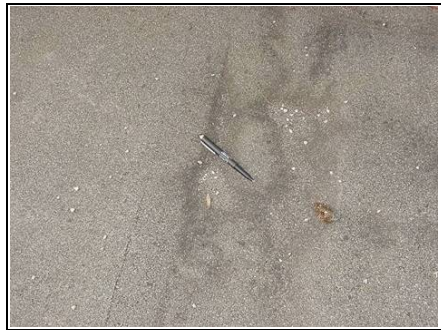
The lower roof, which was the only one that was accessed, has some areas of blistering and the high level roof has an awkward central valley drainage gutter.

Close up of the blistering to the felt to the lower level rear flat roof.

ACTION REQUIRED: Renew the roofs with a high performance felt. We would also recommend an insulation cut to falls to ensure better thermal efficiency on the roof and a fall towards the gutters!

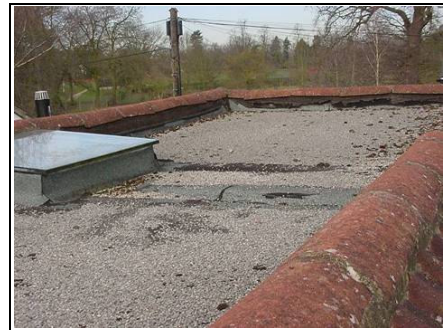
High Level Flat Roof
Awkward central drainage valley

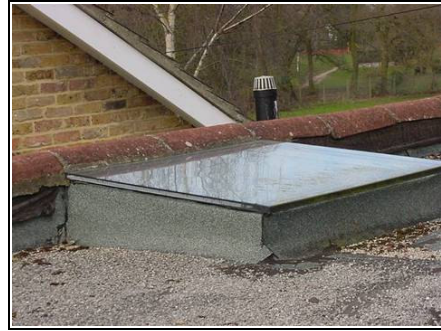
We would also take the opportunity of changing the roof windows / skylights. We could not see a British Standard Kite mark on the glass, indicating that it is not safety glass (it looks to be normal double glazing that is used in windows) and therefore if a tile comes off the roof it is likely to go through the glass.

ACTION REQUIRED: You may wish to replace these windows with safety glass.

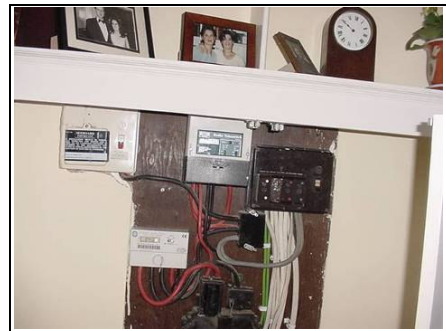
The electrics are from circa 1960s and are dated. We recommend a new fuse board (as small fingers can get into the socket points). We also noted some DIY-type wiring.

ACTION REQUIRED: Have the fuse board replaced by an NICEIC (or similar) registered and approved electrical contractor.

As the property is changing occupancy the Institute of Electrical Engineers (IEE) recommend an NICEIC (or similar) registered and approved electrical contractor carry out an inspection, test and report.

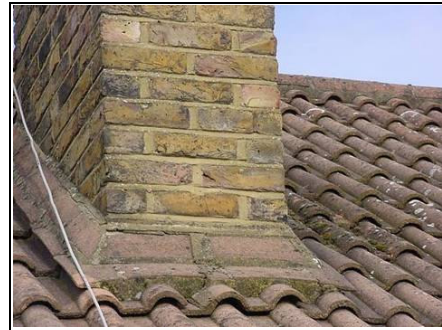
Base of chimney with a tile on edge flashing

A tile sitting sideways, bedded in cement mortar which has been utilised as a flashing. Due to the cement mortar it is bedded in being brittle and prone to cracking, this is not an ideal material. We would always recommend the use of lead flashings.

ACTION REQUIRED: The tile on edge flashing should be replaced with a lead flashing as these keep a much better watertight seal as they are more pliable.

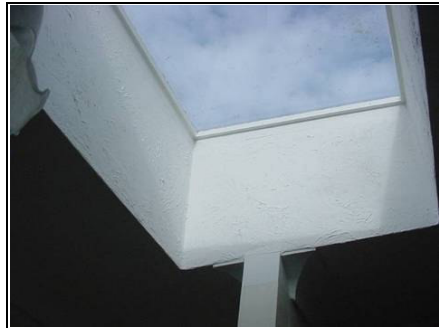
High Level Roof Window above Shower Room

Please see our comments in the Executive Summary. Ideally the roof windows should be replaced and we also recommend that the high level one within the shower room is made openable. Both the current roof windows are purpose made, so it may actually be difficult to buy off-the-shelf. We would always recommend the bubble-type of roof window for a flat roof, i.e. this means that the water cannot sit on it. Having said all of that it seems inevitable with roof windows that they will sooner or later leak. If this doesn't occur then they seem prone to condensation. Keep a cloth handy!

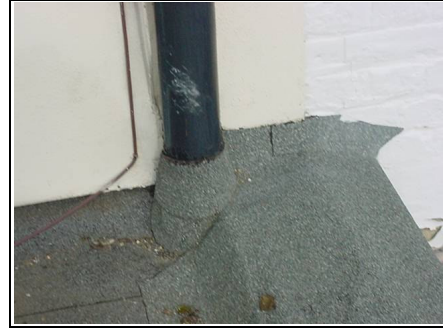
Where the roof meets the main building there is a felt flashing. We would much prefer to see a lead flashing; we recommend that this is added when you renew the roof.

Felt flashing meeting main property

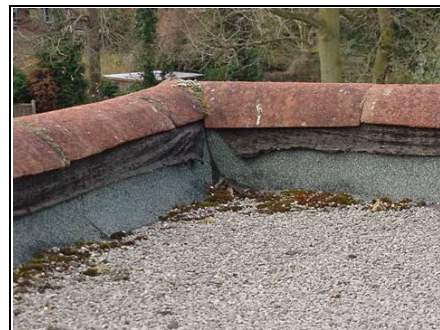
Flashing deteriorating

ACTION REQUIRED: Please see our comments in the Executive Summary. We would recommend that this roof is re-felted and insulation is added.

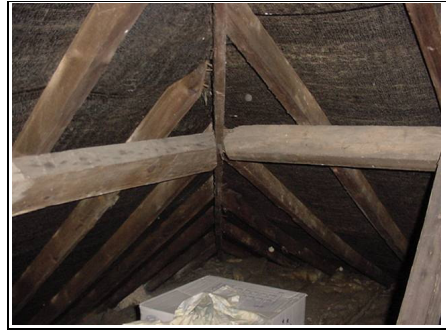
General view of the hip, showing some movement – we would term this as old and established.

We found condensation in the roof in the form of darker areas in the timber, indicating dampness. The roof therefore needs to be vented. We also believe it needs more props. There has also been movement in the roof and these defects have in turn caused deterioration to the timbers.

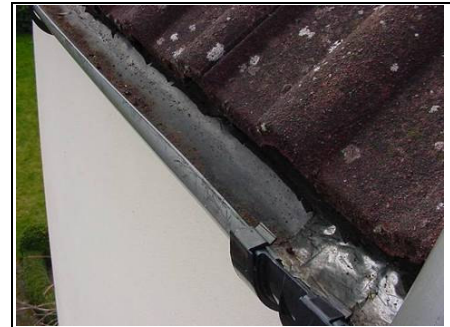
We noted Flashband (trade name) repairs to the guttering, which is not ideal.

Gutter – repaired with Flashband

Flashband is a sticky backed felt which is best used for temporary repairs only.

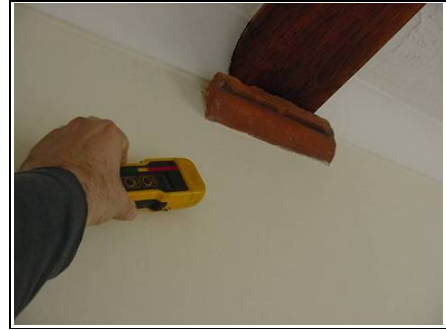
Tests were taken with a moisture meter at random points to internal walls, floors and other surfaces. No significant penetrating/lateral dampness was seen or detected.

Looking for lateral damp

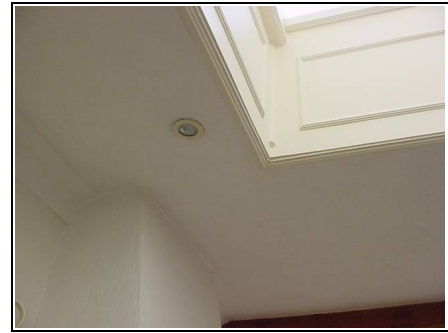
The property has electric inset lights to the ceiling. In some instances these can cause problems as the heat given off has in some cases lead to outbreaks of fire; these tend to be in the older type of ceiling lights and we recommend that where ceiling lights are used that the rear of the light is not covered; this is particularly the case in rooms with a loft space above it where stored items are placed in it.

Inset ceiling light
