RESIDENTIAL BUILDING SURVEY

Welwyn Garden City, Hertfordshire AL8

INDEPENDENT CHARTERED SURVEYORS

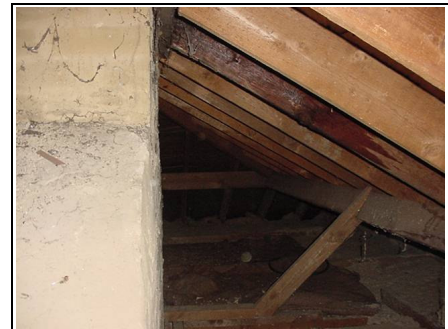
We could see water coming in through the roof at the rear of the property around the chimney. We therefore believe that the chimney needs to have work carried out to it, or the area directly behind it, which unfortunately we were unable to see from the ground level or any other vantage point.

Note the wet timbers to the right hand side of the chimney

ACTION REQUIRED: Inspect the rear of the roof closely. Taking an educated guess, the damage may have been caused by a branch falling on to the roof, a defective flashing to the chimney or dislodged tile.

ANTICIPATED COST: We would estimate a few hundred pounds. Work should be carried out as soon as possible as you can never underestimate the damage that water getting into a structure can do.

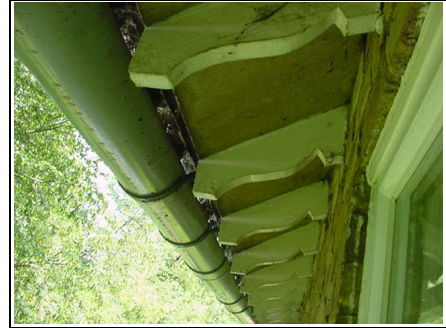
In this age of property asbestos was commonly used (it was used almost as a substitute for wood in some instances). We believe asbestos was used to the soffits, although it is very difficult to tell with the human eye. It is possible it has also been used in other areas in the house, such as to line the staircase and other places as a lining material.

Possible asbestos to the soffits boards

ACTION REQUIRED: The perception of problems with asbestos is a concern to house purchasers. We would always recommend that any asbestos is removed, but in the first instance you will need to have a specialist asbestos company check the property and advise the type and condition of the asbestos.

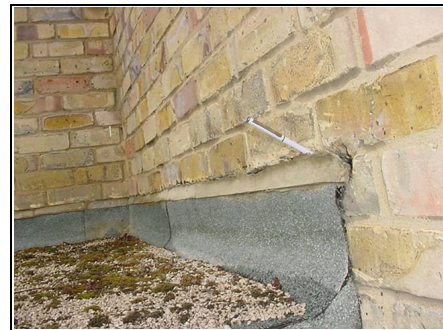
3) Loose Flashings

There are several flat roofs to the property. We believe they all have had repairs to the flashings.

You will note in the photograph that there is a white pen. This is stuck behind the mortar of the flashing where it is coming away.

ACTION REQUIRED: You will need to re-bed flashings. We would recommend that you look to replace the flashings with a lead flashing. This should be bedded into mastic, which allows for movement unlike the cement mortar that you presently have.

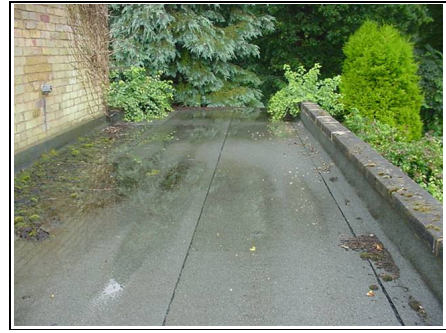
4) Garage

The garage has a flat roof which has water sitting on it, this is not ideal. We can see that previous repairs have been carried out to the parapet wall around the flat roof.

We feel this will discharge water into the garage and may make it difficult to get out when it is icy.

Garage roof, likely to be leaking

ACTION REQUIRED: We would recommend re-roofing with an insulation cut to falls.

ANTICIPATED COST: £2,000 - £5,000 or you may alternatively wish to wait until this roof fails (lets in water) before carrying out any work and then do a relatively inexpensive job depending of course on what you intend to store within the garage.

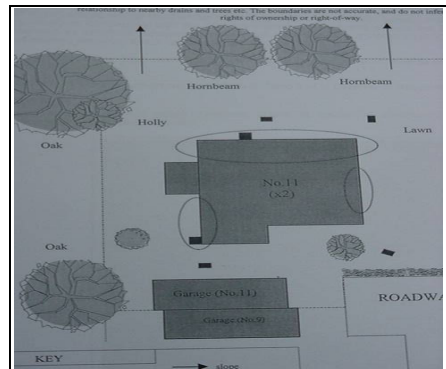
We do, however, feel that anyone purchasing the property is in a precarious position for several reasons. The main one being that they are susceptible to future movement in the property as the repair works are simply that, repairs works rather than measures being taken to stop the problem from re-occurring.

Planned view of the house taken from the report showing areas affected by movement

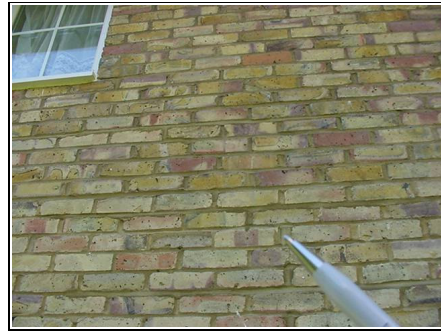
Cracking indicated by the pen

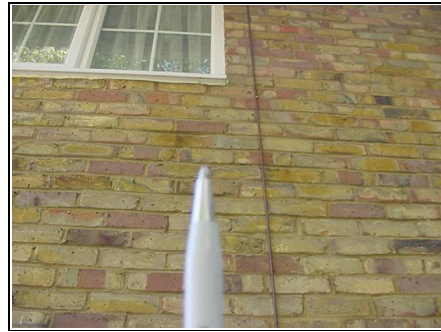
Movement indicated by the pen

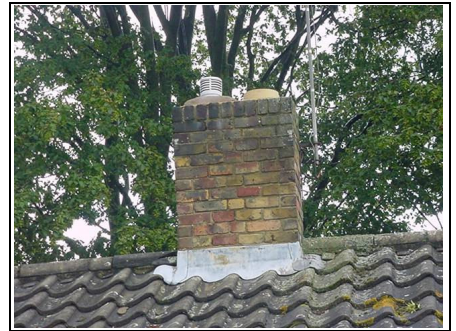
This chimney is brick finished with a metal flashing which we believe to be lead. It has two small chimney pots, one of which is a flue. From what we could see the chimney looks in average condition. Unfortunately we were unable to see the very top of the chimney known as the flaunchings, we therefore cannot comment upon this.

ACTION REQUIRED: Please see our comments in the Executive Summary about the dampness getting in around the chimney.

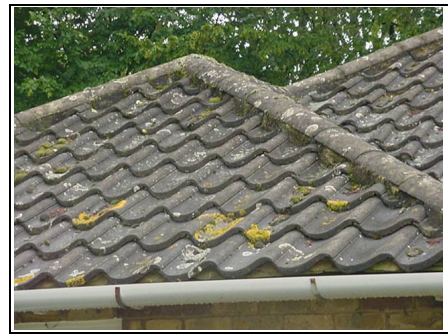
Moss on concrete tiles can cause problems with damage to the face of the tiles and blocked gutters. The side that we can see has minor moss but we often find the sides near the trees have excessive moss

You need to check the entire roof and clear it of moss.

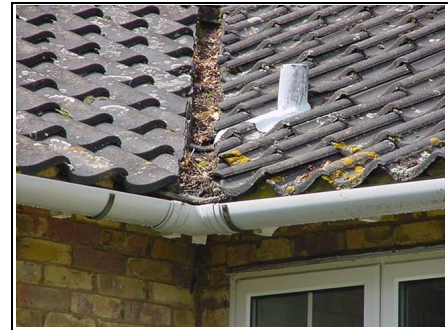
There are several valley gutters to the property. Valley gutters occur where two roofs join and are generally considered weak areas. In this instance we can see that it is getting blocked with leaves etc.

Blocked valley gutter

ACTION REQUIRED: Remove the leaves from the valley gutters and also check the sides of the valley gutters as these often come away.

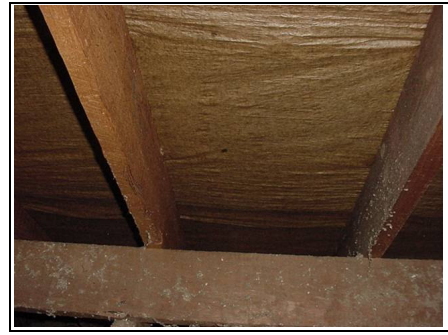
The underlayer is formed from a Bitumen based paper which is brittle and fragile. Although it is not in good condition it is very difficult to advise to replace it, as to remove and replace the underlayer is a very expensive job because the entirety of the roof covering has to be removed.

This photo shows the common rafters (the ones that form the pitch of the roof) and the brown area between is the underlayer.

ACTION REQUIRED: The underlayer needs to be monitored. For example, the dampness that we could see behind the chimney.

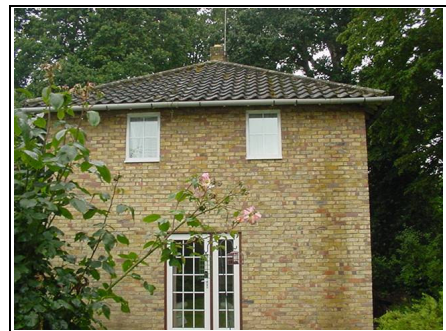
If you look at the adjoining photograph you will see staining on the walls where the gutters overflowed. We do feel that the rain was exceptional in this instance and we did have to cope with flooded roads on the way to the survey. We do feel that the gutters would cope with most usual rainstorms (providing they are not full of leaves).

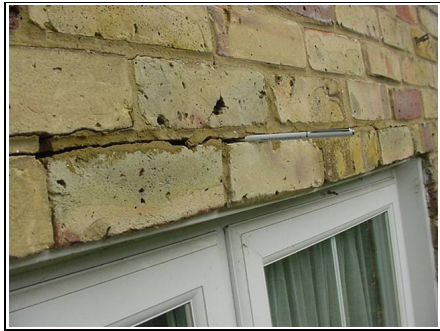
There is evidence of what we would term as minor cracking to the property. However, the hairline cracking is extensive and we can see why it was of concern to the owners and to the insurance company. As mentioned, we have read the relevant reports relating to the litigation work that was carried out and the subsequent underpinning system that was used. Our initial thoughts were that the insurance company has used “a sledge hammer to crack a walnut”, though we would temper this comment by saying general insurance companies are looking for 110% certainty in what they are doing.

Cracking to the rear elevation

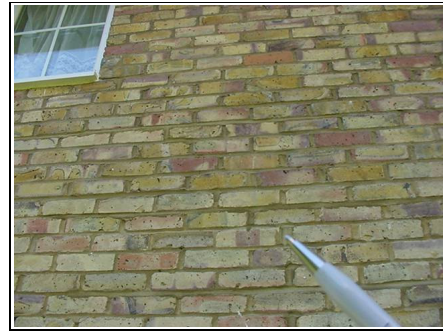
Cracking to right hand elevation

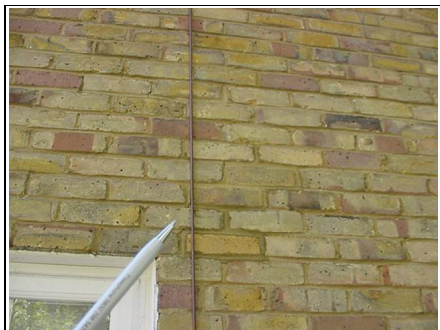
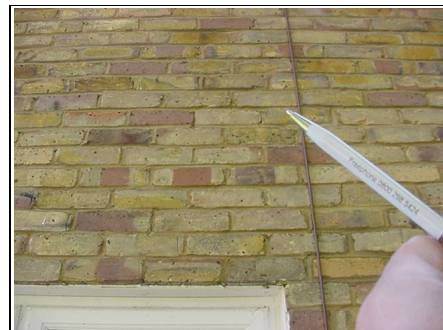
Cracking over front left hand window

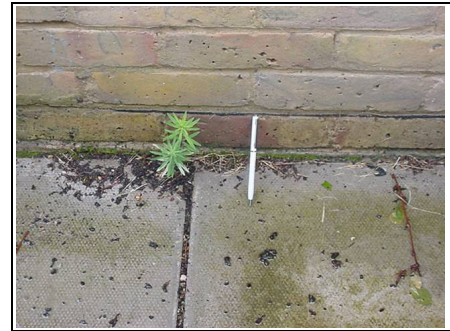
We could see a damp proof course to the property. It is slightly low in some areas, but this is nothing overly to be concerned about, particularly bearing in mind the other issues on this property.

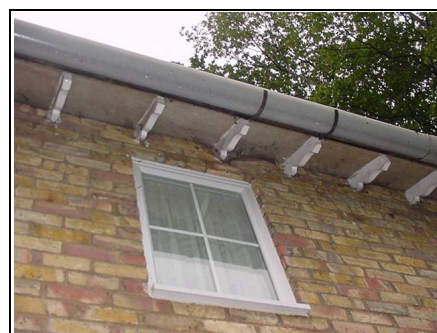
The fascia and soffit detail includes exposed rafter feet. We generally find that due to the awkwardness of these they do not get painted / stained as often as they should and you may find rot if they are closely examined.

ACTION REQUIRED: Please see our comments in the executive summary with regard to asbestos.

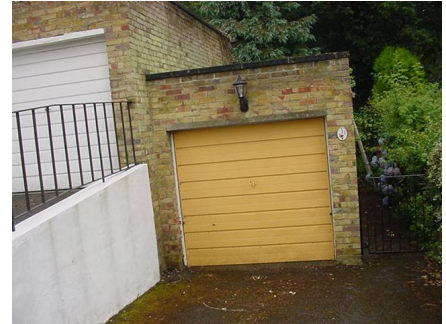
Unfortunately we were unable to gain access to the garage. We could, however, see from the roof that there had been leaks to it and we could see the newer brickwork that we found to the parapet wall of the garage, that these had been quite extensive. We suspect that there is water damage within the garage, though we would reiterate that we have not been in the garage.
