RESIDENTIAL BUILDING SURVEY
OF
A 1980's Detached Bungalow, Whittlesey, Cambridgeshire

FOR
Mr.Q

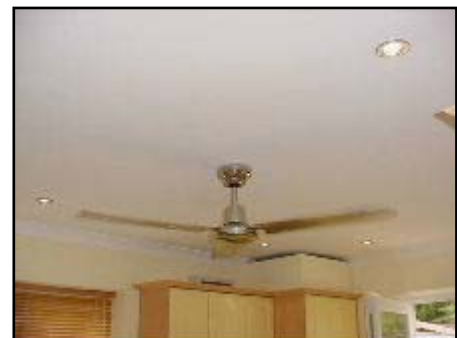
4) Fans

You may or may not like the fans within the rooms. They should in theory be positioned a minimum of 2.1 metres above floor level for obvious reasons!

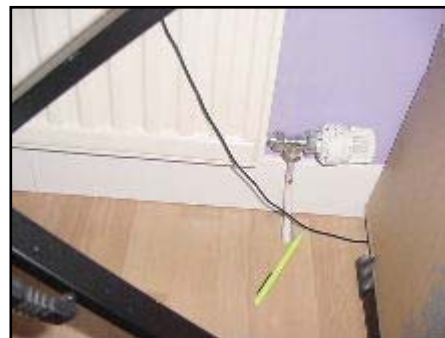
5) Microbore Pipes

We noted that the property has microbore pipes. These tend to be used today by plumbers as they are very quick and easy to install and not requiring any real plumbing work such as bending and also reduces the number of joints. However, it does leave you with the problem that it blocks up.

We discussed this with the owner during our question and answer session who was well aware of the problems and advised that he had drained down the heating system and therefore cleared it – he offered this advice before we made our comments with regard to the problems with them. We do feel he is genuine, however, we cannot be certain without literally draining down the plumbing system, which we do not do in our building survey.

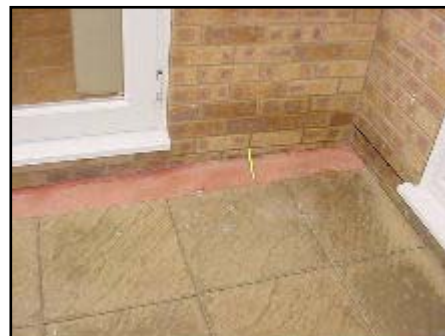
Shingle around the conservatory has been removed and replaced with a concrete fillet. We spoke to the owners about this, as it will encourage dampness into the conservatory (in the form of rising damp). We were advised that with the practicalities of having dogs they decided to remove the shingle.

ACTION REQUIRED: We would recommend that the cement fillet is removed and replaced with pea-shingle.

ANTICIPATED COST: A few hundred pounds.

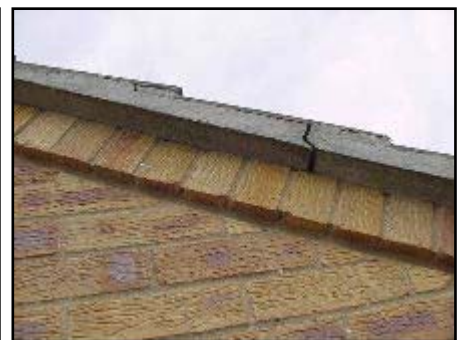
Splitting to the gable perimeter concrete, this needs sealing.

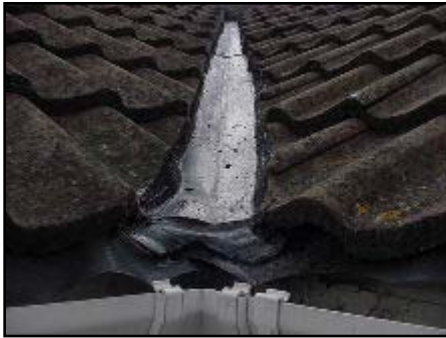
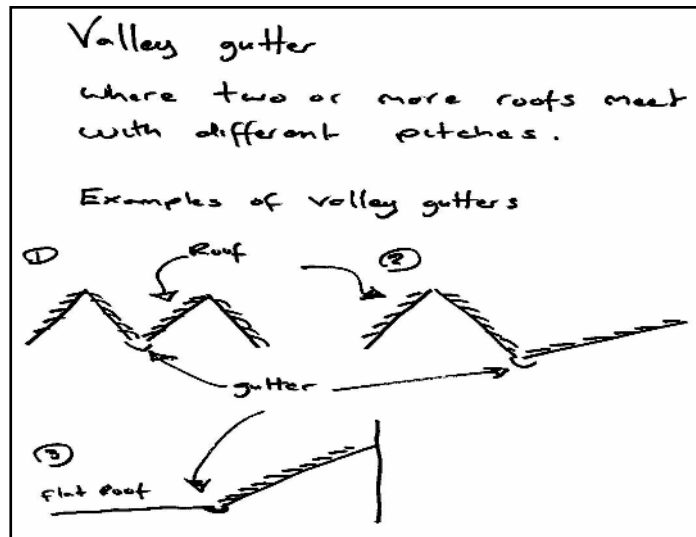
Valley Gutters

Valley gutters come about where two roofs meet. The valley gutters have been recently tarred. We spoke to the owner about this and he advised that it was due to dampness getting in through them. We would personally have not recommended tarring until we had actually found the leaking area and repaired it. Tarring the entire valley gutter is very much a lazy solution.

Valley gutters occur where two roofs join, these are generally considered weak areas. In this instance we noted that the gutters have been tarred.

ANTICIPATED COST: In the region of a few hundred pounds every time a leak appears.

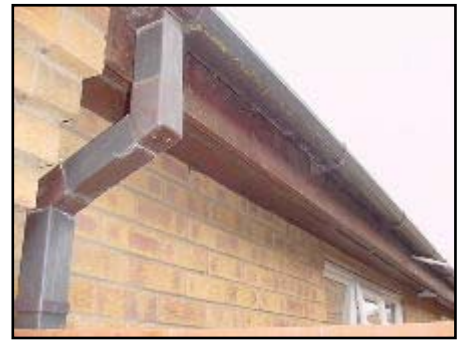
Minor leaks to the downpipes

ACTION REQUIRED: We would always recommend that the gutters and downpipes are cleaned out, the joints are checked and the alignment checked to ensure that the gutters fall towards the downpipes.

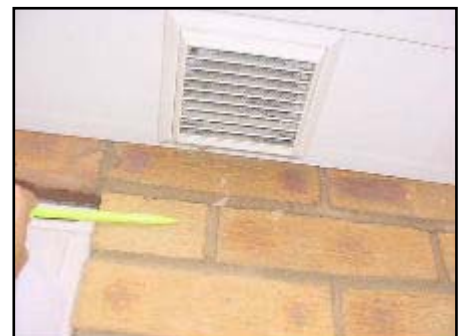
Hairline Cracking

We noted horizontal hairline cracks over the windows. This is reasonably common where replacement plastic windows have been used.

This is usually due to new windows being a slightly different size to the original windows and a small amount of settlement occurring in the walls, although we have never read any research into this. We believe that the plastic windows are usually not as strong as the original windows (unless specifically
