RESIDENTIAL BUILDING SURVEY
OF
A 1900's Semi-Detached Property, Whittlesford,
Cambridgeshire

Dr M

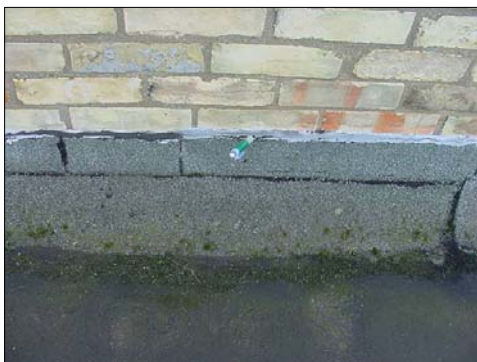
To the rear of the property there are felt covered flat roofs and one of these has been covered in bitumen to extend its life. This is usually carried out when the original felt has started to deteriorate; we can only assume this is the case in this instance.

A close up of the flashing; the pen indicates where the seal is broken which has previously been repaired.

ACTION REQUIRED: Budget for re-roofing within the next five to ten years. Expect some day to day repairs. Ideally we recommend that the roof is replaced, the sooner this is carried out the less repairs will be needed to the roof decking. We suggest you ask the Roofer to patch repair.

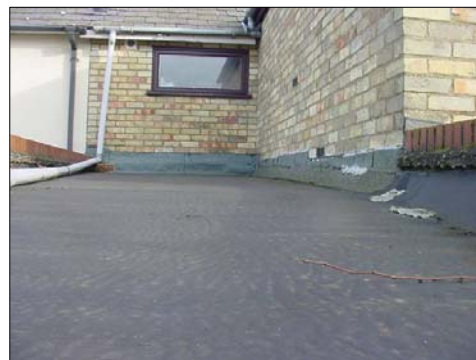
A general view of the roof. Note the deteriorating flashing to the rear and right hand side.

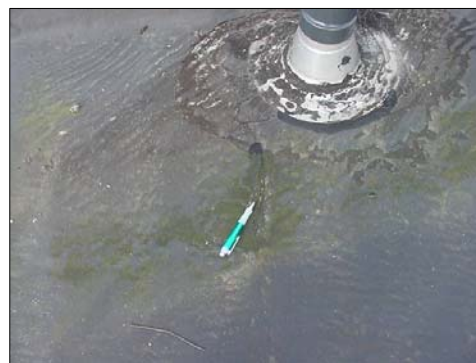
Split starting to occur in the roof which is indicated by the pen.

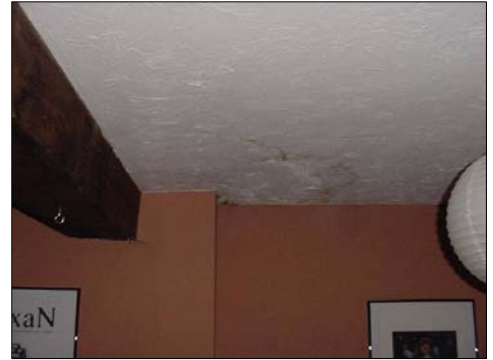
Generally the property is in a slightly unkept/cared for state which is often the case with rented properties. We noted for example to the internal decoration there was water staining to the ceiling below the bathroom indicating that the bath has been allowed to overflow. This will all need redecorating.

If you look closely you can see some staining to the ceiling. This picture was taken in the main lounge.

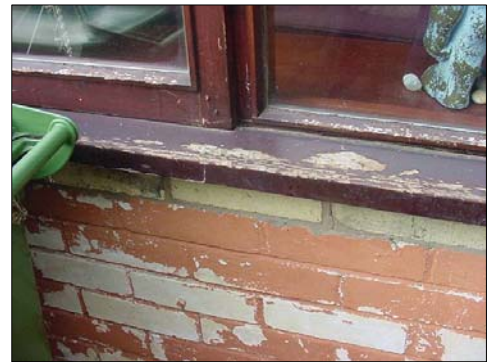
There is deterioration to both the windows and the fascias and soffit boards. We would class it all as saveable. We noted small areas of wet rot to the windows in the worst cases. Generally a redecoration with some minor repairs will suffice to the windows. With regard to the fascias and soffits; these look to be in need of replacement in some areas although we can't be certain until you inspect them closely.

Wet rot is visible to some of the windows.

ACTION REQUIRED: We recommend repair and redecoration to the windows. The fascia and soffit boards you will need to replace.

ANTICIPATED COST: In the region of £1,000 to £3,000 (one thousand to three thousand pounds) dependent upon the amount of replacement work required.

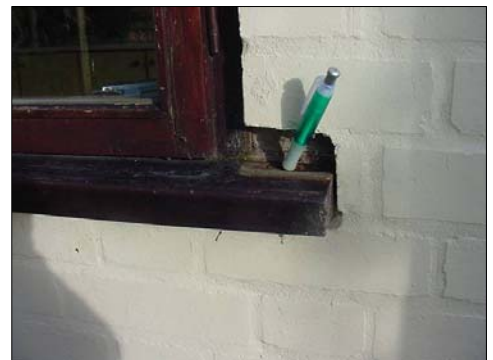
The pen is pushed into an area of wet rot in the window.

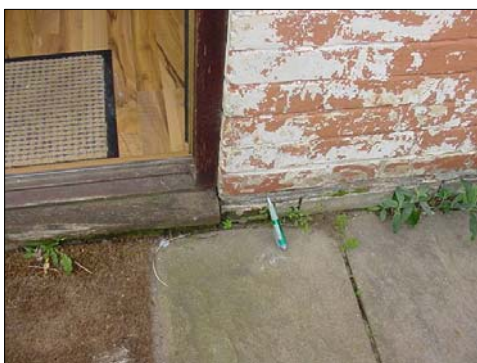
This shows that the damp proof course is too low; it should be two courses of brick from the ground level therefore indicating there is likely to be damp in the property.

ACTION REQUIRED: To be on the safe side we recommend that you have a damp proof estimate but insist that the owner moves the record collection away from the wall. Have a damp proof contractor carry out quotations for damp proofing work. The owner of the property will need to ensure that the record collection is moved back from the wall!

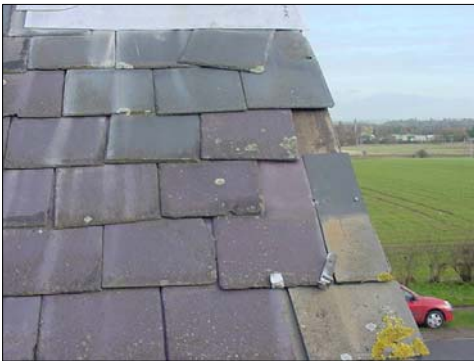
The property has the original pitched slate roof, this is coming to the end of its natural life. We noted from within the roof there were many areas of light visible indicating that the slates have moved. We also noted externally there was a large number of lead tingles; these are used to hold slates in place where the nail fixing has rusted/corroded away.

An example to the rear of missing slates and slates having been replaced with tingles.

ACTION REQUIRED: Whilst we would first comment that we are always amazed by how long slate roofs last, we really think this one now requires re-roofing work. The difficulty is with this type of roof is that it is very difficult to do patch repairs successfully. We feel that you are likely to end up re-roofing the entire slate roof.

ANTICIPATED COST: We feel you should obtain estimates for this and we anticipate it will be in the region of £4,000 to £6,000 (four thousand to six thousand pounds) to replace with a quarry slate roof.

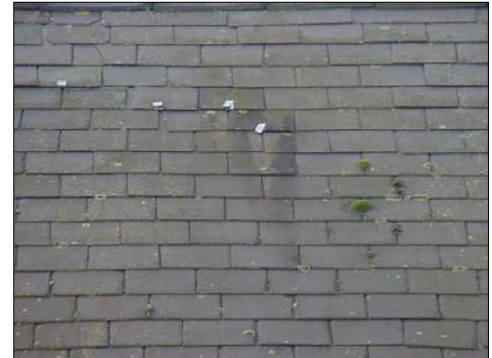
A close up of the slate roof. You can see the lead tingles (the grey bits) to the centre of the photo.

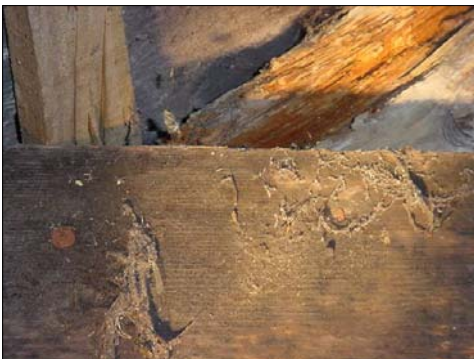
In addition to this we noticed wet rot to the roof structure where rain is getting into the roof. The rain will have to have been coming in for quite a while to have caused the wet rot.

A close up of the wet rot.

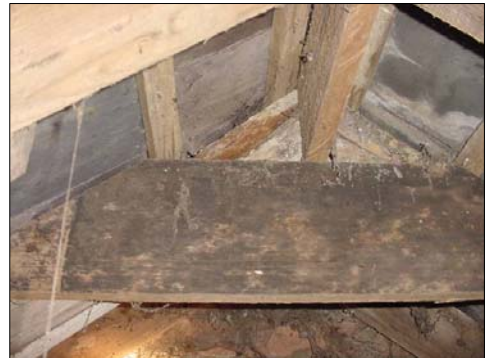
This is a view taken within the roof; looking at the ridge you can see the wet rot to the left hand side.

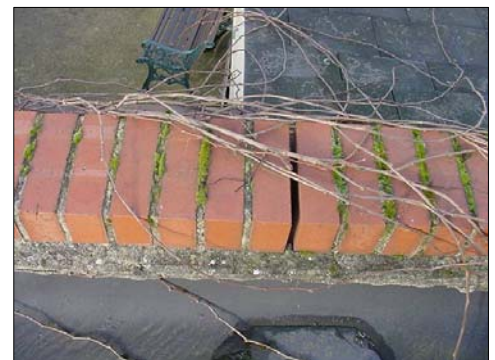
In this photo you can see the weak area of mortar that is common in this sort of parapet wall.

ACTION REQUIRED: We did note one area of deterioration. This needs to be picked up by a Roofer.

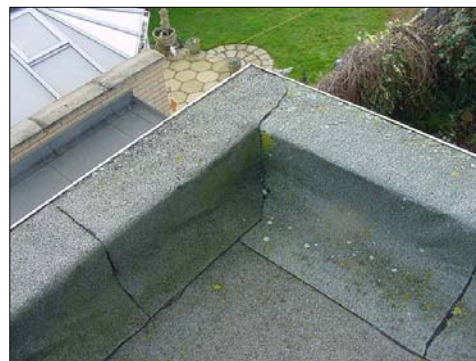
We did note what we would term as some smudging, this is where the mineral felt is not quite bonded properly. This is around the parapet wall area as these tend to be more difficult areas.

This roof is not in particularly good condition and whilst we have seen worse it is likely to have survived for some time. Please see our comments within the Executive Summary. However we would add that we feel that the best course of action with this roof is to completely renew it as soon as possible using a mineral high performance felt.

ANTICIPATED COST: In the region of £3,000 (three thousand pounds) and a quotation is required. We would recommend that any flashings are carried out in lead.

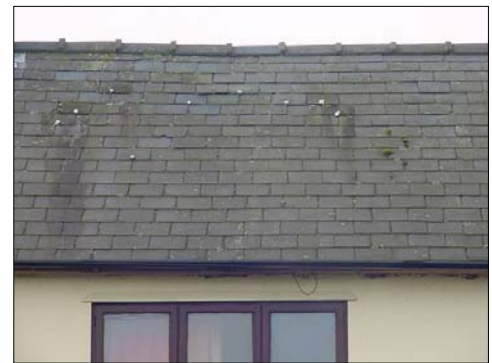
A view of the main roof with some lead tingles.

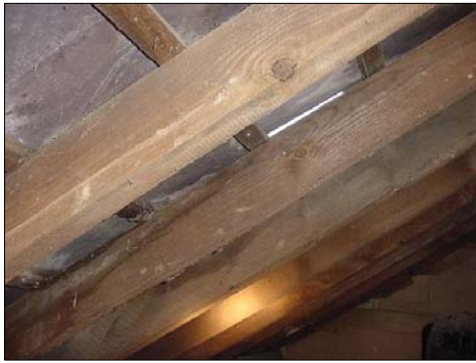
There are visible signs of wet rot in some areas and also some of the timbers have been strengthened by other timbers being added. Please see our comments in the Executive Summary.

Here if you look closely you can see where additional timbers have been added.

ACTION REQUIRED: When the re-roofing work is being carried out the timbers may need repair and/or replacing. The materials are relatively cheap the work can however be labour intensive.

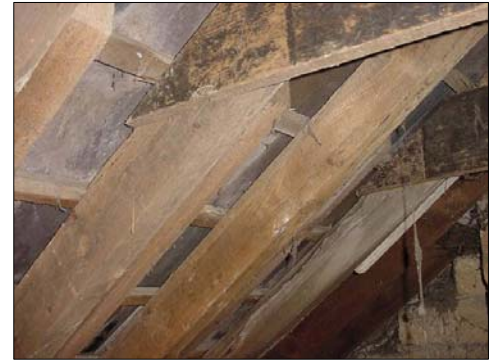
A general view of the common rafters (the ones that form the pitch of the roof). You can see some staining to the timbers where dampness is getting in and also light to the centre of the picture.

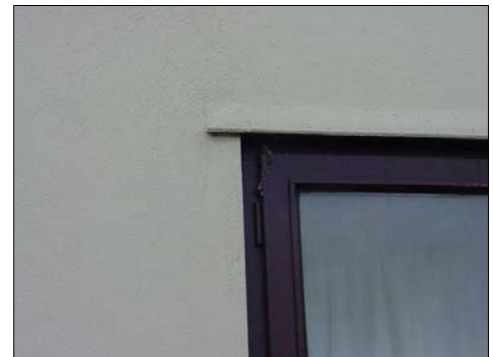
In this photo you can see the drip detail is formed in render over the window; note the hairline cracking.

ACTION REQUIRED: We anticipate that some repair work will be required to the render in the next five years.

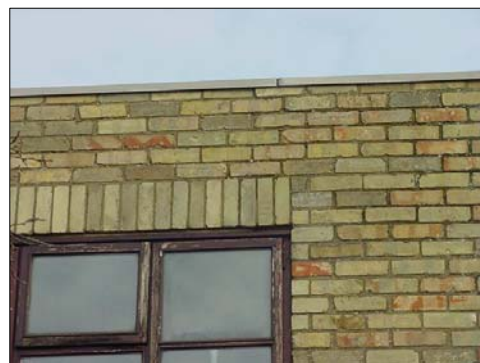
This is looking at the parapet walling. There is a stretcher bond some of which has hairline cracking in it.

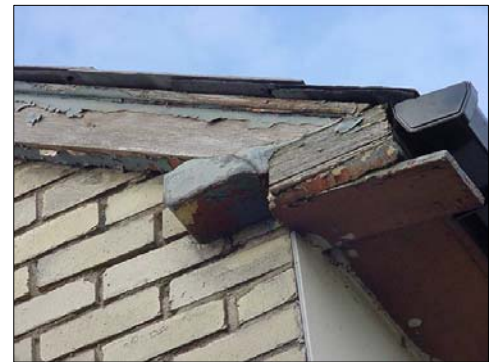
Please see our comments in the Executive Summary. The paintwork to the fascias and soffits is literally peeling off.

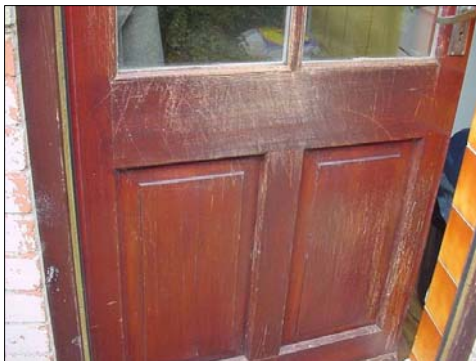
Please see our comments in the Executive Summary. In addition we would draw your attention to the fact that the windows have sealed double glazed units which can fail, particularly as a result of poor workmanship during installation. Failure of the seal leads to condensation between the two panes of glass and simply replacing the affected units may not provide a satisfactory long term solution. In this case we would say that some of the sealed double glazed units looked to have deteriorated and may well need replacing. We note there was some damage to the doors to the rear that looks to have been attacked by a dog.

In need of redecoration!

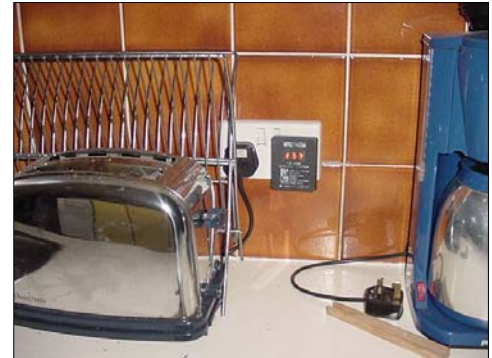
The visible wiring and fittings are slightly dated. Under new legislation any future alterations to this system will have to be carried out by a qualified electrician and certification obtained.

ACTION REQUIRED: If there is no record of an electrical test having been undertaken within the last five years, it is recommended that the installation be tested by a competent electrician (NICEIC registered) and all recommendations implemented. Thereafter, the installation should be re-tested every five years.
