RESIDENTIAL BUILDING SURVEY

Wimbledon, London. SW19

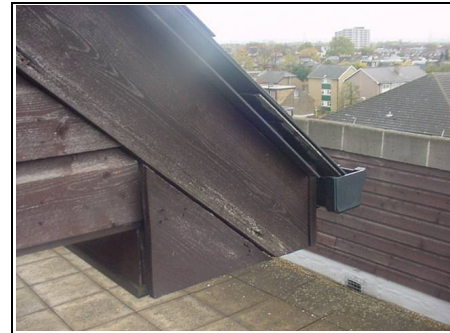
The main roof is pitched, where the slates are at the verge the detail would normally be in-filled with cement or a dry verge in this instance the cement that was originally there has now come away meaning that dampness can get into the structure.

Verge where cement has come out

ANTICIPATED COST: Whilst it does not directly affect your property it is likely that you will have to contribute to the cost of repairing this, £1000-£5000 dependent upon the extent of this to other areas we could only see the left hand side of the roof which was easily accessible from the flat roof; quotations required.

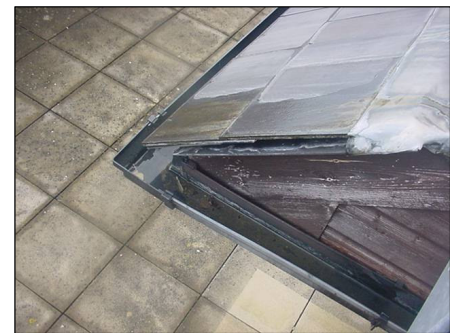
Verge showing signs of dampness getting in

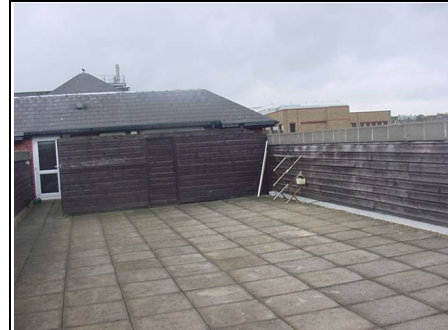
The high level timber has a protective stain on it this is in need of redecoration due to deterioration, we can see it is flaking and cracking in some areas.

ACTION REQUIRED: We recommend the high level work is redecorated to protect it and prolong its life.

ANTICIPATED COST: This would normally be a shared cost and a sinking fund, which is a fund of money built up over many years will normally be built up for such work. It is likely to be costly as it will need scaffolding in the region of £10,000 - £20,000; quotations required.

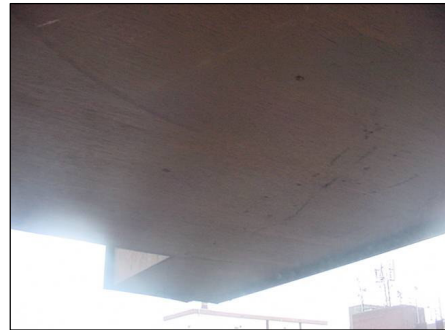
Soffit taken through the window on the lift landing

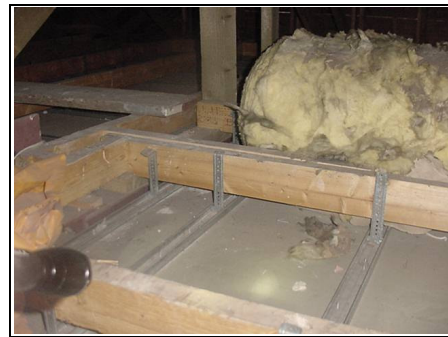
We went into the main roof and were surprised that it has not all be insulated and we could see some rolls of insulation that had not been laid within the roof.

ACTION REQUIRED: Entire roof needs insulating. We also suggest that the property needs a general check as to where insulation was missed. Insulation missing in roof were

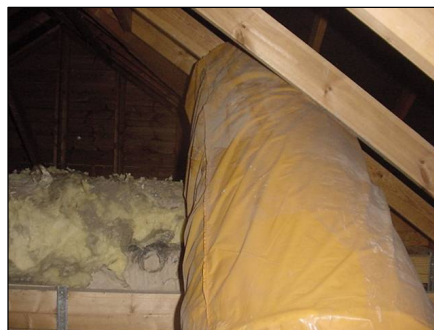
Roll of insulation waiting to be laid in roof

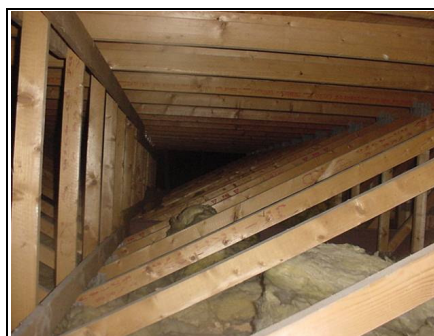
We were also surprised when within the pitched roof (access adjacent to the lift) it had not been compartmentalised therefore limiting the spread of fire. The ceilings have been suspended therefore where we could view it there is a void which would allow fire to travel from one area to the next. This is assuming that the ceilings do not have a fire board.

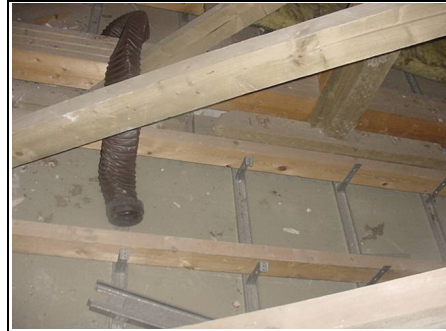
In our experience with this type of layout where you have an internal bathroom be it that they have extractors we find that condensation goes to the colder areas such as bedrooms and within cupboard space. We noted during the course of our inspection it was very warm and when we ran the hot tap for approximately 15 minutes there was a build up of steam within the bathroom which was not dispersed by the extraction fan that quickly.

Extractor fan not extracting to outside air

ACTION REQUIRED: We would recommend that your solicitor specifically asked are there condensation problems within the property and we would also recommend that if you do decide to buy the property that thermostatically controlled extract fans are used. At the very least you need to clean the existing extract fan until new ones are put in place.

ANTICIPATED COST: We would recommend a larger extract fan and all the extracts being fitted to outside air we would expect these costs to be in the region of a few hundred pounds; quotations required.

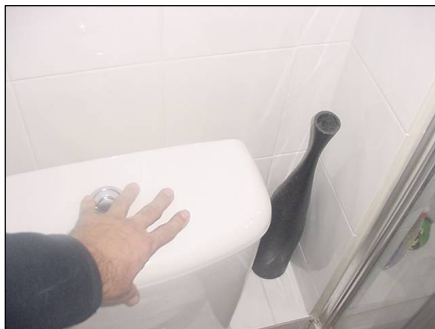
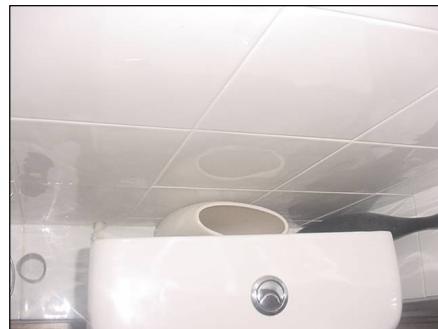
We noted that the backs to the WCs (WC cisterns) are not supported other

WC cistern not supported

than by the flower vase and by the water supply pipe that they are fixed to and therefore they will give and we feel there would be the possibility of damage.

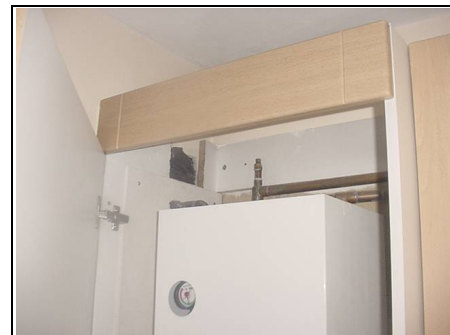
The Potterton Prima gas boiler located in the kitchen should be vented to external air, this is normally carried out by the way of a flue. Within the cupboard that the boiler is located in we cannot see any flue that goes to the outside air, there is however a vent there which is not ideal.

ACTION REQUIRED: Boiler system and associated heating systems needs to be checked and tested to the current Gas Safe requirements.

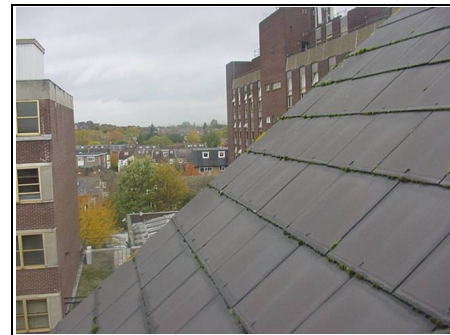
The roof is pitched and clad in manmade slates, which sit fairly true, although there is some moss and missing verge detail with slipped and cracked slates. Whilst we would not normally comment on this on an older quarried slate roof, with a manmade slate roof this means it is in fairly poor condition.

Moss on man-made slate tiles

If you look closely at the photograph you will see that moss has gathered, we rarely come across this and we believe it is due to wind driven rain which will ultimately lead to deterioration of the slates.

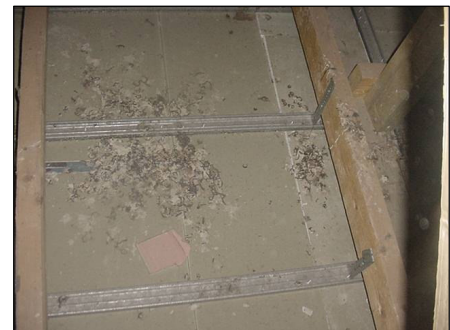
Our examination is also impeded by the general configuration of the roof, the insulation (in some cases where it had been put down), as mentioned what we could see we generally found to be in an average condition considering its age but our view was limited. It is, however, feasible that there are problems in the roof that are hidden. We did note that pigeons had

got into the roof space indicating there are holes in the fascia soffit or roof itself although we did not find these (these should be repaired during a general maintenance check that the management company should have in place).

We noticed pigeon droppings in the roof

ACTION REQUIRED: The only way to be 100 per cent certain is to have the roof cleared and checked.

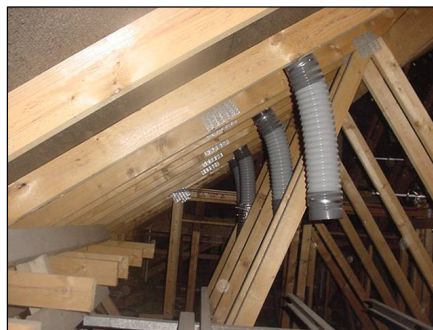
We could see some ventilation tubes within the roof which we assume are to vent the roof, upon reflection equally they could have been shower extract piping that has not been connected.

Tubes within roof

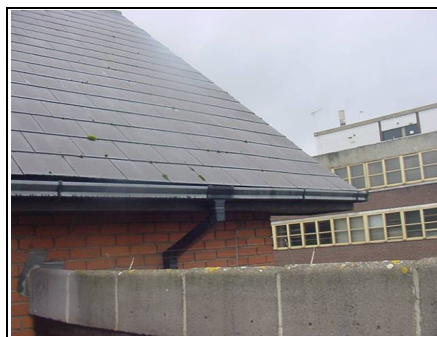
From ground level we could see profile (shaped) plastic gutters, these appear to have been put in, in different ages due to the different colours of the pipes that have been degraded by the sunlight. There may be a few repairs, but we feel that most people would be happy to live with these. Generally in a property such as this they would be carried out as part of the maintenance plan.

Plastic downpipe

ACTION REQUIRED: We would always recommend that the gutters and downpipes are cleaned out, the joints are checked and the alignment checked to ensure that the gutters fall towards the downpipes.

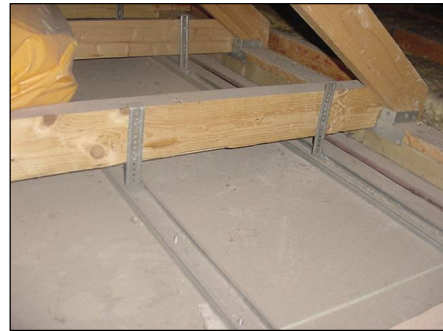
From within the roof space we can see the ceiling is formed using a suspended ceiling system. The grid is not visible from within the rooms and appears to be a normal plasterboard ceiling type construction.

ACTION REQUIRED: Request further information to comment exactly why this type of ceiling has been used you need specification details from the original construction.

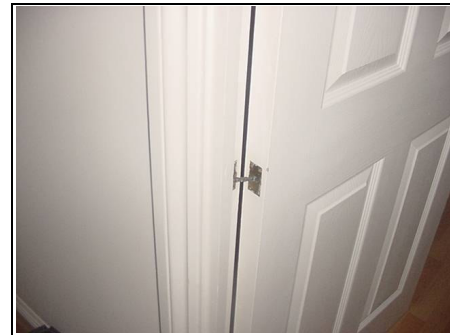
Within this property there should be fire doors. Fire doors are generally half hour resistant for this type of layout and, in addition, they should have door closers, in this instance they have Perco (trade name) door closers, these are positioned in the middle of the door.

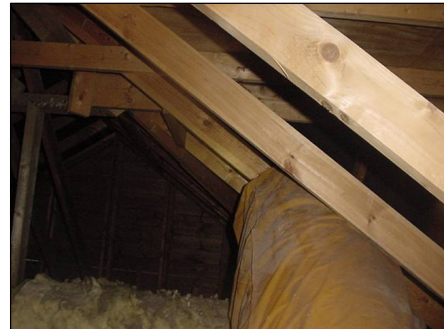
We found insulation in the roof although there are areas where there is no insulation at all and the insulation is still literally in the insulation bags.

Insulation still in a bag ready to be laid!

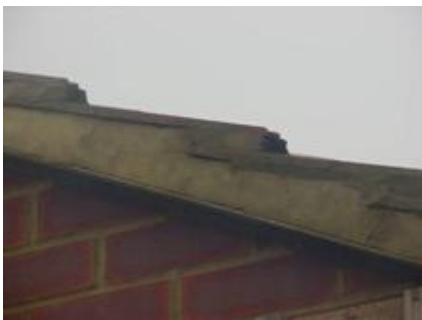
If you look closely you can see cracks to the left hand side that have been filled in with cement mortar. It is only a matter of time before they open up again.

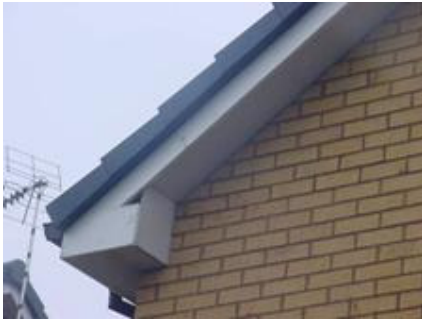
Dry Verge system – interesting lack of skill to the fascia and soffit board with the hole opening in it

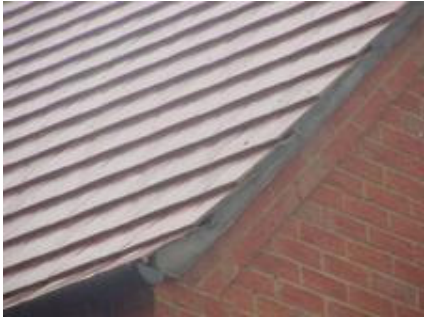
Gaps left for the water to get in!
