# RESIDENTIAL BUILDING SURVEY

Windermere, LA23

**Mr and Mrs G**

**INDEPENDENT CHARTERED SURVEYORS**

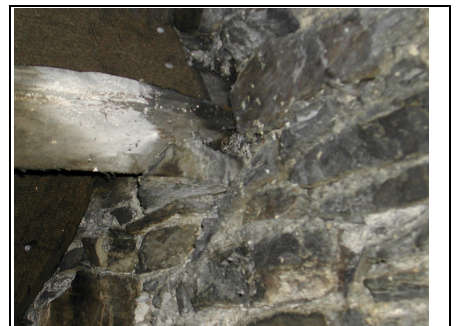
Purlin requiring repair

Further investigation is required to the condition of the purlins and the existence of rot within the timber.

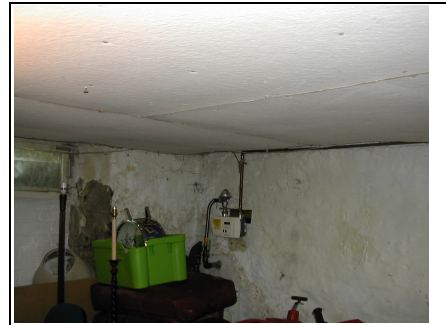
- Defective cement fillet on the chimney and roof.
- Failure of the lime mortar used in the wall structure.
- Defective gulley drain adjacent to the front of the cellar.
- Lack of ventilation to the roof space and property generally.
- Apparent lack of any damp proof membrane to the perimeter walls of the property and the cellar in particular.
- Rain ingress at doorways and windows.
- Roof repairs being necessary

Dampness in cellar

In addition to the comments made about dampness in the property the cellar requires extensive works, including, drying out, the removal of any defective plaster and repair, tanking, and decoration.

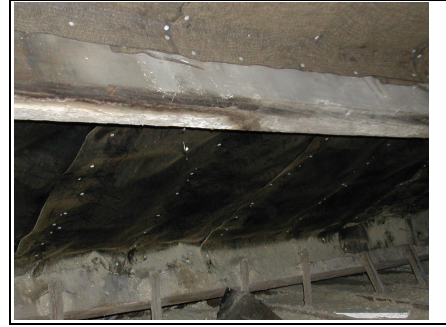
Purlins

**ANTICIPATED COST:** depending on the works necessary allow sum of £3500.

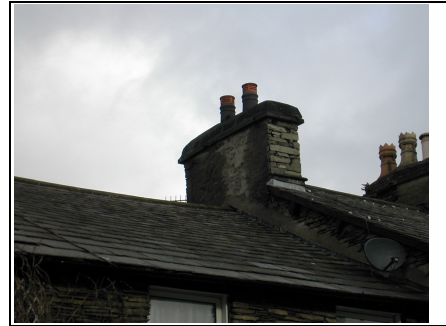
This chimney is constructed of Lakeland stone finished with a lead flashing and two number chimney pots. The area around the chimney pots appears to have been filled with cement mortar. From what we could see from ground level it looked in average condition considering its age, type and style. The reverse side of the chimney appears to have been rendered with mortar. Unfortunately we were unable to see the top of the chimney known as the flaunching, we therefore cannot comment upon them.

The chimney to the right of the property with the party wall to the retail outlet appears in similar condition with an area of cement mortar affixed thereto.

Front view of chimney

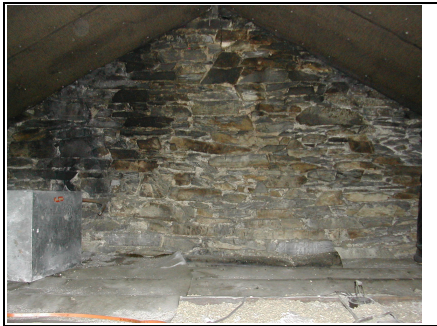
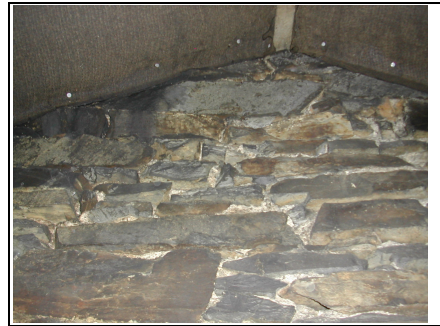
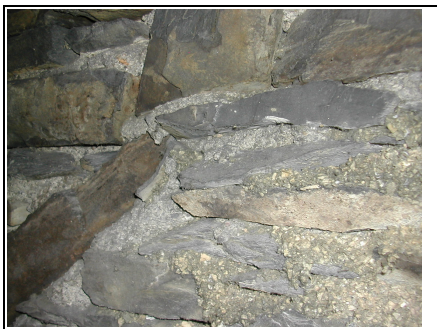
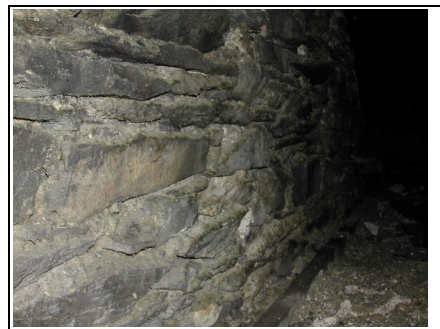
Party walls

The only other point to make with regard to the party wall is the straps that have been used for the aerial. We have found in the past that these cause damage to the brickwork as they produce pressure points ; we suggest that this be checked.

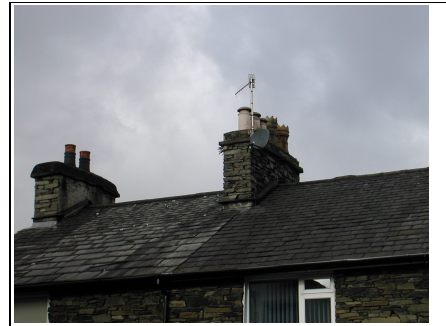
The main roof is pitched and clad with slates and, from ground level, this looks in average condition considering the roof's age, type and style. With this age of roof there will usually be a few missing or displaced tiles, this is nothing unusual.

Main roof

The roof appeared relatively flat, although there looks to be a slight dishing effect. Some slates are broken and missing.

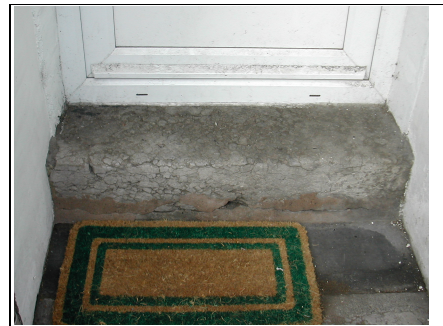
The front step leading to the door is of concrete and craze cracked.

Crazing to front door step

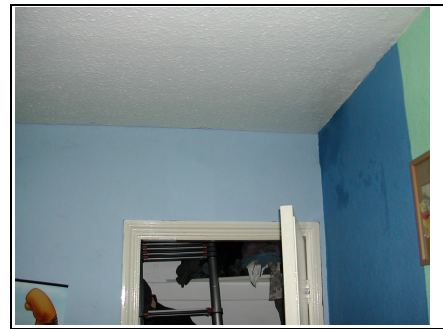
The main roof is accessed via the loft hatch located in a cupboard in the front bedroom. There is no loft ladder, electric light or secured floorboards. We recommend that these be added, as it will make the loft space safer and easier to use.

Loft hatch and ladder

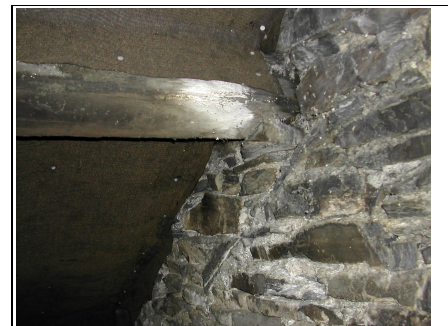
We noted that the roof purlins were wet in places, along their length and at their ends where they fit into the stonework forming the party walls. Ceiling joists were mostly concealed by loose fill insulation but we feel that there may be problems hidden. What we could see was generally found to be in poor condition for its age, type and style.

Purlins

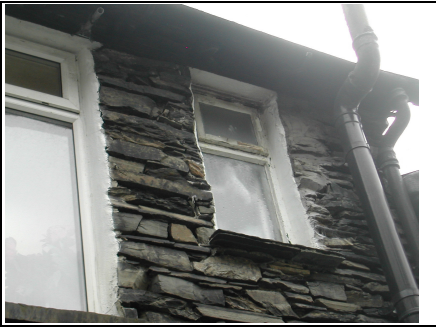
The property has plastic soil and vent pipes. These show evidence of leaks.

Plastic soil and vent pipes

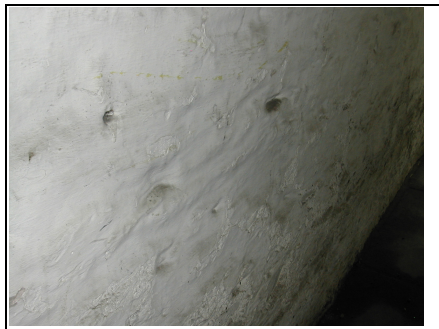
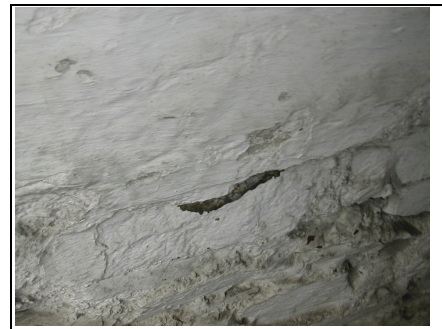
External wall in the side passageway in poor condition

The face of the wall alongside the passageway is in poor condition. It has been painted and it is suspected that cement mortar has been used contributing to its poor condition.

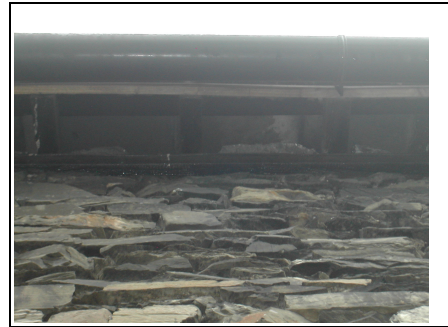
The fascia and soffit detail includes exposed rafter feet. We generally find that due to the awkwardness of these they do not get painted as often as they should and you may find rot if they are closely examined.

Wooden rafter feet

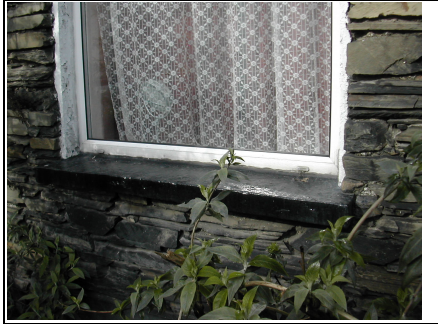
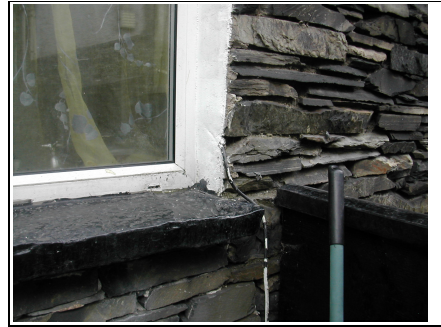
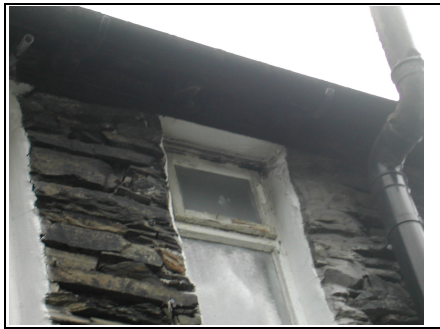
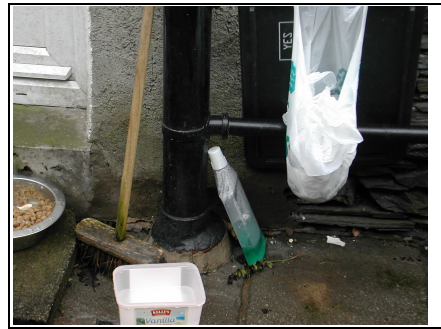
One timber casement to the bathroom was noted. This was in poor condition.

Windows in poor condition

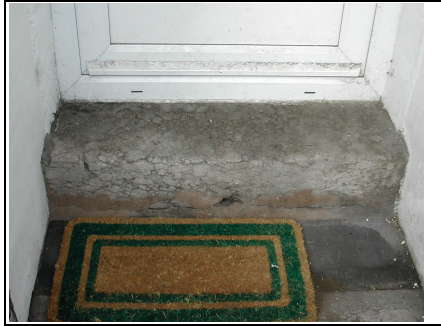
Front door and cracked door step

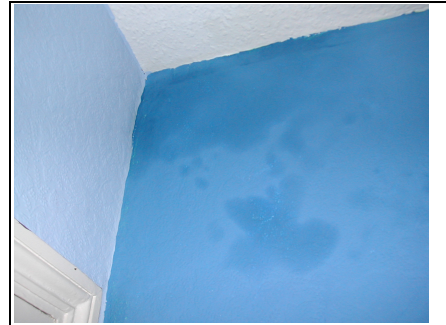
We have mentioned elsewhere within the report that there is dampness in the property. This can cause the plaster to degrade and it is generally recommended that walls are replastered where dampness has occurred. If this is an older property we would always recommend a lime based plaster, where as in a newer property carlite plaster is recommended.

Damp ceilings and walls

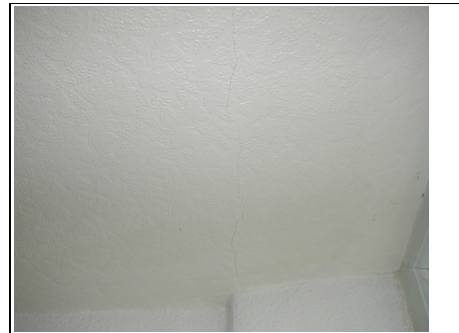
Hairline cracks to ceiling

There is a hairline crack between the front door and left side at the start of the hallway.

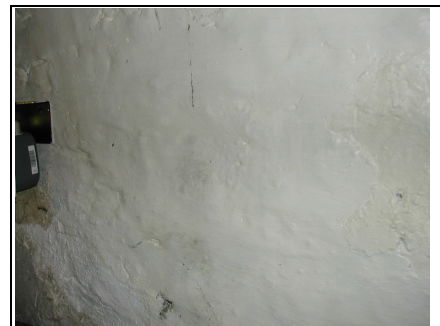
Wall in cellar beneath chimney breast above

We took meter readings on your chimney with our electronic damp meters and found dampness is coming through. This is probably due to the chimney and flashing being defective.

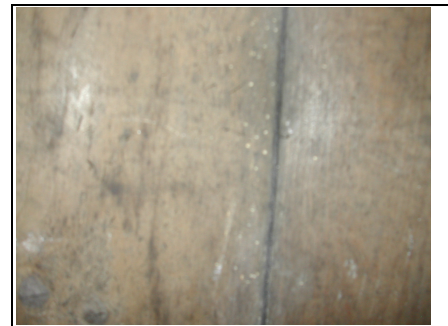
We noted evidence of woodworm through a small gap in the ceiling board to the cellar.

Evidence of woodworm

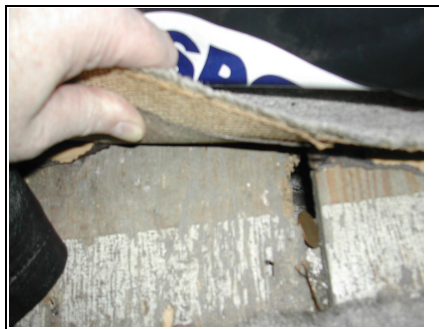
Within the floor we found signs of woodworm activity at the entrance to the cupboard in the front bedroom, in the ceiling timbers to the side passageway and, in the underside of the lounge floor.

Signs of woodworm activity in front bedroom floor

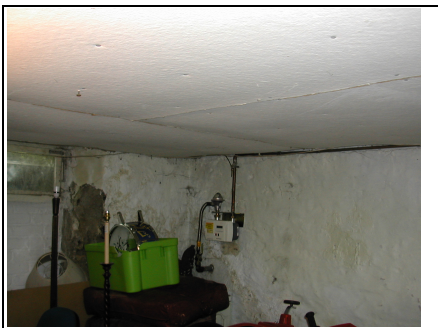
Excessive damp in cellar

Due to dampness usually found within the cellars, we would recommend that only non-perishable goods are stored in this area.

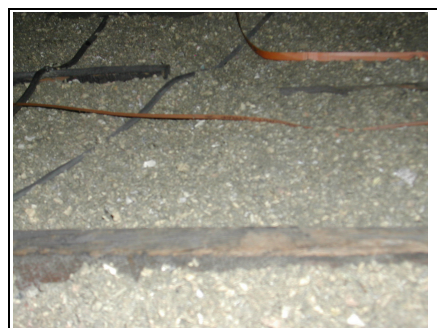
Some loose fill roof insulation was present although not to current Building Regulations requirements of 300mm.

Loose fill roof insulation

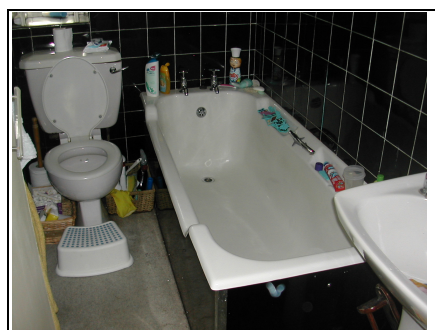
The bathroom has no natural ventilation. We therefore recommend that an extract fan be added that discharges externally and preferably fitted to a light switch or even a humidity stat to control its operation.

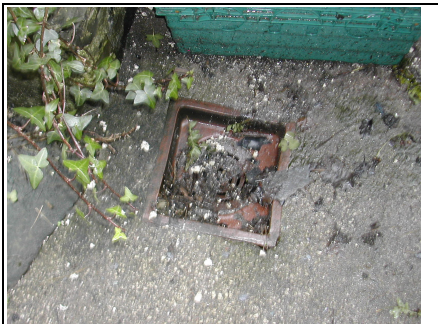
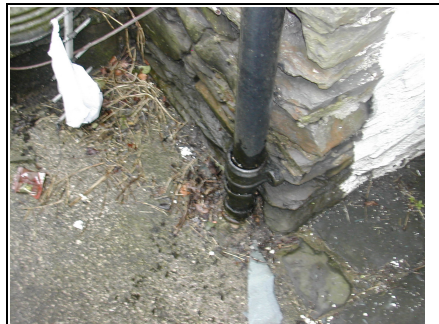
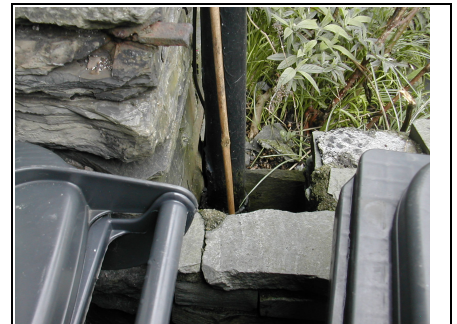
Drains and gullies

We believe that the gully at the front left of the property may have failed contributing to the conditions found in the basement.

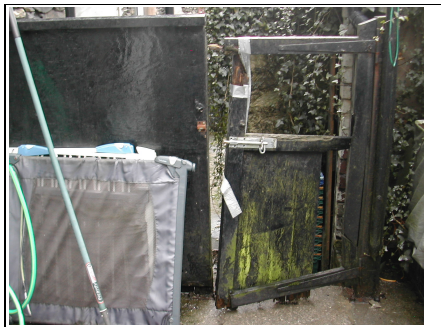
Dilapidated gate to courtyard

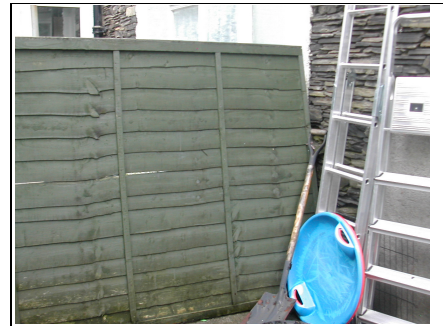
Timber fence in poor condition
