RESIDENTIAL BUILDING SURVEY

Shooters Hill,
SE18

FOR
Ms A

INDEPENDENT CHARTERED SURVEYORS

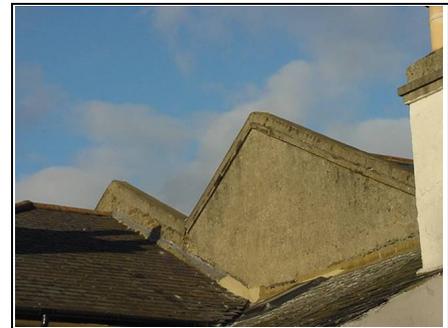
Generally work is required to the roof areas. This we are dividing firstly into the chimneys and parapet walls where repair, re-rendering and checking of the coping stones is required. Secondly the flashings of which there is a mixture of, concrete and Flashband, and which we would much prefer to be replaced with Lead.

Parapet Wall

Flashband is a sticky backed felt which is best used for temporary repairs only.

ACTION REQUIRED: We would estimate the sum of £5,000-£10,000 (five thousand – ten thousand pounds) to carry out this work. However until you get onto the actual roof you will not be able to estimate the cost of this properly. Our concern is that you may

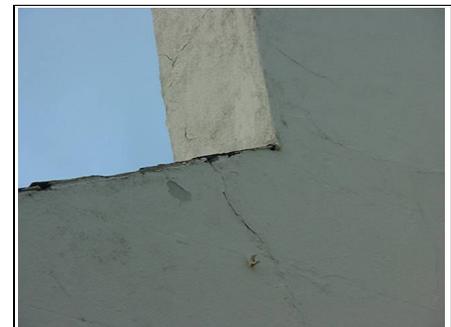
Cracked render

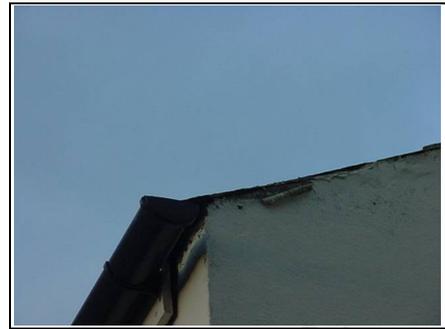
Cracked render

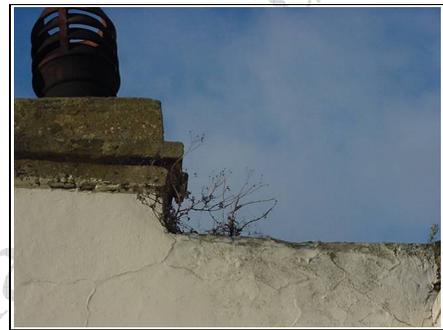
Vegetation growing on wall

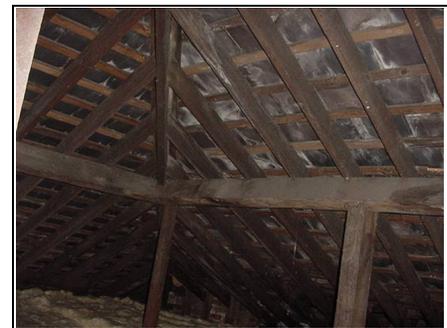
The slate roof is probably original as there is no protective underlayer beneath it. Without a protective underlayer it means that wind driven rain can get into the structure. We would add that we could also see light in some areas indicating that some slates are missing/moved/broken meaning the roof is leaking.

Dampness visible to the timbers.
The darker areas are dampest.

We could see the dampness in the timber that could ultimately lead to rot.

ACTION REQUIRED: As a short term measure you can overhaul the entire roof. Particular attention needs to be paid to the valley gutter area. Again it should be noted that we weren't able to get a good view of the roof due to the mass of insulation which prevented us from accessing it properly. There may

By short term we mean in the next one to three years. For a long term solution most people will be looking at removing the slate roof and re-roofing which would cost in the region of £10,000 - £20,000 (ten thousand –twenty thousand pounds) depending upon scaffolding requirements and temporary roofing requirements. Please obtain quotations before you commit to purchase.

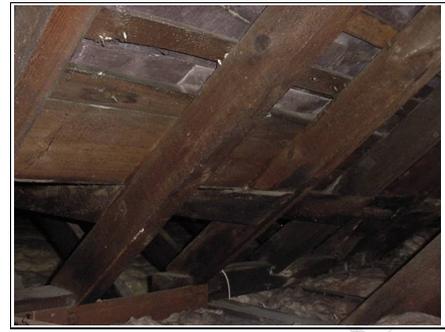
Close up of the valley gutter showing dampness in the timbers

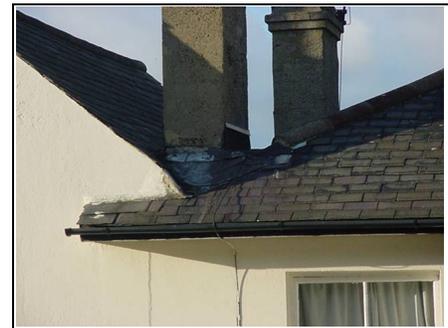
There is a valley gutter to the property that cannot be seen properly from the front but can be seen from the rear and in the roof space. These are generally considered problematic areas and we think that dampness is getting in which will lead to rot on the roof structure.

Hidden valley gutter

ACTION REQUIRED: We recommend that a roof light or access panel of some sort is put into the pitch of the roof so that the valley gutter can be seen, accessed and cleaned. Please note we did

not gain access to the valley gutter and our view within the roof was limited due to the mass of insulation. Please note you may need local authority approval to add a roof light/access panel.

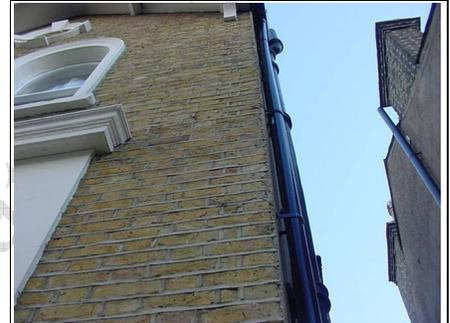
Unfortunately the brickwork has been re-pointed in a cement mortar rather than a lime mortar. It has also been proud pointed which means that ultimately it will cause damage and deterioration to the brickwork which is unfortunate. It should be lime mortar every time as this allows the buildings to breathe.

Cement mortar wrongly used instead of lime

ACTION REQUIRED: We would recommend a programme over the next few years of gradually removing the cement mortar and replacing it with lime mortar to allow the property to breathe again.

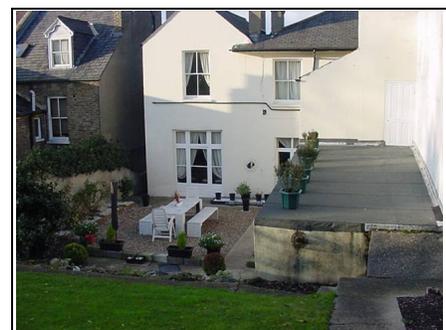
Very unusually the kitchen roof is formed in concrete with a felt covering. We were able to see the concrete, possibly with an asbestos content, roof by lifting the ceiling tiles in the kitchen. The felt covering looks to be in reasonable condition although where

Kitchen roof

there is Flashband flashing around the roof we would much prefer to see this replaced with lead as generally Flashband is considered a temporary repair material.

ACTION REQUIRED: Further investigation is required. Have a “cup of tea meeting” with your next door neighbour on the left hand side to check the construction of their rear area and to see if they have altered or amended their roof. We would also have an asbestos check on this roof to see if there is any asbestos content. You also need at the very least to use a ‘rust stop’ agent to stop the rusting that we can see.

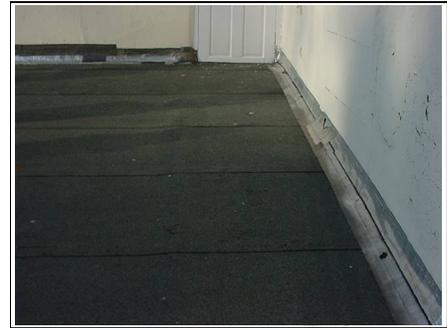
General view of the kitchen roof

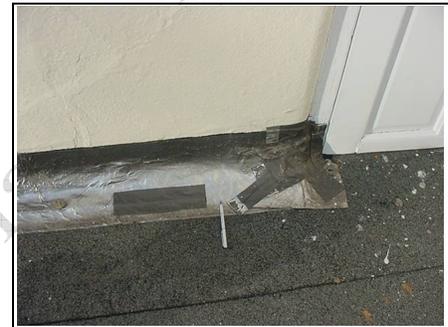
Flashband is a sticky backed felt which is best used for temporary repairs only.

Close up Flashband repairs with concrete roof in view

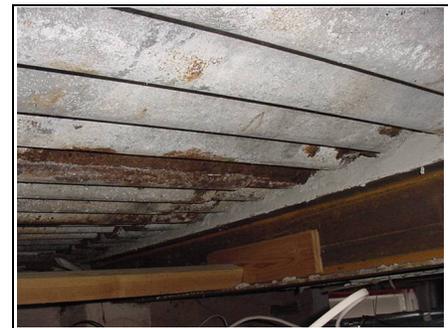
Possible asbestos in concrete
This needs checking

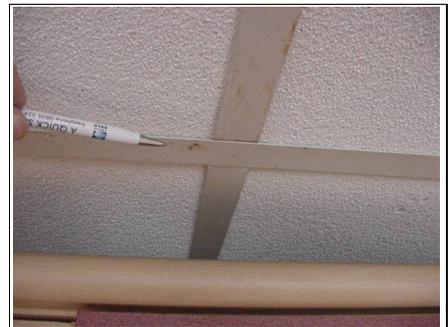
Dampness has come through as shown by the rust on the suspended ceiling system 17

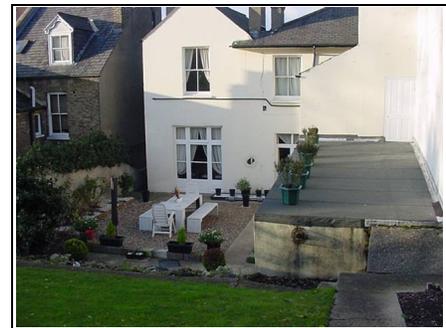
The kitchen stands out as an area where the sloping site really will affect it as part of it is directly against the ground level. This means that dampness will get into this area unless tanking has taken place or a good French gully.

Kitchen same level as ground

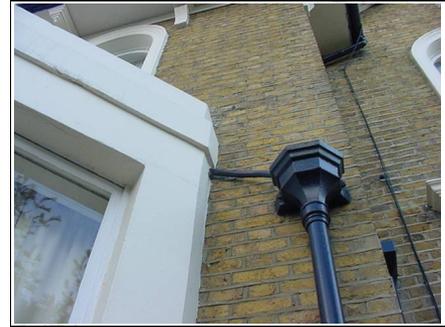
Small downpipe from bay window.

Often problems are caused for example over the bay window where there is only a small downpipe. This then backs up and over flows and allows dampness to get into the structure.

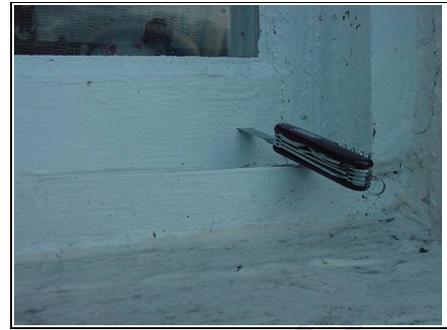
Rotten timber knife test

ACTION REQUIRED: Repair by splicing in new timber. We would always recommend saving as much of the old timber as possible as it was better quality than today's timber.

ANTICIPATED COST: As you are likely to need to scaffold the area to give a protective roof layer so that the kitchen is not damaged we would say £10,000 - £15,000 (ten thousand – fifteen thousand pounds) ; please obtain quotations.

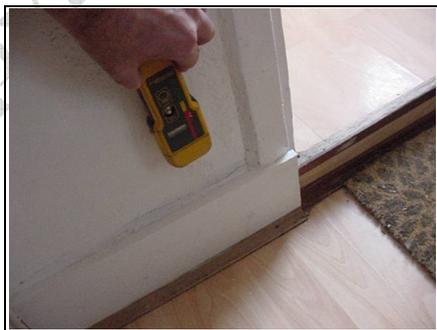
Dampness was found particularly to the rear of the property. We noted the high ground levels.

Dampness found in dining room due to the ground levels

ACTION REQUIRED: We would recommend lowering the ground level and ideally adding a French drain.

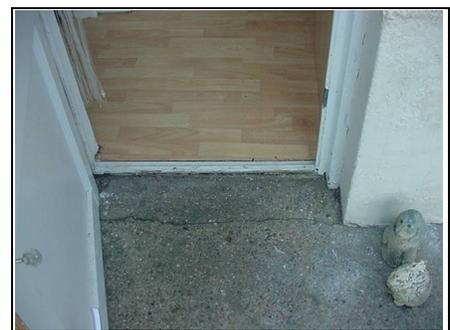
High ground levels

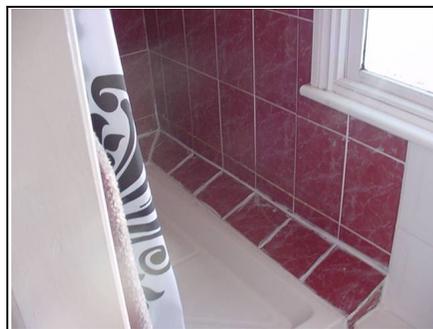
It does look as if the shower has been repaired several times indicating that it leaks.

Leaking Shower room

ACTION REQUIRED: We would recommend that you re-seal this area as one of the first tasks you carry out.

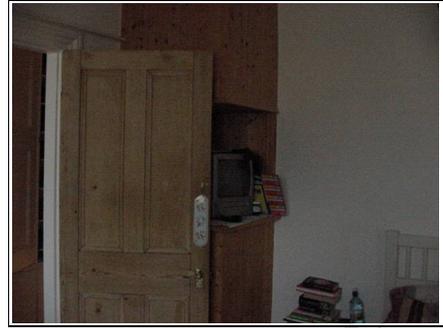
Boxed in old boiler

ACTION REQUIRED: Open up area to check its condition and see if the boiler and pipe work needs removing.

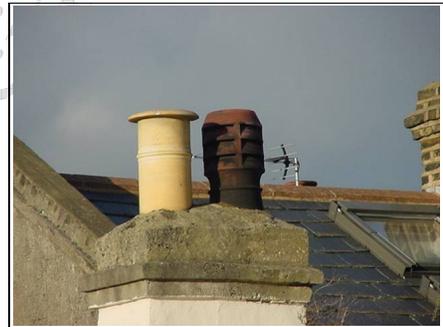
Rear left hand side chimney

This chimney is render finished with a cement flashing and two chimney pots. From what we could see we believe there may be problems with the render as we can see vegetation growing which normally means there is dampness in the render.

ACTION REQUIRED: Please see our comments in the Executive Summary with regard to repairs to all the chimneys.

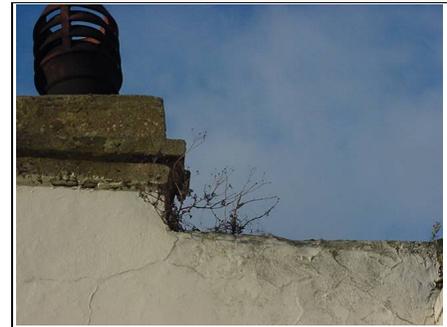
Vegetation growing in render

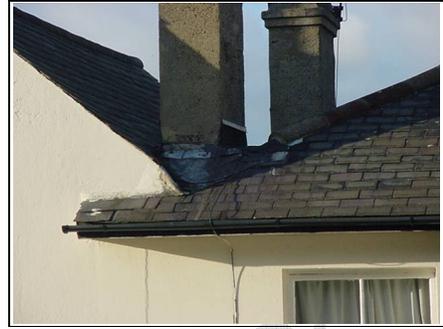
It is the base of the chimneys that concerns us as they sit in a valley gutter. It looks from the outside that there have been various repairs including re-tarring of the valley gutter. Within the roof we can see that dampness is getting in.

The two centre chimneys sitting in the valley gutter

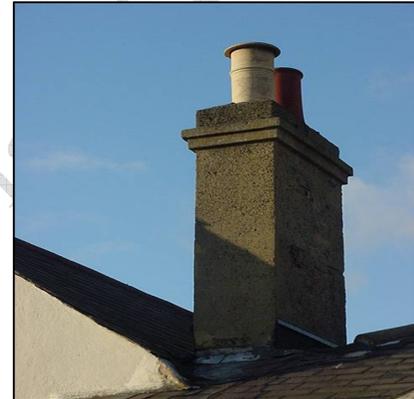
To Chimney two (the front chimney) there are repairs to the render and the render generally looks weathered.

To Chimney three (the rear chimney) the render looks weathered. This is the stage that it starts to deteriorate and dampness gets in and frost can damage it considerably.

Weathered render on chimney

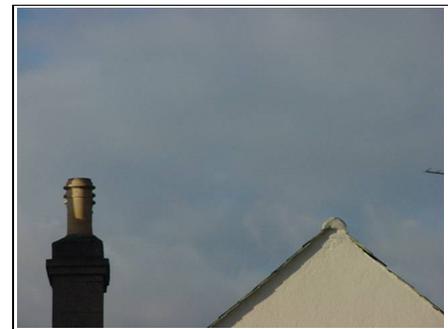
Right hand side chimney

This is the chimney we had the poorest view of and is the greatest concern. This is a large fairly slender chimney that needs a close inspection. We would recommend the summer of 2012 for this.

ACTION REQUIRED: We have concerns about all the chimneys. Please see our comments in the Executive Summary. We have recommended that a roof light is put in the valley gutter roofs. This is a roof window in the valley gutter that will give access to the central chimneys but will also give a better view of the other chimneys. This work should be carried out first and you would be better able to assess the work required to the chimneys.

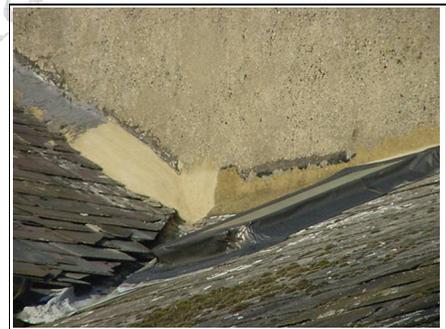
There are some awkward junctions to the rear of this roof and unfortunately the flashing looks to have deteriorated which in turn will mean dampness will get in. We could not gain access to the rear roof properly and we were very limited on our movements within the main roof due to the mass of insulation (we would not recommend this amount of insulation in this age of property).

Awkward junction

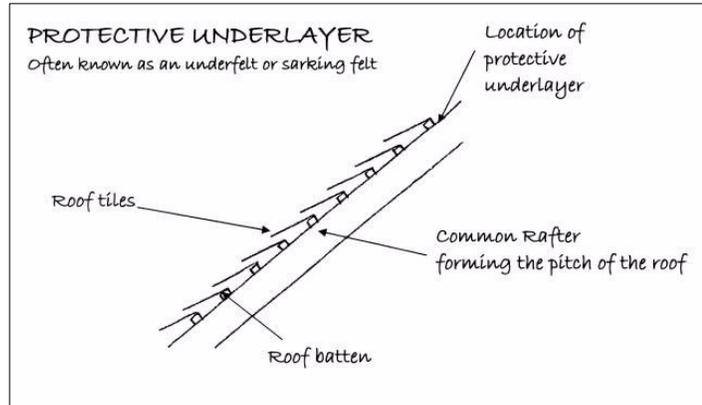
In this case this roof doesn't have a protective underlayer. It simply has the slates protecting the property.

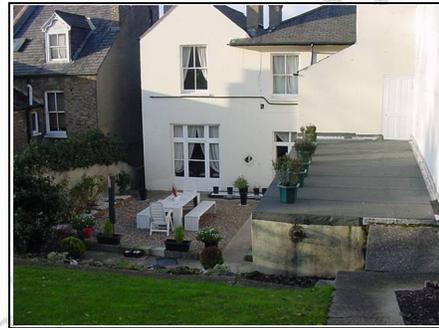
This has a mineral felt finish that looks in reasonable condition with the exception of the detailing where it meets the main parapet wall and the on the felt edge detail where there is no gutter. Our concern with the flat roof is the detailing and the roof structure.

Flat Roof on kitchen

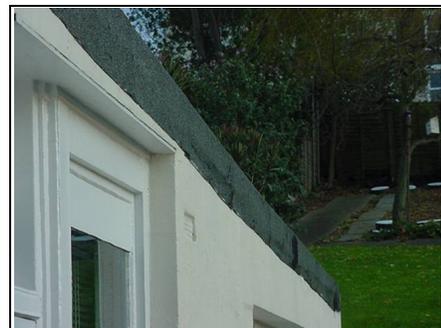
As far as we can see any rainwater will run off the roof and down the walls of the property causing dampness and deterioration.

Flat roof with no gutter

ACTION REQUIRED: The detailing needs to be improved with the addition of guttering and the flashings need to be replaced with lead flashing.

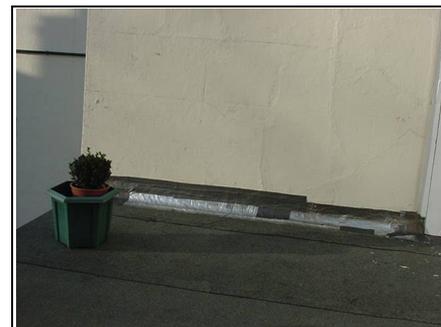
Repaired flashing

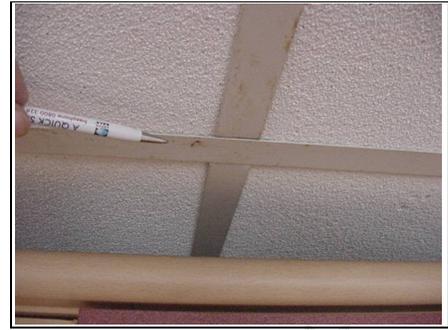
Rust on ceiling system

ACTION REQUIRED: Ideally carry out tests to the kitchen roof before you commence with this purchase. You should consider as fact that you will need a new kitchen roof.

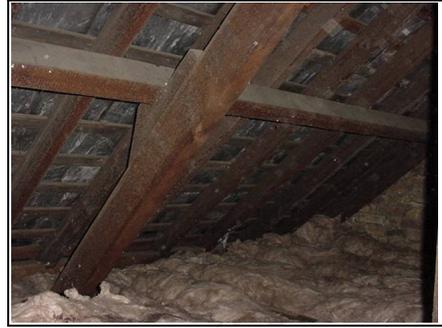
Looking at the roof to the right hand side with mould on the timbers.

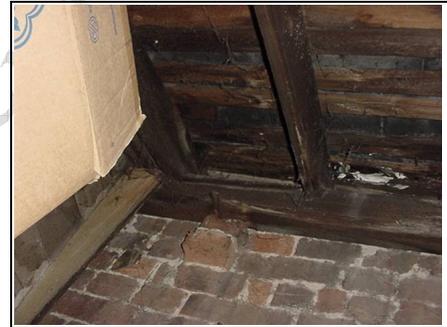
Rear Left hand side roof showing damp getting in.

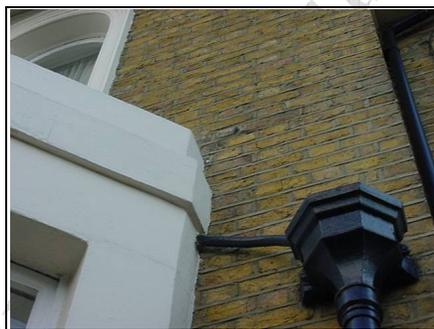
These looked in average condition apart from there being no guttering at all to the kitchen area. Also the canted bay window to the front of the property has the traditional 50mm piping which always becomes blocked

Small pipe outlet from the canted bay window that will leak and these always get blocked.

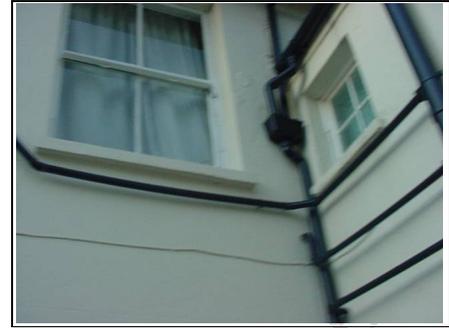
One of these runs from the far right hand rear bedroom to the soil pipe at the rear which we think is a blockage waiting to happen.

Long run of Soil and vent pipe

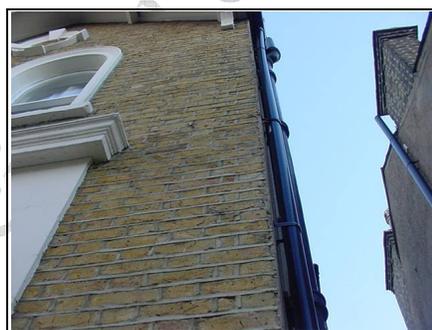
Re-pointing to the cement mortar to the front of the property

We would draw your attention to the cement mortar re-pointing that has been carried out on the exterior of the property that we feel is not appropriate to this building. Originally it will have been built with a lime-based mortar and this is what should be used for any re-pointing in the future.

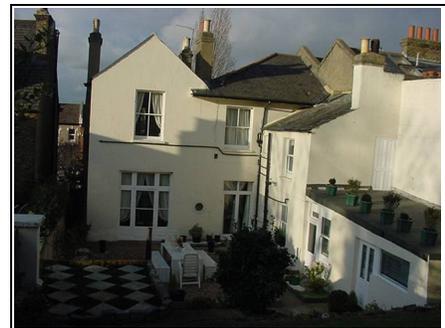
In this particular case we believe it is part of the original aesthetics and we would consider the render to be in average to below average condition.

Painted render to rear walls

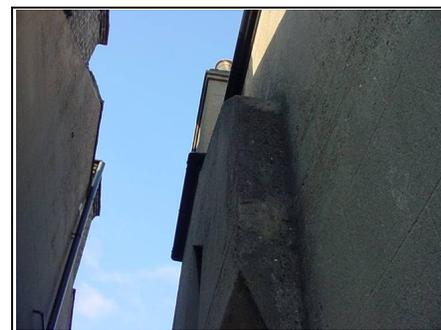
The render on the right hand side is unpainted and has a stucco effect which is lining of the plaster to make it look like stone. This area does not get much light and will be susceptible to dampness which means you need to keep the render in top condition to prevent this.

Render to right side wall 46

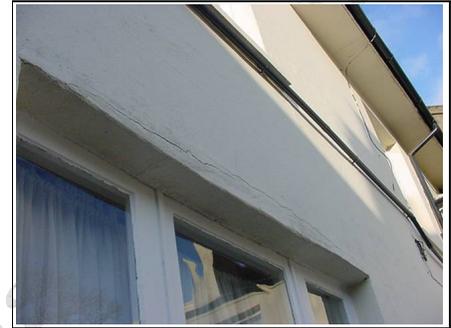
No drip over window

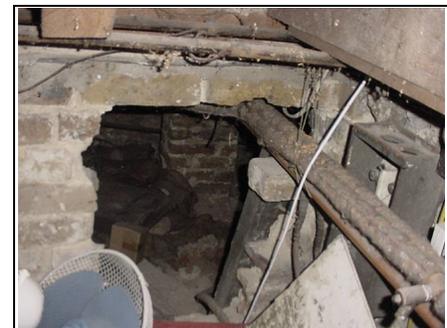
Stored items in cellar

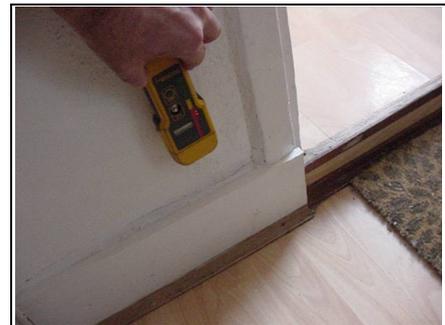
A random visual inspection and tests with a moisture meter have been taken to the perimeter walls and some internal walls. In this particular case we have found rising damp and we would comment as follows.

Testing and finding rising damp
