RESIDENTIAL BUILDING SURVEY

Surrey,
KT4 xxxx.

INDEPENDENT CHARTERED SURVEYORS

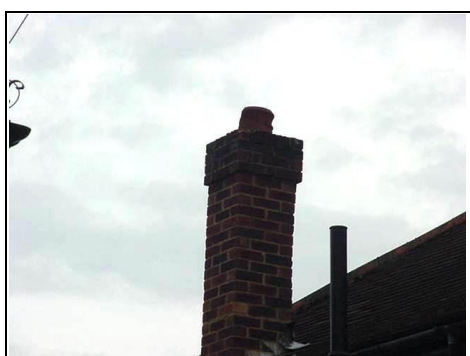
The chimneys need re-pointing ideally as soon as possible but at the latest the summer of 2014. The photographs below taken during our inspection show leaning to the chimney and the pointing required to them. There may also be rebuilding necessary although this looks unlikely at the moment. The longer you wait to carry out repairs the more likely this becomes.

Left hand chimney appears to have an inwards lean on it

ACTION REQUIRED: Re-point as soon as possible.

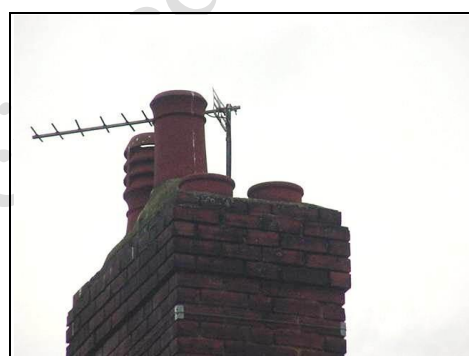
Right chimney also needs the flashings repaired

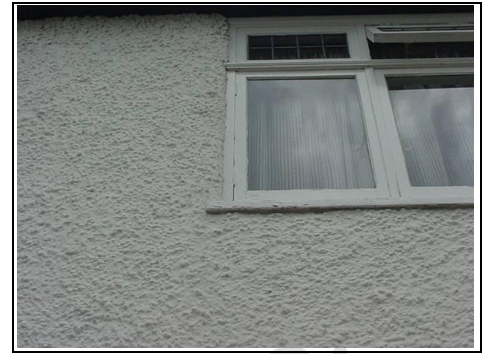
The property has the original older style rendering. We tend to find that in this age of building there is hairline cracking to the render which in turn allows dampness through. We noted some yellow staining to the front of the property that may relate to the old colour paint work grinning through (coming through).

Older style Render

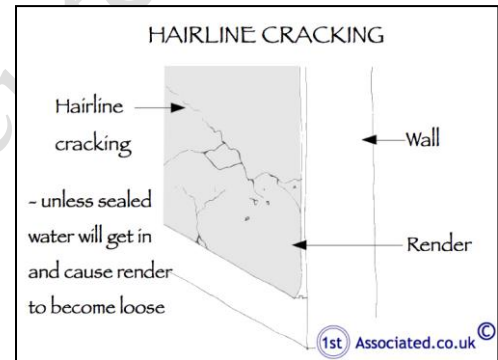
Please see our adjoining sketch that shows the typical hairline cracks that you get in the property. These are very fine and do not show up in the photos.

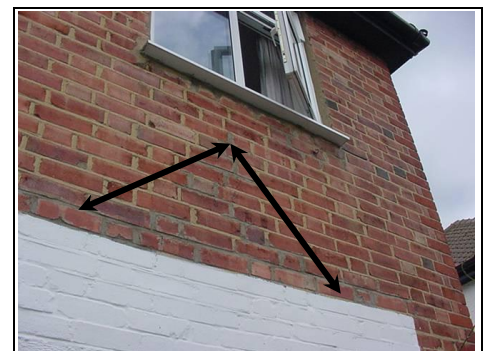
We can see to the rear of the property there has been movement. This does look to be longstanding. Nevertheless it is difficult to be one hundred per cent certain from a one off inspection and without any opening up of the structure. For example the render to the front of the property has been recently painted and may hide latent defects.

Different coloured mortar in an 'A' shaped pattern below the window indicates there has been movement

If you wish to be one hundred per cent safe and limit any possible liability then we recommend that you get the existing owner to place an insurance claim and that you see confirmation of this in writing. This way it will limit any future liability to the excess only. Then you can stay insured with the same insurer.

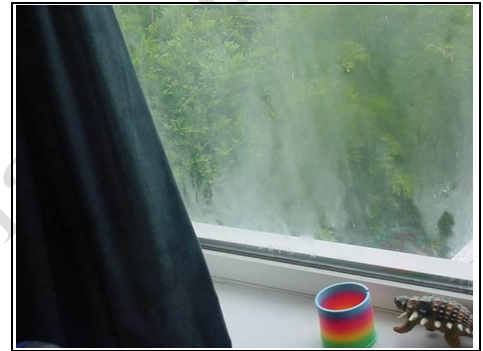
The windows are misted over indicating that the sealed double glazed units have failed or that there could have been movement in the property as a whole.

Misted window

ACTION REQUIRED: You may be able to put up with these for a while but ultimately you should budget for replacement.

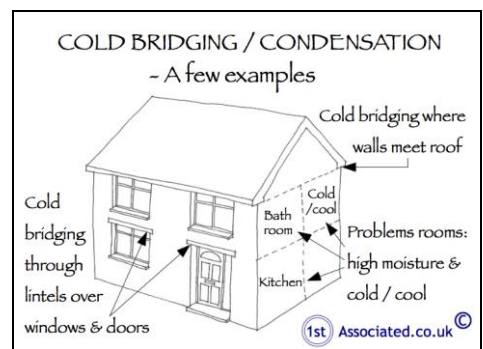
In this era of property cold bridging can be a problem (please see our article within the appendices). Unfortunately due to a few areas we have seen in the building this is likely to be above average. The issues are, firstly, the lack of proper extract fans in the kitchen and the bathroom. This means condensation is more likely (as seen in the bathroom).

Also it looks as if concrete lintels are present. These cause cold spots that then cause the cold bridging and condensation.

ACTION REQUIRED: There is very little that you can do with the lintels without major work. We would recommend that larger humidity controlled extract fans are added.

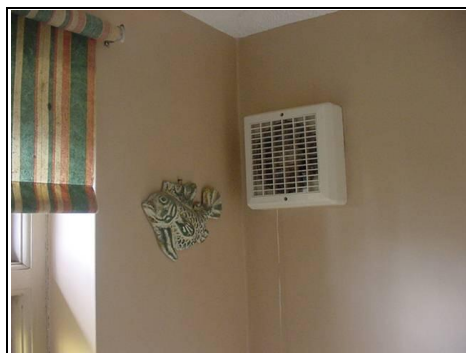
This extract fan needs replacing with a larger humidity controlled extract fan

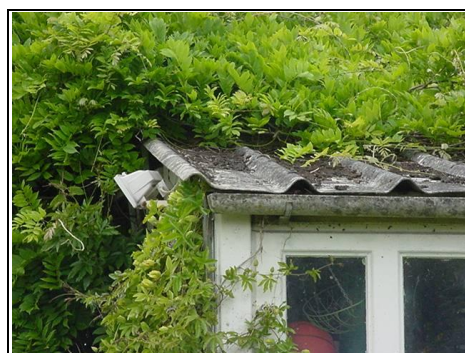
There is an asbestos roof on the garage. This is partly covered in overgrown plants and so could be deteriorating underneath this.

Asbestos Roof

ACTION REQUIRED: We always recommend the removal of asbestos roofs as legislation relating to it means it is getting harder to remove. It will also deteriorate with age. Asbestos also puts off many future purchasers and limits your market considerably.

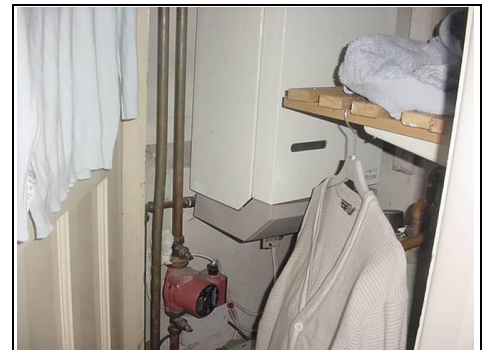
Old style Potterton boiler

ACTION REQUIRED: Budget for replacement.

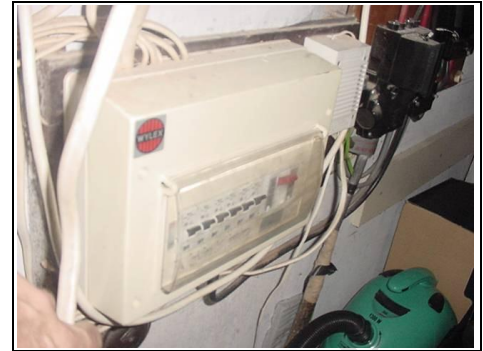
Dated electrics

ACTION REQUIRED: These should ideally be replaced. We would also recommend an Institute of Electrical Engineers standards (IEE) test and report be carried out by an NICEIC registered and approved electrical contractor or equivalent.

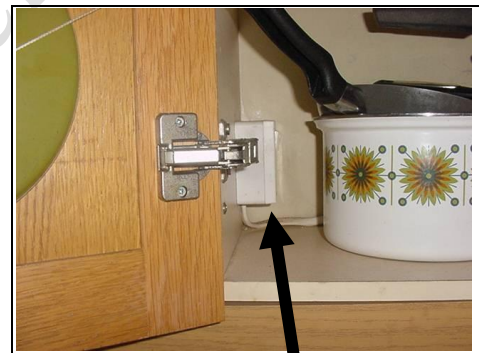
We noted there are some unusual locations for some of the socket points in the kitchen i.e. in the cupboard. This indicates to us there may be DIY re-wiring. There may be other examples of this in other areas.

Socket point in the cupboard

ACTION REQUIRED: Have an IEE test and report as mentioned above and carry out all recommendations.

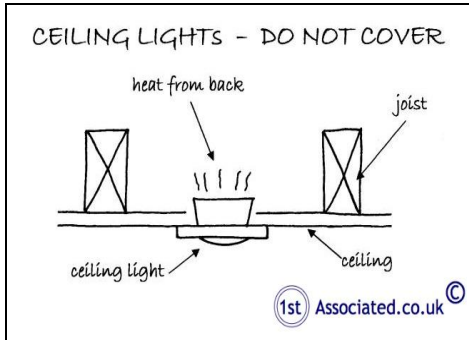
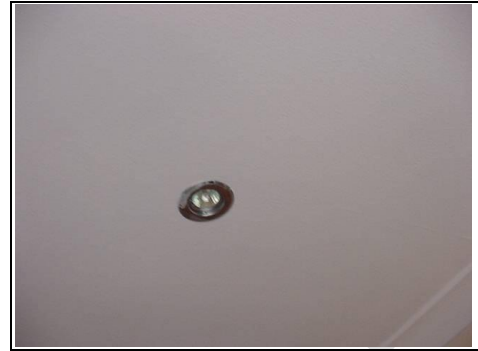
Electric lights in this position do give off heat and can cause fires.

Ceiling light

ACTION REQUIRED: Have an IEE test and report as mentioned above and carry out all recommendations.

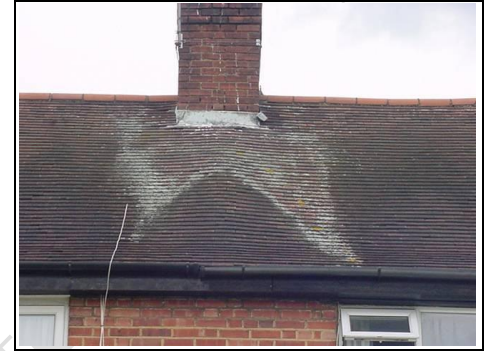
The property has a pitched hipped roof that has no protective underlayer which would be included if it was constructed today. As such rainwater can get in; typically this will be wind driven rain and also snow. Over the years this has caused the nibs on the tiles to deteriorate which ultimately will mean a new roof is required.

There is a dip in the rear roof

ACTION REQUIRED: We would recommend re-roofing in the next few years. It is difficult to give an exact time scale as to when as our weather is unpredictable and we seem to be getting highs and lows. For example, we have had a very dry spell followed by a very wet spell.

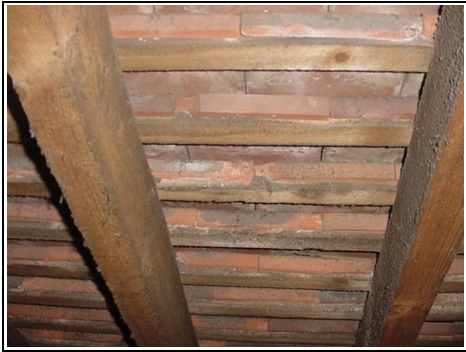
Back of the tiles, some have been replaced and some are spalling.

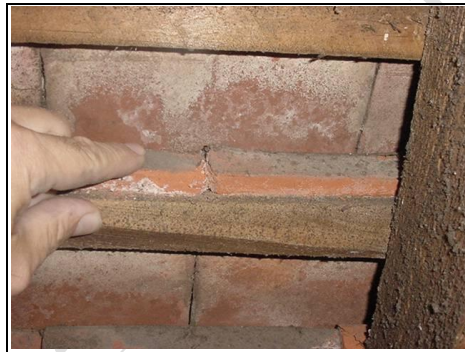
Closer still this shows dampness coming through

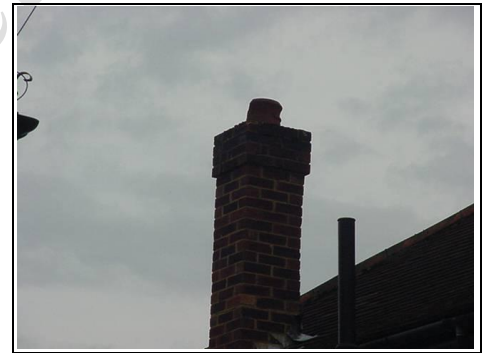
The chimney is right at the back of the property and we cannot recall seeing the chimney internally in this area. It may have been partially removed and in which case may have to have repairs carried out. To be on the safe side we suggest you budget for a thousand pounds for repairs to this chimney which would involve lintels or rebuilding part of the chimney on the lower ground floor.

Left chimney is leaning over

ACTION REQUIRED: Please see our comments within the Executive Summary and periodically inspect the chimney.

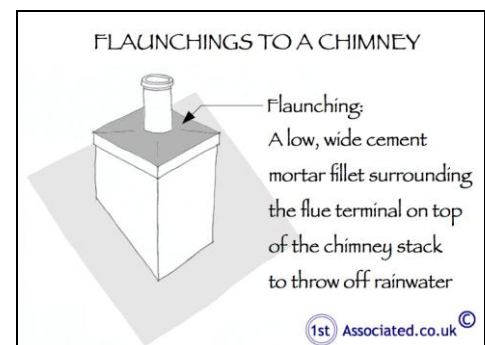
Unfortunately we also were unable to see the flaunching, however as the chimney is at an angle it does tend to indicate that the flaunchings are deteriorating.

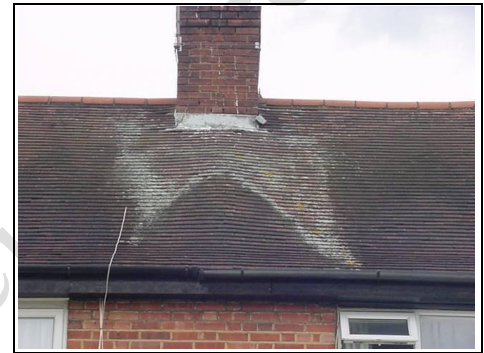
The main roof is pitched and clad with a small nibbed clay tile and needs re-roofing. There is also a dip to the rear of the roof.

Dip in the main roof to the rear

ACTION REQUIRED: Please see our comments within the Executive Summary. We would recommend a discount on the price of the property and you should consider every year that the roof lasts to be good luck and nothing more as it really does depend on the strength of the weather. You should budget for a replacement.

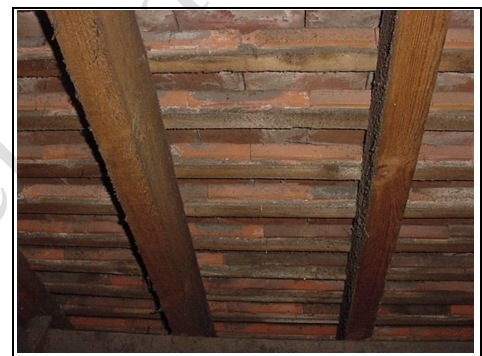
The tiles are nibbed tiles with no protective under layer. This means that wind driven rain can get underneath the tiles and indeed we can see that this is happening from the staining within the roof. We are always in a Catch- 22 with regard to this type of roof as although it is letting in some rain water it is not letting in that much.

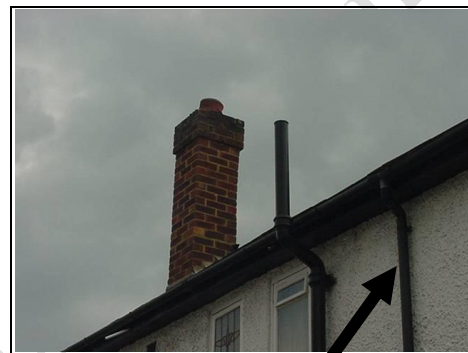
There may be some minor leaks but most people would be happy to live with these providing repairs are carried out within the next six to twelve months.

Gutter and downpipe

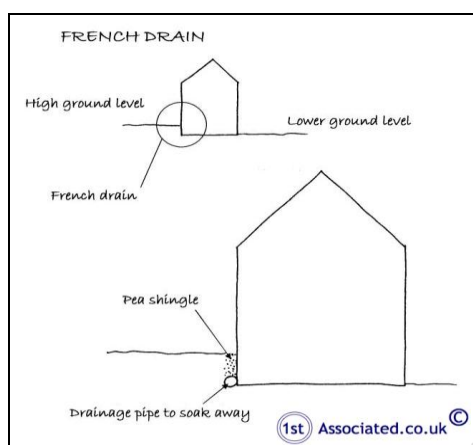
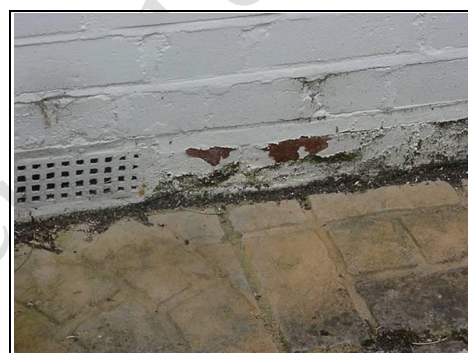
Water damage at base of property

ANTICIPATED COST: In the region of £1,000 - £2,000 (one thousand to two thousand pounds) dependant on if there is a drain for it to go in to. This helps with the general dampness under the property and we would stress that you need to open the floor as soon as possible.

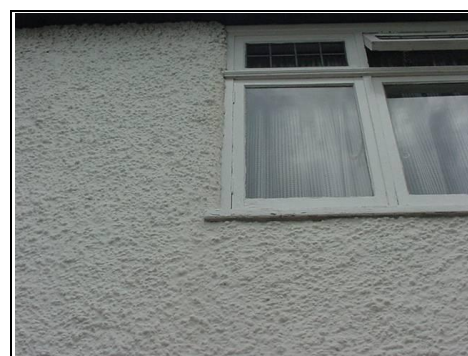
Cracking

ACTION REQUIRED: Please see our comments within the Executive Summary.

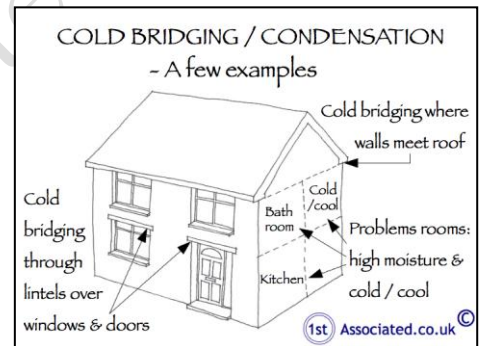
There may be cold bridging in this property because of the concrete lintels. This is a common problem and there looks to have been problems in the past which is why the lintels have been replaced. There does not seem to be any other reason for this other than possibly minor settlement.

ACTION REQUIRED: To be on the safe side regarding the settlement we would recommend a closed circuit TV report or as mentioned previously that you get the owners to submit an insurance claim.

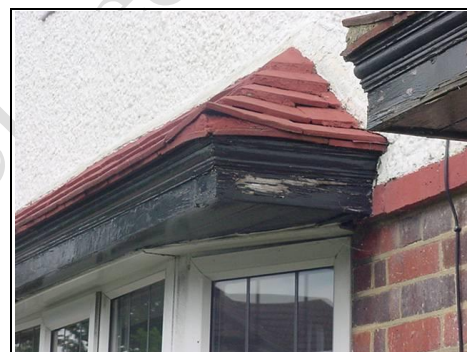
The fascias and soffits are timber. They are painted and are deteriorating in some areas, for example, the right hand side of the fascia board to the bay window.

Deteriorating fascias

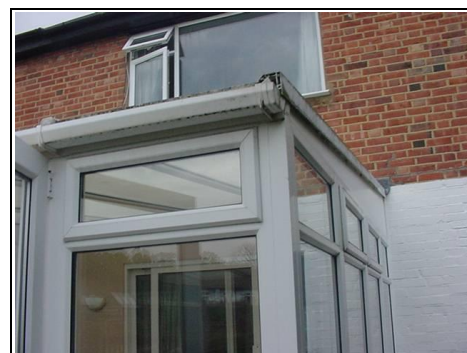
The property has a combination of plastic double glazed windows (without trickle vents) and timber single glazed windows. We would specifically comment that the plastic windows are the older style and as we mentioned do not have trickle vents. The conservatory also does not have trickle vents which both together means you will have an added chance of cold bridging.

Conservatory does not have trickle vents

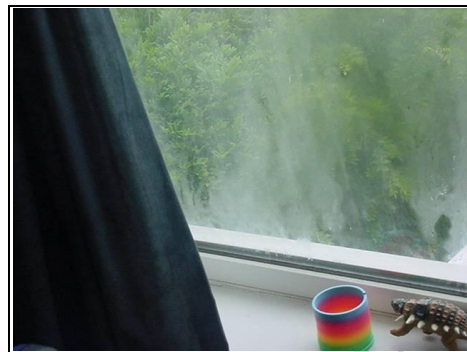
Misted window

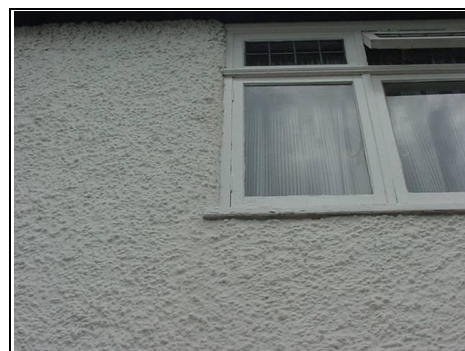
Some windows did not have sills

ANTICIPATED COST: Likely to cost in the region of £500 - £1,000; please obtain quotations.

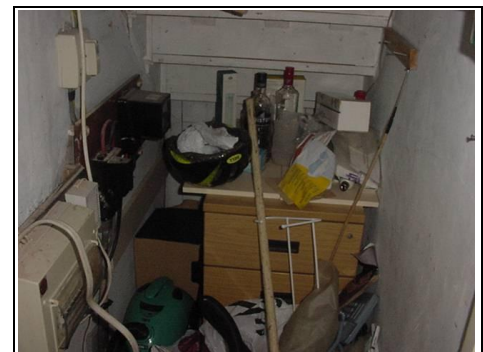
We noted that the underside of the staircase was exposed. It is more normal today to have a half hour fire barrier to stop fire spreading from the ground floor to the first floor in a worse case scenario. You may wish to take a view on whether you add this.

The stairs are not lined

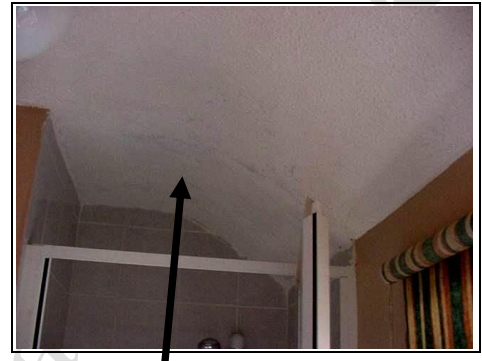
There is also a shower cubicle within the bathroom that suffers heavily from condensation.

Dampness above shower (sorry this is not very clear in the photo)

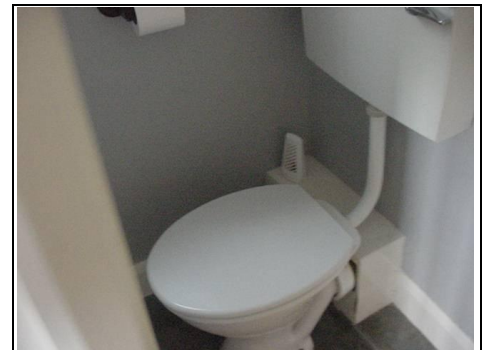
This is dated.

Dated W.C.
